**Reference: 2015 CCR Rule Inspection  
Initial Annual Landfill Inspection  
Clifty Creek Generating Station  
Madison, Indiana**

**2015 CCR Rule Inspection  
Clifty Creek Landfill**

Clifty Creek Generating Station  
Madison, Indiana  
Jefferson County

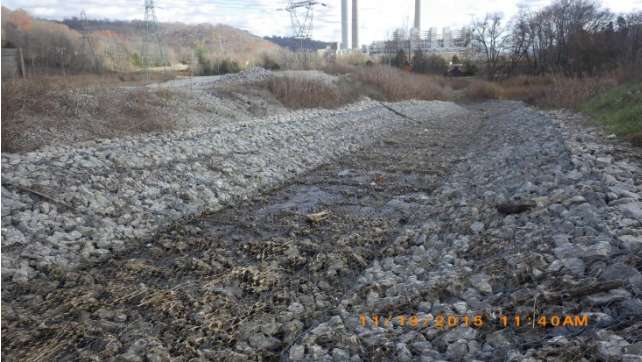
**Photo 1**

- The northwest final grade surface/storm water channel Conspan outlet has a trapezoidal shape with riprap and gabions in place as designed (Point 1, Appendix A). The amount of vegetation and debris in the channel is low and does not impede proper function of the channel (Photo 1, Appendix B). This channel lies just south of the paved haul road east of the landfill. See reference Drawing No. 16-30870-05 in Appendix C, provided to clarify the four surface water channels observed east of the Type I landfill.

Northwest final grade surface water channel.

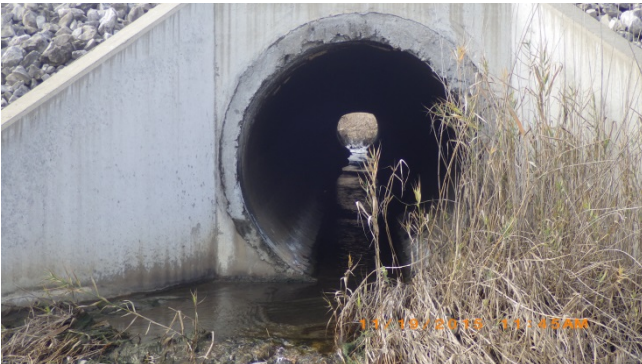
**Photo 2**

- The northwest final grade surface/storm water channel includes two headwalls passing under the access road past the temporary construction office trailers. A slight bow in the crown of the southern of the two pipes was observed; however, no depression was noticed in the road, and flow is not impeded. Minor grass was present at the pipe outlets. Riprap and gabions were in place. (Photo 2)

Northwest final grade surface water channel pipe outlet. Slight bow in pipe and minor grass in channel.

- Continue to monitor the surface water channel headwalls and culverts east of the landfill. Repair as needed.

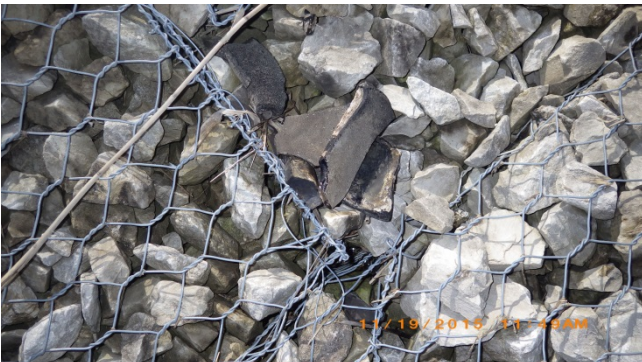
**Photo 3**

Small amounts of boiler slag mixed in with riprap and gabion baskets.

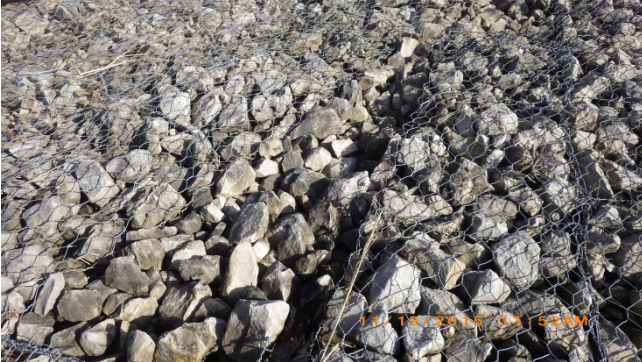
**Photo 4**

Wire mesh missing around riprap in surface water channel.

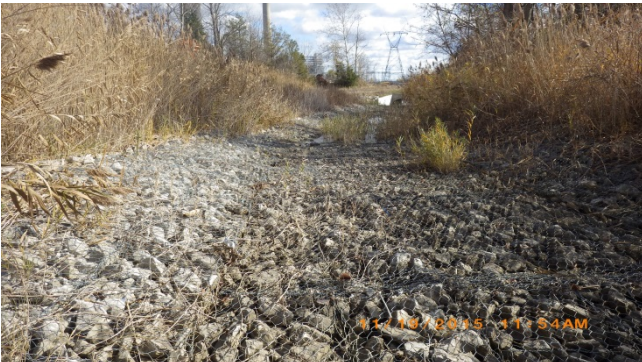
**Photo 5**

- Some grass and vegetation was present in the channel on the upstream side of Conspan closest to the West Boiler Slag Pond. The vegetation present did not impede proper function of the channel. The Conspan is a preformed concrete culvert and foundation represented on reference Drawing No. 16-30870-05 in Appendix C and a 72-lf 20'x5' culvert at 1.25% (Detail 2/23). (Photo 5)

Grass and vegetation in surface water channel approaching Conspan near the West Boiler Slag Pond.

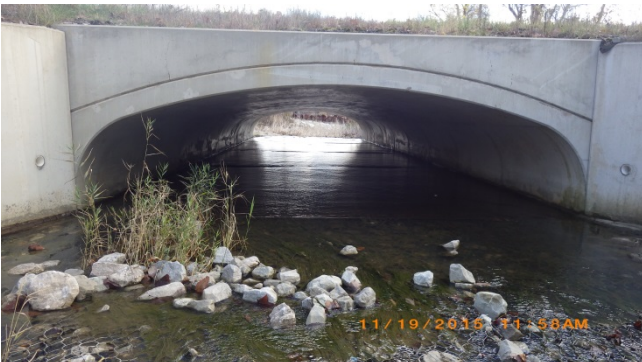
**Photo 6**

- The West Boiler Slag Pond Conspan flow appears unrestricted with slight vegetation growing. (Photo 6)

Conspan inlet near West Boiler Slag Pond.

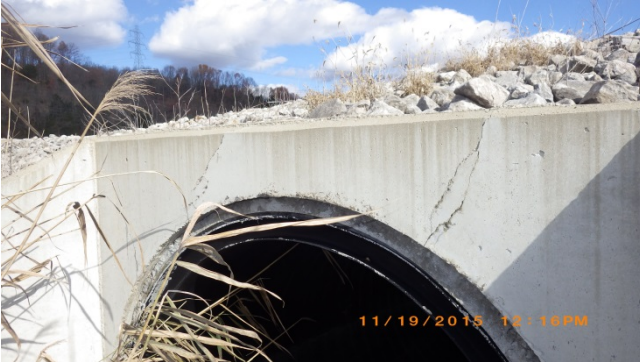
**Photo 7**

Cracks in headwall for inlet of pipe to the northwest final grade surface water channel.

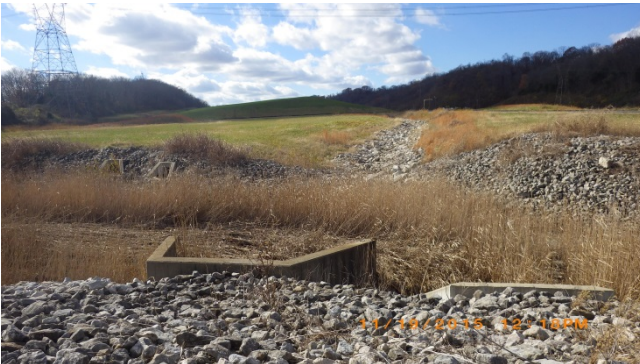
**Photo 8**

Significant amount of reeds and vegetation in the ditch at the northeast corner of the Type III landfill.

- Remove excess vegetation from drainage channels, pipe inlets, and outlets. Particularly, the northeast surface/storm water channel inlet pipes and the leachate collection system outlet pipes are overgrown and should be maintained to allow for visual inspection. Flow was observed by Stantec and plant personnel at both the inlet and outlet pipes.

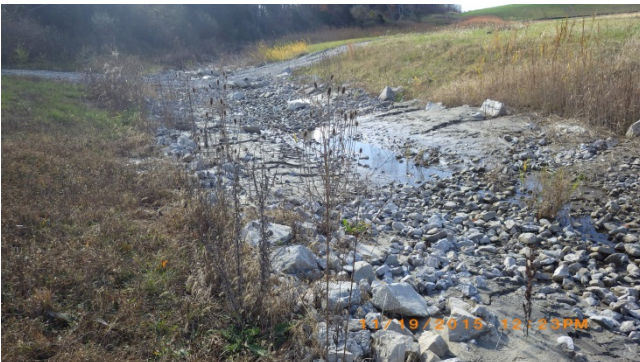
**Photo 9**

- Significant amounts of CCRs and vegetation were observed in the channel around the southern perimeter of the closed Type III landfill. Interviews with plant personnel suggested that the CCRs accessed the final cover channel during a heavy rainfall event. Maintenance activities were in progress to address the CCR movement. (Photo 9; Points 4 and 6, Appendix A)

Significant ash and vegetation in the channel around the southern perimeter of the Type III landfill.

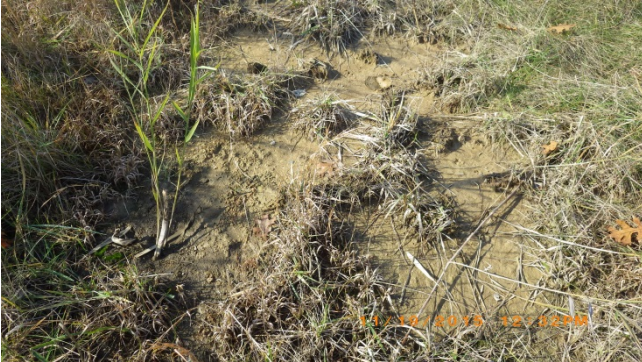
**Photo 10**

- Two bare spots were observed in close proximity to one another between the two southeast storm water channels approaching the tower. One was approximately six feet in diameter; the other was about two feet in diameter. (Photo 10; Point 5, Appendix A)

Bare spots between the two southeast surface water channels near the tower on the Type III landfill.

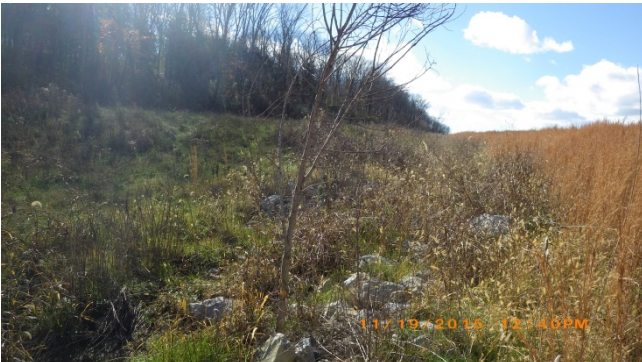
**Photo 11**

- Several trees one to three inches in diameter were observed near the base of the tower in the southeast storm water channel. (Photo 11; Point 7, Appendix A)

Several 1- to 3-inch diameter trees near the base of the tower on Type III landfill.

- Maintain the vegetation along the exterior slopes and within the surface drainage channels to facilitate inspections by removing taller weeds and woody vegetation or reestablishing vegetation as needed.

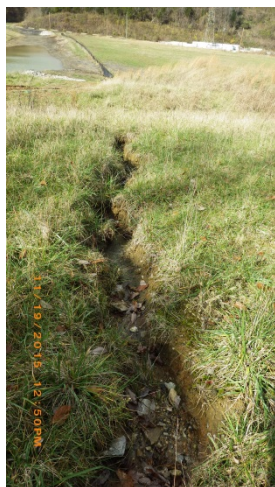
**Photo 12**

- Two significant erosion gullies were observed near the southeast corner of Subphases 1A1/1B1, but outside the limits of waste placement. They are near the surface water channel. One gully is approximately 3.5 feet wide by 2 feet deep, while the other is approximately 1.5 feet wide and 1.5 feet deep. (Photo 12; shown on Appendix A)

One of two erosion gullies near the southeast corner of Subphases 1A1/1B1.

- Continue to repair erosion features, reestablish vegetation, and continue to monitor in future inspections.

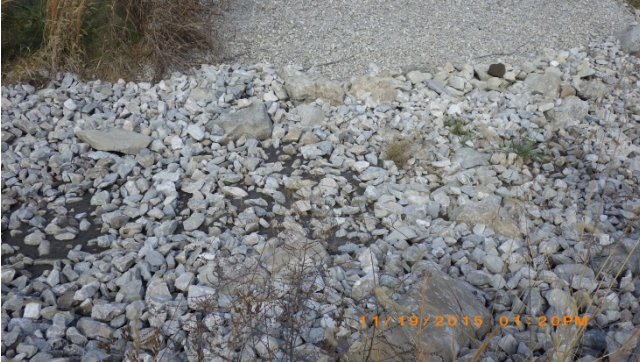
**Photo 13**

- CCR material was observed in the surface channel that runs adjacent to the haul road, next to the truck wash station, on the closed Type III landfill side. (Photo 13; Points 8 and 9, Appendix A)

Ash in surface water channel adjacent to haul road.

- Continue to conduct field inspections to limit CCR encroachment into noncontact areas. This includes in the vicinity of sediment traps and other areas where surficial flow of water occurs. Continue to maintain rock check dams to provide adequate drainage for stormwater and to alleviate excessive hydrostatic pressures at the toe of the slopes.

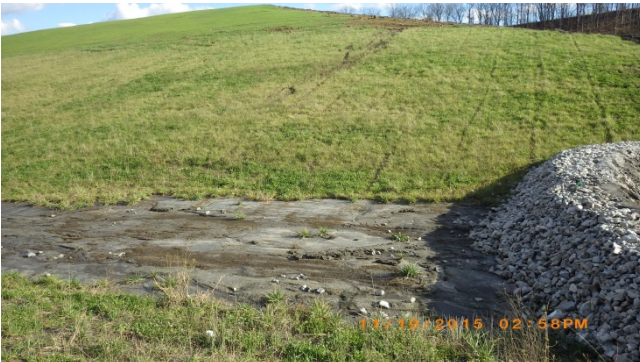
**Photo 14**

Ash in northwest channel past the rock check dam.

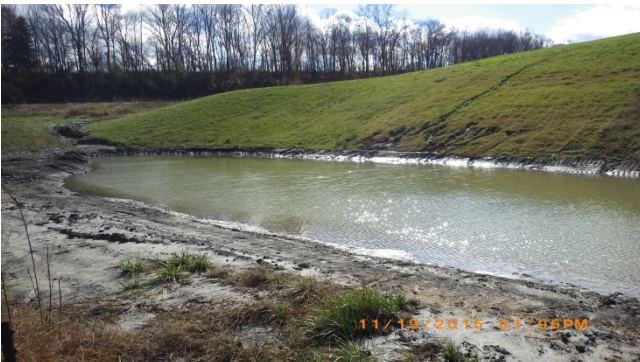
**Photo 15**

- Significant amounts of CCRs have collected in the northwest grass channel past the rock check dam and the east channel between the Type I and Type III landfills. Water has pooled in both channels, but more significantly in the east channel. (Photos 14 and 15)

Water pooled behind rock check dam on east channel between Type I and Type III landfill.

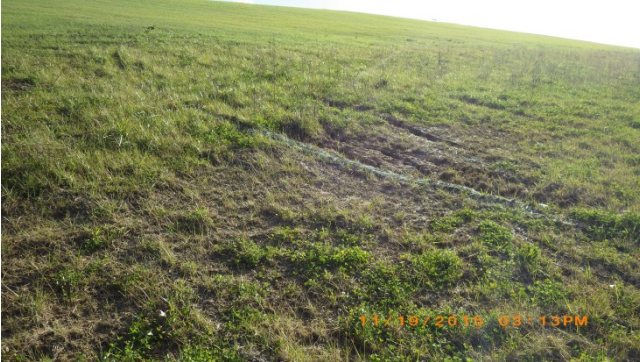
**Photo 16**

Bare spot with exposed erosion control netting, northern slope of Subphase 1A1.

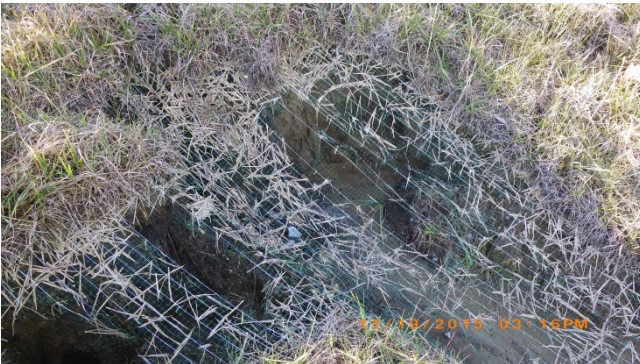
**Photo 17**

Holes on northeast slope of Subphase 1A1.

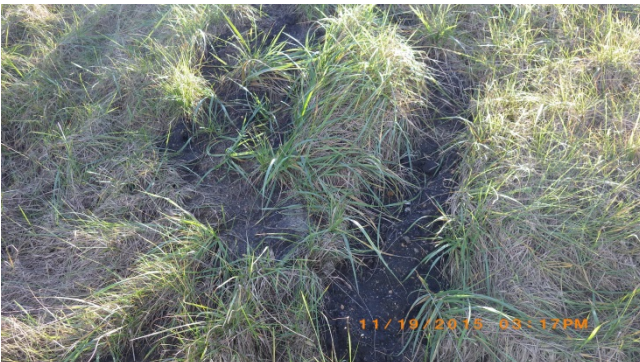
**Photo 18**

Erosion rill in temporary cover on eastern slope of Subphase 1A1.

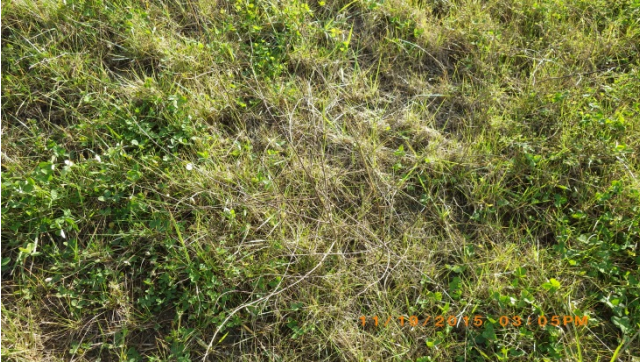
**Photo 19**

Small, woody vegetation on lower slope of northern and eastern sides of Subphase 1A1.

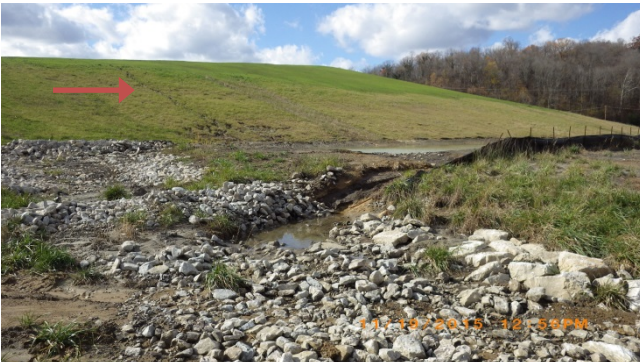
**Photo 20**

- An erosion rill runs from top to bottom of the eastern slope of Subphases 1A1/1B1 near the northeast corner. It is approximately 1.5 feet wide by 1 foot deep. (Photo 20; Point 16, Appendix A)

Erosion rill running top to bottom near northeast corner of Subphase 1A1.

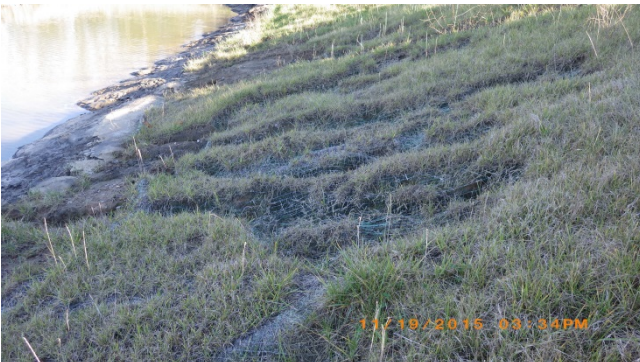
**Photo 21**

- Approximately 10 small rills have distressed the vegetation and exposed the erosion control netting within the temporary cover at the toe of the southeast corner of Subphases 1A1/1B1 on the east side. (Photo 21)

Approximately 10 small erosion rills distressing the vegetation at the toe of the southeast corner of Subphase 1A1.

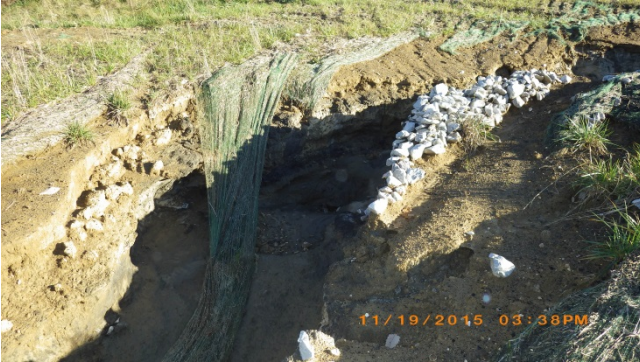
**Photo 22**

- The surface/storm water channel at the northeast corner of Subphase 1A1, downstream of the rock check dam, has eroded to expose holes/drops deeper than approximately four feet. These are undercutting slope and channel on the Devil's Backbone side and on top of the flatter Subphase 1B1. (Photo 22; Point 18, Appendix A)

Significant erosion of surface water channel at northeast corner of Subphase 1A1.

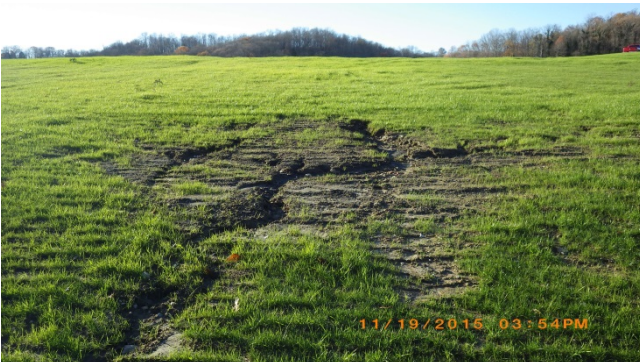
**Photo 23**

Bare area on southeast corner of Subphases 1A1/1B1.

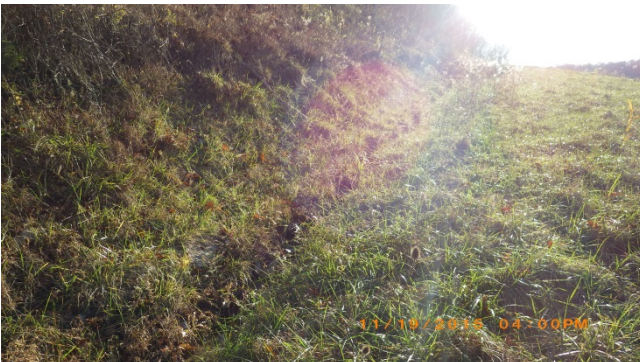
**Photo 24**

Erosion rill in protective cover at the northeast corner of the active Subphase 1A2 on Devil's Backbone slope.

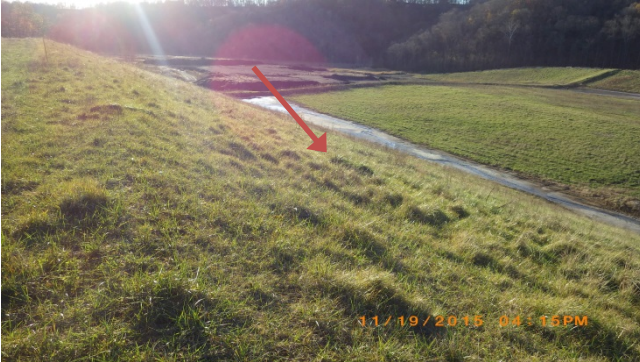
**Photo 25**

- Vegetation on the southern slope of Subphase 1C1 is approximately six inches tall. In Subphases 1A2/1B2, a minor percentage of vegetation is approximately two feet tall; whereas in Subphase 1C1, the minor percentage of vegetation is three to four feet tall. (Photo 25)

Vegetation on southern slope of Subphase 1C is taller than that established in other subphases.

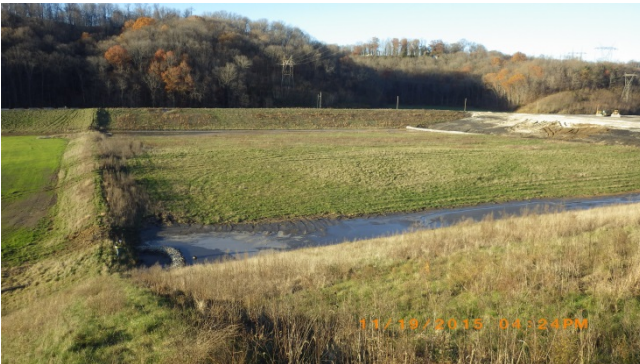
**Photo 26**

- Water and CCRs were observed running through the surface ditch on Subphase 1C1 from the active subphase as designed. It is being contained by the rock check dams on both the north and south side ditches. This is a contact water channel controlling runoff from the active cell towards the Landfill Runoff Collection Pond. (Photo 26)

Water and ash in surface ditch on Subphase 1C1, contained by rock check dam.

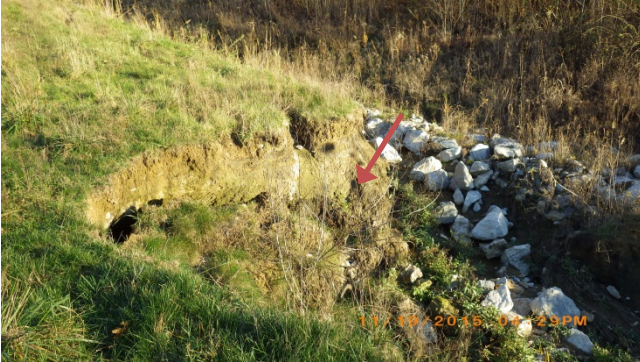
**Photo 28**

Severe erosion of surface water channel down Devil's Backbone on south side of Subphase 1C.

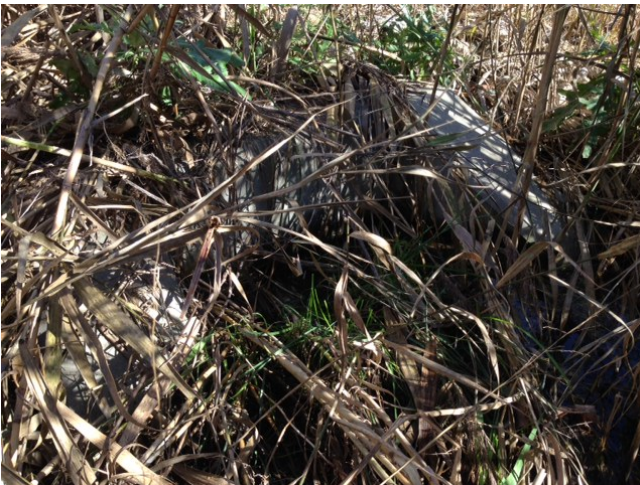
**Photo 29**

- An erosion gully was encountered on the slope near the west end of Subphase 1C toward the landfill runoff collection pond. The gully is approximately 1 foot wide by 1.5 feet deep. (Photo 27; Point 26, Appendix A)
- The surface/storm water channel running down Devil's Backbone on the south side of Subphase 1C is severely eroded from nearly the top of the slope down to the area of boiler slag beneficial reuse subgrade placement. (Photo 28)
- The leachate pipe outlet is obstructed by vegetation. (Photo 29)

Leachate pipe outlet obstructed by vegetation.
