Re: Indiana-Kentucky Electric Corporation
Clifty Creek Station's 2018 Annual Landfill Inspection

**Reference: 2018 CCR Rule Inspection
Annual Landfill Inspection
Clifty Creek Generating Station
Madison, Indiana**

**2018 CCR Rule Inspection
Clifty Creek Landfill**

Clifty Creek Generating Station
Madison, Indiana
Jefferson County

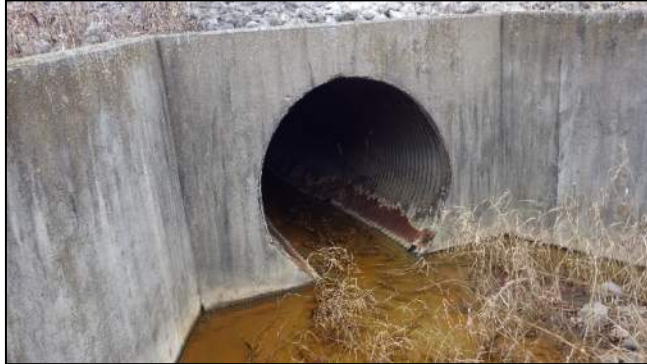
**Photo 1**

- Cracking, spalling, and deterioration was observed affecting the interior lining of the southernmost of the two culverts passing under the access road on the east end of the closed Type III landfill (Point 1, Appendix A; Photo 1, Appendix B). The deterioration has caused the corrugated metal to be exposed to flow. Both culverts were obscured by vegetation (Point 2, Appendix A; Photo 2, Appendix B).

Cracking, spalling, and deterioration of pipe lining in culvert. Photo looking west, from downstream to upstream in pipe.

- Continue to repair erosion features, reestablish vegetation, and monitor in future inspections.
- Continue to monitor the surface water channel headwalls and culverts east of the landfill. Repair as needed.

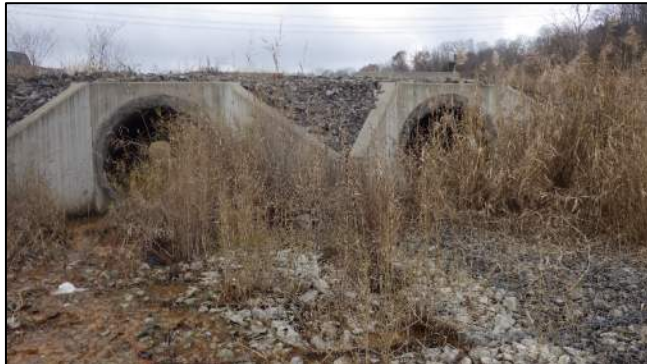
**Photo 2**

Vegetation blocking visual inspection of the combined surface/storm water channels at the eastern edge of the landfill areas, flowing east to the West Boiler Slag Pond. Photo looking northwest, from downstream looking upstream.

- Remove excess vegetation from drainage channels, pipe inlets, and outlets. Flow was visible at the pipes observed by Stantec during the December site visit.

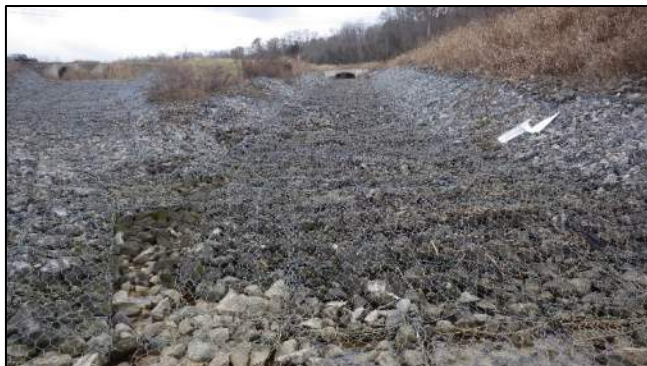
**Photo 3**

- The riprap mattress in the north stormwater channel near the haul road was observed to be slightly displaced with bulging and was wavy in appearance (Point 3, Appendix A; Photo 3, Appendix B). This did not appear to impact functionality.

Slight displacement of riprap mattress in combined storm/surface water channel. Bulging of mattress and wavy in appearance. Photo looking west, from downstream to upstream.

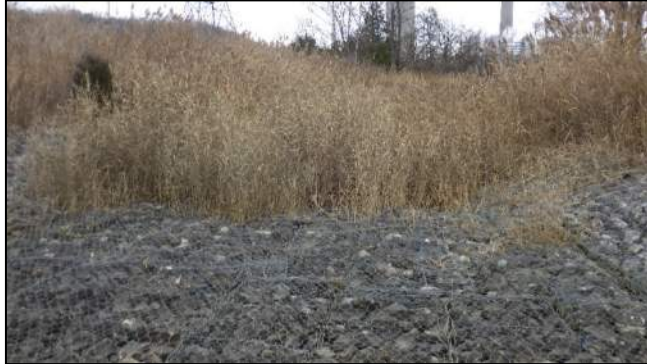
Photo 4

A low area in the combined surface/storm water channel upstream of the Conspan flowing into the West Boiler Slag Pond. Photo looking east, toward West Boiler Slag Pond.

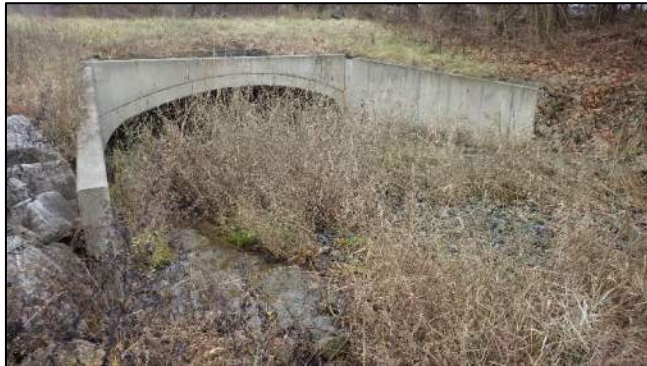
Photo 5

Grass and vegetation in the channel upstream of the Conspan near the West Boiler Slag Pond. Photo looking southeast from upstream side of Conspan.

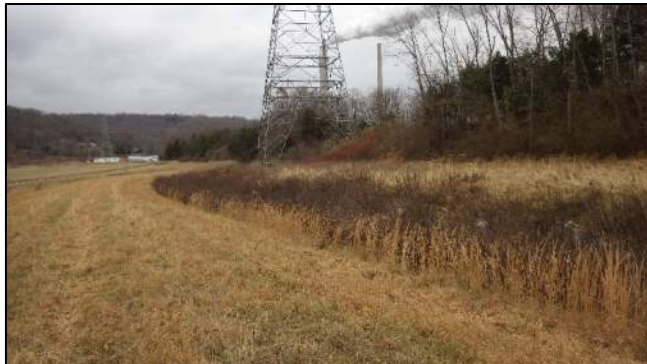
Photo 6

Upstream end of heavy vegetation in the southern surface/storm water channel. Photo looking east. See Point 6 in Appendix A.

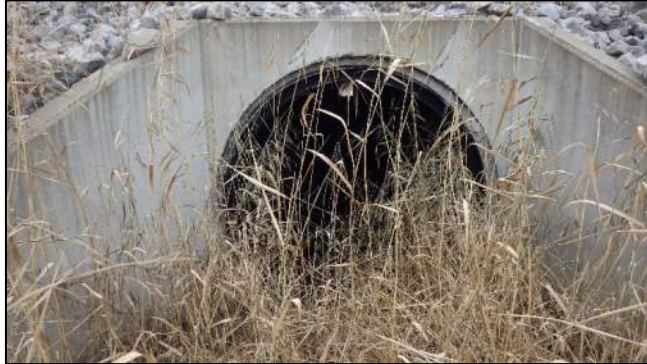
Photo 7

The cracks in the inlet headwall for the northwest final grade channel appears unchanged since the 2015 visit. Photo looking east at upstream headwall.

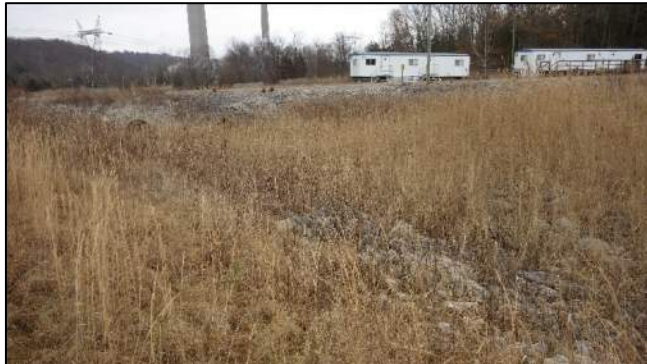
Photo 8

Grassy vegetation in the sedimentation pond for the final grade channels. Photo looking northwest.

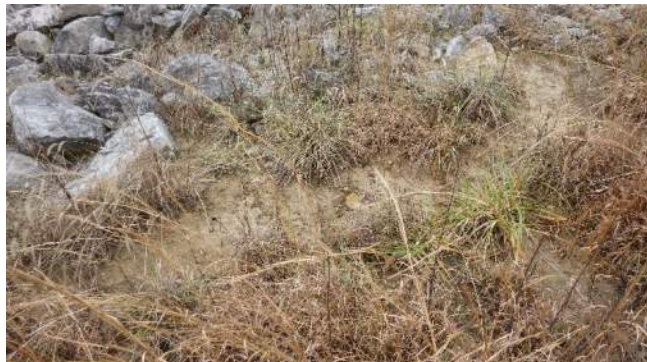
Photo 9

- Vegetation was sparse in a bare area (approximately 4 feet wide by 30 feet long) along the north side of the final grade surface/storm water channel adjacent to the riprap (Point 9, Appendix A; Photo 9, Appendix B). This appeared to be in the same condition as observed the previous two annual CCR Rule inspections.

Bare area zone along northern final cover channel. See Point 9 in Appendix A. Photo looking south.

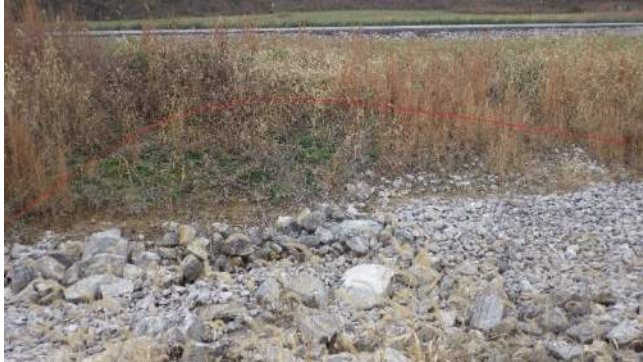
**Photo 10**

- A potential slough was observed along the south side of the haul road at the toe of slope toward the northeast corner of the Type III landfill (Point 10, Appendix A; Photo 10, Appendix B). The scarp appeared to be semi-circular, approximately 15-20 feet in diameter. It did not appear to impact the integrity of the haul road. The 2017 photo is included due to denser vegetation during the 2018 site visit.

Potential slough observed on south side of haul road at toe of slope. Approximately 15-20 feet diameter, and did not appear to impact the haul road. See Point 10 in Appendix A. Photo looking north. (2017 photo provided due to denser vegetation in 2018.)

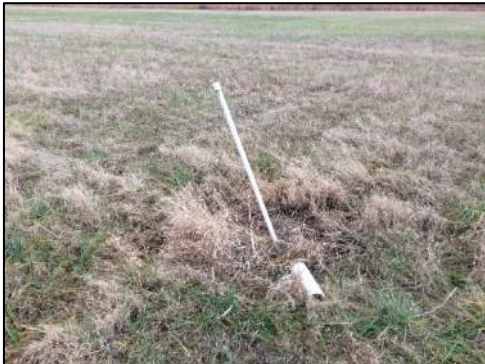
**Photo 11**

The one-inch PVC standpipe marking the end of the four-inch PVC pipe on the Type III landfill cover. See Point 11 in Appendix A. Photo looking southeast.

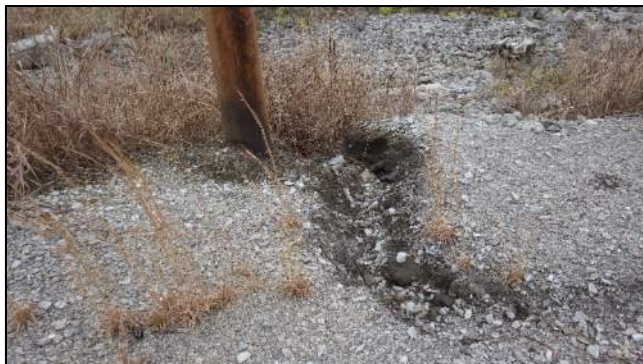
**Photo 12**

The erosion rill near the utility pole at the southeastern edge of the truck wash station into the northern storm/surface water drainage channel. See Point 12 in Appendix A. Photo looking south.

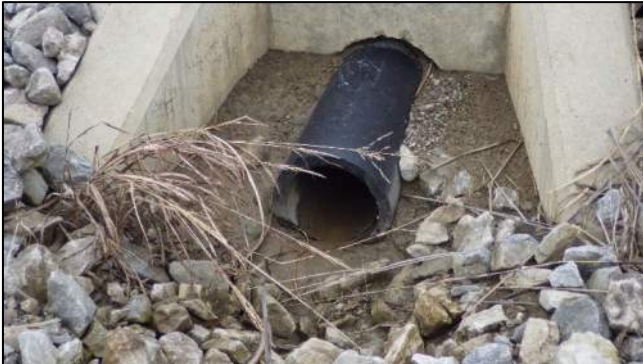
**Photo 13**

The surface drainage pipe from the truck wash station into the northern storm/surface water drainage channel on the Type III landfill cover was partially obstructed by sediment. See Point 13 in Appendix A. Photo looking north.

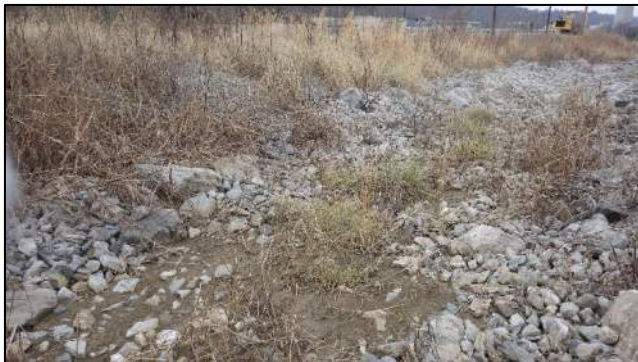
**Photo 14**

- A bare area was noted in the northern final grade surface/storm water channel bed west of the truck wash and downstream of the landfill's check dams (Point 14, Appendix A; Photo 14, Appendix B).

Bare area in the northern storm/surface water channel bed west of the truck wash. See Point 14 in Appendix A. Photo looking east.

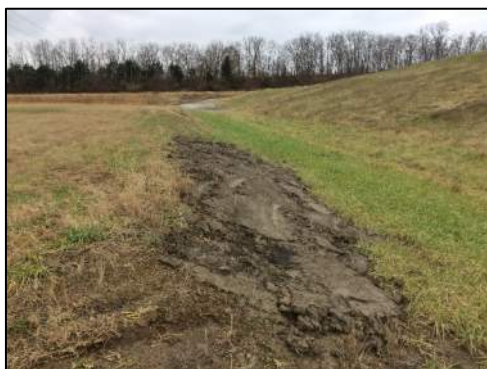
**Photo 15**

Bare area noted along western edge of Type III landfill cap. See Points 15 to 16 in Appendix A.

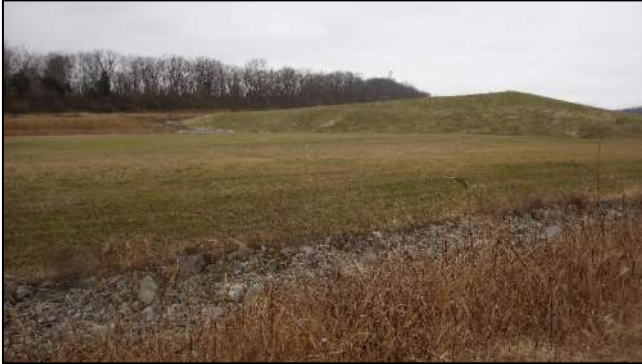
**Photo 16**

The Type III landfill cap appears uniform, mowed, and maintained.

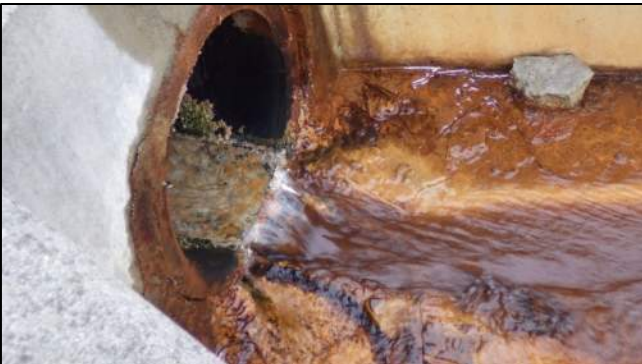
**Photo 18**

Flow out of the southern leachate pipe. Discoloration around outside circumference of pipe. Standing water and sheen above headwall.

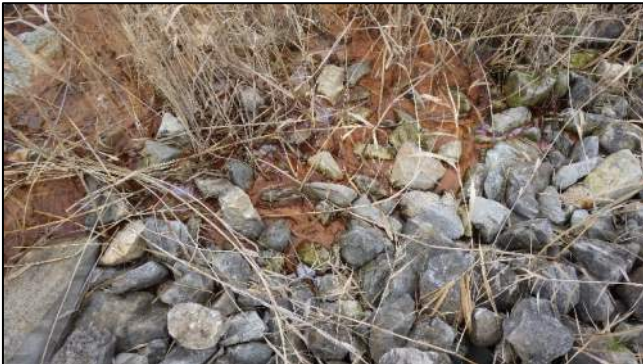
Photo 20

Seep at outlet of southern Type I landfill
leachate pipe. Standing water and
sheen above headwall. See Point 17 in
Appendix A.

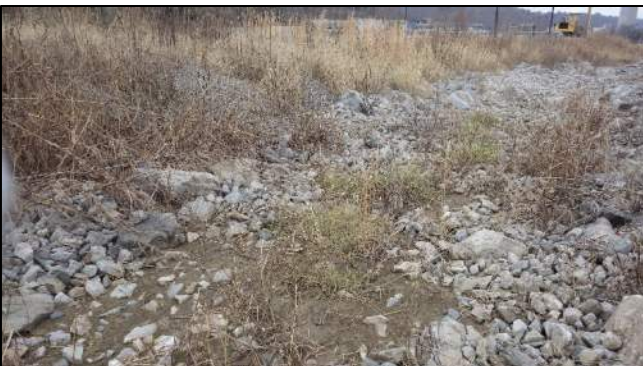
Photo 21

Sediment in the final grade southern
surface/storm water channel. Photo
looking northeast. See Point 18 in
Appendix A.

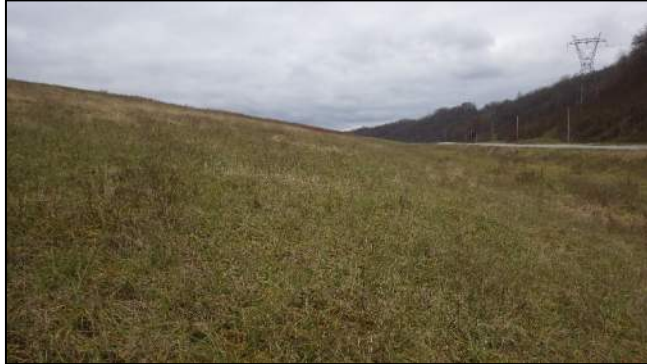
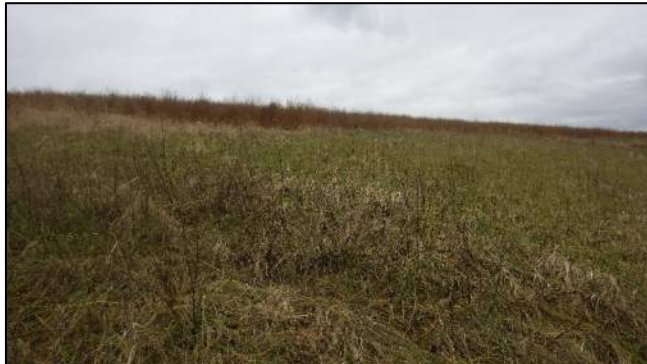
- The temporary cover vegetation on the top of Subphases 1A1/1B1 (Points 21 and 22, Appendix A; Photos 22 and 23, Appendix B) was generally in one of two conditions: 1.5 feet or taller grasses that were typically laying down, or 4 feet or taller brushy vegetation. The dense vegetation obscured a visual inspection of the slopes for erosion rills. The slopes appeared fairly uniform and unchanged from previous inspections. Additional grading may be needed to prepare the slopes prior to final cover placement.

Typical image of the northern temporary slope of Subphases 1A and 1B showing the uniformity of the slope and vegetation. Photo looking northwest.

Typical image of the northern temporary slope of Subphases 1A and 1B showing the uniformity of the slope and vegetation. Photo looking south toward the vegetation change.

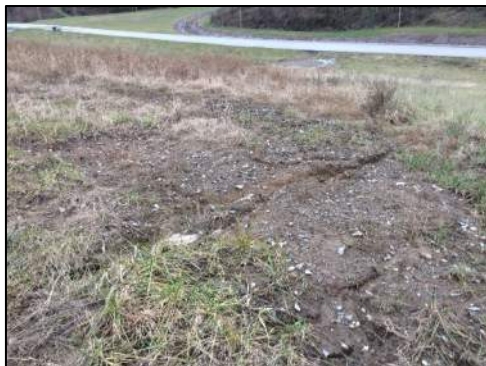
**Photo 24**

Bare/rocky area of temporary cover, approximately 15 feet by 11 feet. See Point 27 in Appendix A. Photo looking north across the temporary soil cover of the landfill.

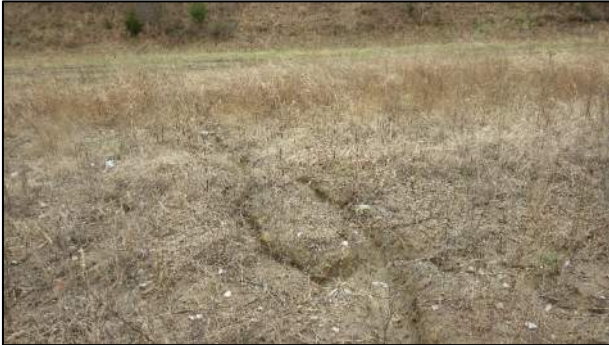
**Photo 25**

Erosion rill from top to bottom of northeastern slope of Subphases 1A1/1B1 near the north corner. Has been monitored since 2016 inspection. This rill runs downhill from Point 28 as shown in Appendix A.

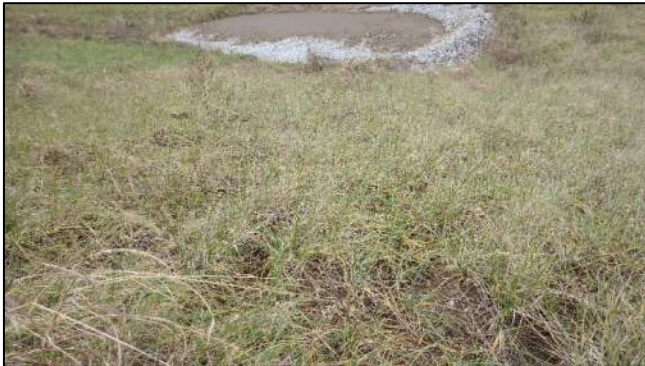
**Photo 26**

Erosion rills above the check dam on the northern slope of the landfill. See Point 29 in Appendix A.

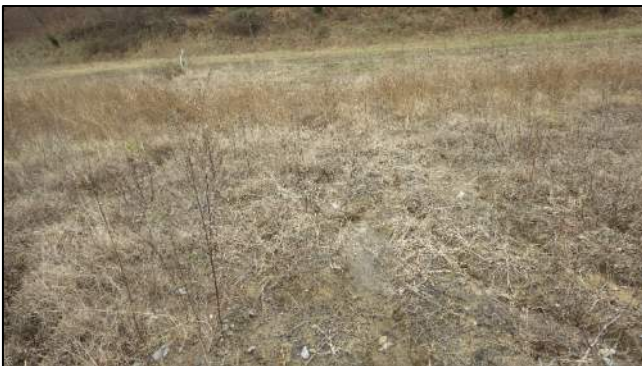
**Photo 27**

Poor vegetation areas with multiple erosion rills estimated as six-inches wide, one-foot deep, and six visible. See Point 30 in Appendix A. Photo looking north.

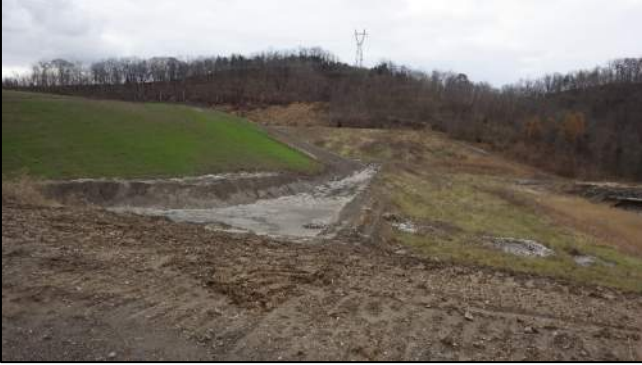
Photo 31

Stormwater collection outlet on south side of Subphase 1C. Sediment collected at outlet. Photo looking west.
