**2024 CCR Rule – Surface Impoundments  
Clifty Creek Dam/Dike Inspections**

Clifty Creek Generating Station  
Madison, Indiana  
Jefferson County

January 19, 2025

Stantec Consulting Services Inc.  
Cincinnati, Ohio

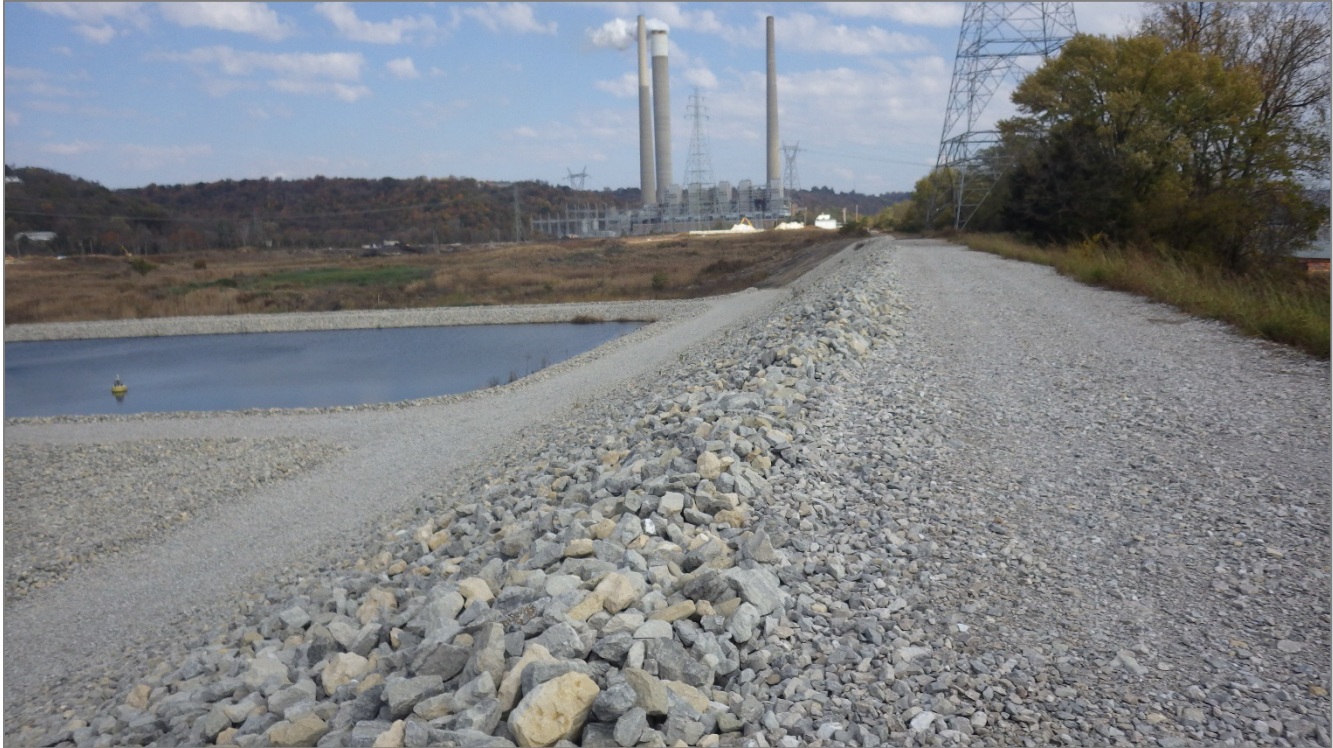
Photograph 1 – South dike embankment, upstream side looking east. LVWTS on left.

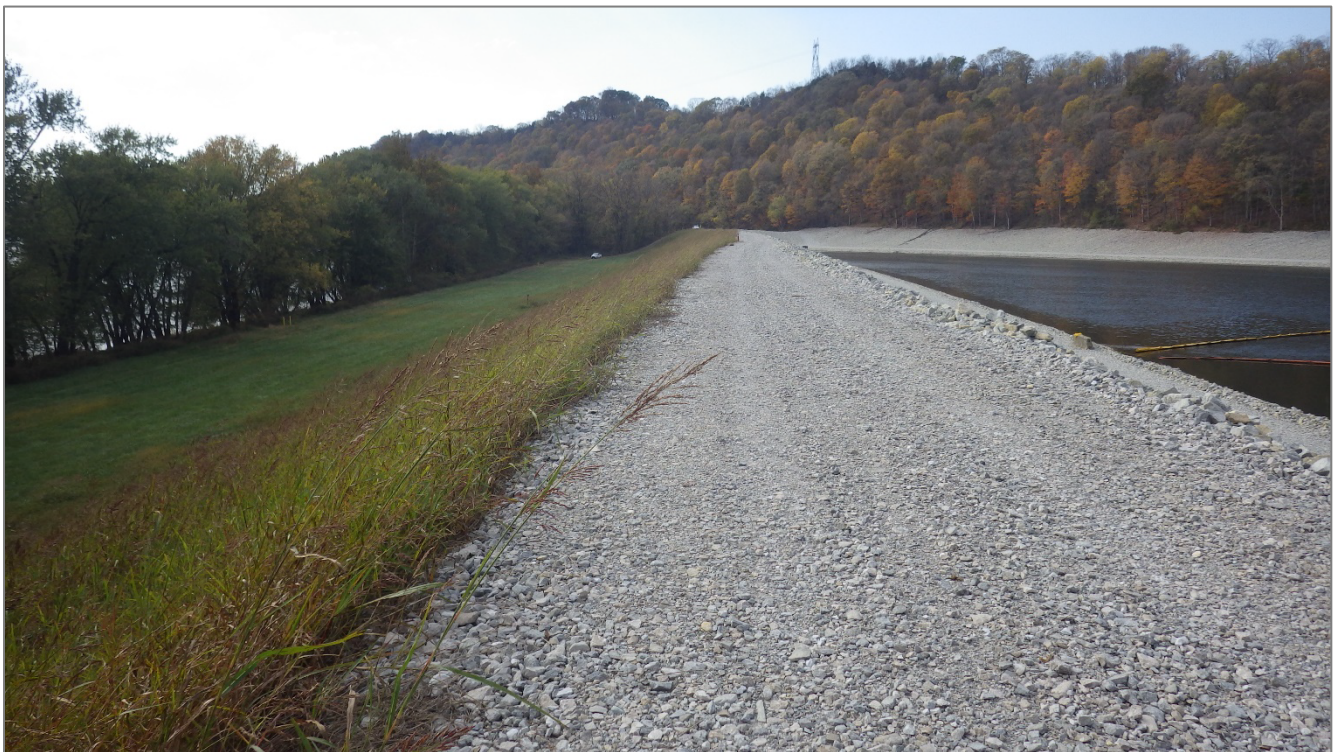
Photograph 2 – Exterior southwest dike embankment crest, looking west.

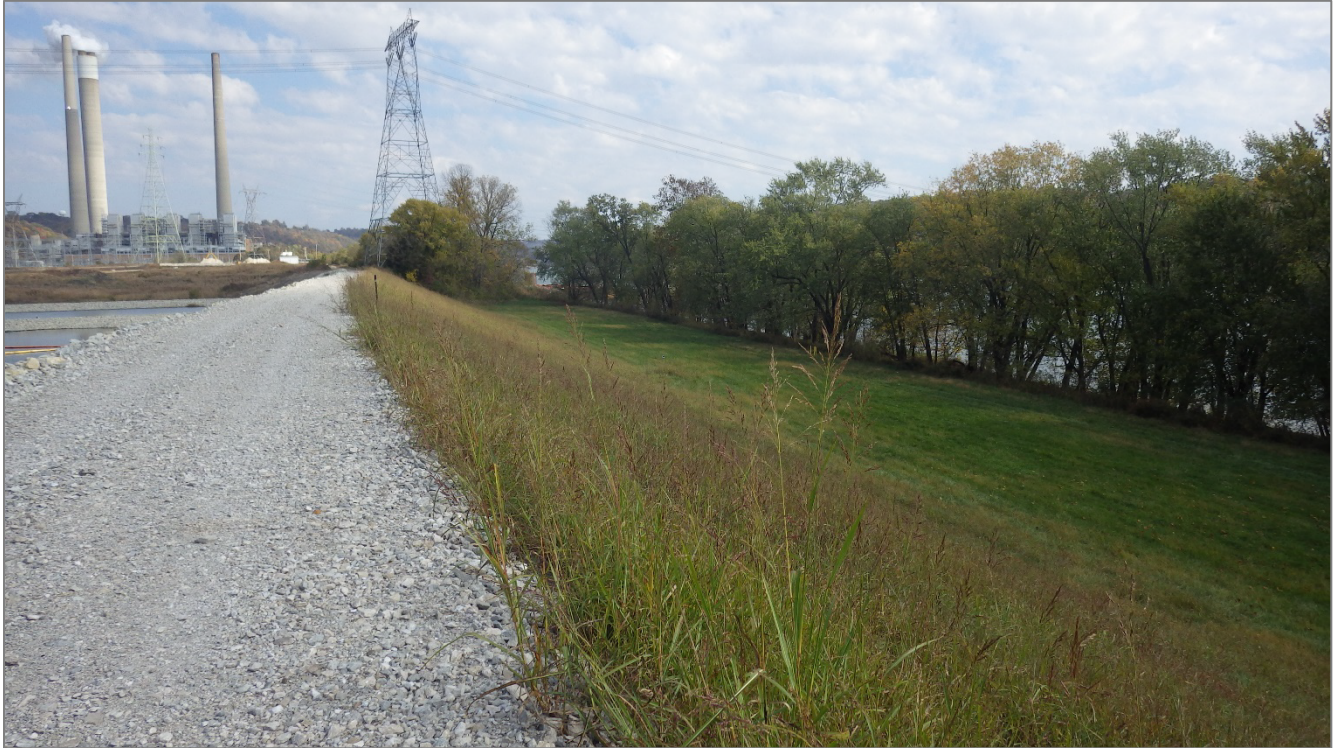
The upstream and downstream dike slopes and crest areas, east of the LVWTS, are overgrown with small to large trees and heavy brush (Photographs 3, 4, and 6 in Appendix D). These conditions make it virtually impossible to inspect the slopes. The trees and larger brush can also provide seepage pathways as the larger foliage dies off. Trees that topple in windstorms can leave large holes exposed in the face of the dam. Stantec recommends that the overgrown crest and downstream side of the dam be stripped of foliage, graded for ease of maintenance, and seeded with grass to protect it from erosion. This will allow for future inspections to be conducted on this portion of the dam.

Photograph 3 – Exterior southwest dike embankment, looking east.

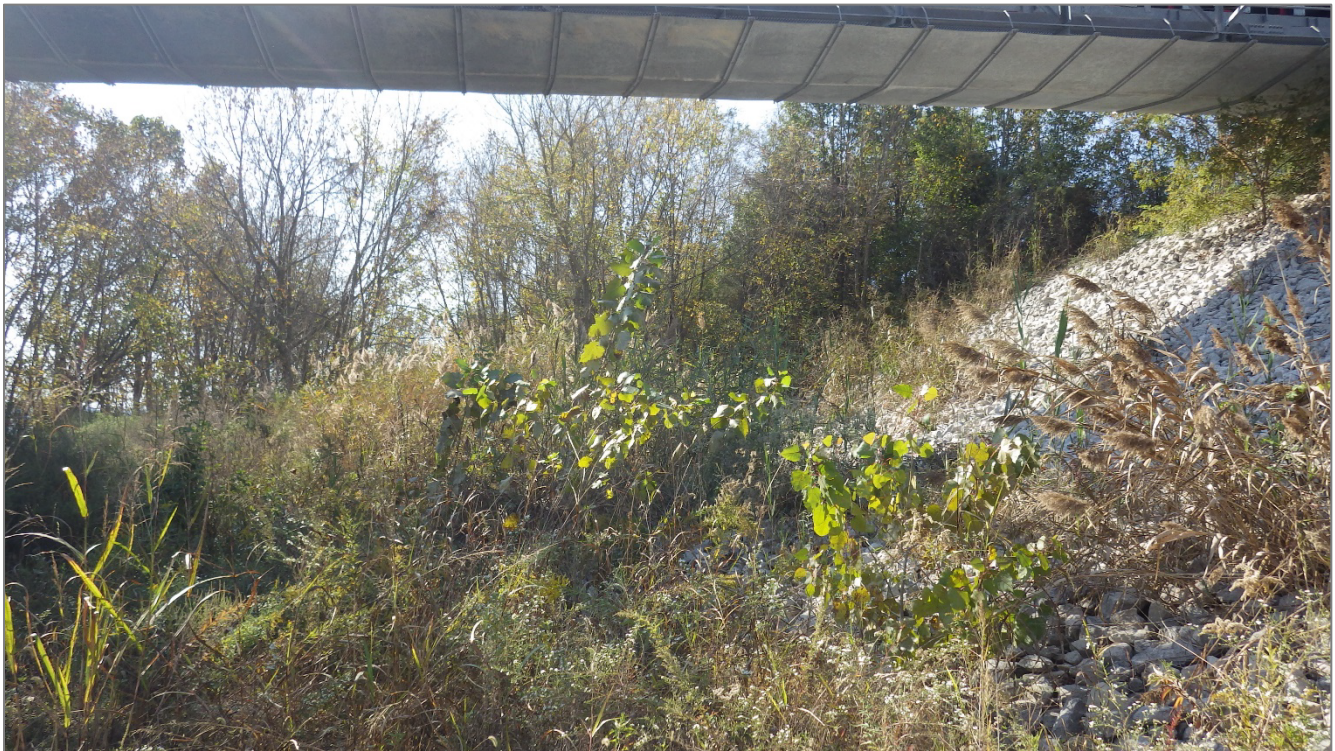
Photograph 4 – Exterior southeastern dike embankment e looking west beneath the gypsum conveyor.

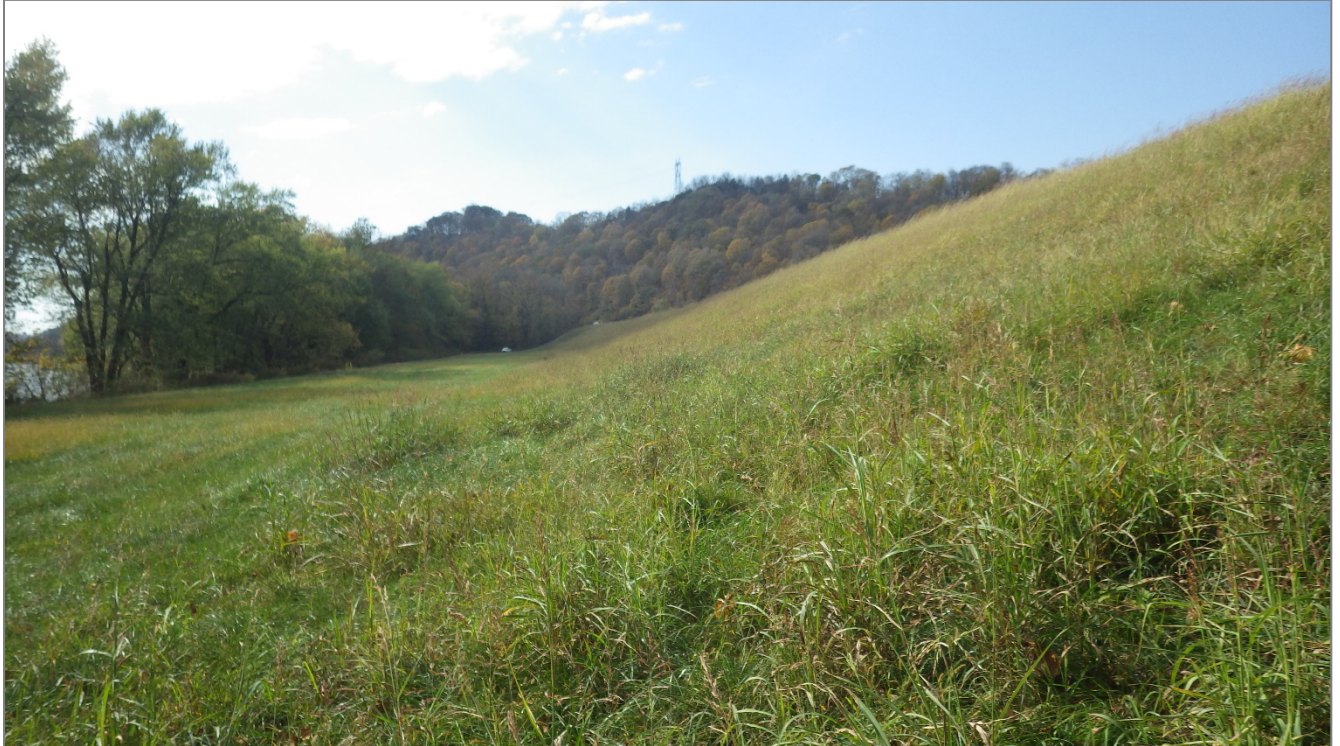
**Photograph 5 – Southern dike embankment downstream side, looking west. Note tall grass.**

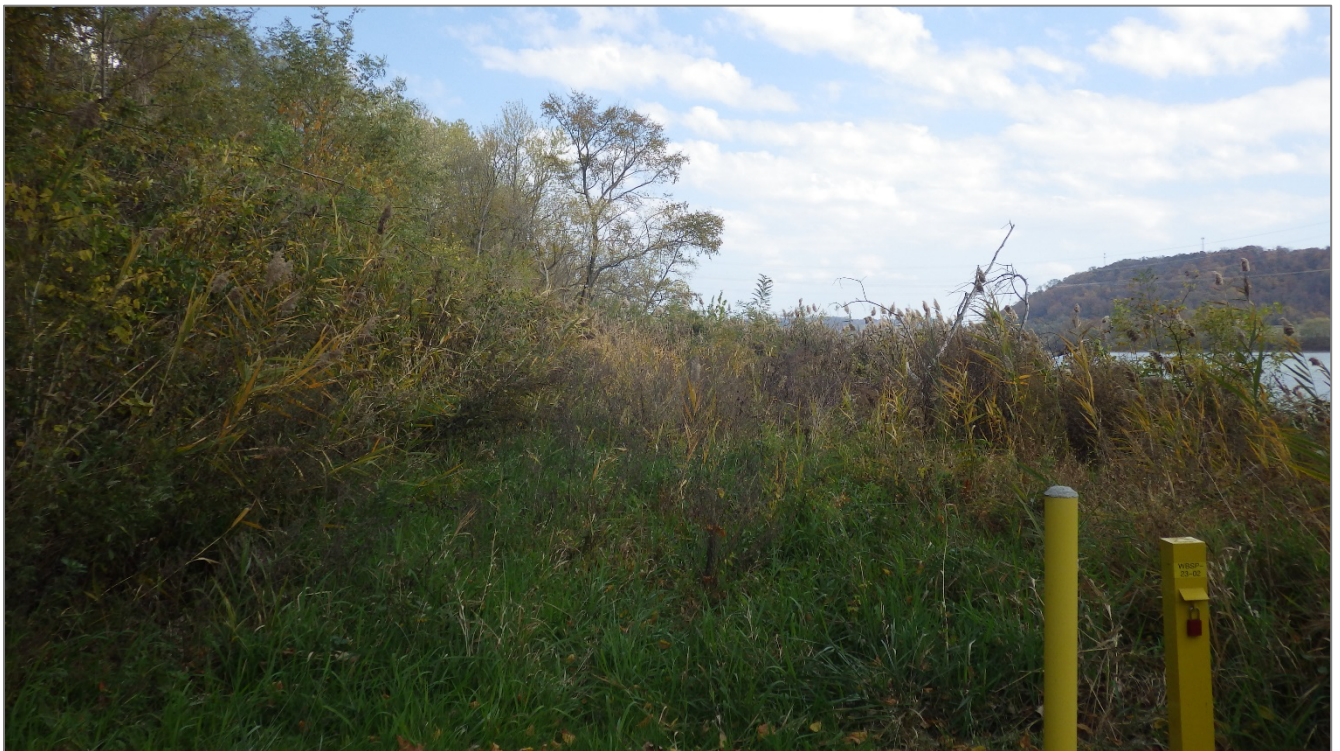
**Photograph 6 – Exterior southern dike embankment looking east at limits of dense vegetation. Ohio River on right.**

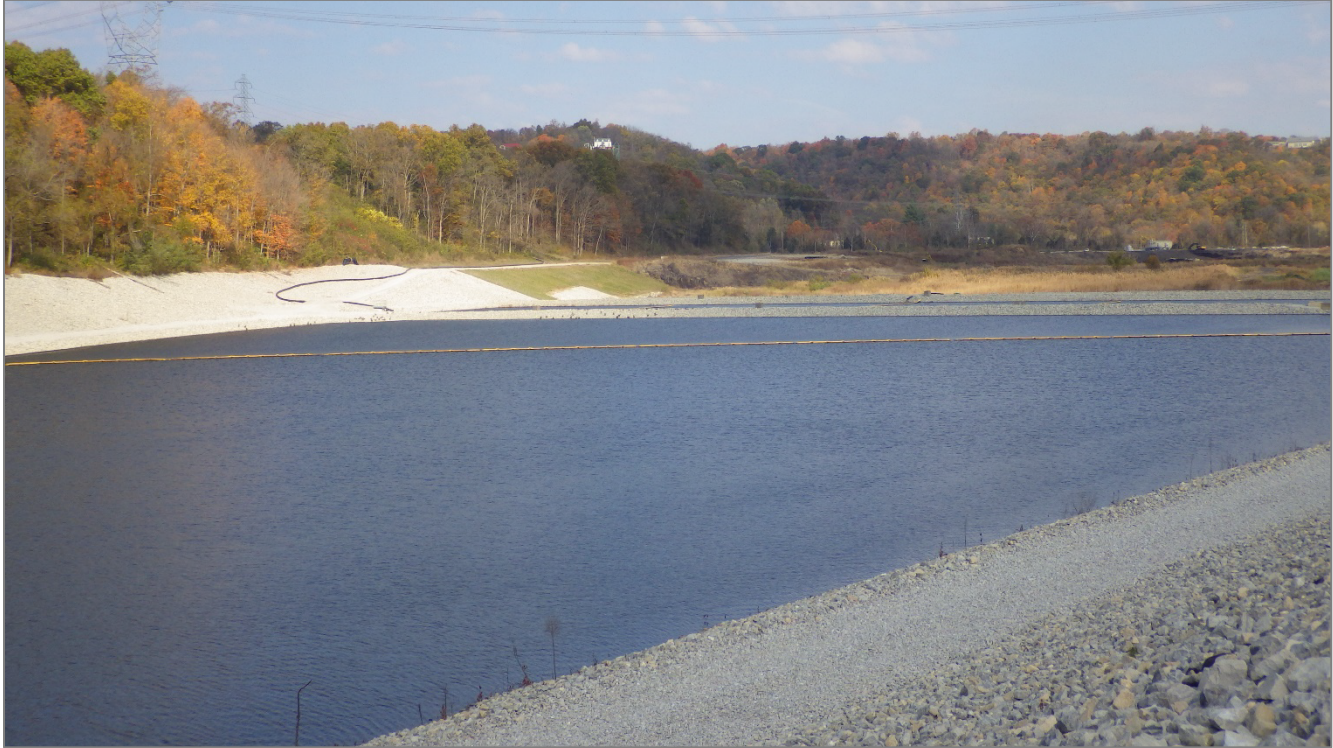
Photograph 7 – Looking north and west across LVWTS from the southern dike embankment.

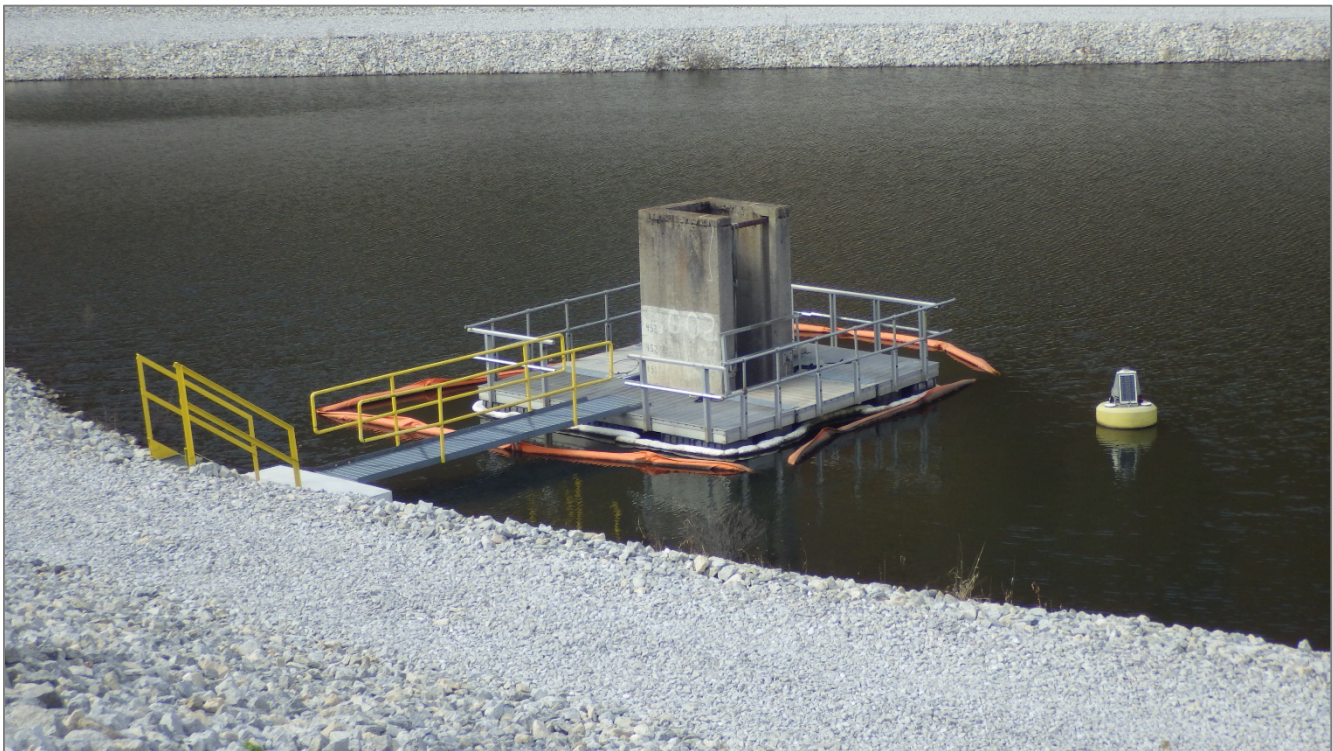
Both the upstream and the downstream side of the outfall structure from the LVWTS to the Ohio River appear to be in satisfactory condition. No other water inlet or outlet structures were observed for the WBSP other than the pipe carrying process water to the LVWTS. A culvert controls flow between the two LVWTS lined basins.

Photograph 8 – Outfall structure at southwestern corner of the LVWTS.

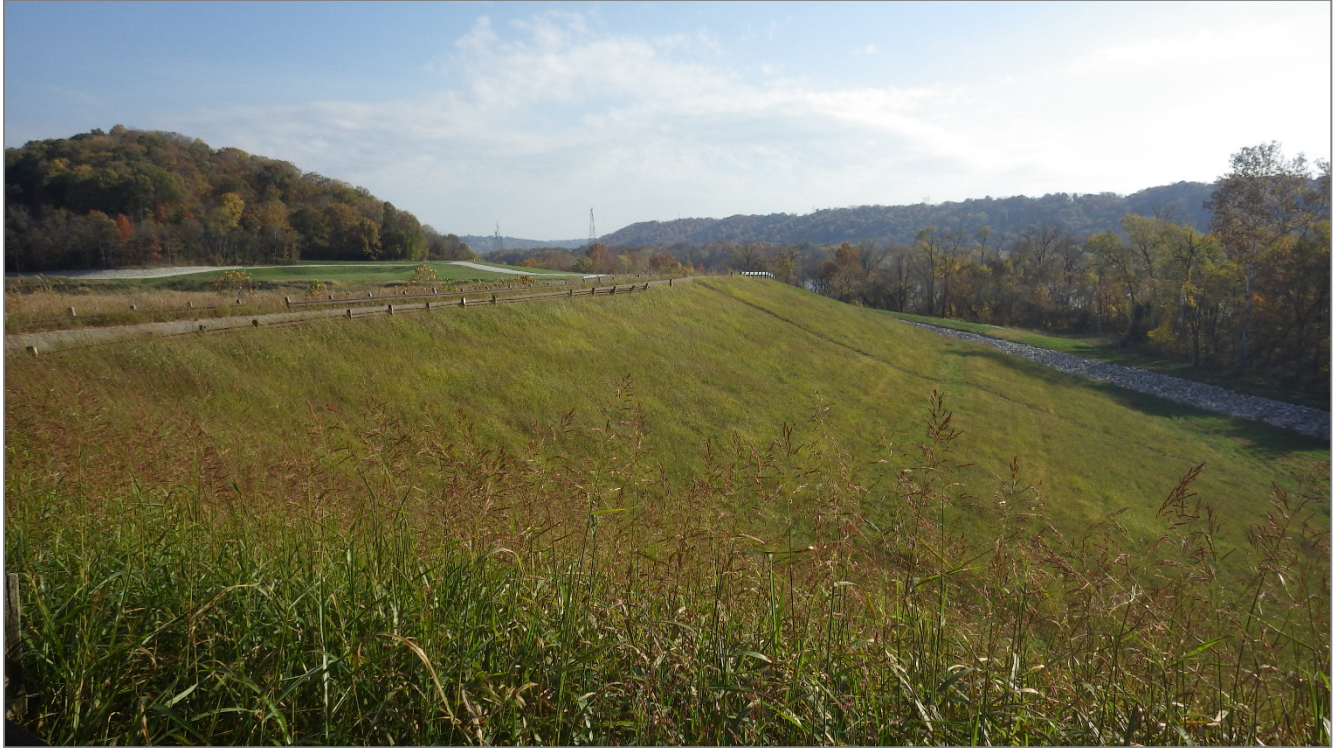
**Photograph 1 – West downstream side of LRCP looking east.**

Minor maintenance for the LRCP includes mowing of the dam slopes to observe potential issues or concerns, repairing the erosion rills above the downstream channel, and monitoring the surface-sloughed area beneath the access road to the toe will likely require attention as well (Photographs 1, 2, 3, 6, and 9).

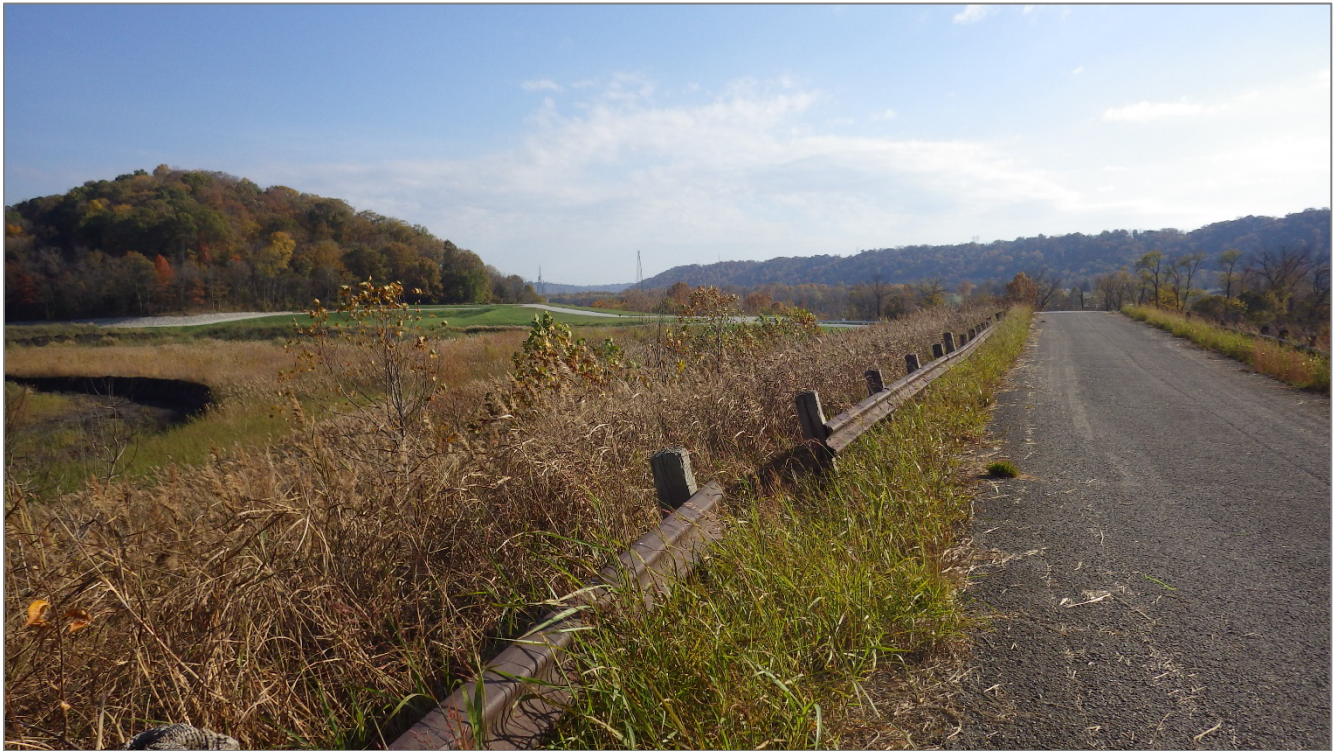
**Photograph 2 – West upstream side of LRCP looking east.**

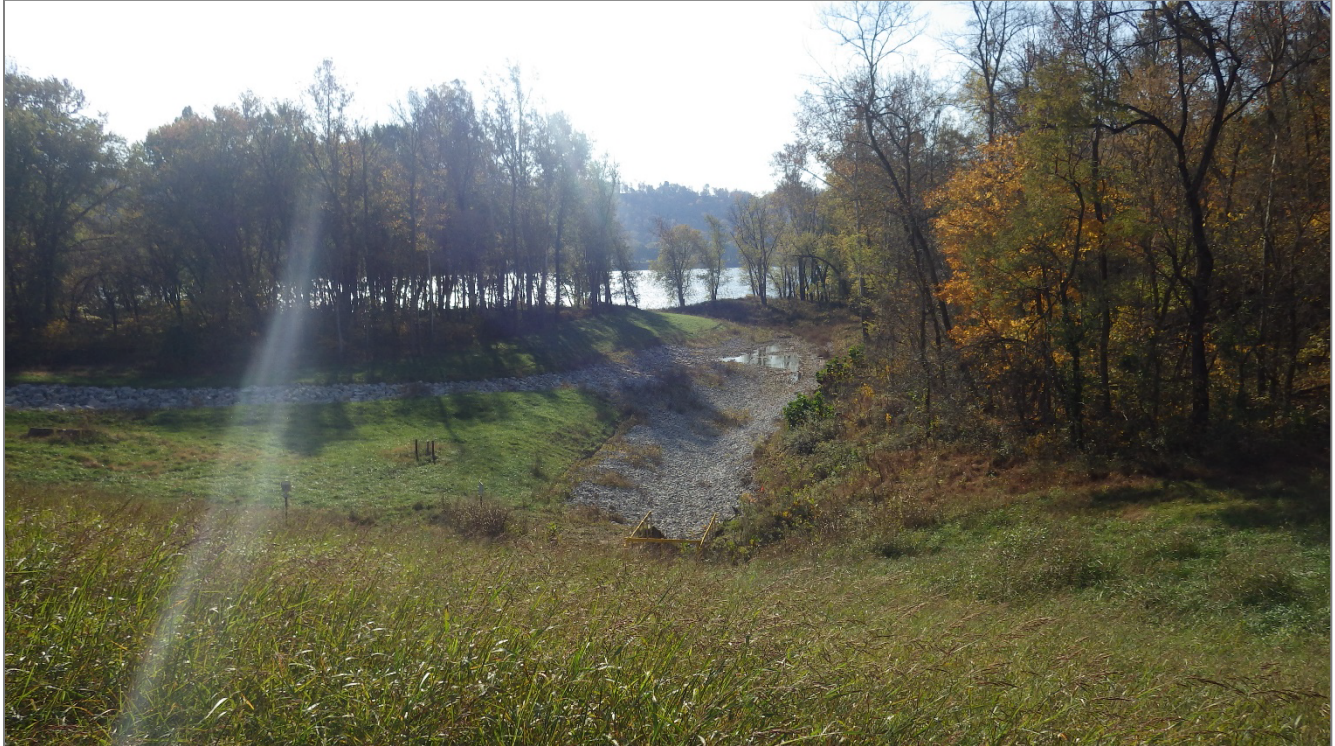
**Photograph 3 – Downstream side of dam, outfall channel to the Ohio River.**

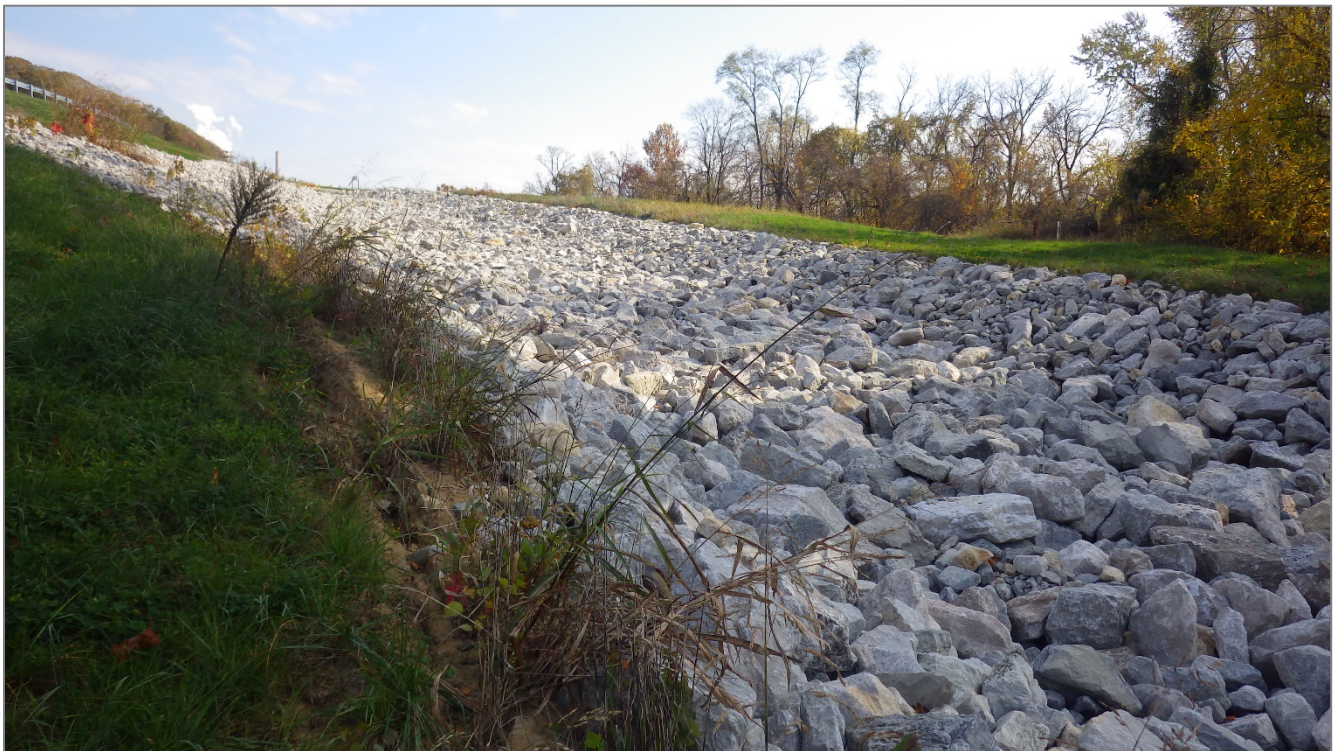
**Photograph 4 – Western downstream channel showing erosion due to material change and silt fence removal.**

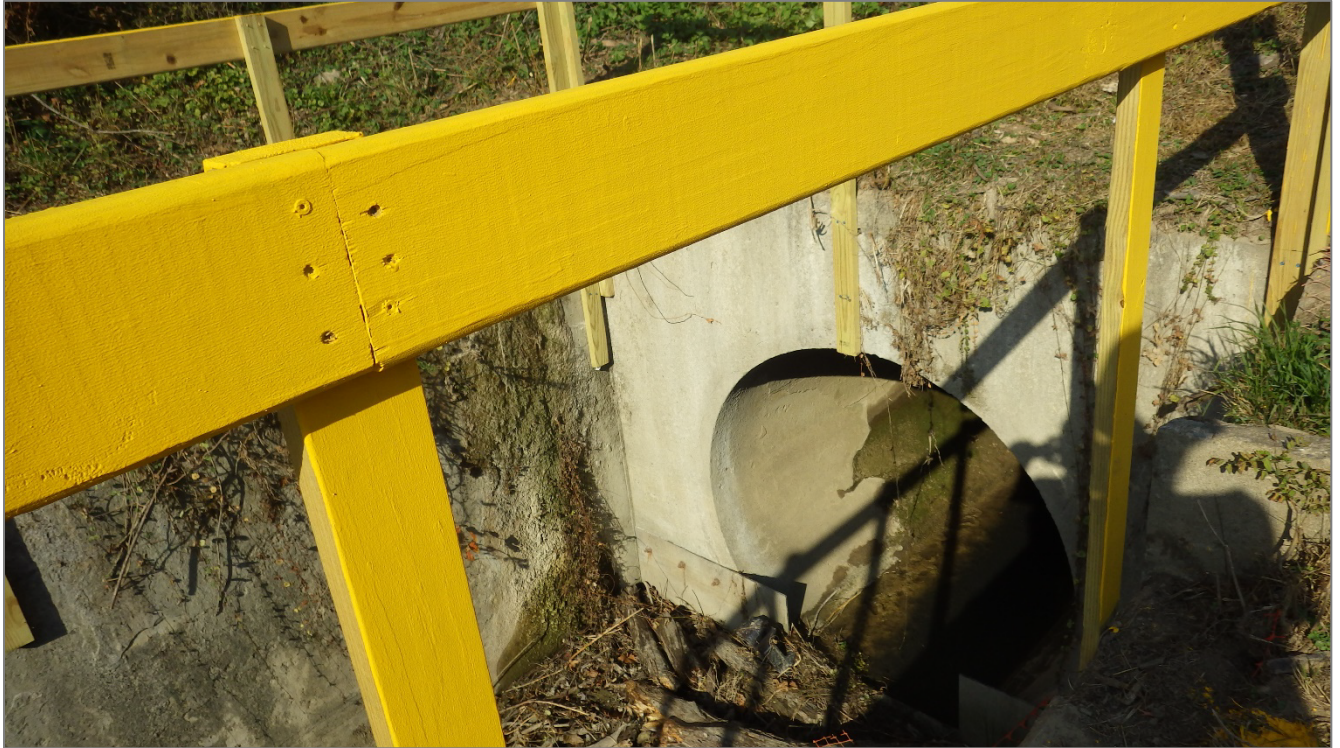
**Photograph 5 – Outfall 001 outlet structure at toe of dam.**

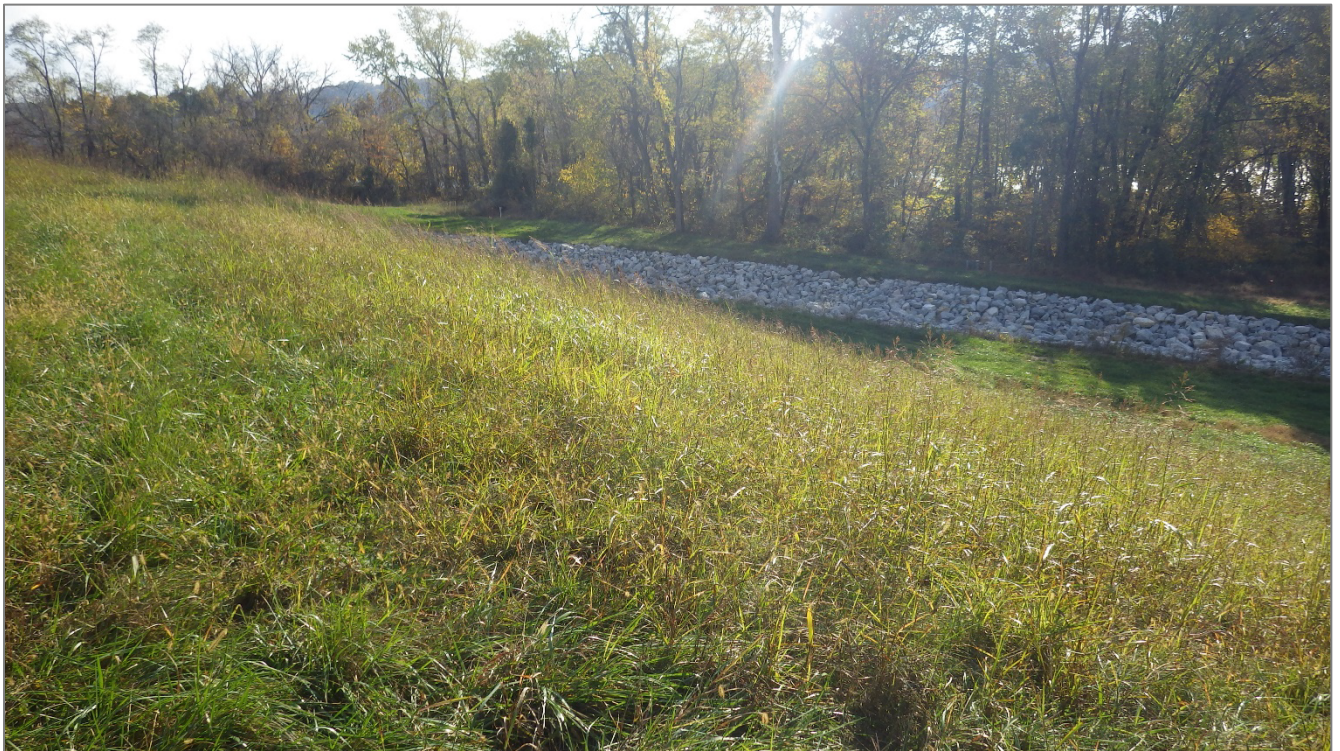
**Photograph 6 – Western downstream side where the channel extends along the face and toe of the embankment. Note tall grass along slope.**

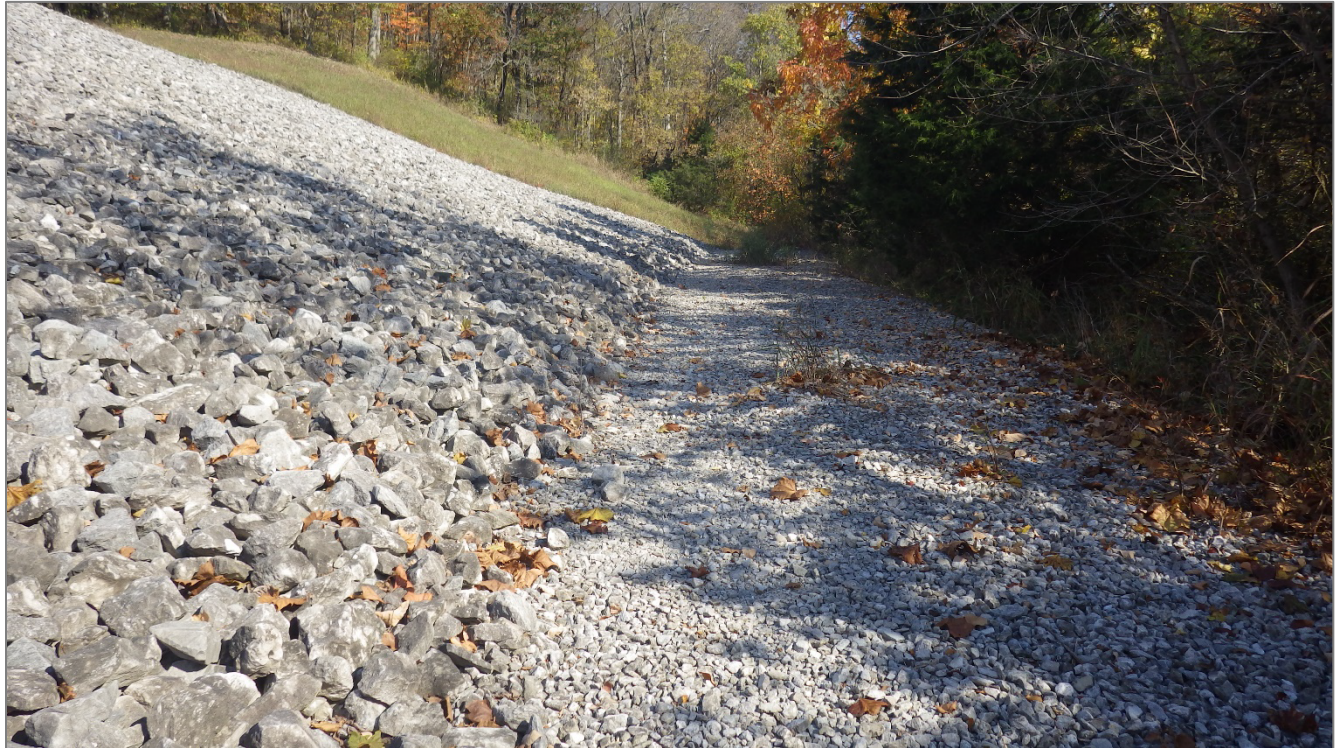
Photograph 7 – Downstream side of dam. Eastern side, looking east.

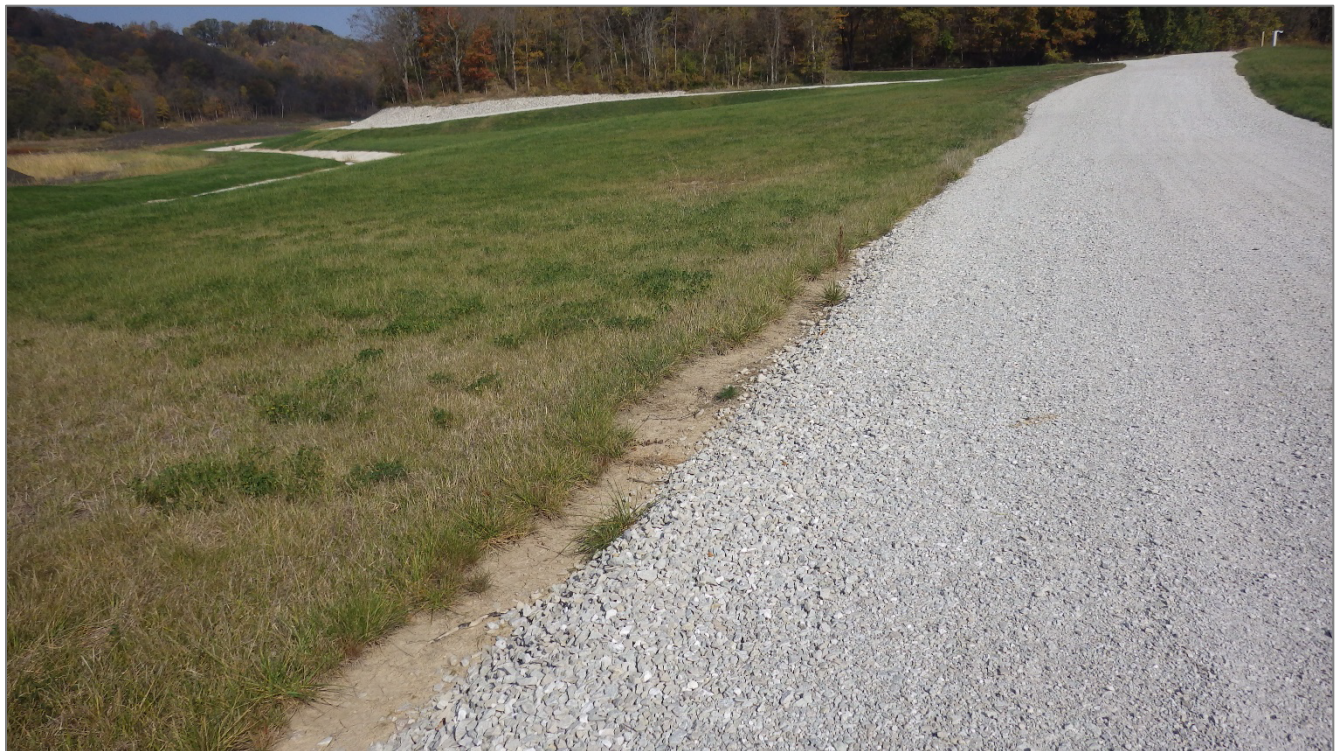
Photograph 8 – Crest of dam at the east end, looking north at access road and Phase 1 closure area.

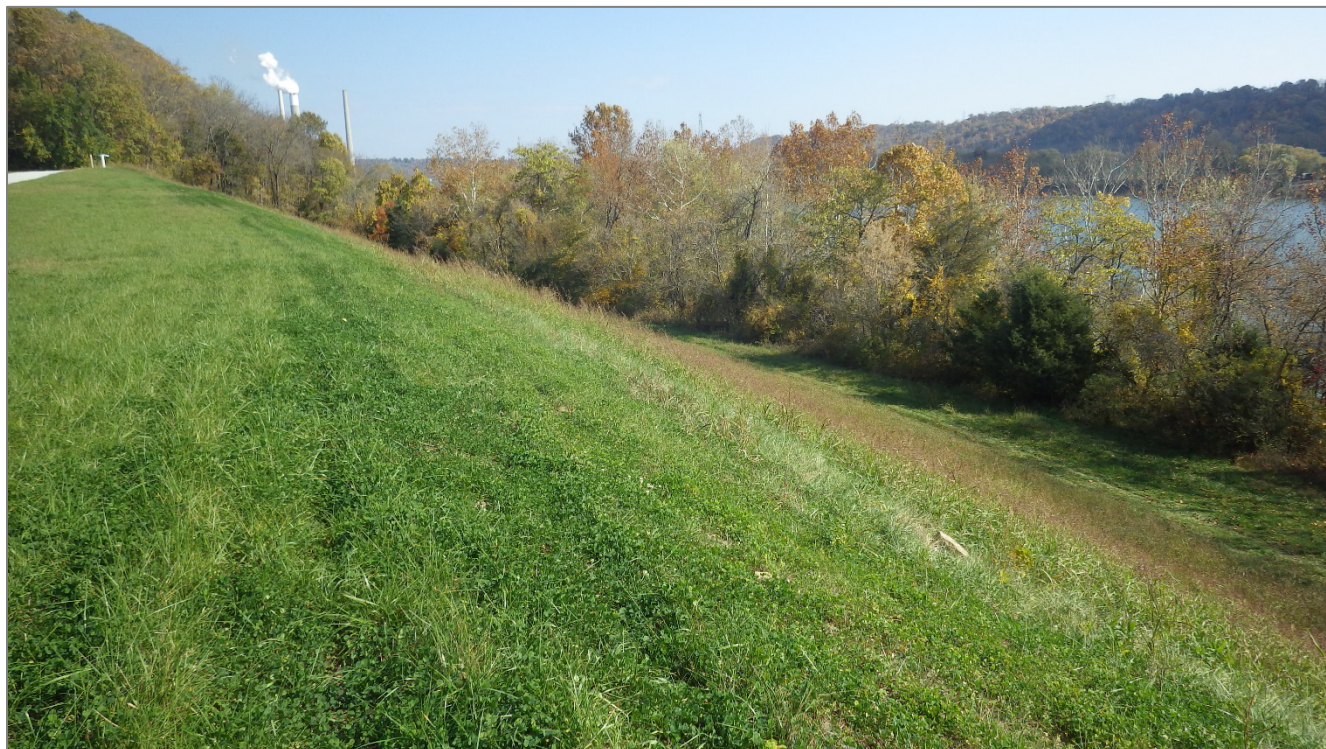
Photograph 9 – Crest of dam near center, looking east. Note tall grass on downstream slope.

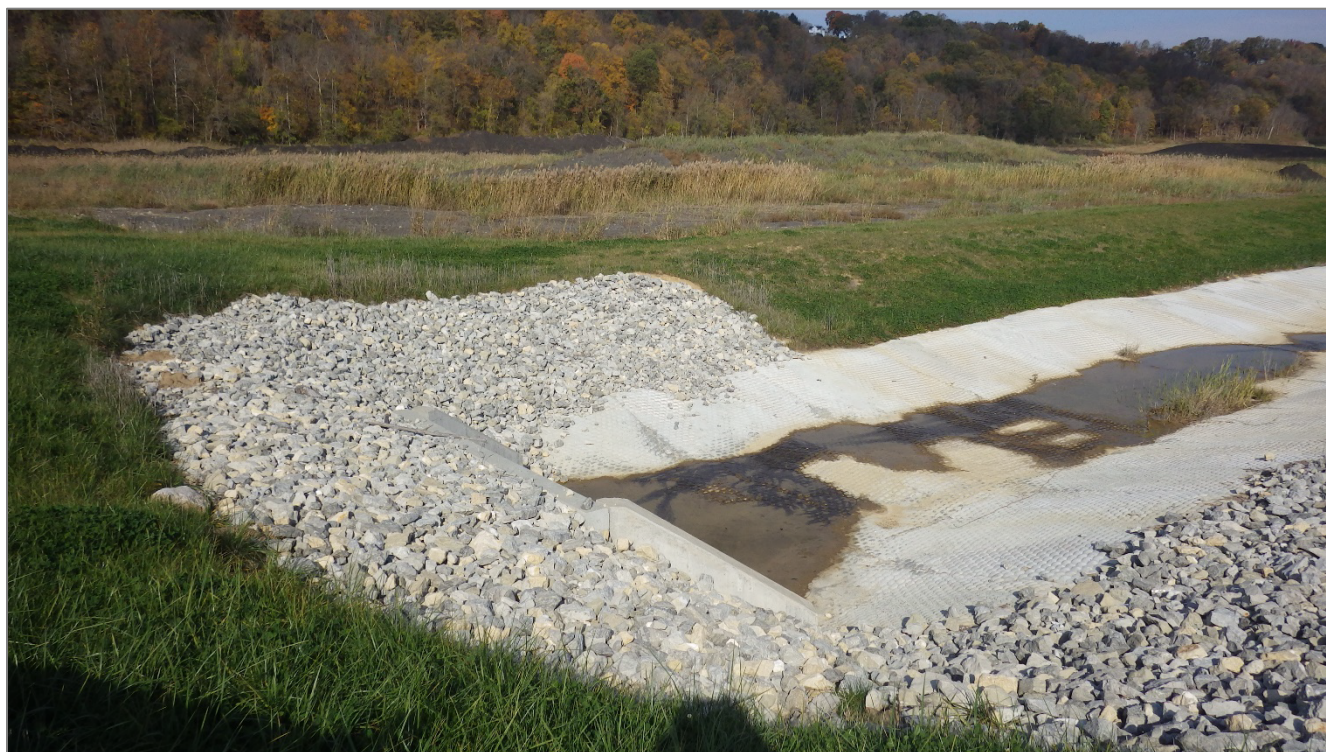
Photograph 10 – Upstream side of dam at 12 ft. x 4 ft. culvert.

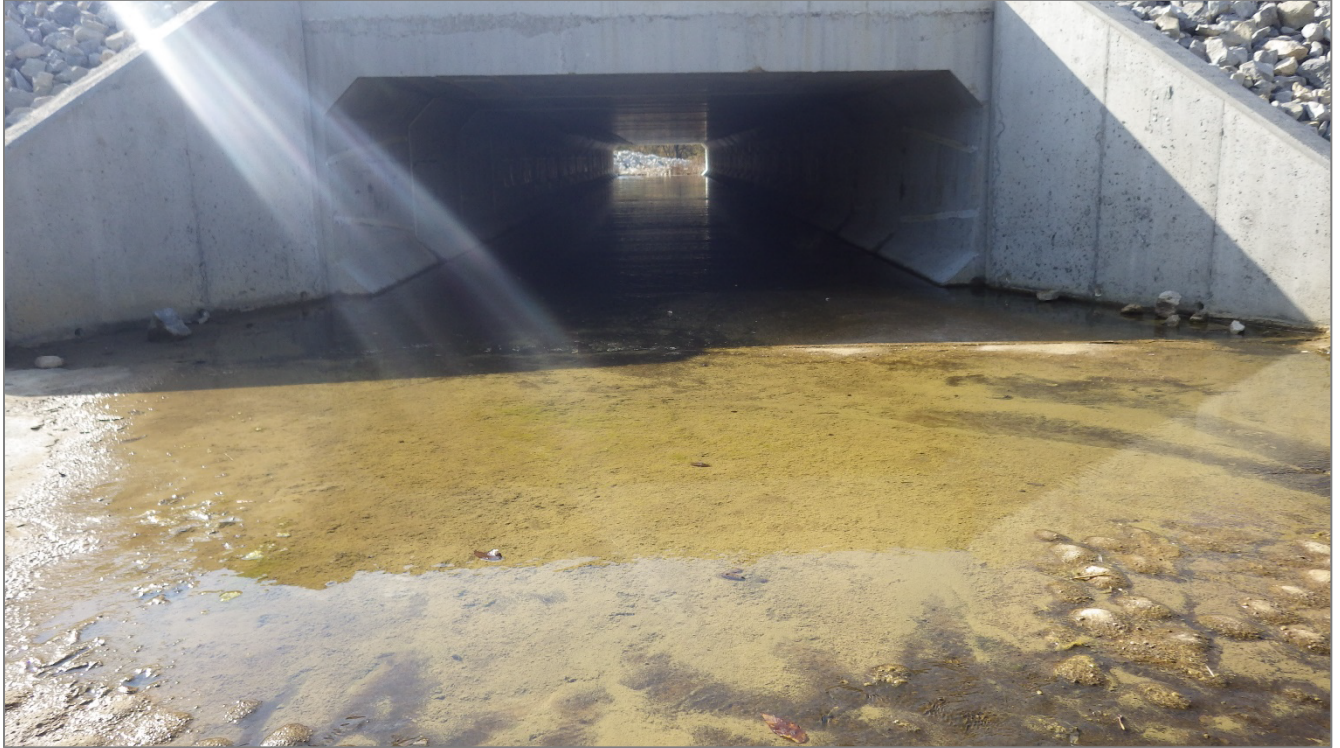
Photograph 11 – Upstream side of dam at 12 ft. x 4 ft. culvert, looking southwest through the culvert.

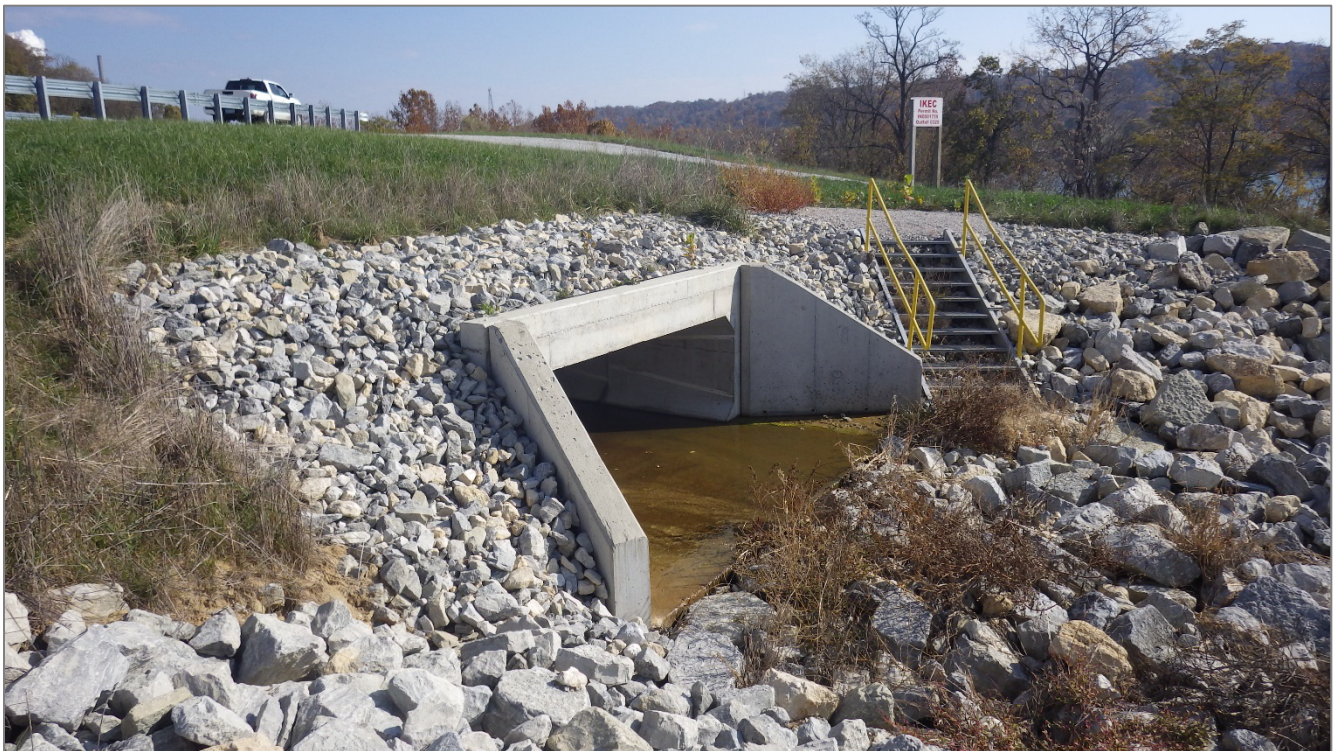
Photograph 12 – Downstream side of dam at 12 ft. x 4 ft. culvert.
