2021 ANNUAL DAM AND DIKE INSPECTION REPORT

**West Boiler Slag Pond
& Landfill Runoff Collection Pond**

**CLIFTY CREEK PLANT
Indiana-Kentucky Electric Corporation
MADISON, INDIANA**

Document ID: GERS-21-080

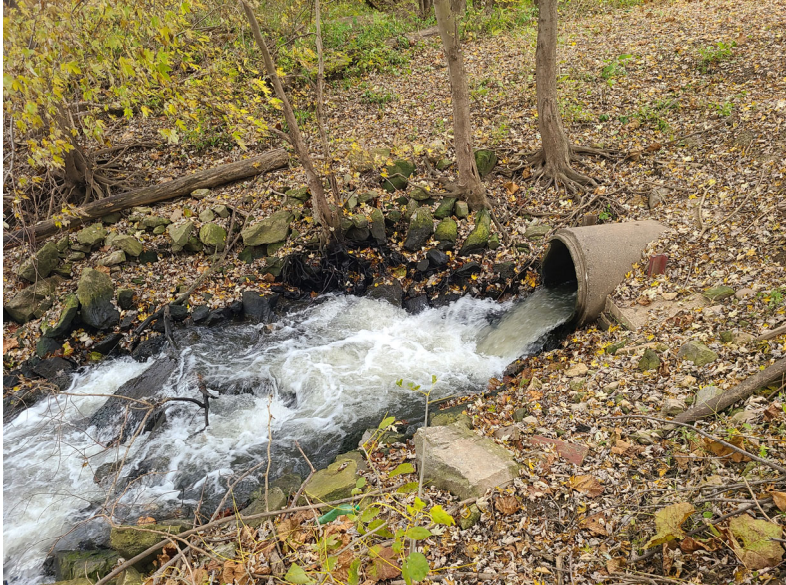
Photo No. 10

West Boiler Slag Pond Principal Spillway Pipe Discharge

General Condition of End of Pipe and Outlet Channel

Some wood debris carried by the river during flooding events

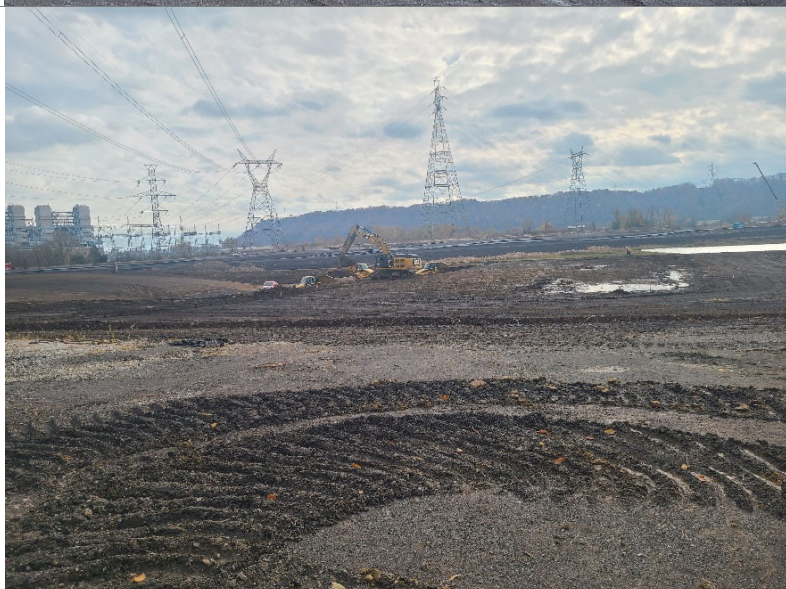
Photo No. 12

West Boiler Slag Pond

Construction within the limit of the pond.

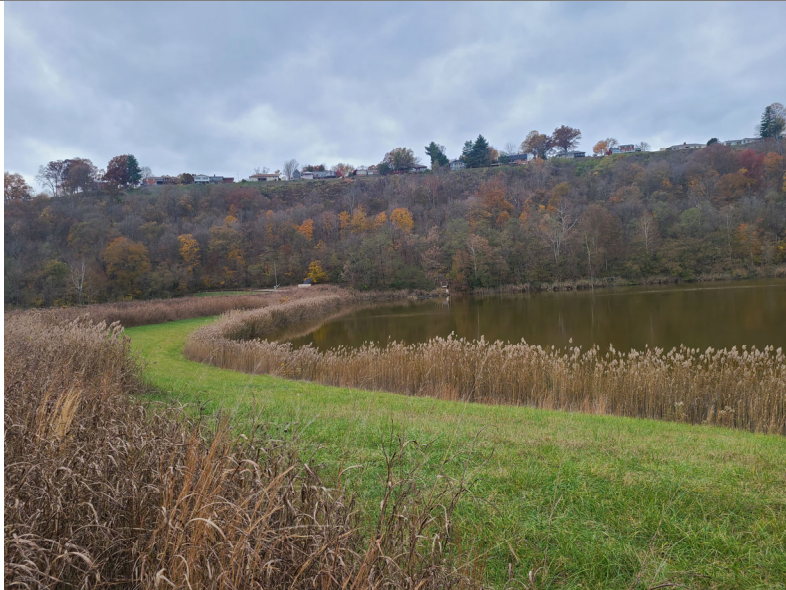
Photo No. 4

2. Photographs Nos. 3 and 4 provide overviews of the interior slope of the dam above the operating pool. Vegetation control near the water line and the upper slope areas is lacking, however, erosion due to wave action was not observed. Overall the slope was found to be in satisfactory and stable condition.

Landfill Runoff Collection Pond Dam
From Up Stream Slope

Overview of Vegetation and General
Conditions

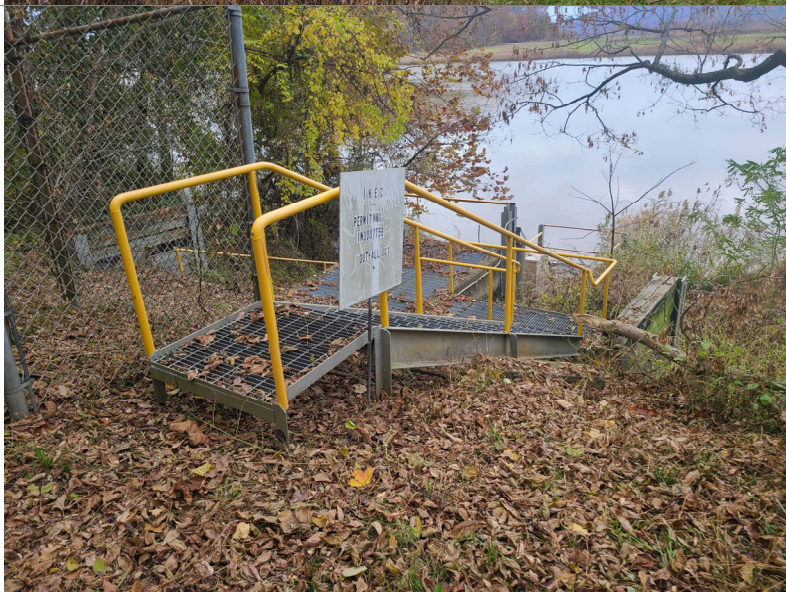
Photo No. 5

3. Photograph No. 5 shows an overview of the principal spillway decant structure. Vegetation control was observed to be lacking. The decant structure and the access stairway appeared to be functioning properly and was free of obstructions. Photograph No.6 shows the recently added pipe to allow for treatment of discharged water with few fallen wood sticks that doesn't appear to restrict the horizontal flow underneath.

Landfill Runoff Collection Pond Dam
From Roadway Leading to Crest Looking
Northeast

Overview of Vegetation Management and
General Condition-overgrown vegetation.
