**Re: Indiana-Kentucky Electric Corporation
Clifty Creek Station
Notification of CCR Rule Information Posting
Annual Certified CCR Dam and Dike (Surface Impoundment)
Inspection Report Posting**

**2023 CCR Rule – Surface Impoundments
Clifty Creek Dam/Dike Inspections**

Clifty Creek Generating Station
Madison, Indiana
Jefferson County

January 19, 2024

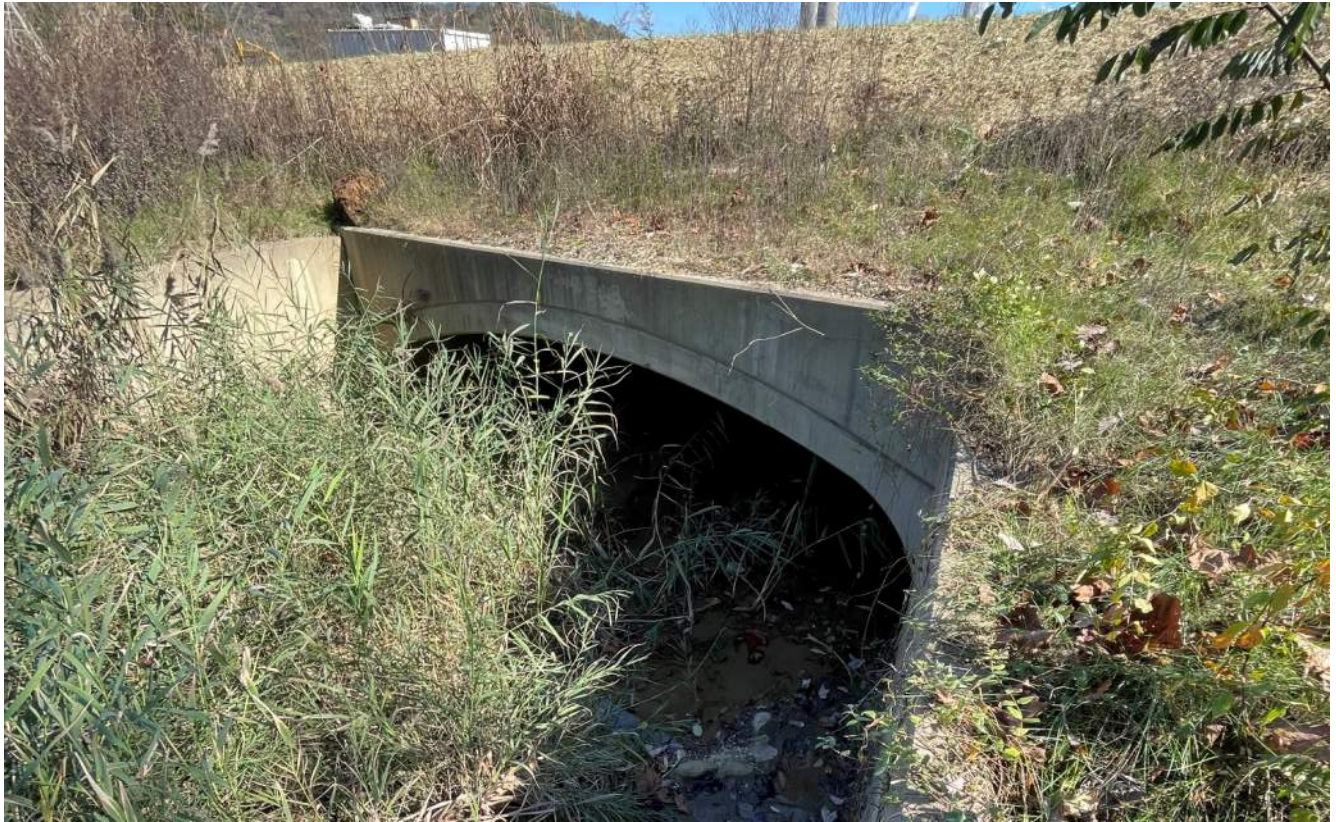
The existing culvert appears to be in satisfactory condition with negligible inflow. Flow appears to be limited to the area immediately adjacent to the culvert. The CCR sluice piping in the northeast corner of the WBSP has been terminated at the perimeter of the pond, and the pipes removed from within the pond.

Photograph 1 – Northwest (upstream) side of inlet culvert structure, northwest side of WBSP

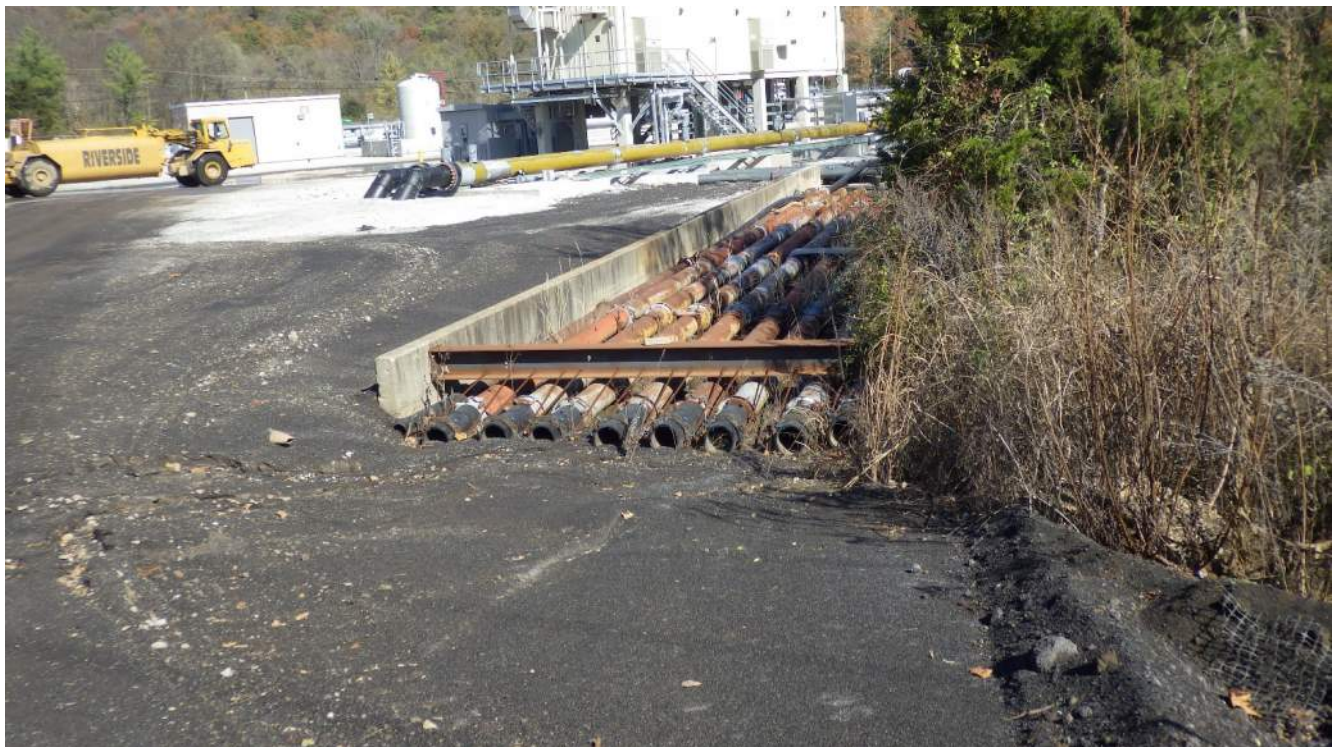
Photograph 2 – Former CCR sluice pipes, terminated, northeast side of WBSP.

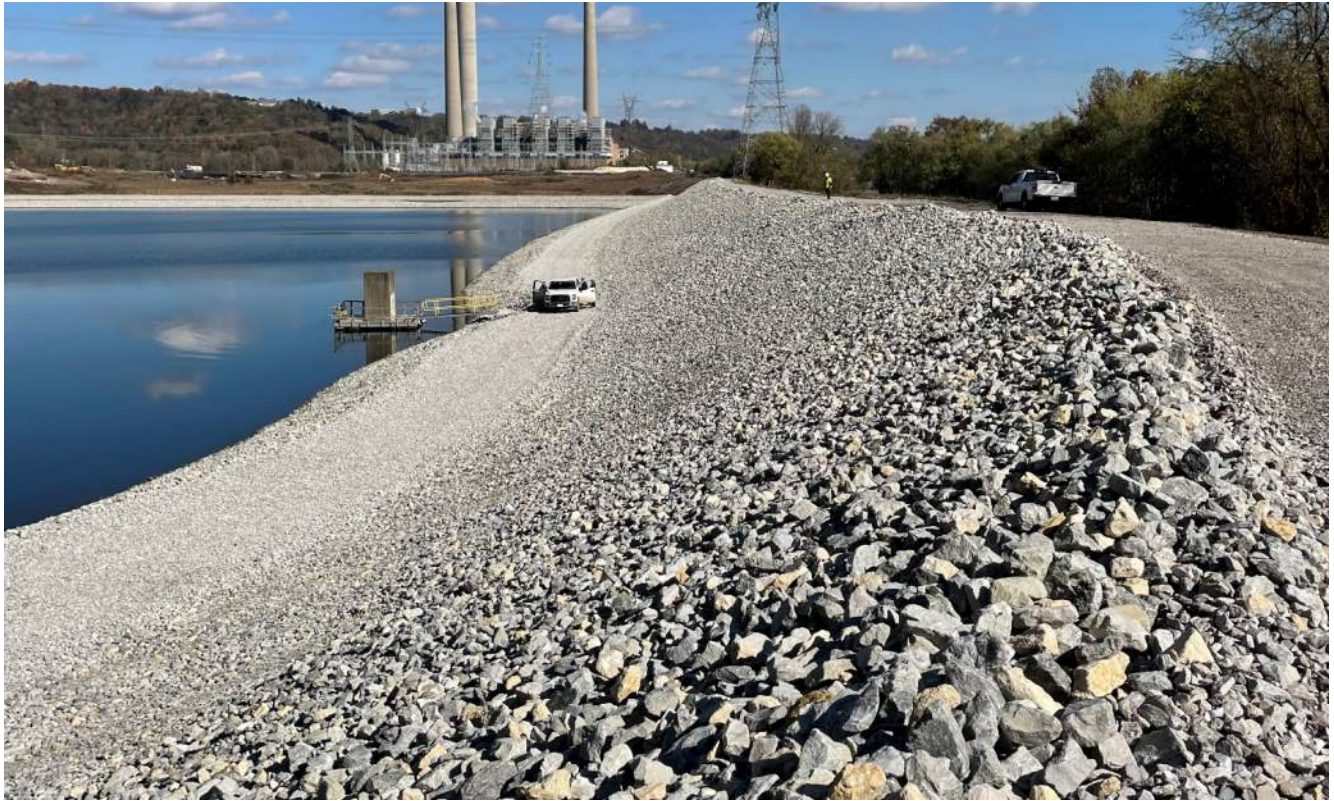
The inlet for the LVWTS outfall structure in the southwestern corner of the pond was observed from the shore due to work being done on the railings accessing the structure and around it. Both the upstream and the downstream side of the outfall structure to the Ohio River appear to be in satisfactory condition. No other water inlet or outlet structures were observed for the WBSP other than the pipe carrying process water to the LVWTS. A culvert controls flow between the two LVWTS lined basins.

Photograph 3 – South dike embankment, upstream side looking east. Crew repairing railing around outfall structure.

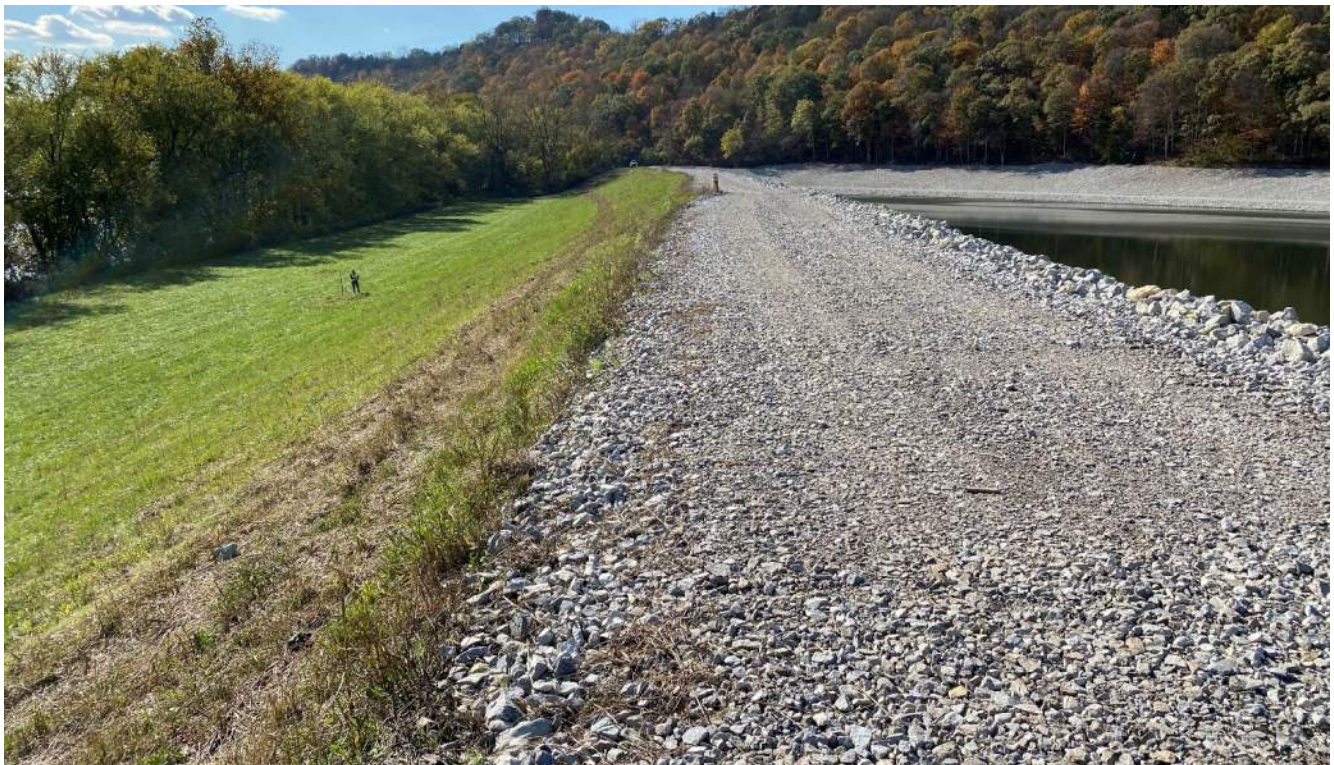
Photograph 4 – South dike embankment crest, looking west. Note the brown damaged vegetation parallel to the top of the slope.

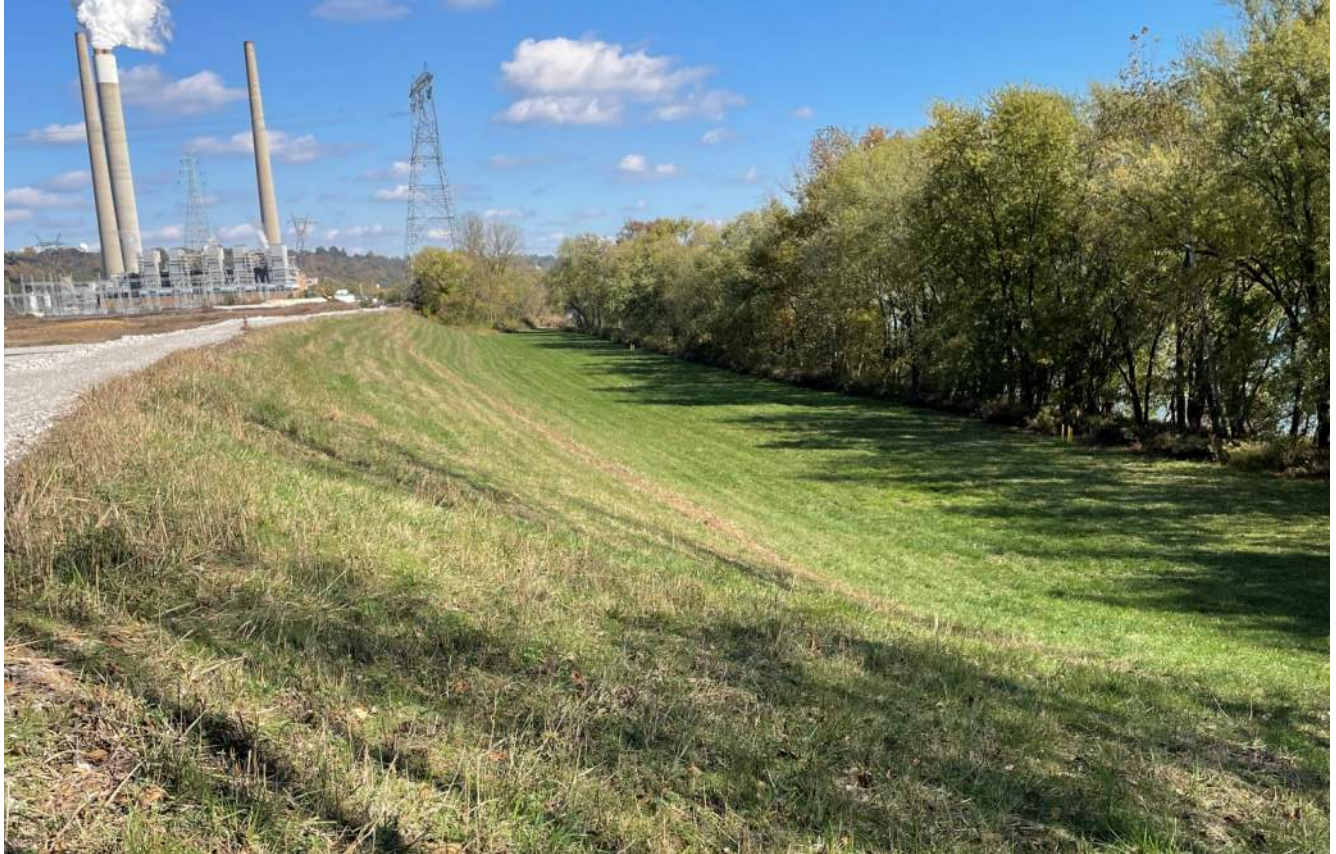
Photograph 5 – South dike embankment, downstream side looking east.

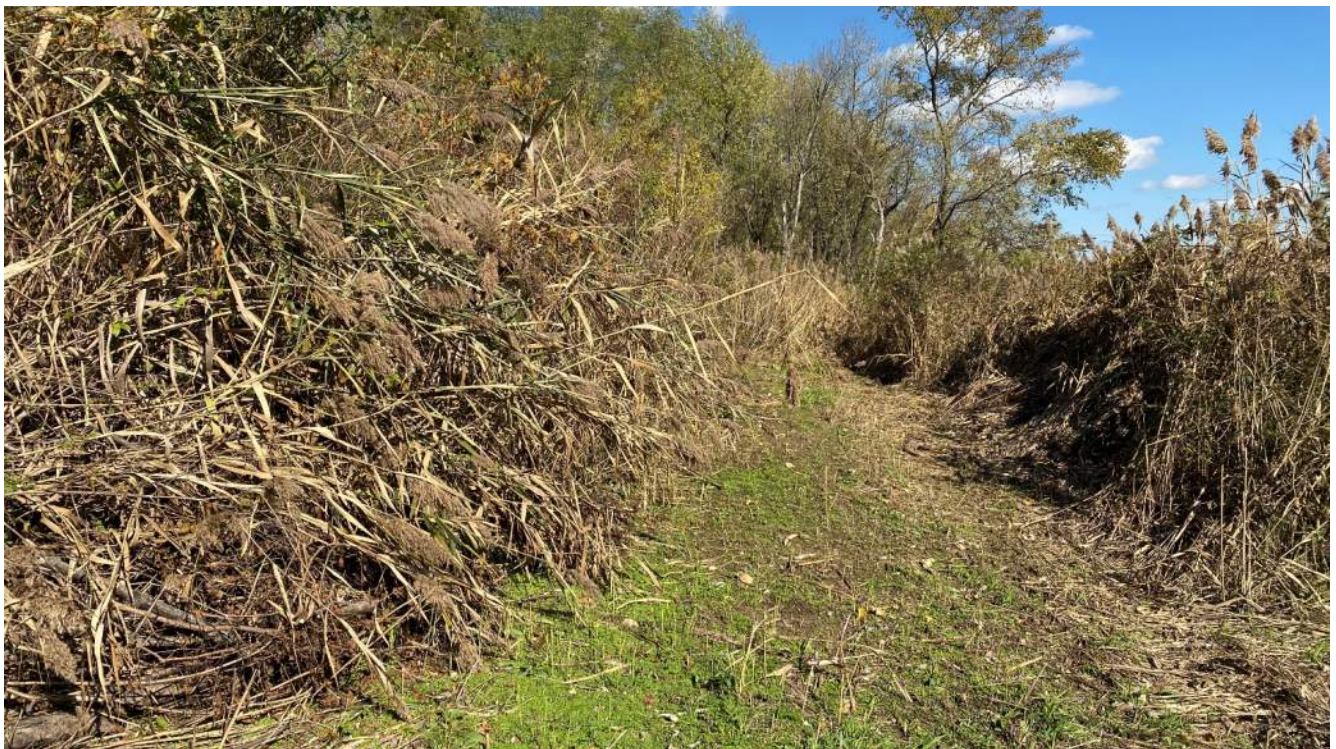
The southern portion of the embankment dam/dike (facing the Ohio River) near the LVWTS is covered with grass but is clear of tall foliage. At the access road to the WBSP outfall, there is minor rutting. There were no observed animal burrows in the grassy area of the dike. Northeast of the LVWTS the interior is marsh-like, and the interior slopes of the embankment dam/dike on the south side are covered with tall weeds and dense brush. The riverside slope northeast of the LVWTS is overgrown with small to large trees, dense brush, and tall grass. The end of the cleared path is noted on the figure in Appendix A. Inspection of these slopes was not possible due to the overgrown vegetation.

Photograph 6 – Southern dike embankment downstream side, overgrown section with trail cut in, looking east.

The upstream and downstream dike slopes and crest areas, east of the LVWTS, are overgrown with small to large trees and heavy brush (Photographs 6, 7, and 8 in Appendix D). These conditions make it virtually impossible to inspect the slopes. The trees and larger brush can also provide seepage pathways as the larger foliage dies off. Trees that topple in windstorms can leave large holes exposed in the face of the dam. Stantec recommends that the overgrown crest and downstream side of the dam be stripped of foliage, graded for ease of maintenance, and seeded with grass to protect it from erosion. This will allow for future inspections to be conducted on this portion of the dam.

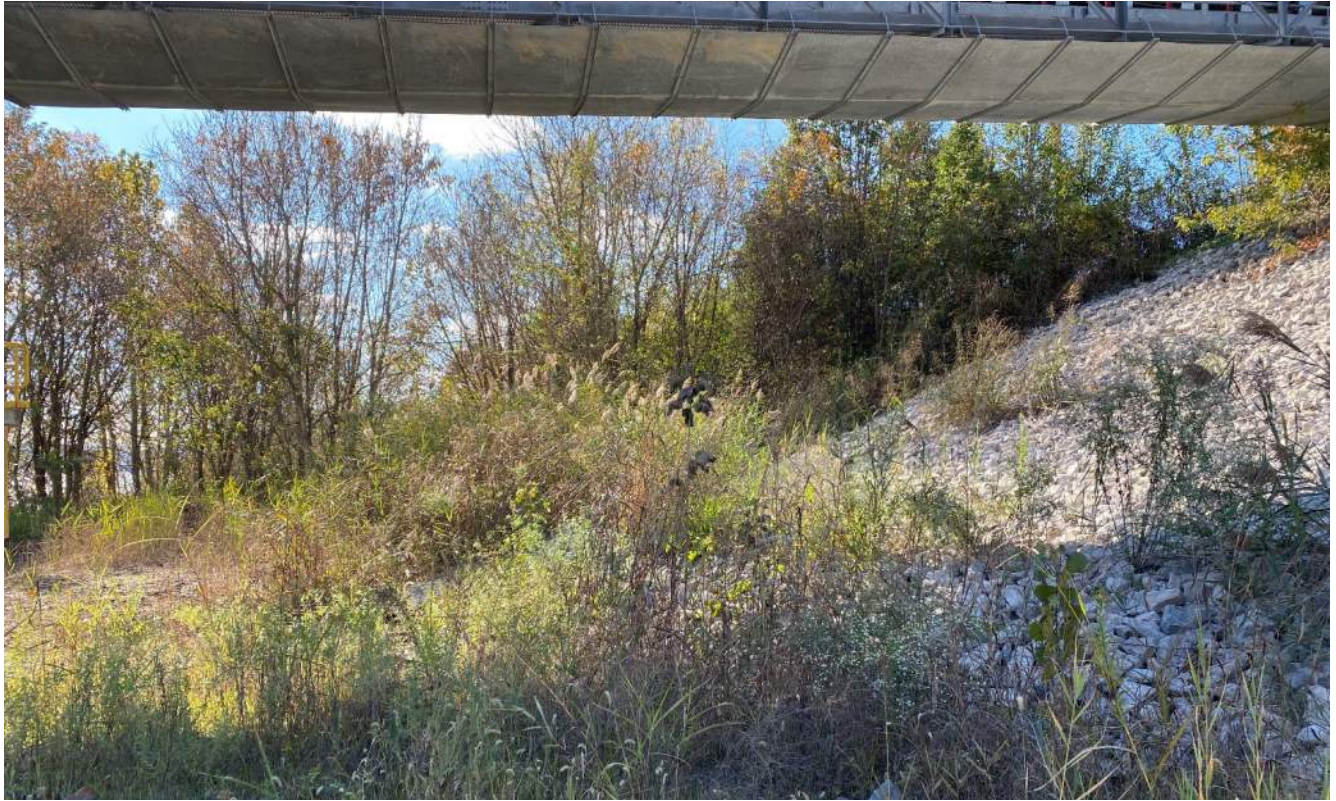
Photograph 7 – Southern dike embankment downstream side, overgrown section looking west beneath the gypsum conveyor.

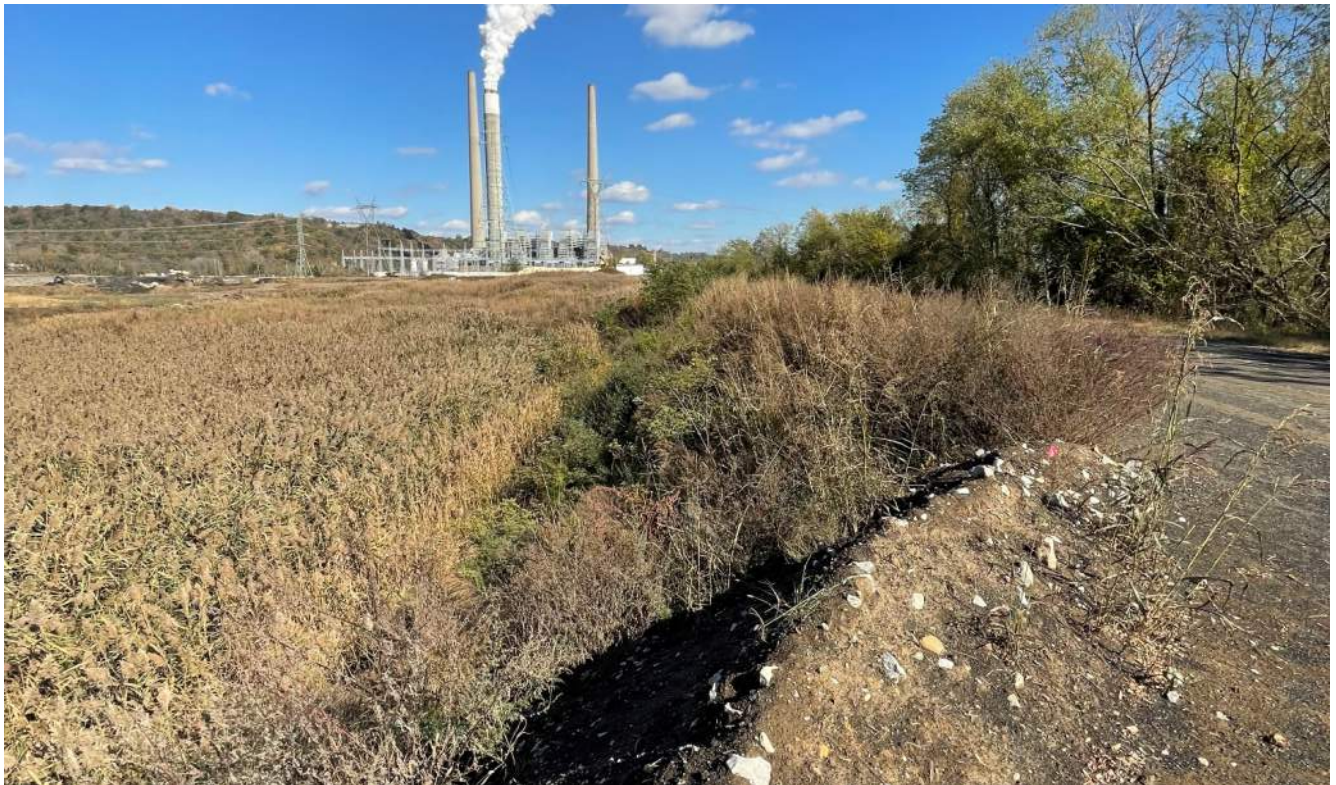
Photograph 8 – Southern dike embankment upstream side, overgrown section looking east beneath the power lines.

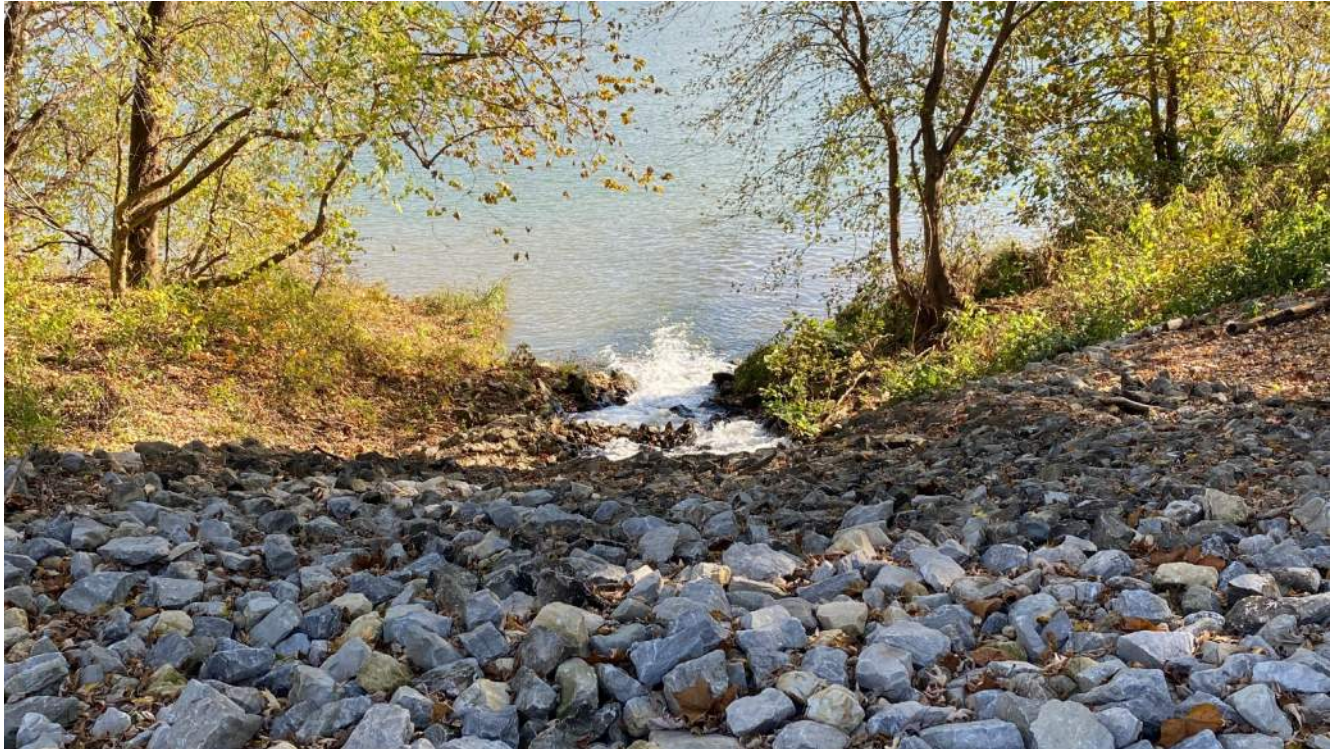
Photograph 9 – WBSP Outfall outlet to the Ohio River.

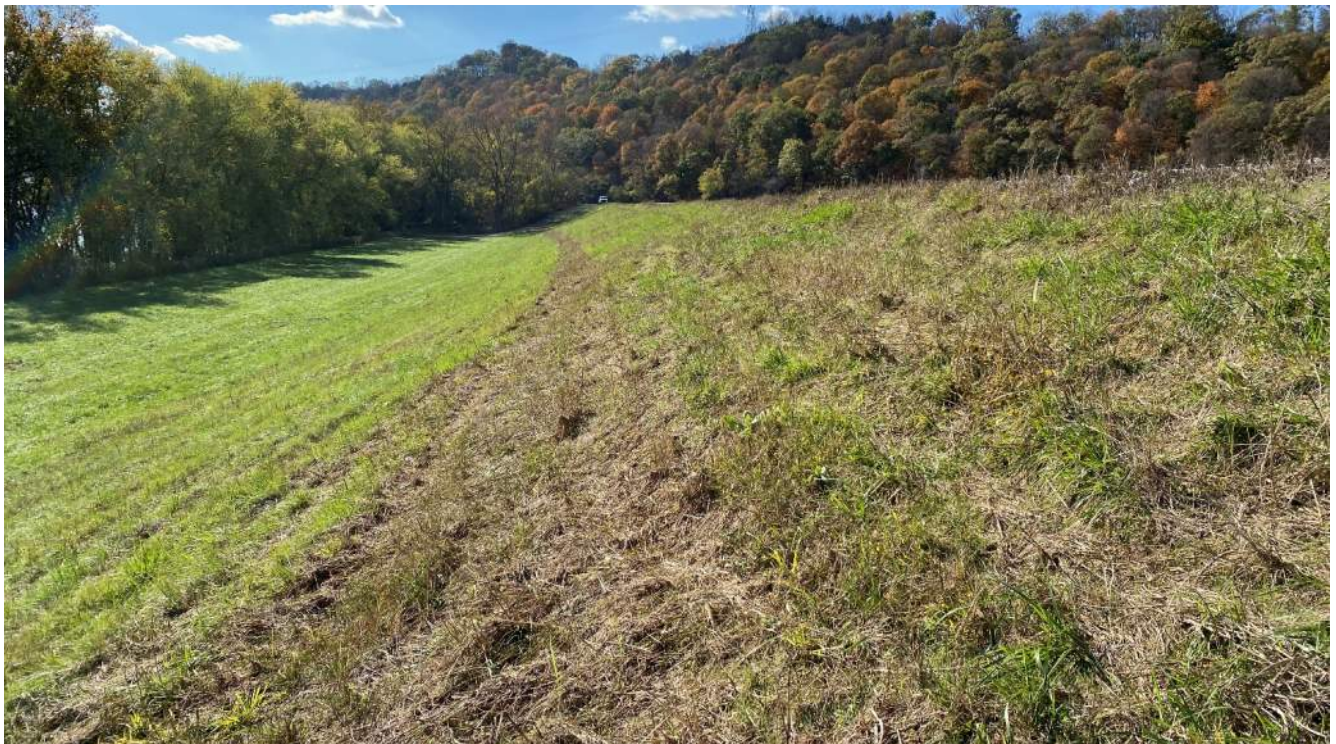
Photograph 10 – Southern dike embankment downstream side, showing damaged vegetation from vehicle traversing slope.

On the downstream face of the dam near the LVWTS, the minor rutting should be backfilled, graded, and reseeded. It appears that minor rutting of the south dike crest mentioned in the 2022 inspection report was repaired.

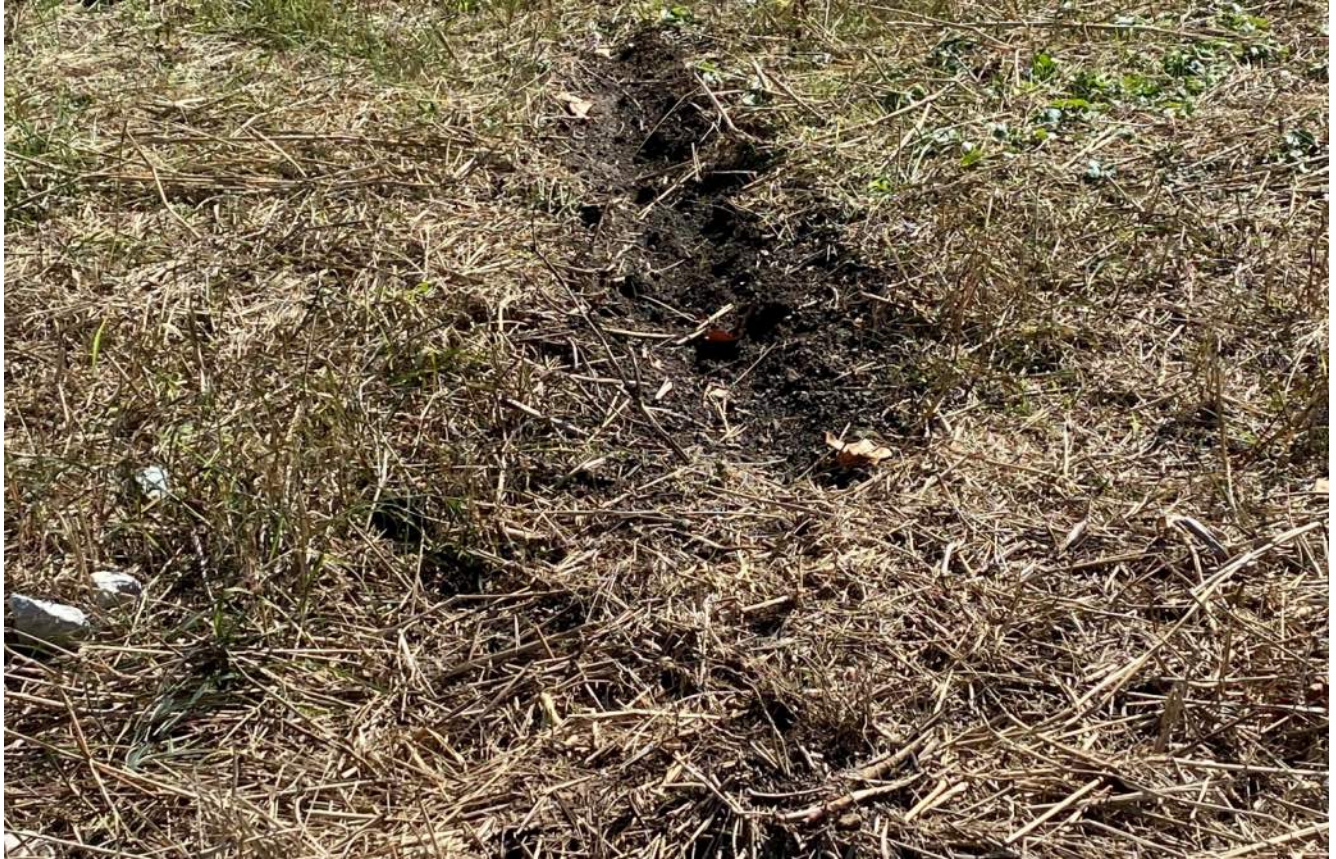
Photograph 11 – Southern dike embankment downstream side, showing erosion in damaged vegetation.

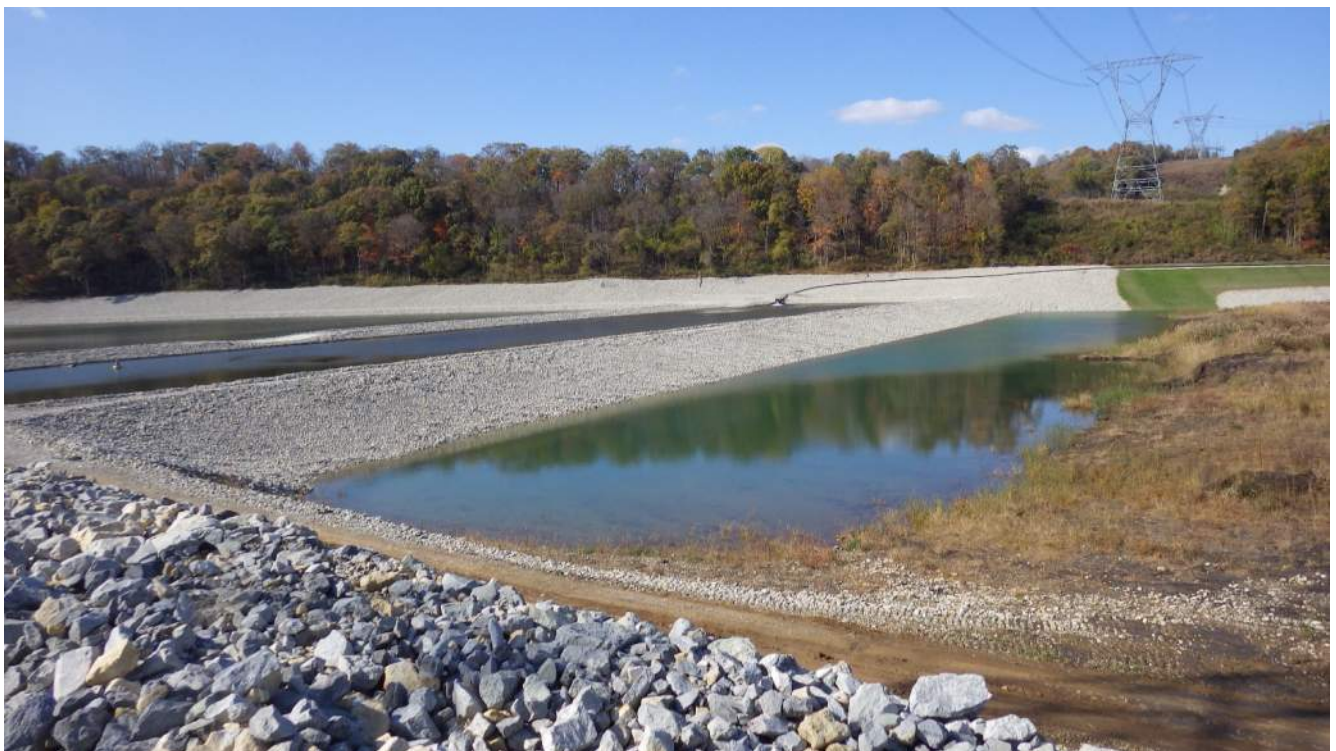
Photograph 12 – Looking north and west across western settling ponds from the southern dike embankment.

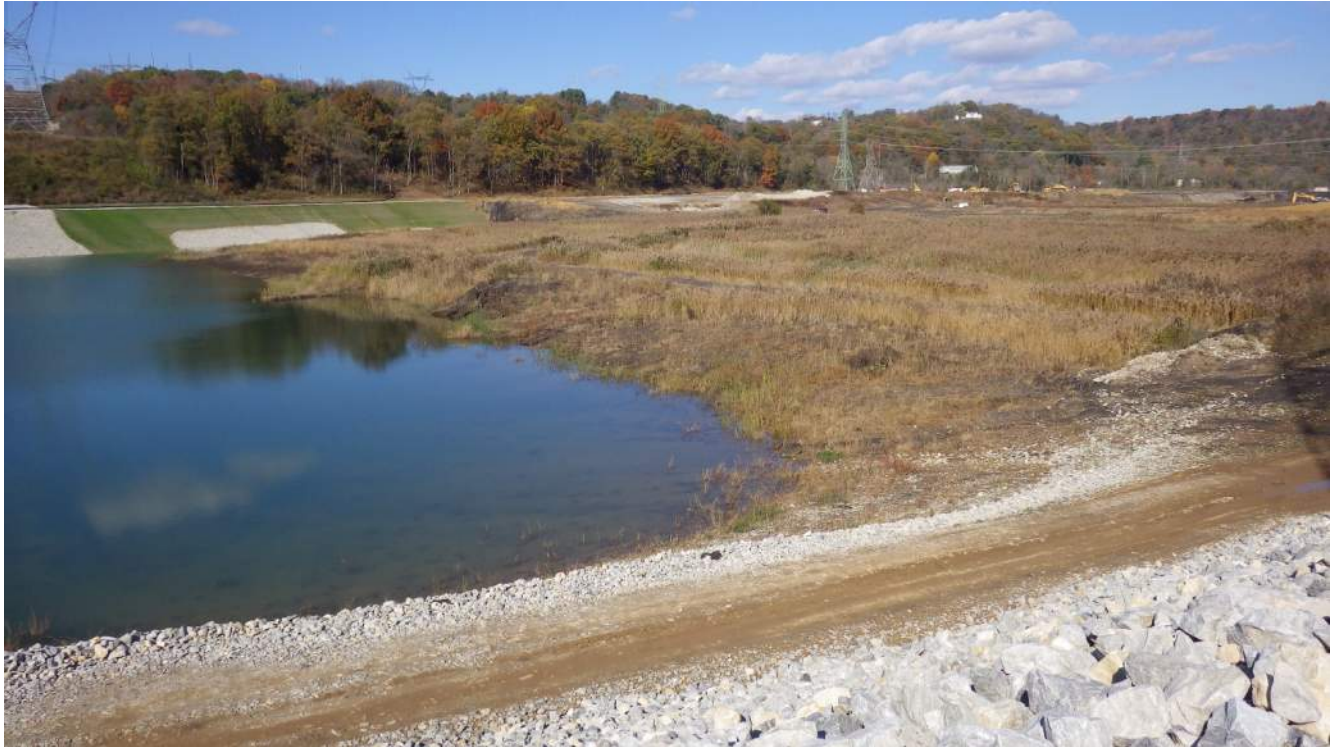
Photograph 13 – Looking north and east across marsh area east of the settling ponds from the southern dike embankment.

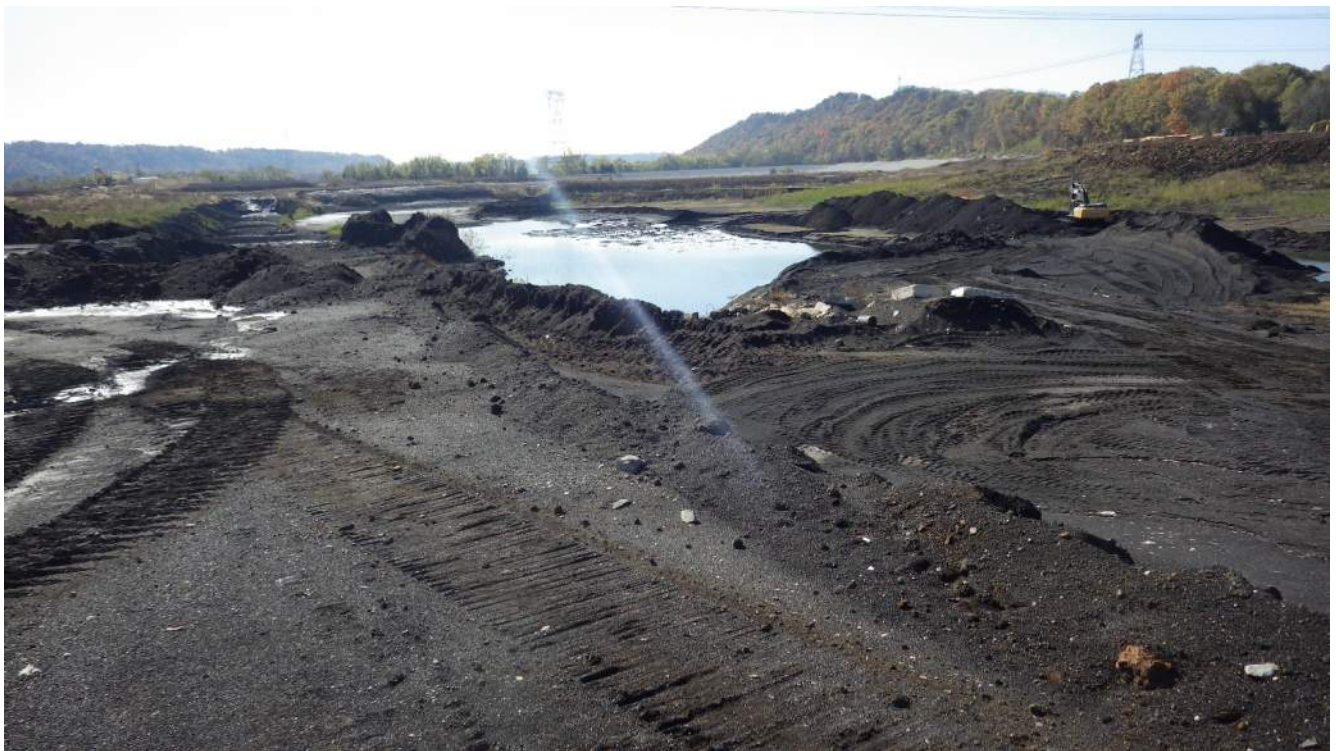
Photograph 14 – Looking south and west from the north western corner of the WBSP.

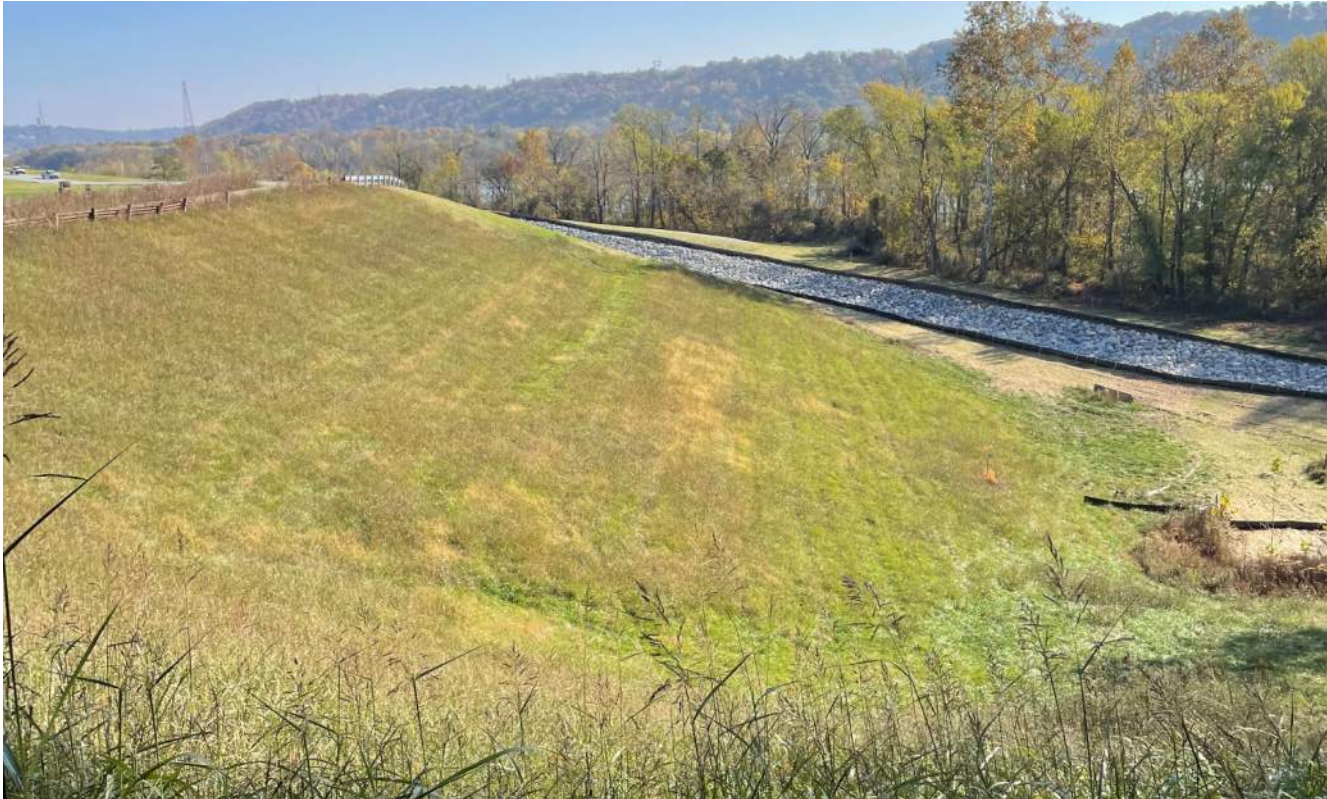
Photograph 1 – West downstream side of LRCP looking east.

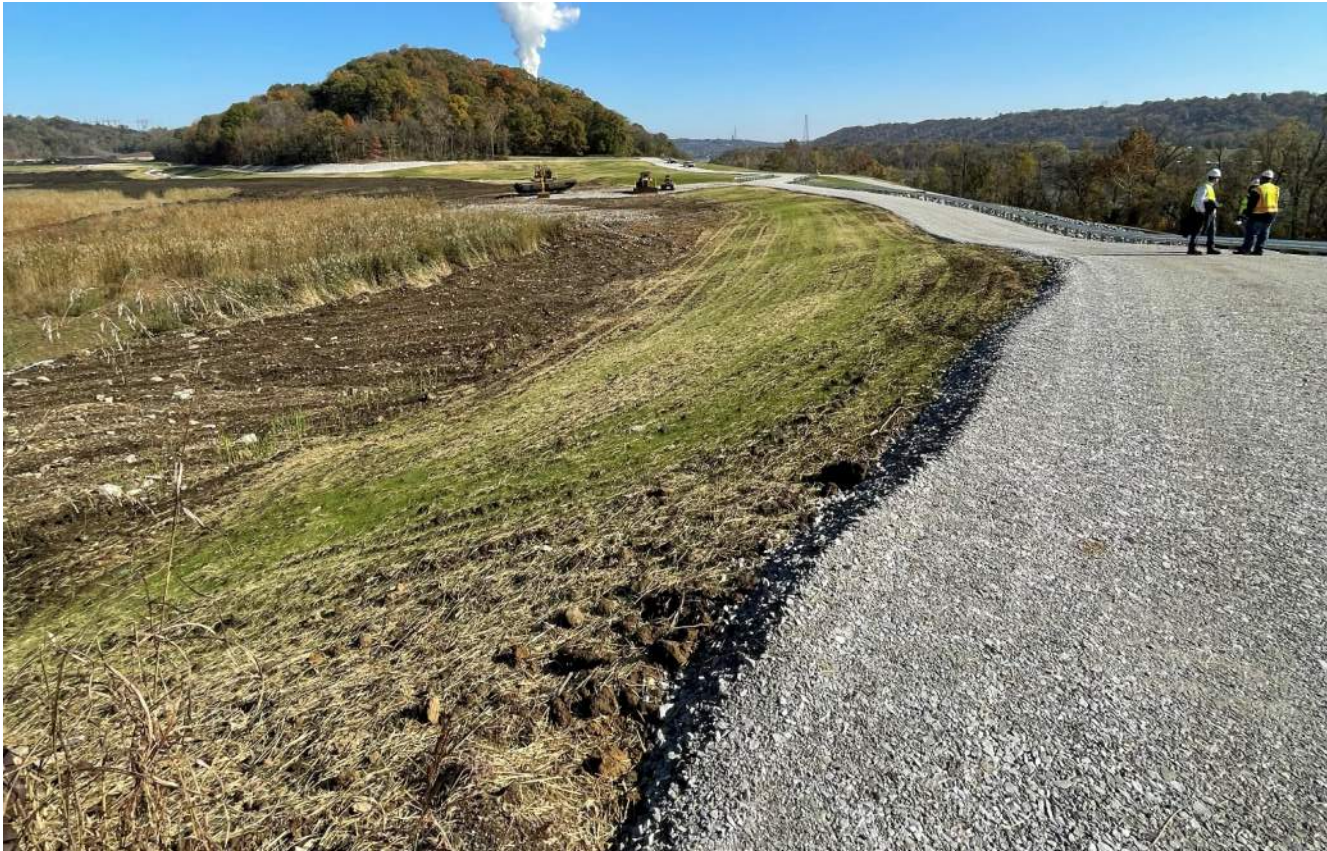
Photograph 2 – West upstream side of LRCP looking east. Starting from recent construction.

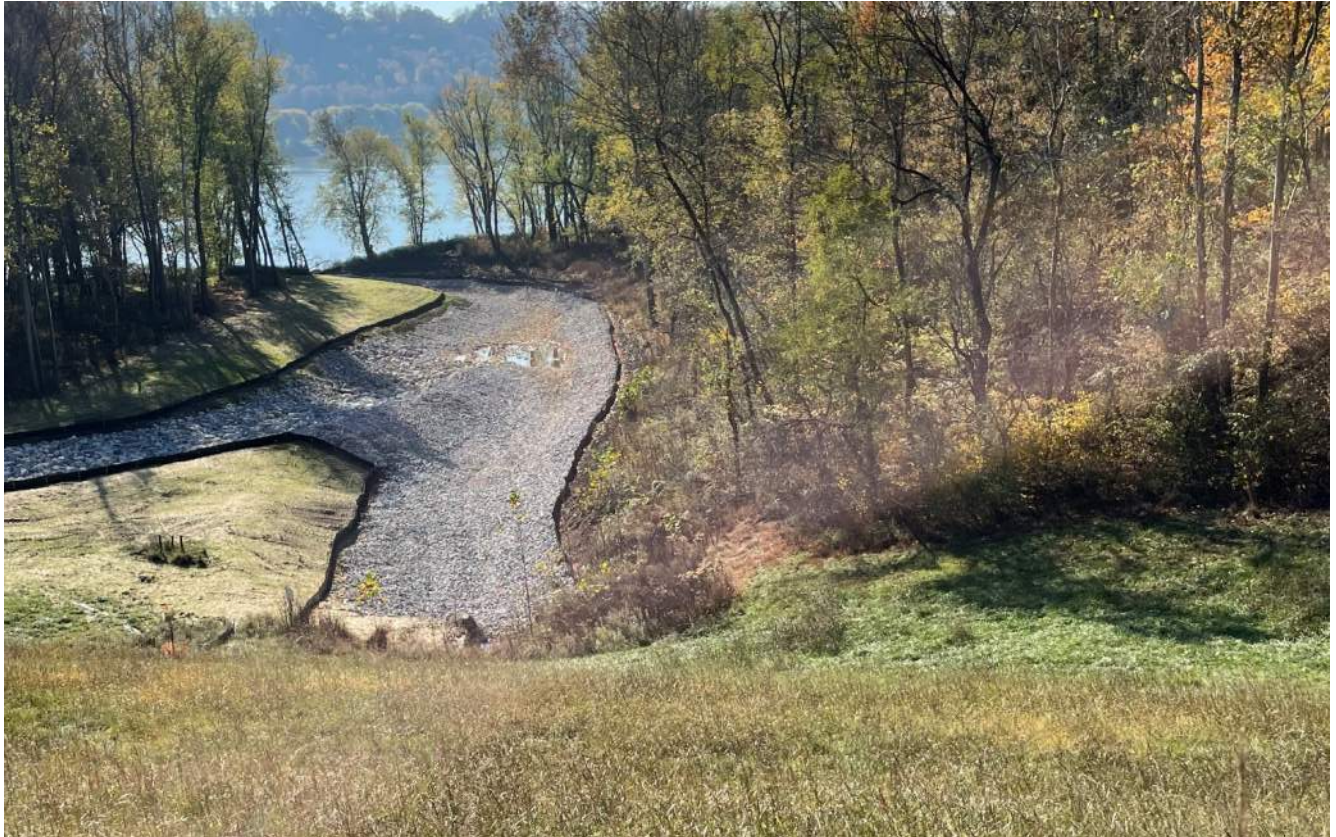
Photograph 3 – Downstream side of dam, newly constructed outfall channel to the Ohio River.

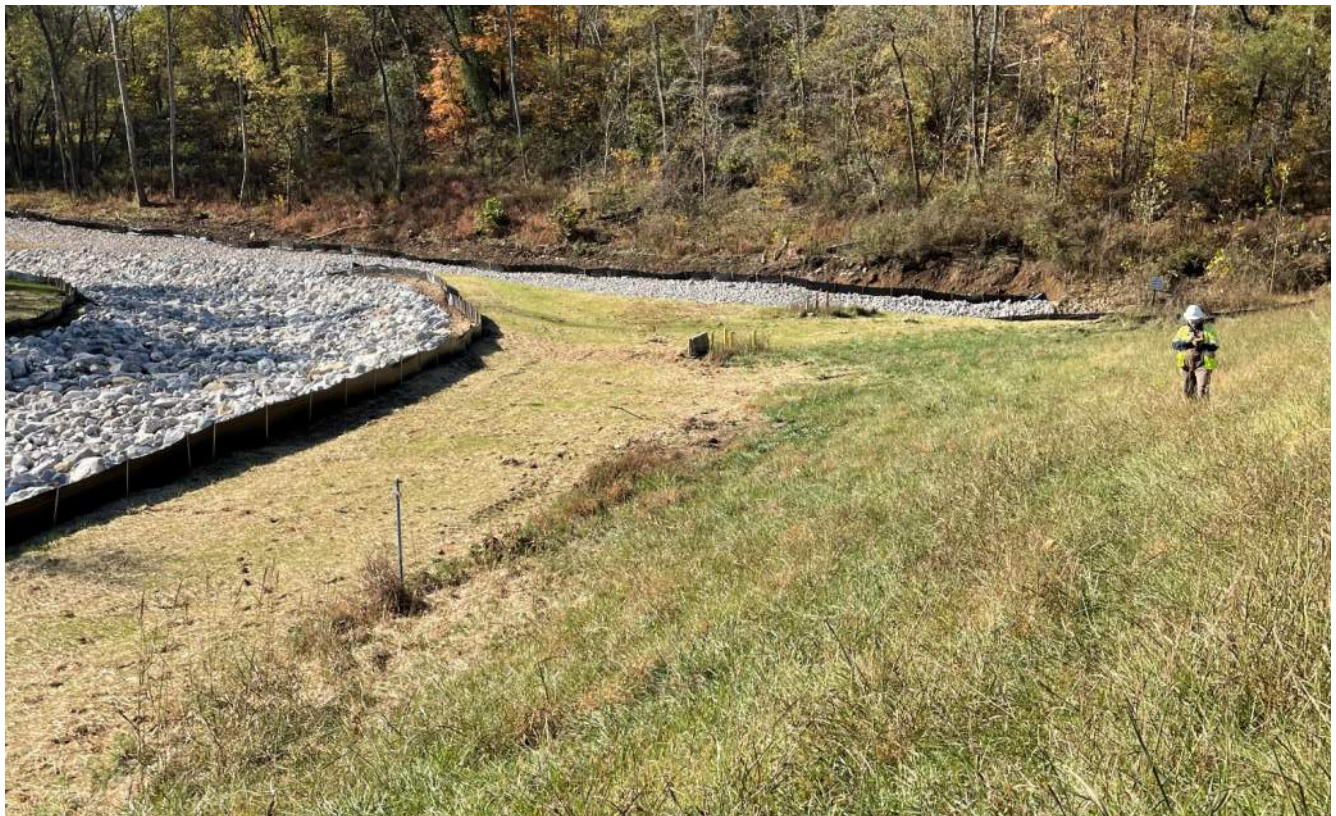
Photograph 4 – Western downstream side of dam where new channel area and toe meet.

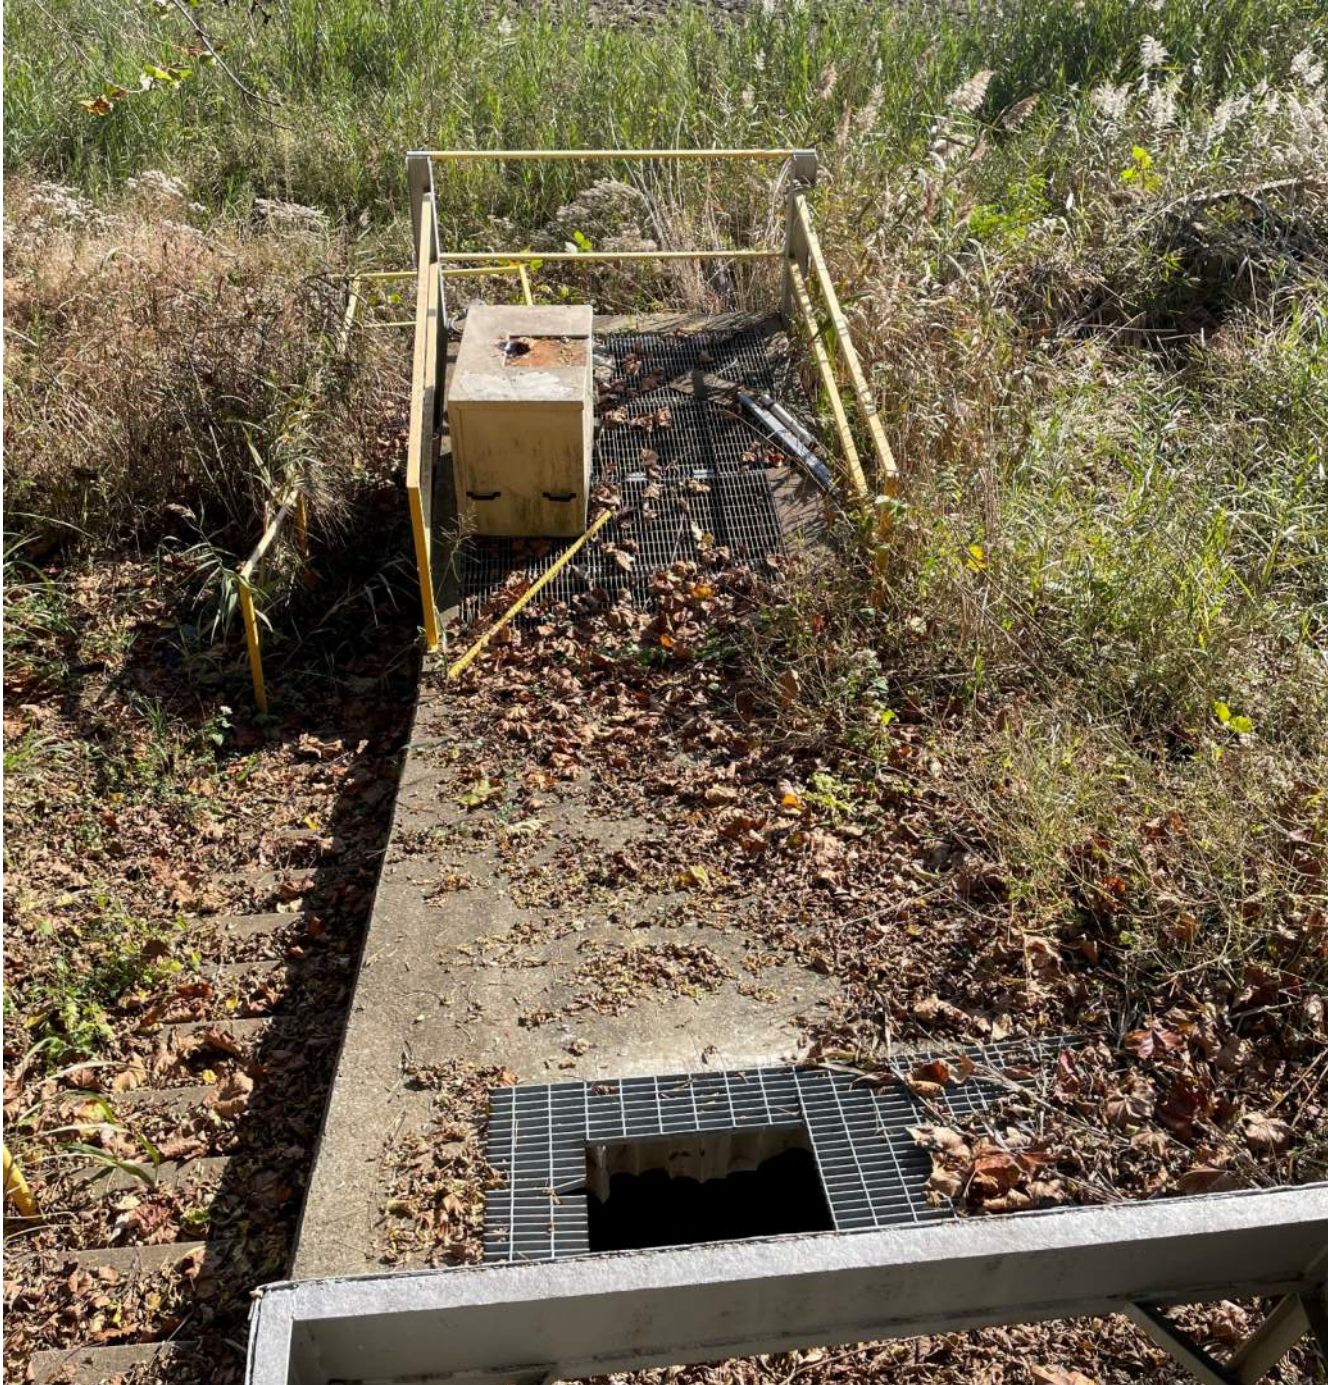
Photograph 7 – Previous inlets for Outfall 001. Access to current inlet via stairway on the left.
