**Re: Indiana-Kentucky Electric Corporation
Clifty Creek Station
Notification of CCR Rule Information Posting
Annual Certified CCR Dam and Dike (Surface Impoundment)
Inspection Report Posting**

**2023 CCR Rule – Surface Impoundments
Clifty Creek Dam/Dike Inspections**

Clifty Creek Generating Station
Madison, Indiana
Jefferson County

January 19, 2024

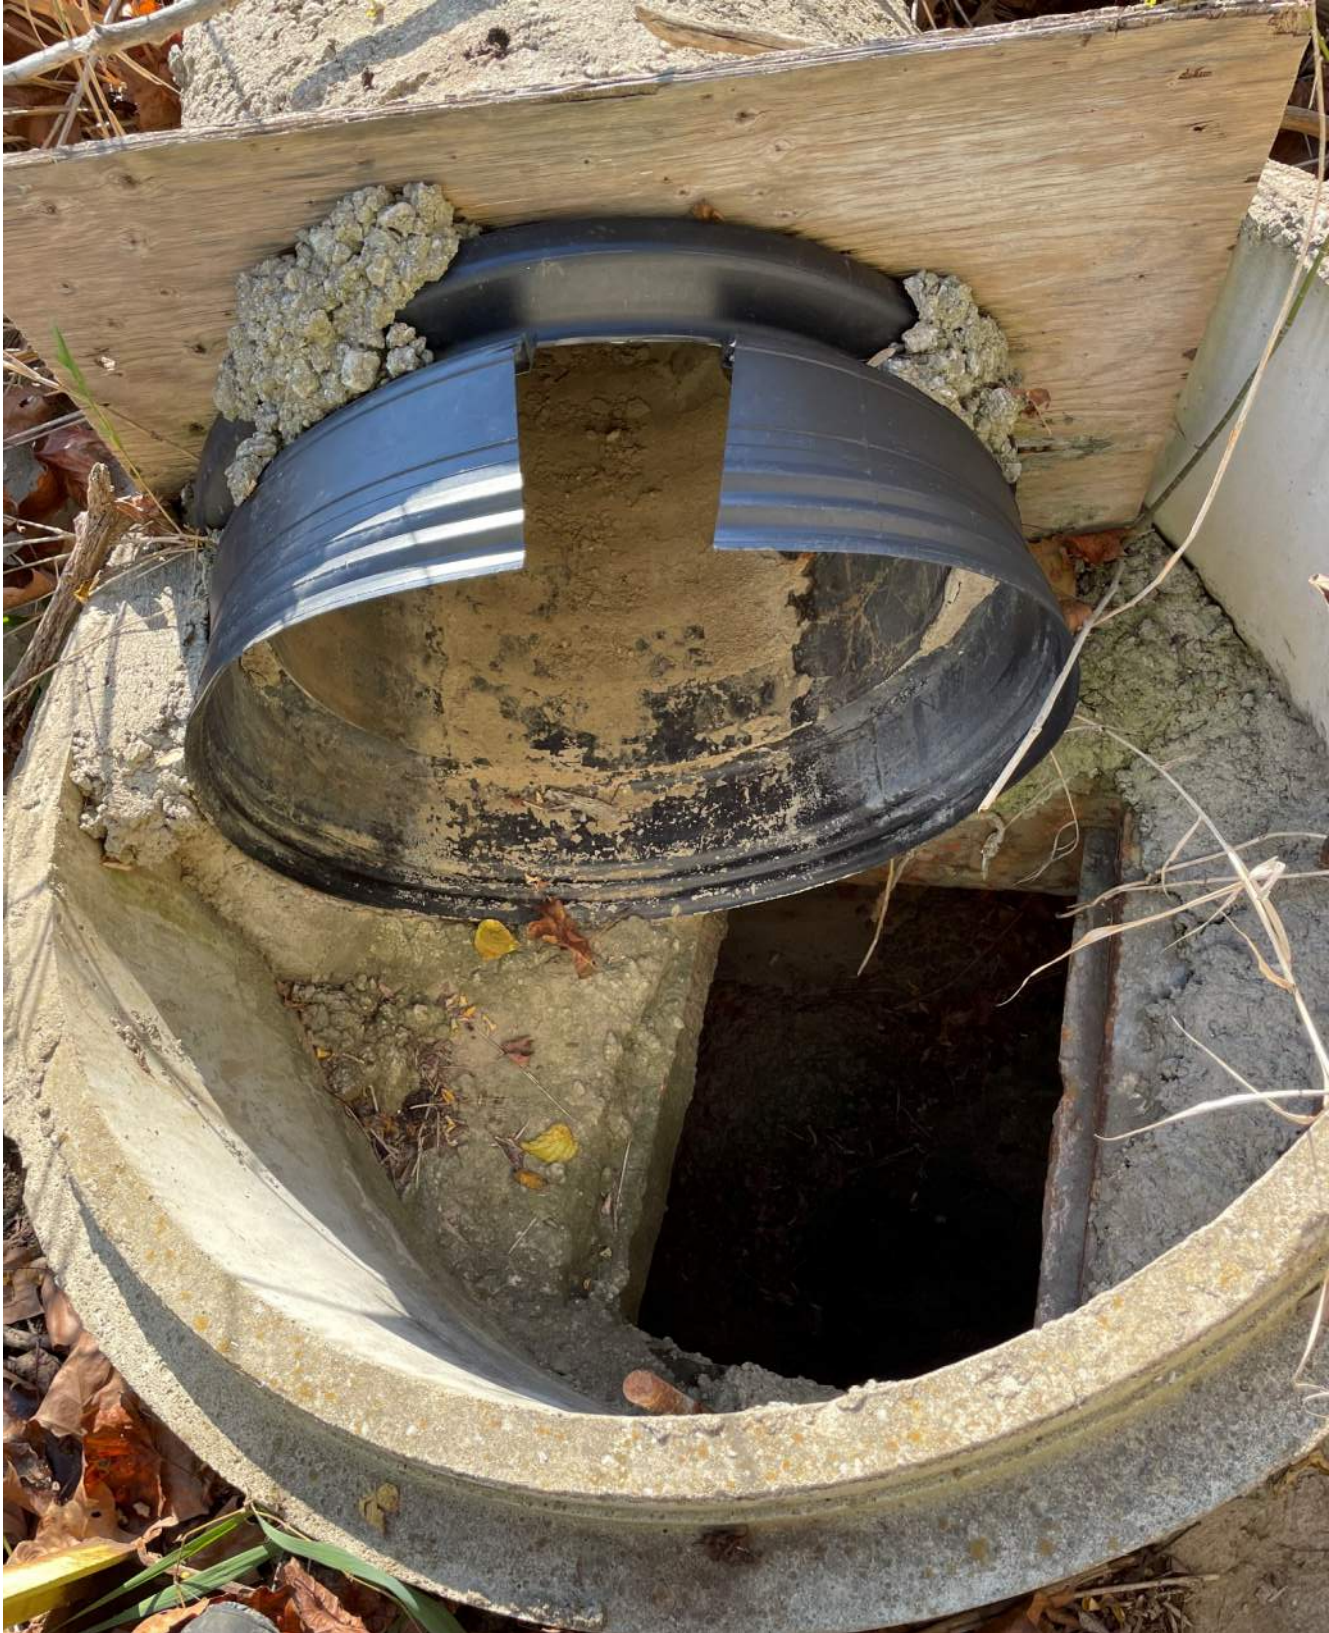
Photograph 8 – Current inlet structure for Outfall 001.

At the outlet for Outfall 001, we recommend that all brush and tall foliage around the wingwalls be removed to a distance of about 20 feet and replaced with either grass or riprap to aid in observation of the outlet structure. A railing around the top of the head and wing walls could also be considered. Debris left over from previous clearing activities should be removed from inside the culvert outlet box (Photograph 5). Since water will no longer be impounded in the LRCP, we recommend that an area at a distance of 20 feet around the inlet structure be cleared of all tall grasses and brush (Photographs 6 and 7). In addition, railings should be replaced or reinstalled around the inlet structure. A portion of the metal grating that covers one of the old inlets has been cut away leaving an open hole (Photograph 7). The grating should be replaced or the hole covered. Any superfluous materials or fixtures associated with the inlet structure should be removed. It is understood that the inlet elevation will be adjusted as part of the Phase 2 construction (Photograph 8).

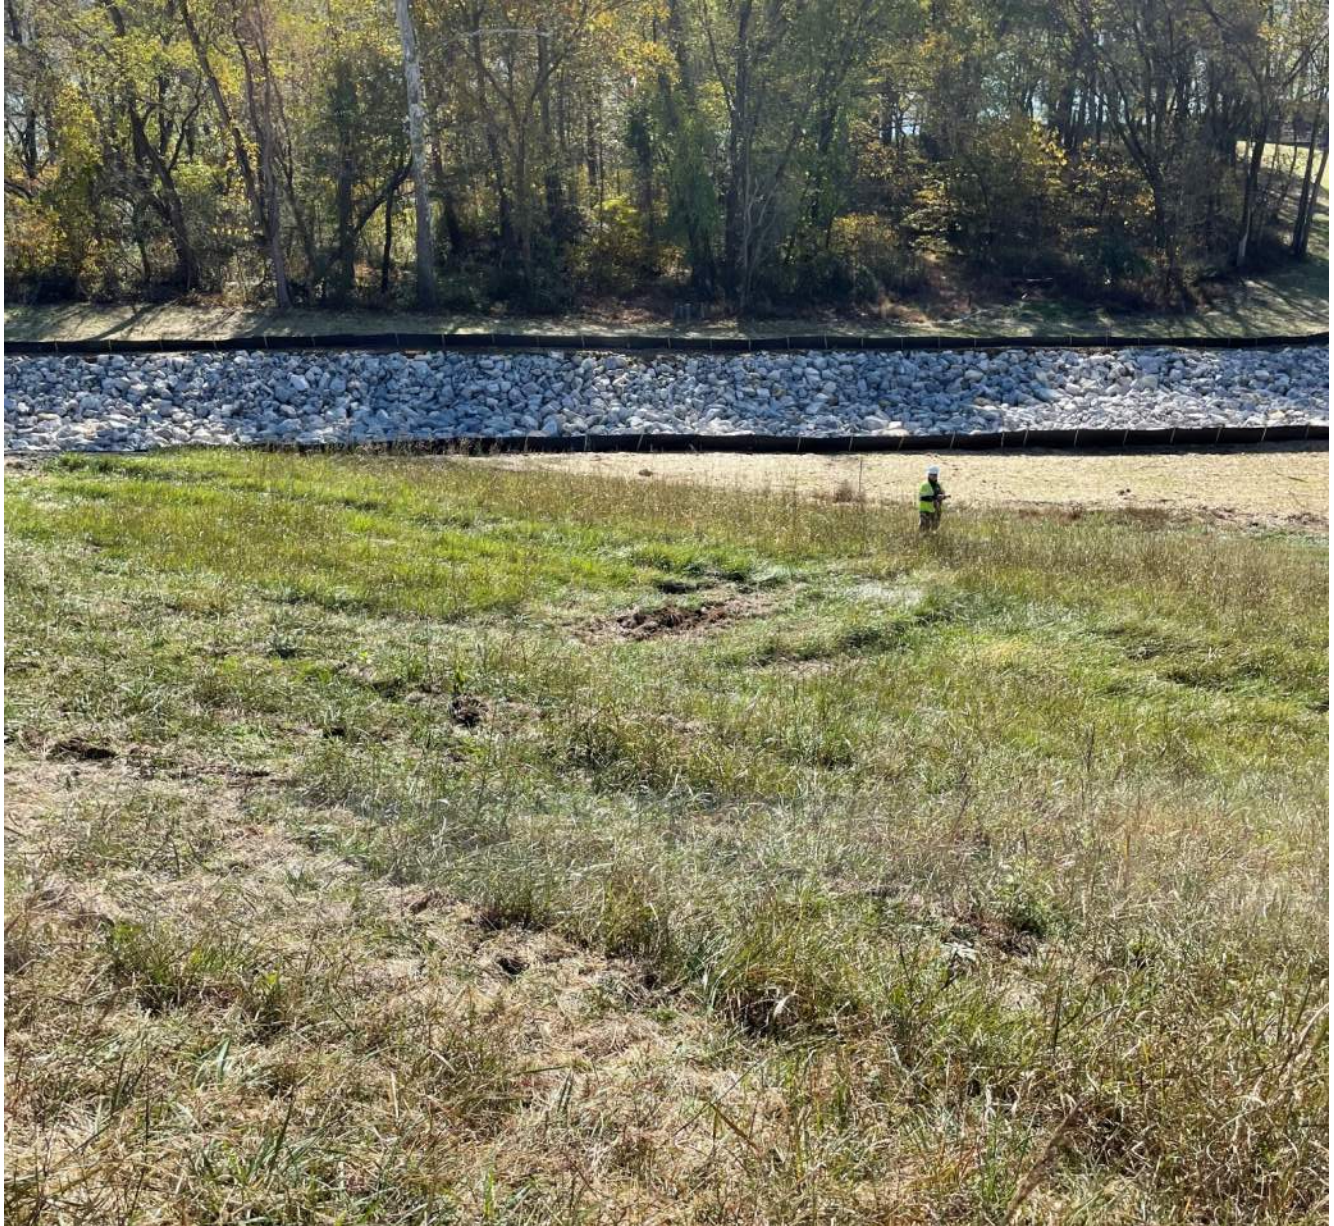
Photograph 9 – Western downstream side where the channel extends along the face and toe of the embankment. Note disturbed spots in grass from equipment.

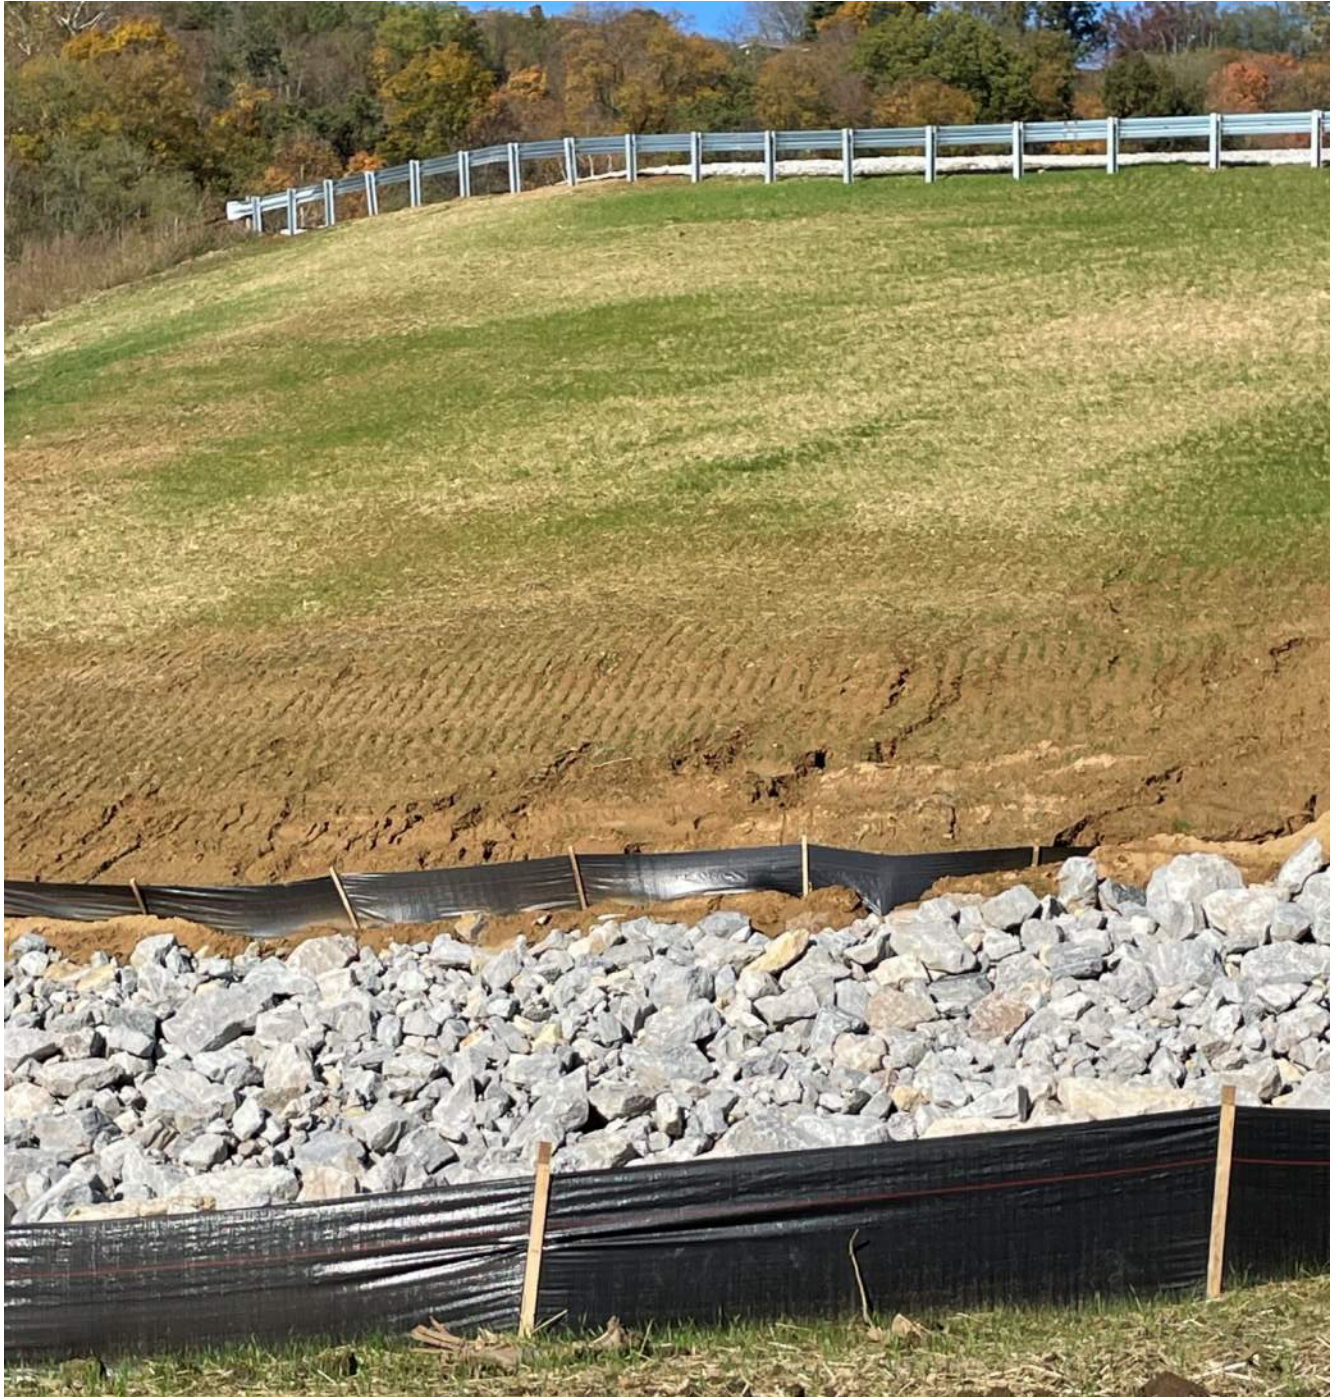
along the north edge of the new channel where erosion rills had started to form and one location below the access road to the toe where the seeded surface had sloughed off the slope. On the downstream slope between the access road to the toe and the riprap-covered slope are several areas where minor grading occurred. In these areas the bulldozer trampled the grass and may require reseeding to prevent erosion. Overall, the dam and associated structures appear to be in satisfactory condition.

Photograph 10 – Western part of regraded downstream side of dam. Note the erosion rills forming above the channel.

Minor maintenance for the LRCP includes mowing of the dam slopes to observe potential issues or concerns, repairing the erosion rills above the downstream channel (Photograph 10) and the disturbed areas on the western downstream slope just west of the newly graded slope (Photograph 9). The surface-sloughed area beneath the access road to the toe (Photograph 12) and the thinly vegetated slopes east of the access road (Photograph 13) will likely require attention as well.

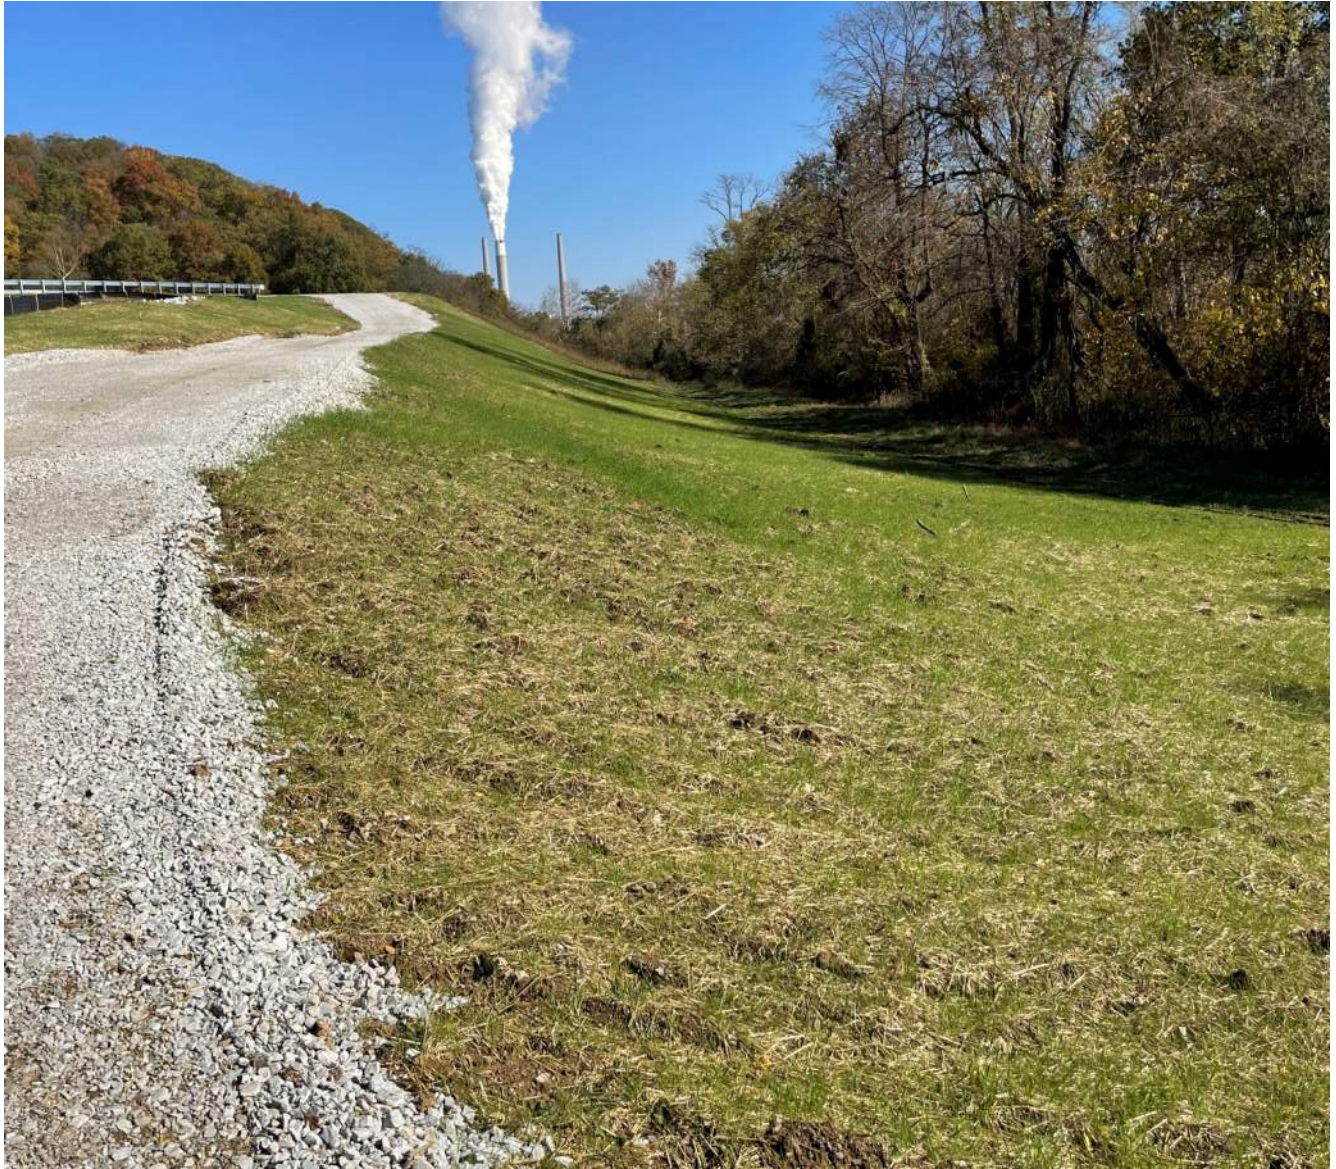
Photograph 11 – Downstream side of dam below the access road to the toe, looking east.

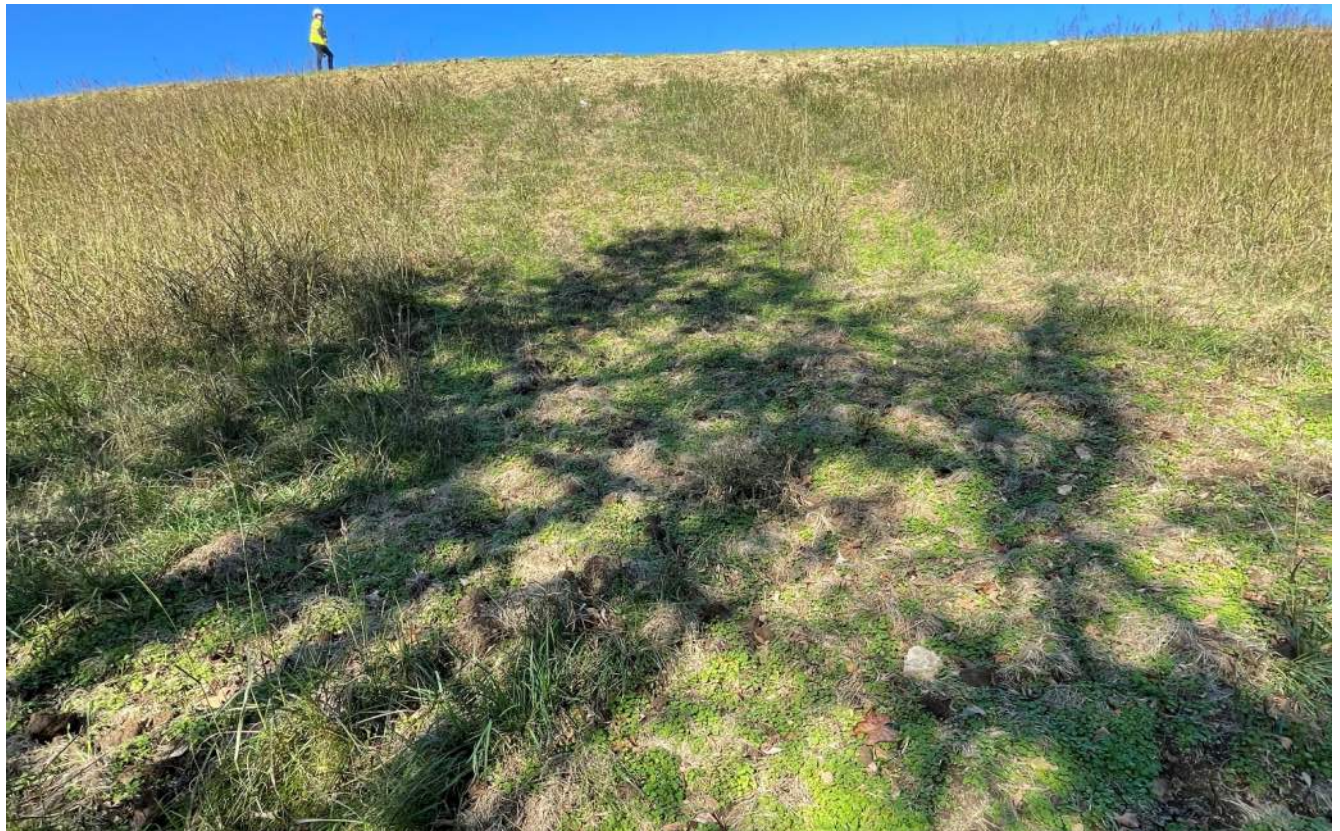
Photograph 13 – Downstream side of dam east of access road. Several areas of sparse vegetation where the bulldozer traversed the slope.

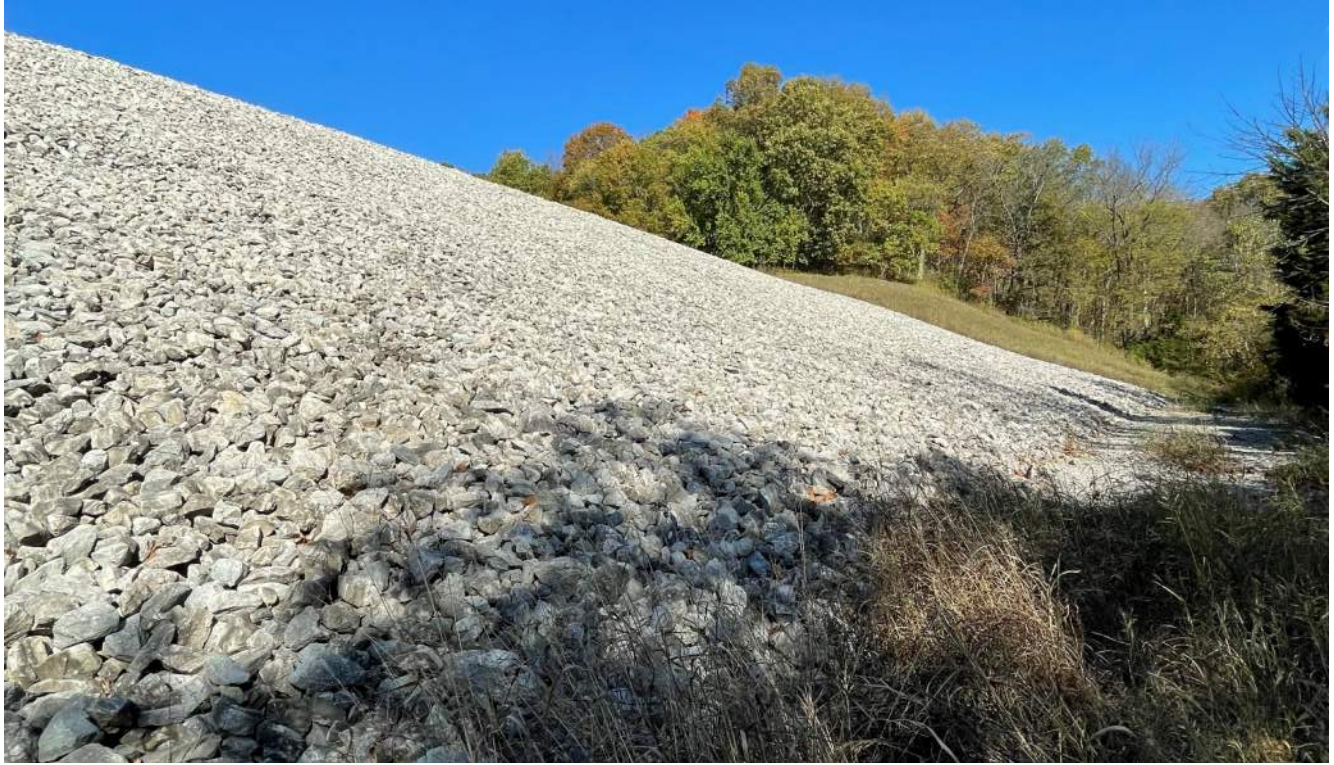
Photograph 14 – Downstream side of dam, previous rip rap slope. Looking east.

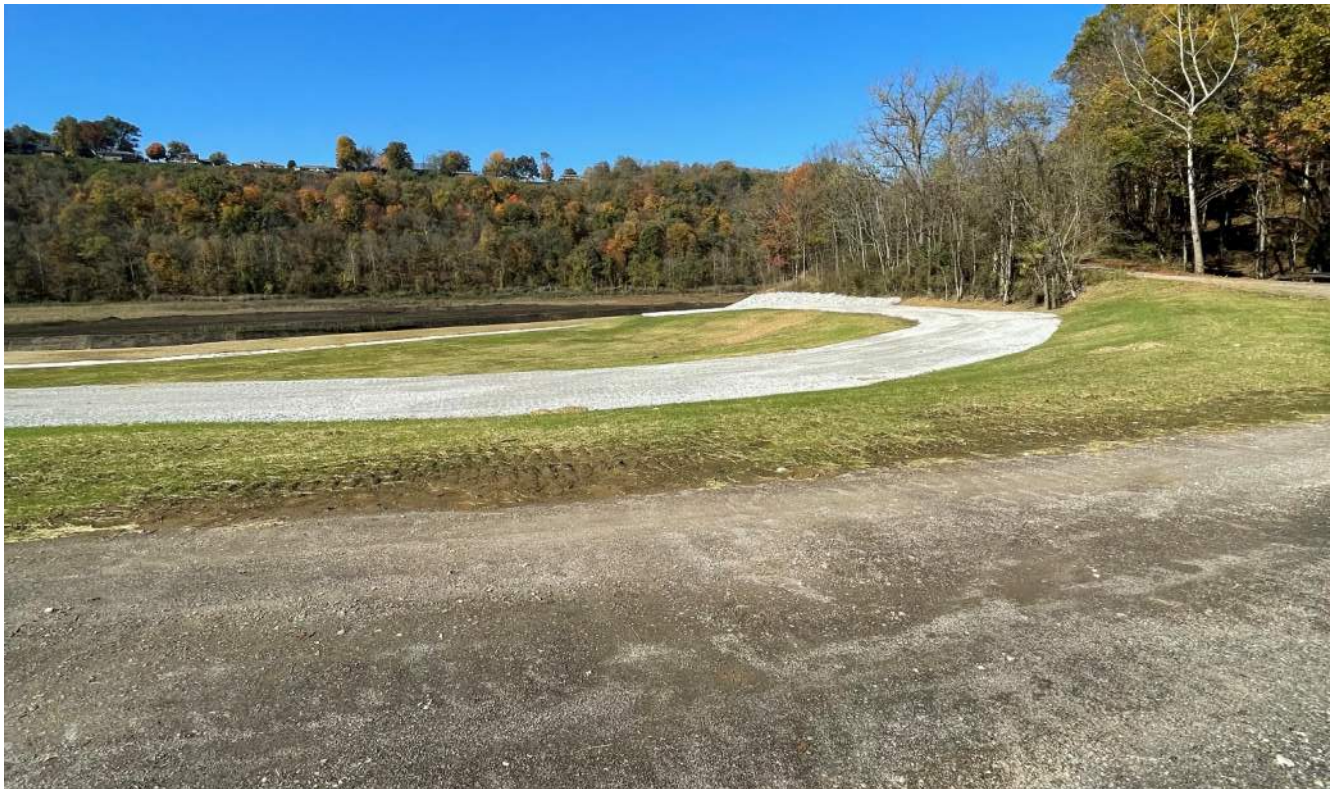
Photograph 15 – Crest of dam at the east end, looking north at new access road and teardrop area.

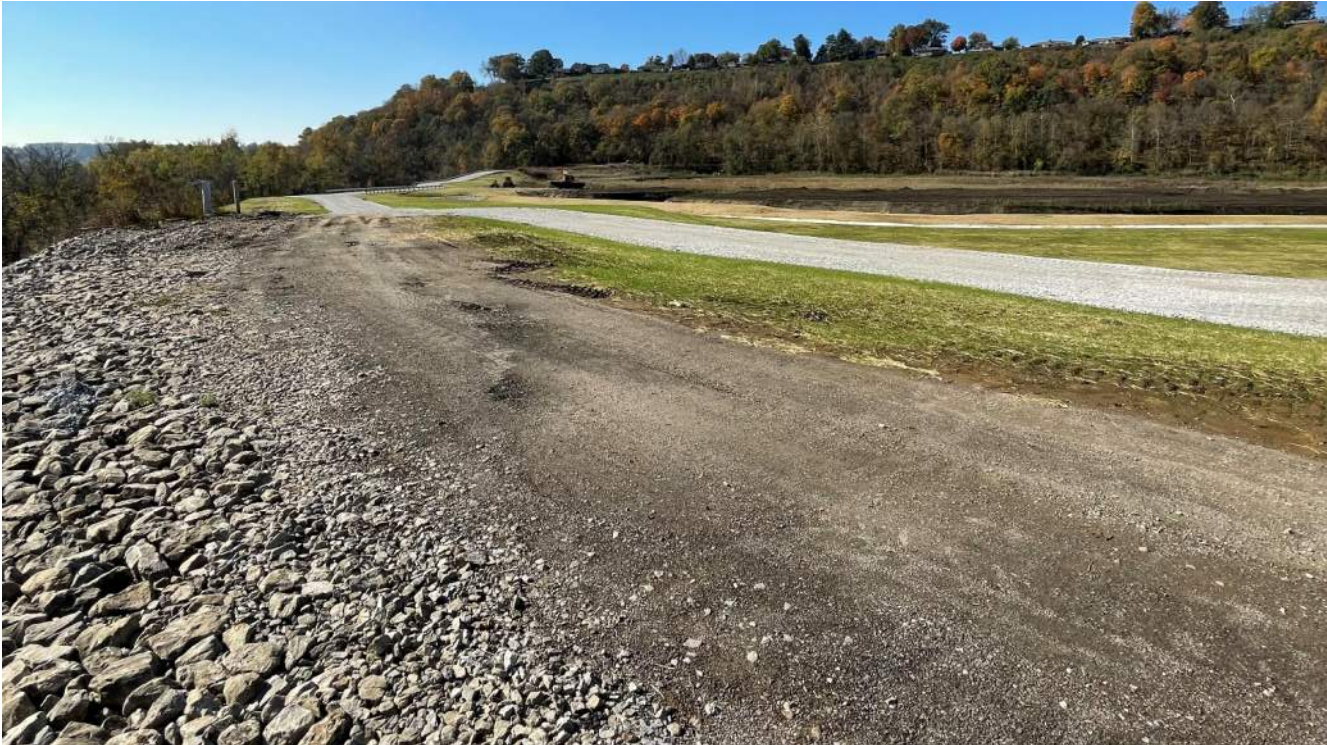
Photograph 16 – Crest of dam at the east end, looking west at the new access road and the top of the dam.

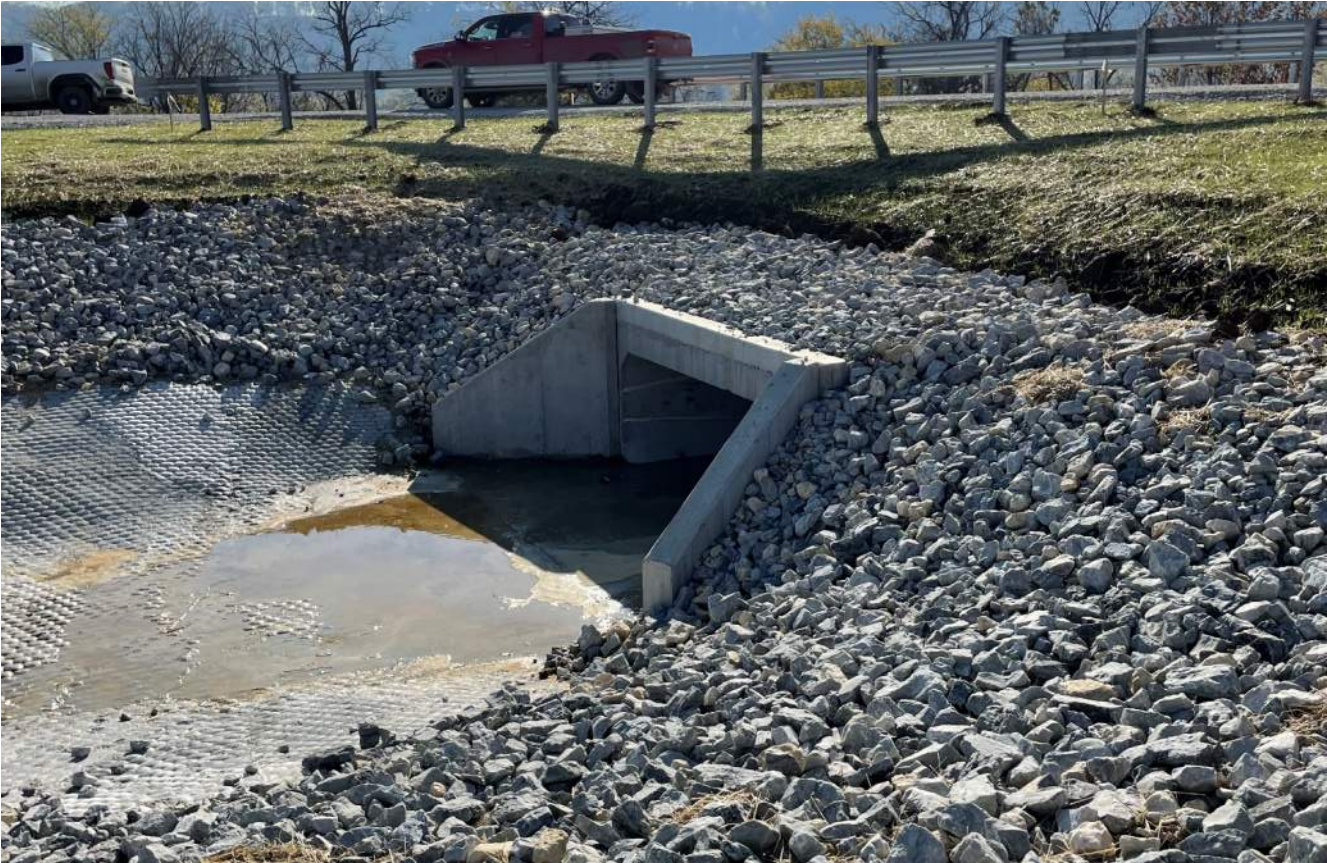
Dam degradation and the addition of the 12-foot by 4-foot box culvert to allow routing of run-on stormwater around the LRCP have potential for affecting the stability of the dam. Placement of a structure in or below an earthen dam provides the potential for seepage around the structure. Stantec provided a professional engineer to provide quality assurance during construction activities on the LRCP dam. Based on review of the construction observation reports, clay fill was adequately placed and compacted around the outside of the culvert structure. Shortly after completion of construction, the culvert appeared to adequately convey water from the upstream side to the downstream channel. Grass should help protect the slopes from erosion once the newly seeded slopes have matured.

Photograph 17 – Upstream side of dam at new 12x4 culvert.

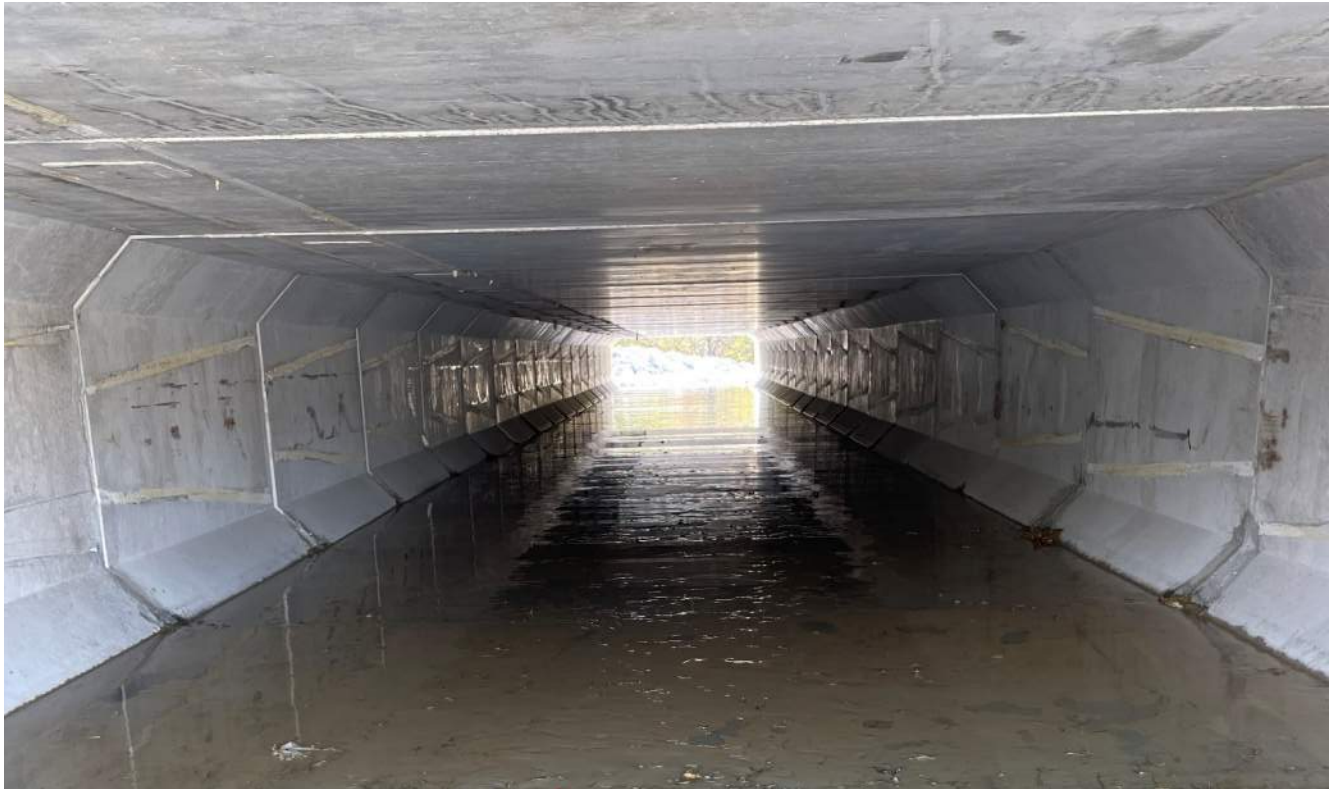
Photograph 18 – Upstream side of dam at new 12x4 culvert, looking south west through the culvert.

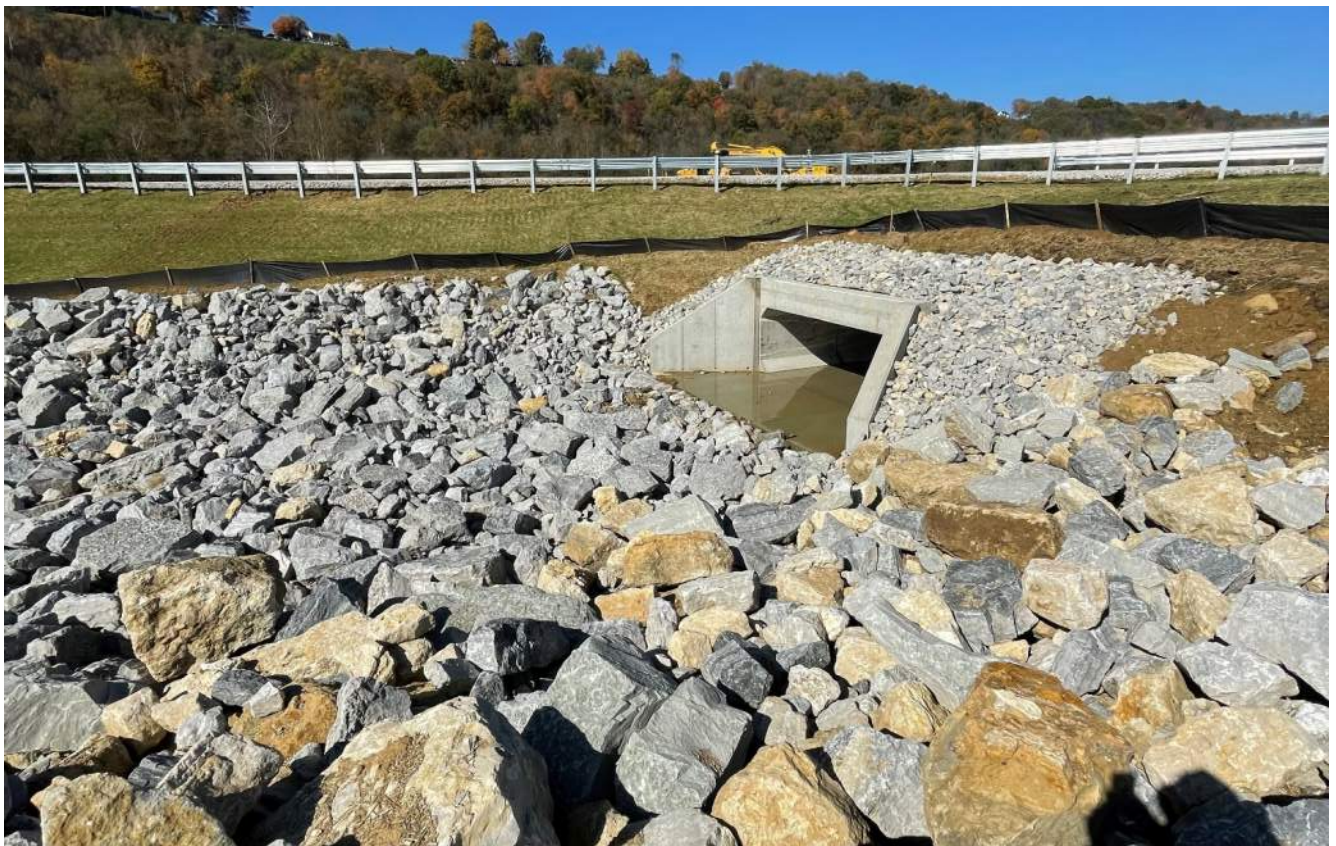
Photograph 19 – Downstream side of dam at new 12x4 culvert.
