**RE:     Periodic Structural Stability Assessment  
          West Boiler Slag Pond  
          EPA Coal Combustion Residuals (CCR) Rule  
          Clifty Creek Station  
          Madison, Jefferson County, Indiana**

**RE: Initial Structural Stability Assessment  
West Boiler Slag Pond  
EPA Final Coal Combustion Residuals (CCR) Rule  
Clifty Creek Station  
Madison, Jefferson County, Indiana**

## **Initial Structural Stability Assessment**

Clifty Creek Station  
West Boiler Slag Pond  
Madison, Jefferson County, Indiana

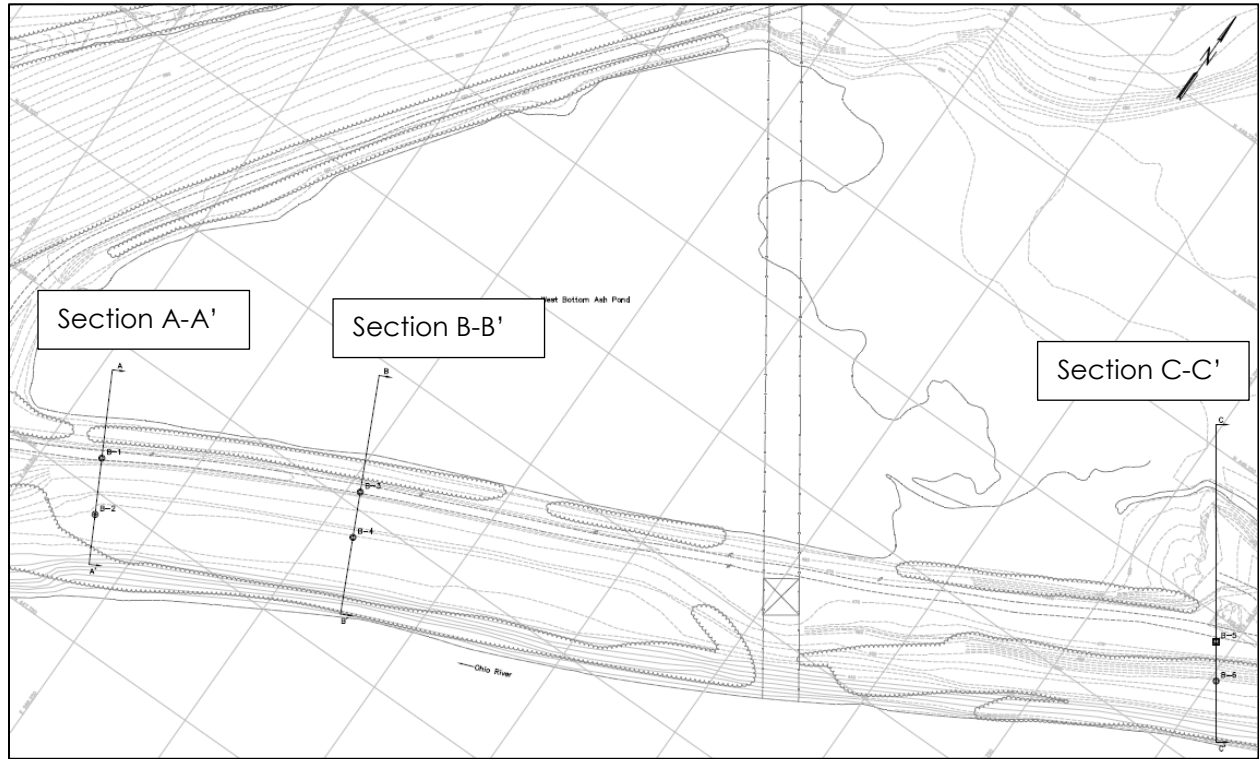
**Figure 1 Clifty Creek Power Plant West Boiler Slag Pond – Plan View of Cross Sections**

Slope stability analyses were available from Stantec (2010a and 2016). Three cross sections from the WBSP Dam were analyzed under static, long-term, steady-state conditions using the maximum surcharge pool. The three sections that were analyzed are labeled Sections A-A', B-B', and C-C' and are shown in Figure 1.
