2019 Annual Dam and Dike Inspection Report

Bottom Ash Pond Complex

South Fly Ash Pond

Kyger Creek Plant

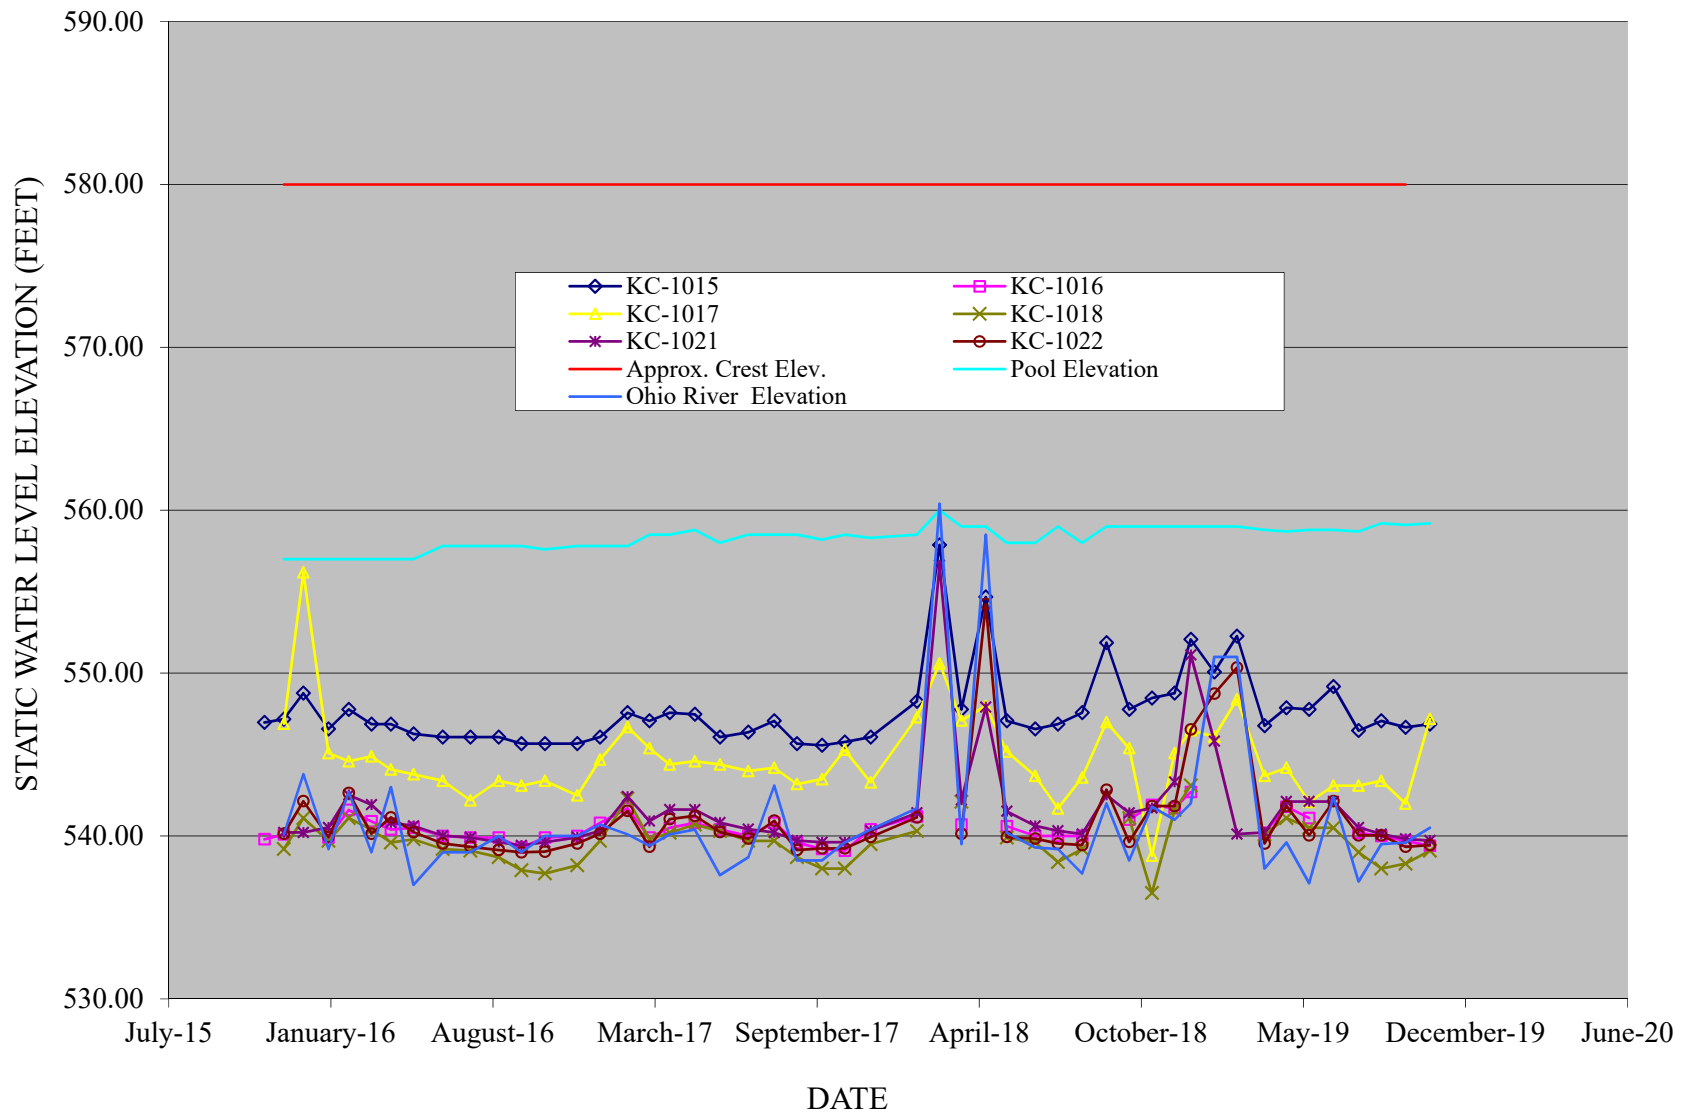
Figure 4 Bottom Ash Pond Complex Piezometers & Pond Levels.

The pond stages have remained fairly constant since the last annual inspection. A review of the piezometer readings indicates that no adverse trends were observed and the water level fluctuation is also responsive to changing Ohio River levels (Figure 4). Maximum piezometer water levels were nearly coincident with high river stages for the Ohio River (Figure 4).

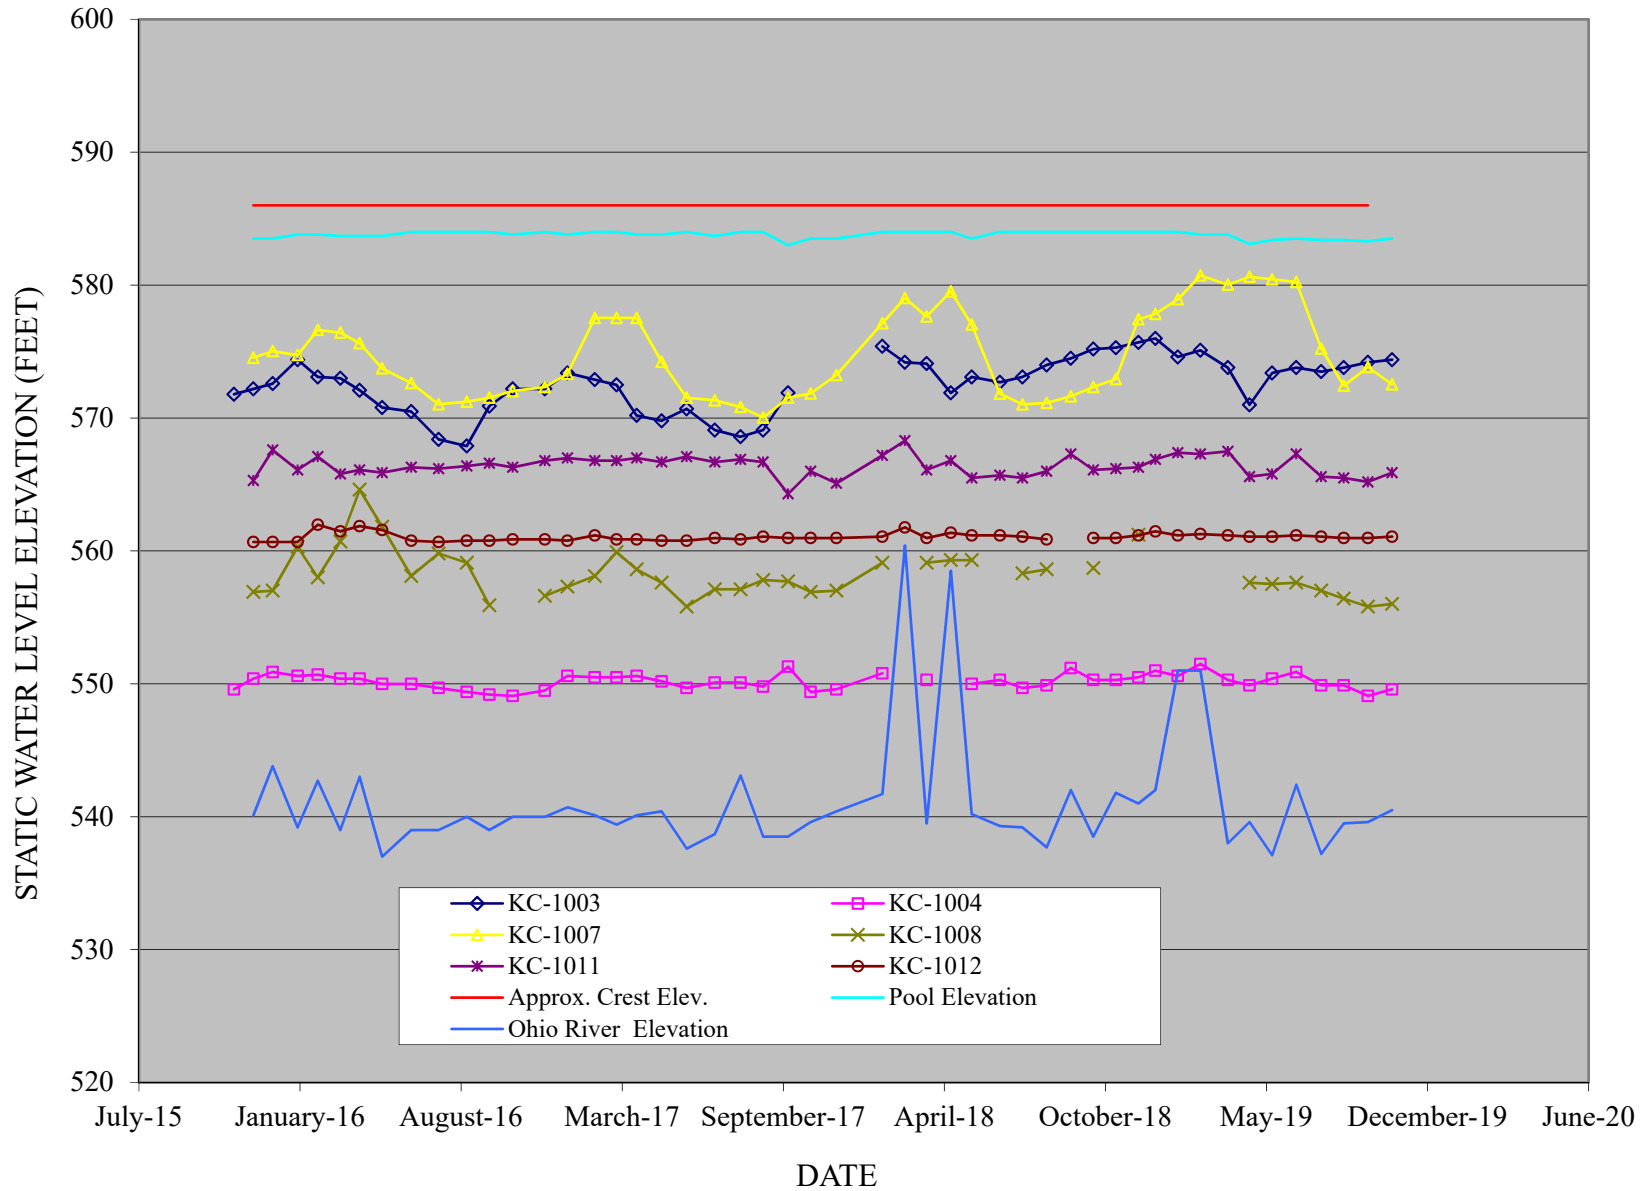
Figure 5 Fly Ash Pond Piezometers & Pond Levels.

The pond stages have remained fairly constant since the last annual inspection. A review of the piezometer hydrographs for each piezometer indicates that no adverse trends are present (Figure 5).

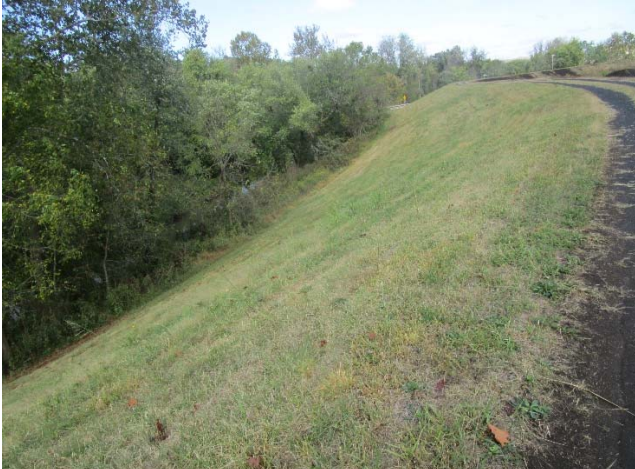
Vegetation is well established and is controlled through an active maintenance program (Photo 1).

Photo 1 Typical view showing good conditions of the boiler slag embankment.

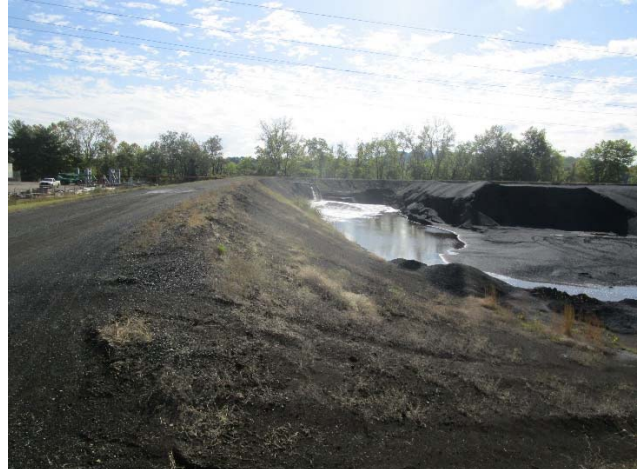
Discharge into the boiler slag pond is unobstructed and free draining (Photo 2).

Photo 2 Typical view showing good conditions of the boiler slag embankment and stockpile of material to be used for beneficial utilization.

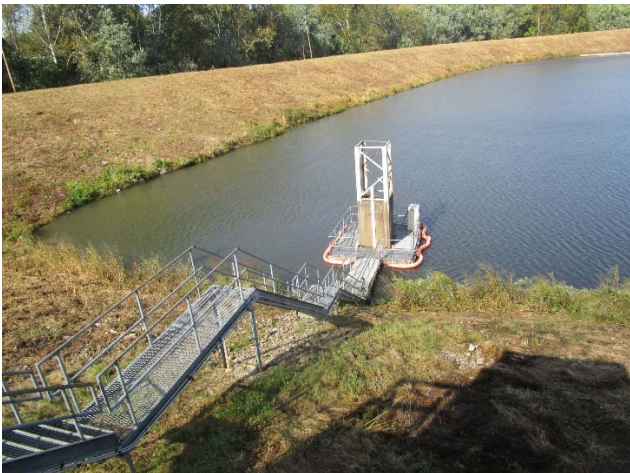
The decant structure for the clear water pond was observed to be in good condition and flow was unobstructed (Photo 3).

Photo 3 Typical view showing good conditions of the decant structure and interior embankment.

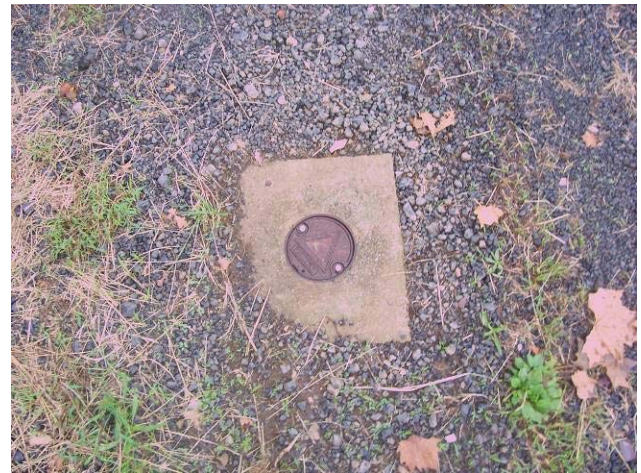
Surface seals and concrete pads for the dam’s piezometers were observed to be free of defects (Photo 4).

Photo 4 Typical view showing good conditions of the flush mounted piezometer installation showing the well cap seal and concrete pad.

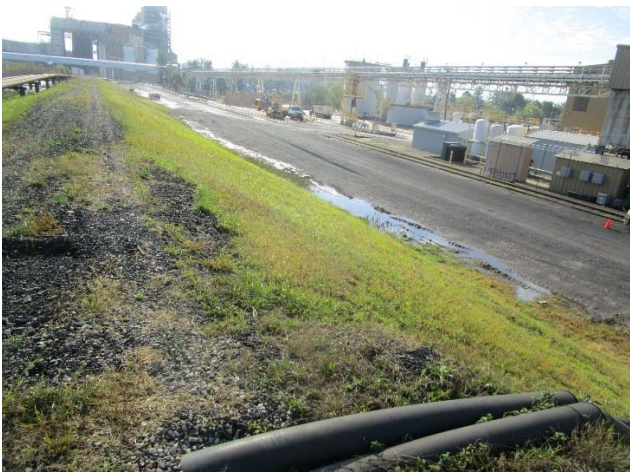
Areas of ponded water along the south dike of the south fly ash pond. (Photo 5)

Photo 5 Areas of ponded water along the south dike of the south fly ash pond.

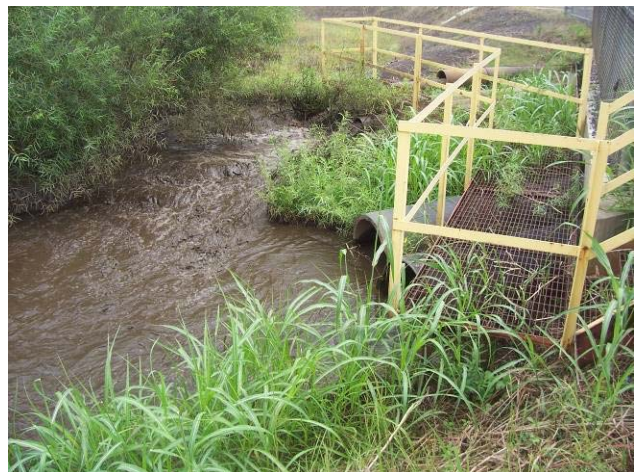
Discharge into the fly ash pond was observed to be free flowing and unobstructed (Photo 6).

Photo 6 Typical view showing conditions of unobstructed discharge into the fly ash pond.

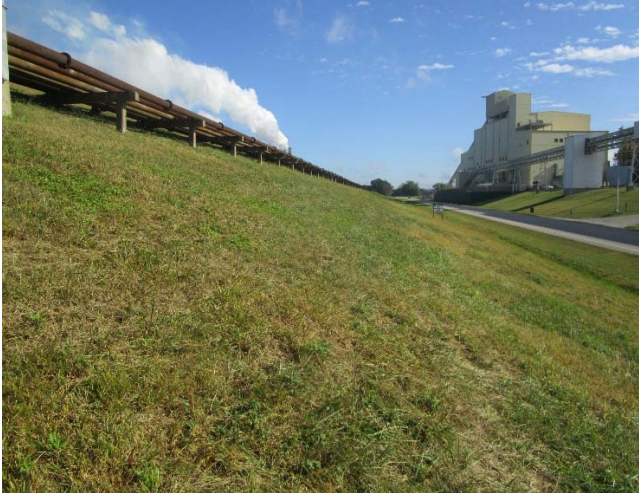
Embankment slopes and crest were observed to be in good condition (Photos 7, 8 and 9).

Photo 7 Typical view showing good conditions of the east embankment showing a uniform slope and a well maintained vegetative cover.

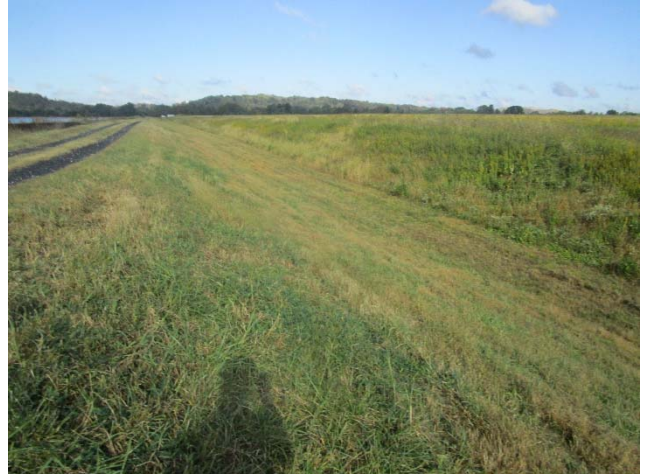
Photo 8 Typical view showing good conditions of the north embankment showing a uniform slope and a well maintained vegetative cover.

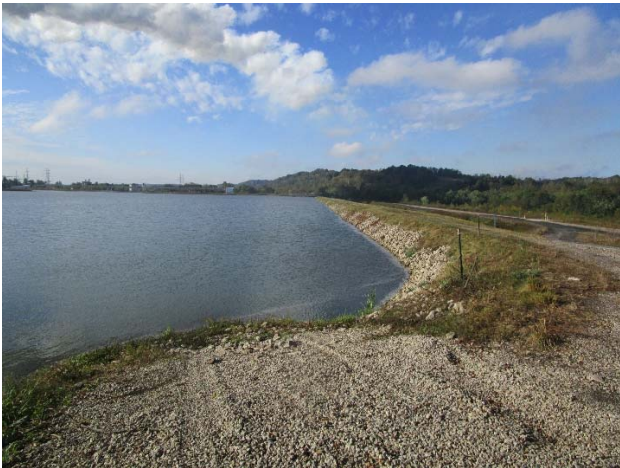
Photo 9 Typical view showing good conditions of the west embankment showing a uniform slope and crest. No erosion of the interior pond slopes was observed.

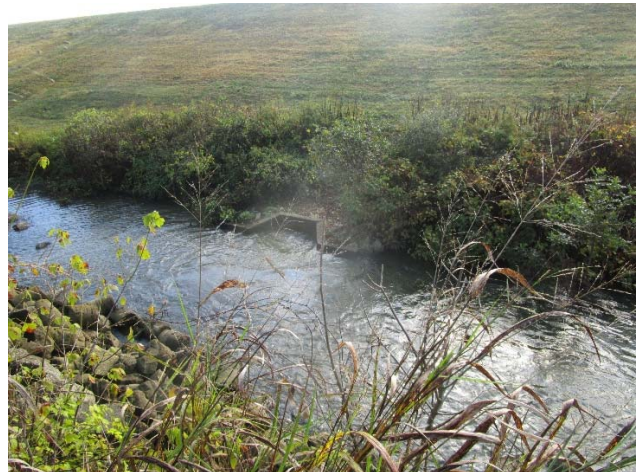
Discharge from the fly ash pond was observed to be free flowing and unobstructed (Photos 10 and 11).

Photo 10 Typical view showing fair conditions of the south fly ash pond discharge structure. Additional mowing is scheduled to be performed within this area.

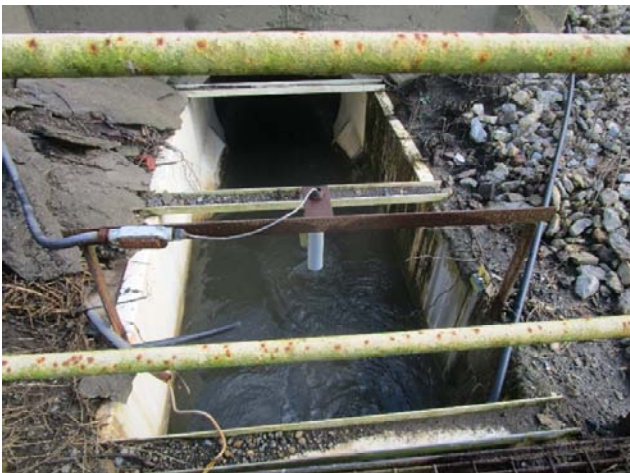
Photo 11 Typical view showing unobstructed flow from the south fly ash pond.

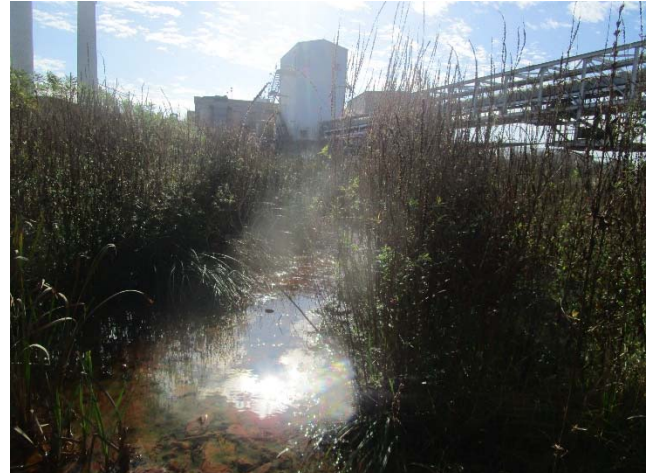
A minor seepage area (approximately 5 ft in diameter) was observed along the outboard slope of the pond's east embankment during the inspection and it seems to be intermittent based of the seven day inspection reports. (See Figure 3 for approximate location). The seep was observed to be visually clear and flow is consistent with previous observations (Photo 12).

Photo 12 – Typical view of seep along the south dike showing a visually clear discharge.

- 1) Isolated wet areas observed through the weekly inspections should continue to be monitored for flow rate and clarity of flow. The plant is actively mitigating such areas and repairing them using the same ODNR approved detail for controlling previous seepage areas along embankment slope. If the flow rate increases or the water flowing from the seep is not clear it should be brought to the immediate attention of AEP-Geotechnical Engineering.
- 2) The seepage located beyond the south toe was observed to have a similar flow rate to previous inspections. Weekly inspections have noted that the flow rate is steady at 24 gpm. The flow was clear and there was no accumulation of solids around the seepage areas. The flow rate and clarity of this seep should continue to be monitored during the 7 day inspections.
