# **2021 Annual Dam and Dike Inspection Report**

**Bottom Ash Pond Complex  
South Fly Ash Pond**

**Kyger Creek Plant  
Ohio Valley Electric Corporation (OVEC)  
Gallia County, Ohio**

Document Number: GERS-21-074

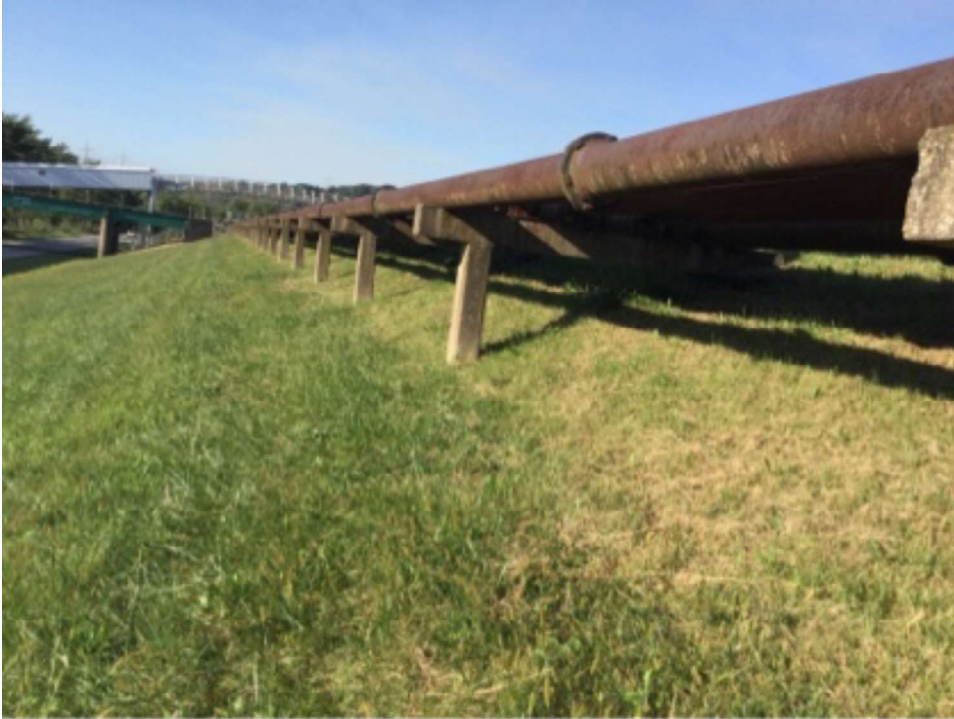
Photo #: 9

Notes: General condition of dike below pipe rack support along exterior slope of east dike

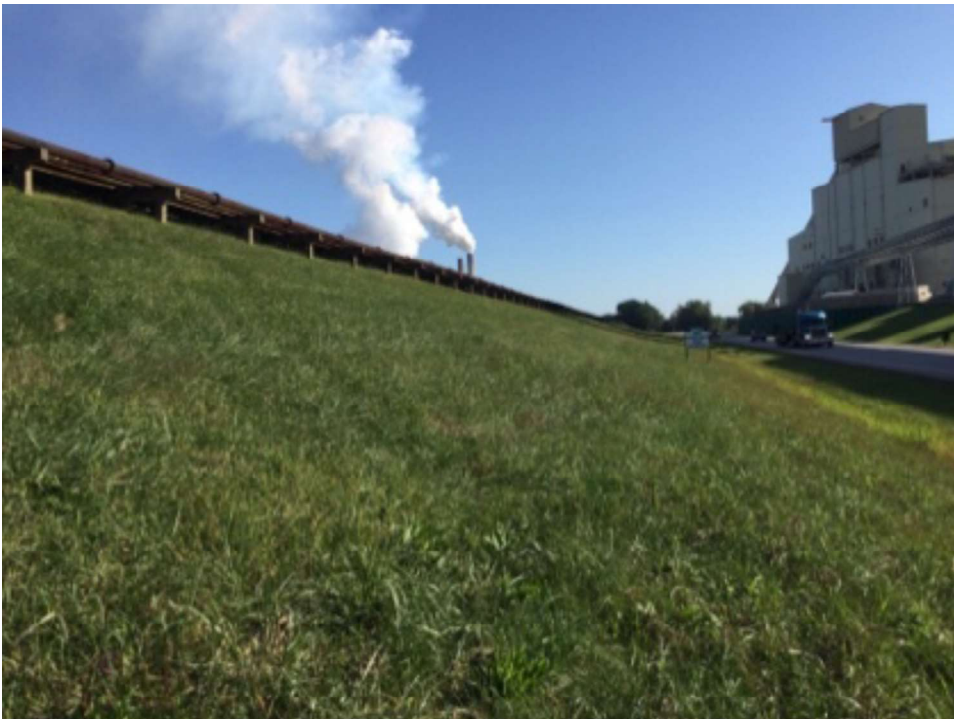
Photo #: 10

Notes: General condition of east dike exterior slope looking north

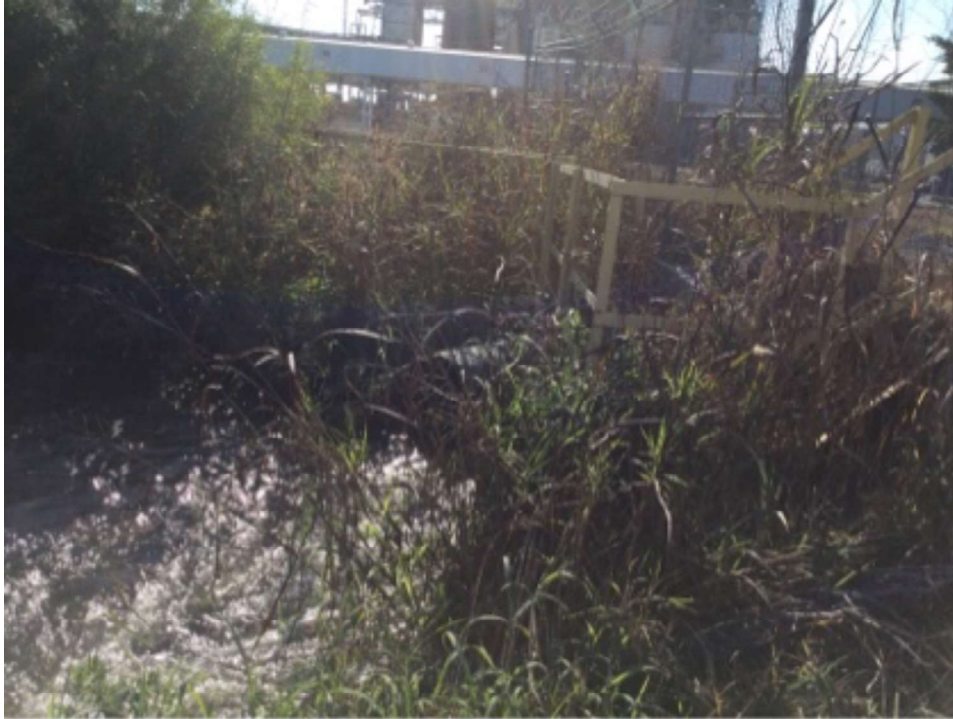
General condition of discharge structure located at southeast. Heavy vegetation inside the pond around the structure made inspection difficult.

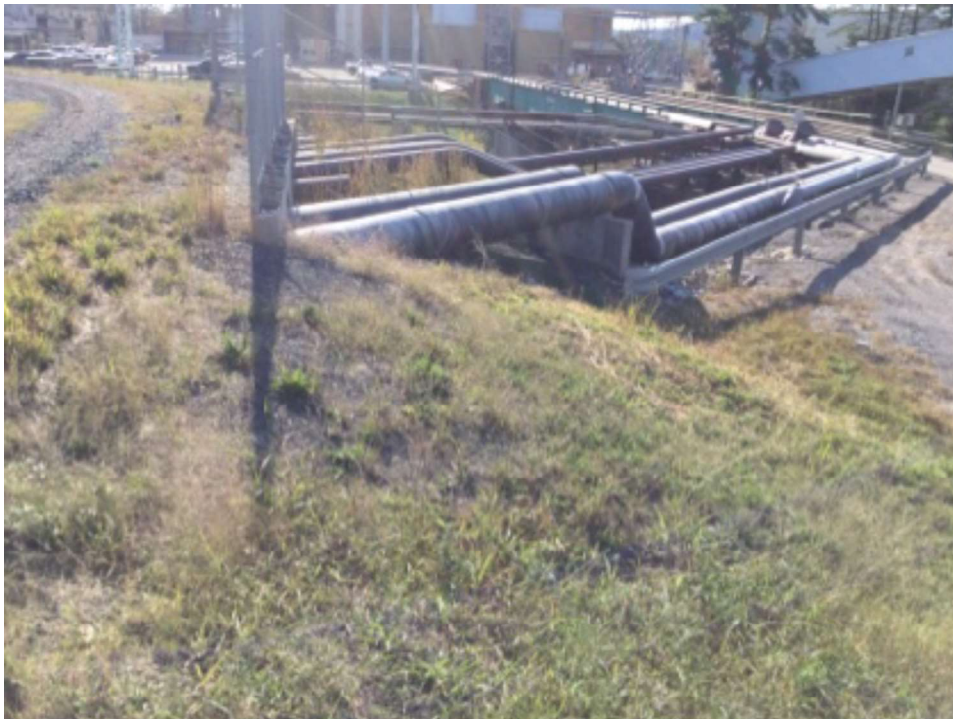
Photo #: 14

General condition of southeast exterior corner with pipes entering the pond

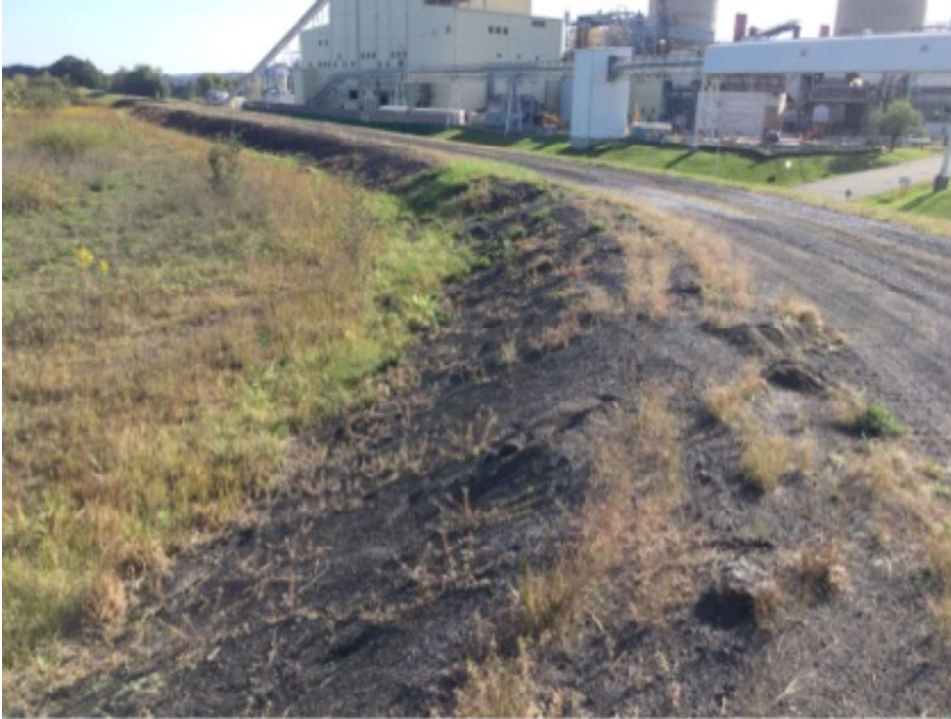
General condition of east dike interior slope and crest looking northeast

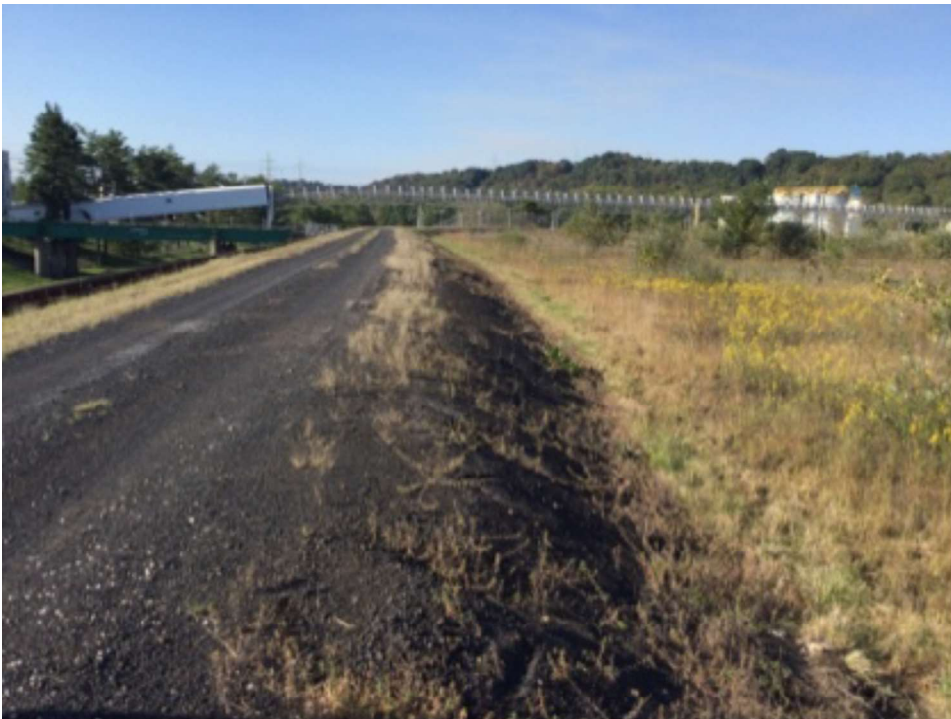
Photo #: 16

General condition of east dike interior slope and crest looking south

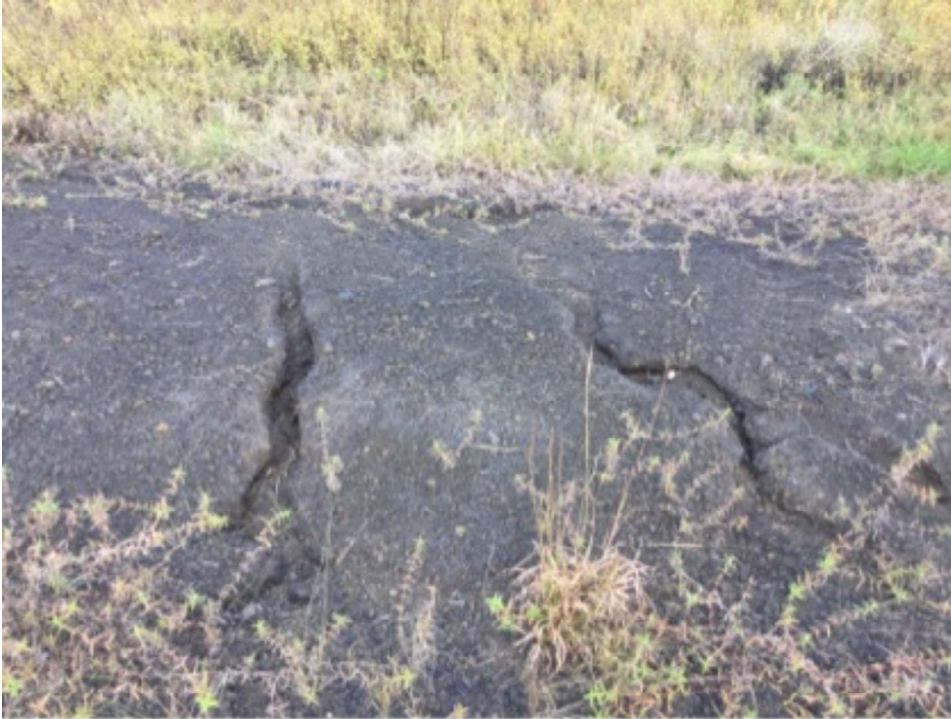
- (ii) Heavy vegetation was observed around the discharge inlet at the southeast corner. The walkway over the discharged was in fair condition.
- (iii) The crest and interior slope of the east dike were in fair condition. There was no signs of settlement or misalignment of the crest. Minor erosion reels were noted in the CCR material deposited on the interior of the slope. The erosion had not impacted the integrity of the dike.

Typical erosion observed in the ash along interior slope on the east dike.

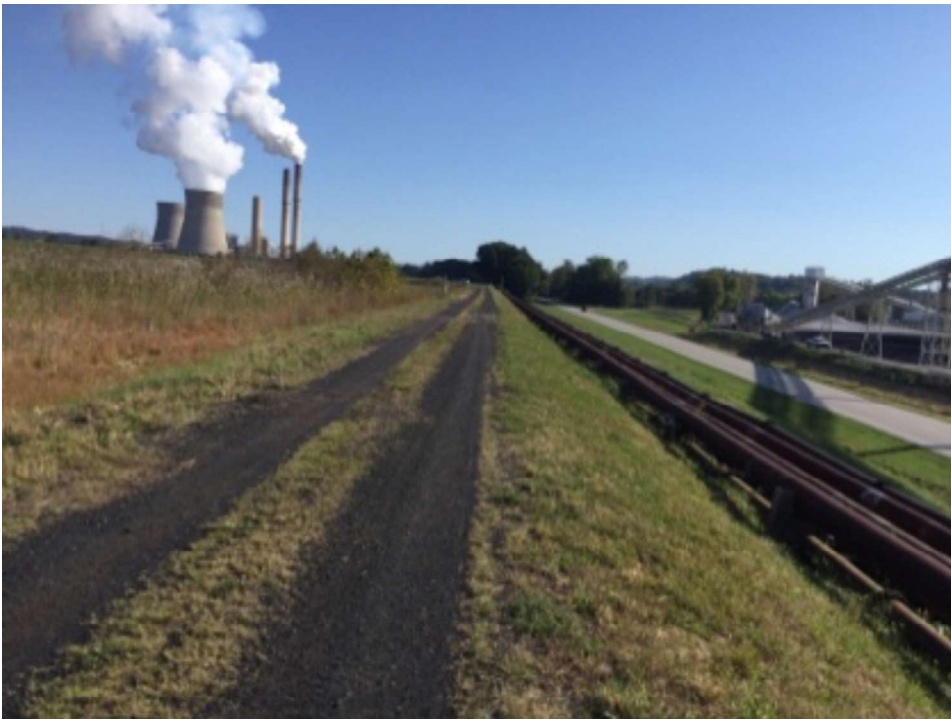
Photo #: 18

General condition of east dike crest looking north

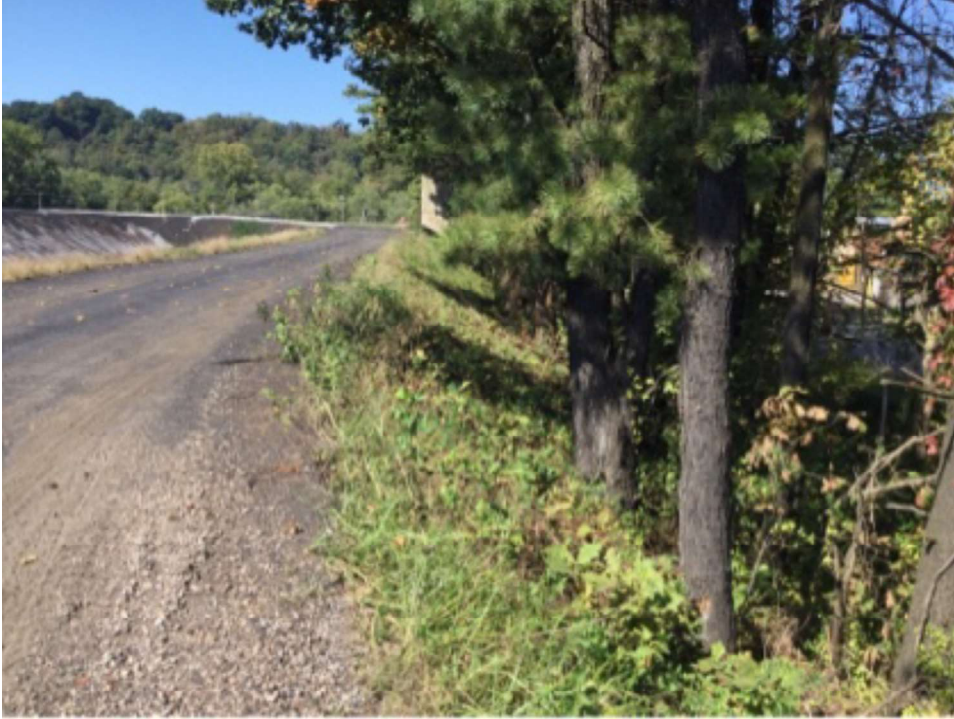
Photo #: 47

Notes: General condition of north dike exterior dike looking west

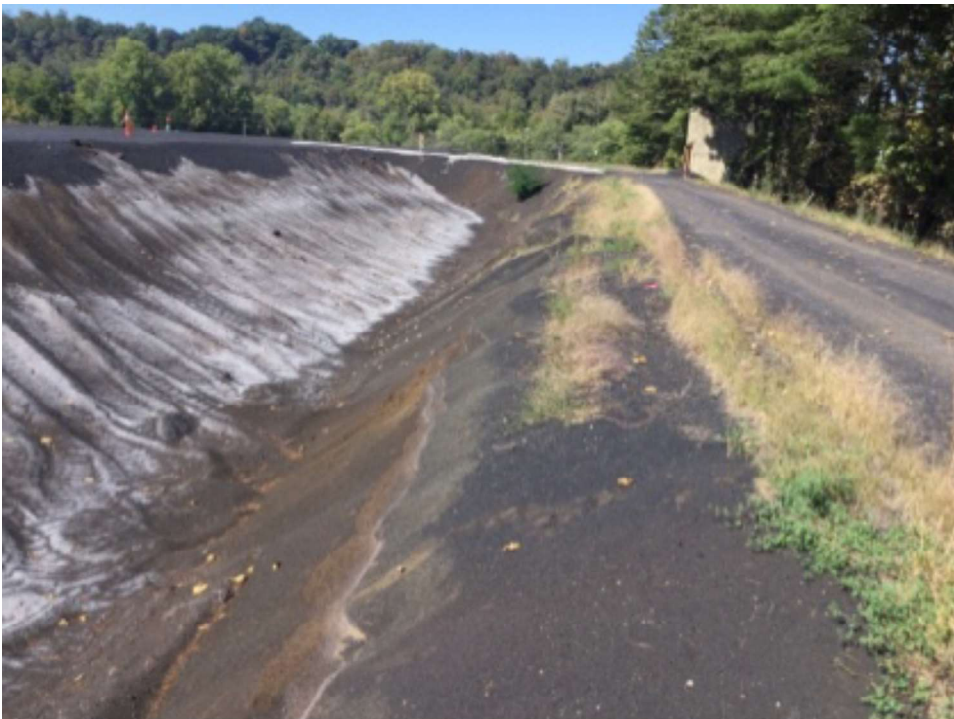
Photo #: 48

Notes: General condition of north dike interior slope looking west

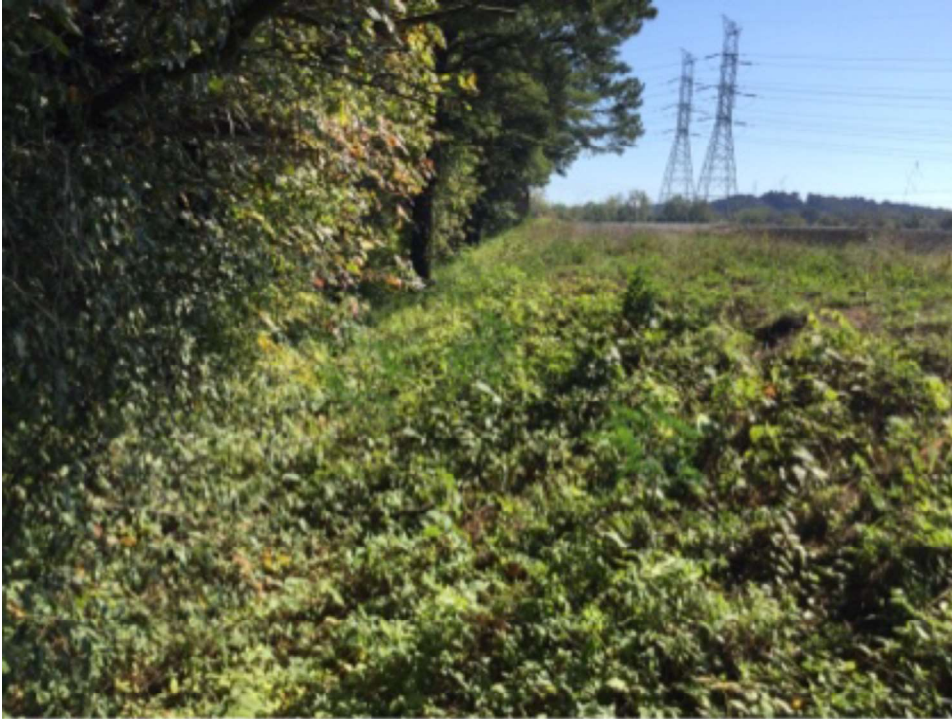
General condition of north dike exterior slope looking east

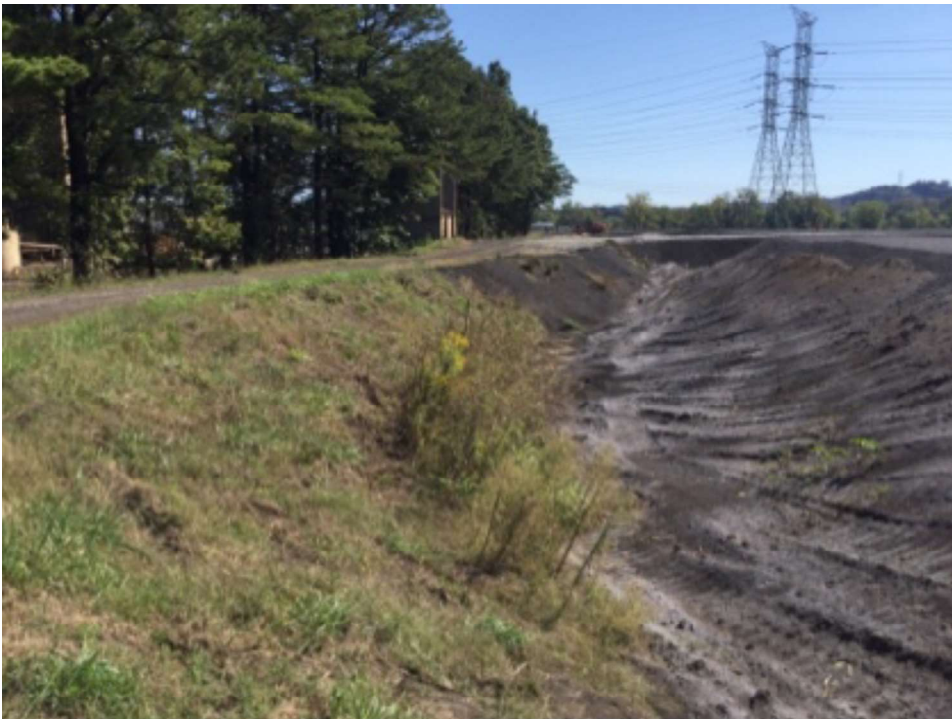
Photo #: 50

General condition of north dike interior slope looking east

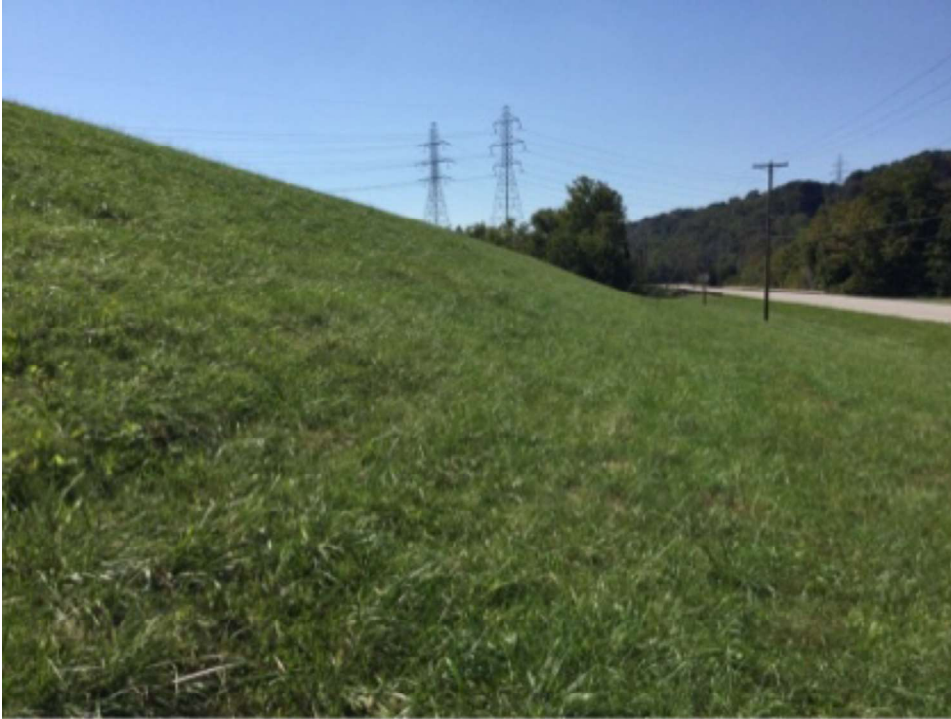
General condition of west dike exterior slope looking south

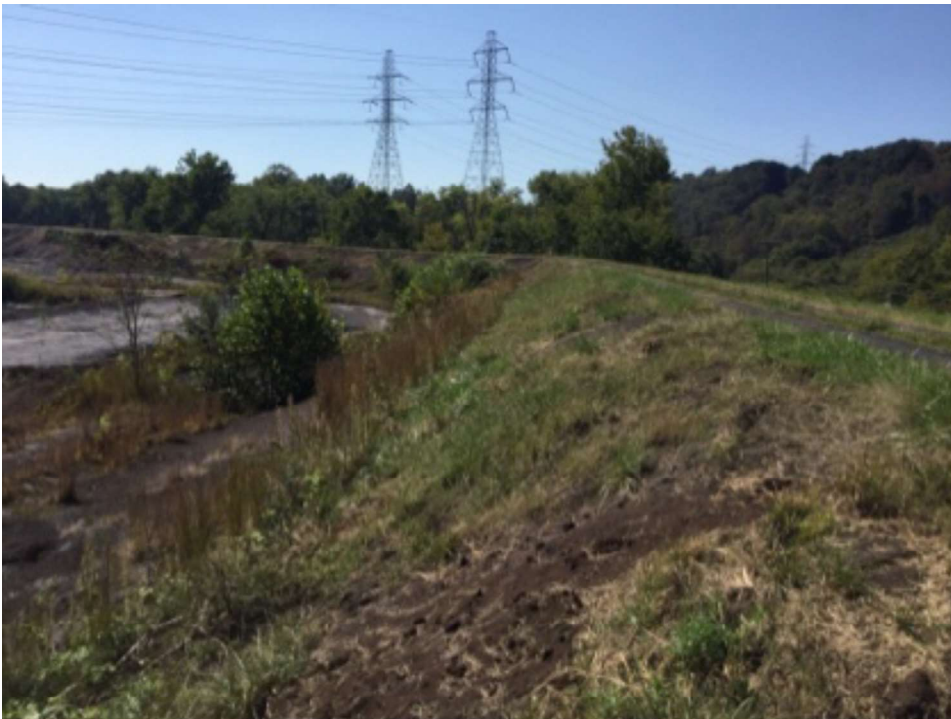
Photo #: 52

General condition of west dike interior slope looking south

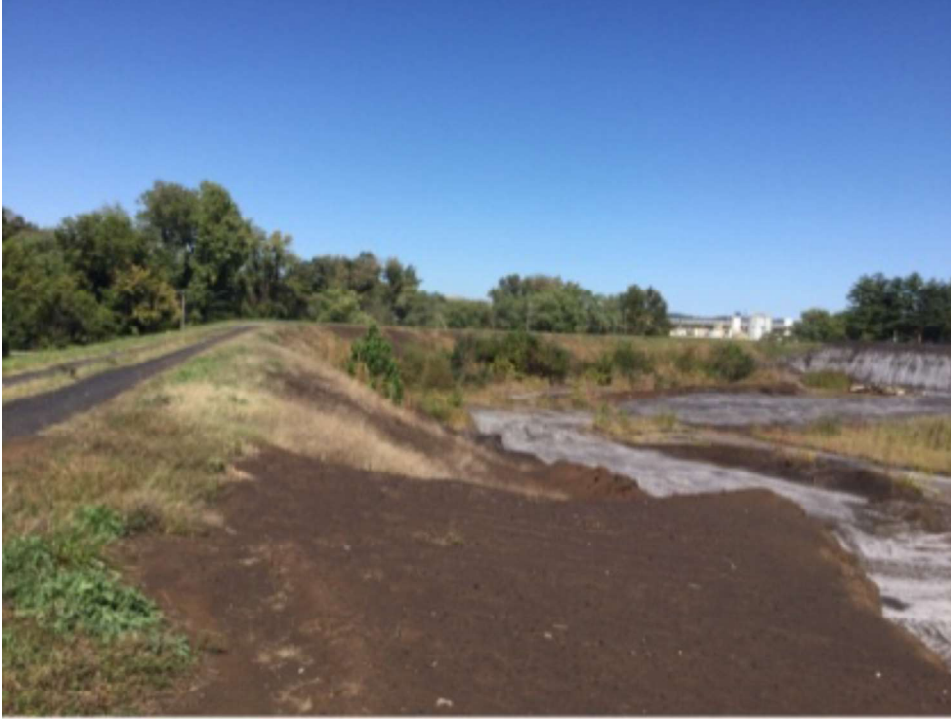
General condition of west dike interior slope looking northwest

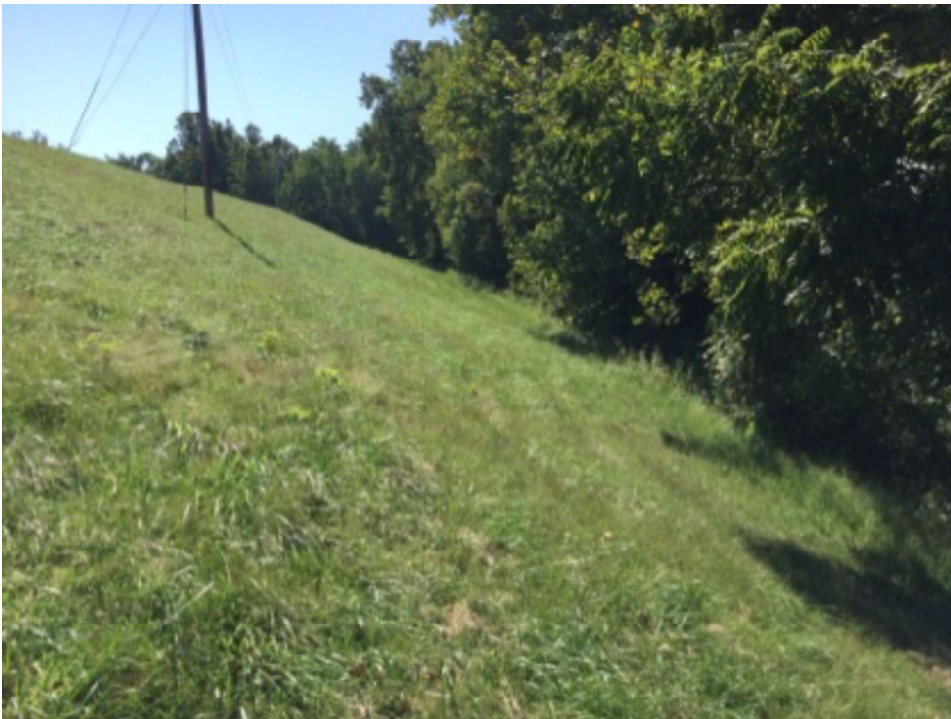
Photo #: 56

General condition of west dike exterior slope looking southeast

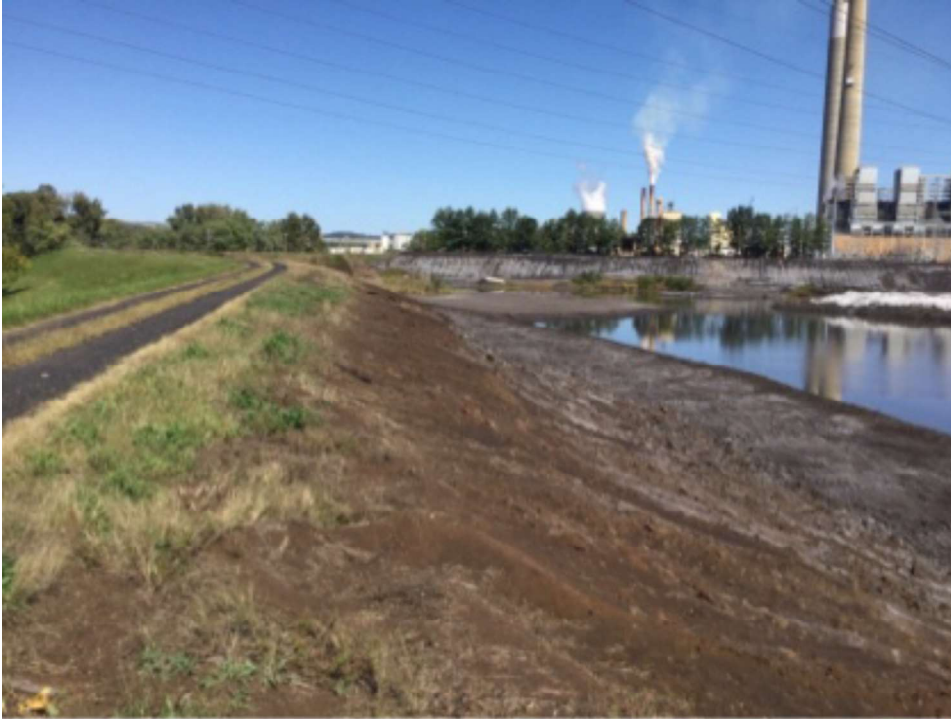
Photo #: 57

Notes: General condition of west dike interior slope looking northwest

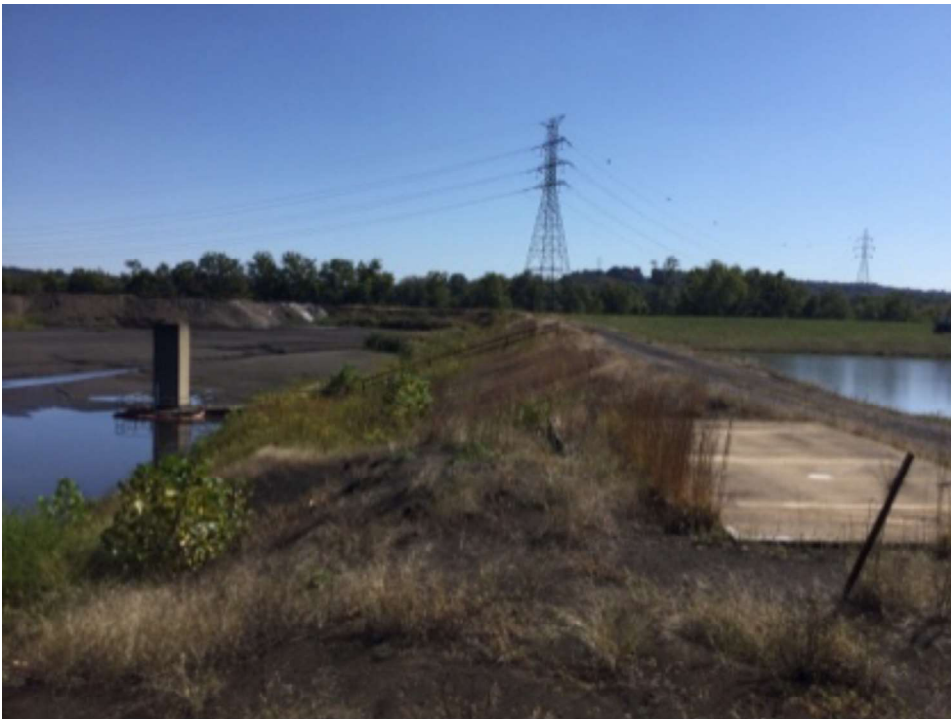
Photo #: 58

Notes: General condition of north slope of splitter dike looking east

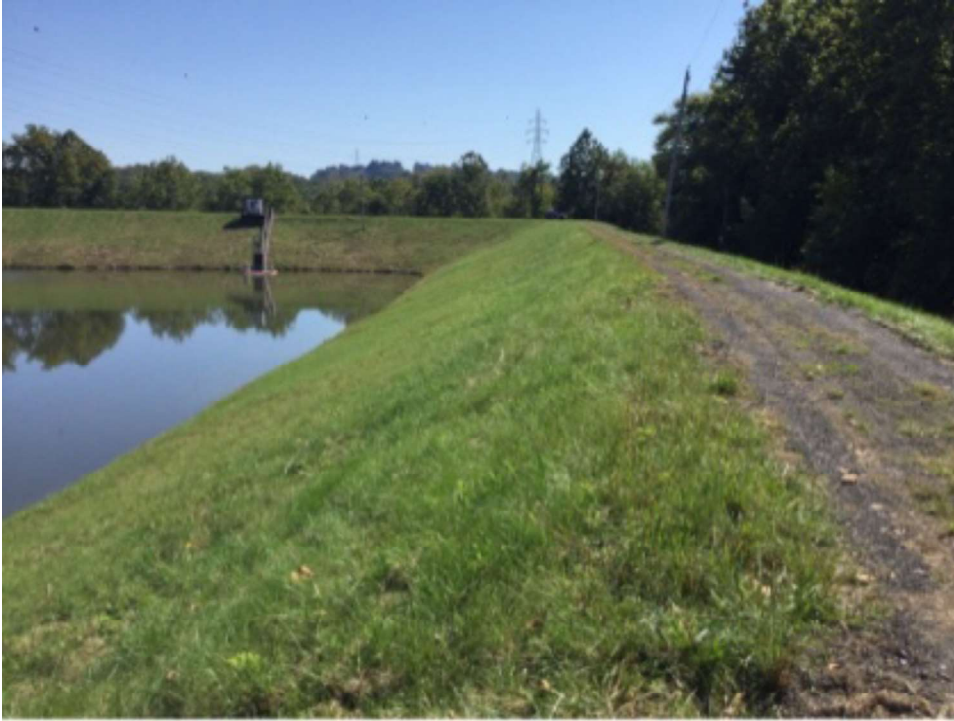
Photo #: 61

Notes: General condition of south dike interior slope and crest looking east

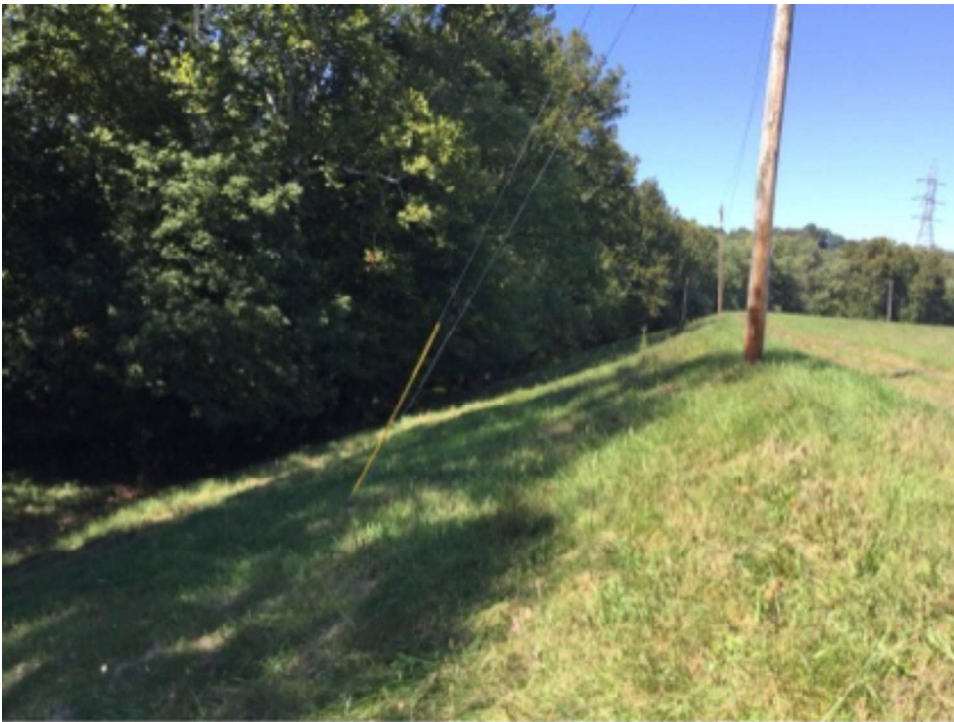
Photo #: 62

Notes: General condition of south dike exterior slope looking west

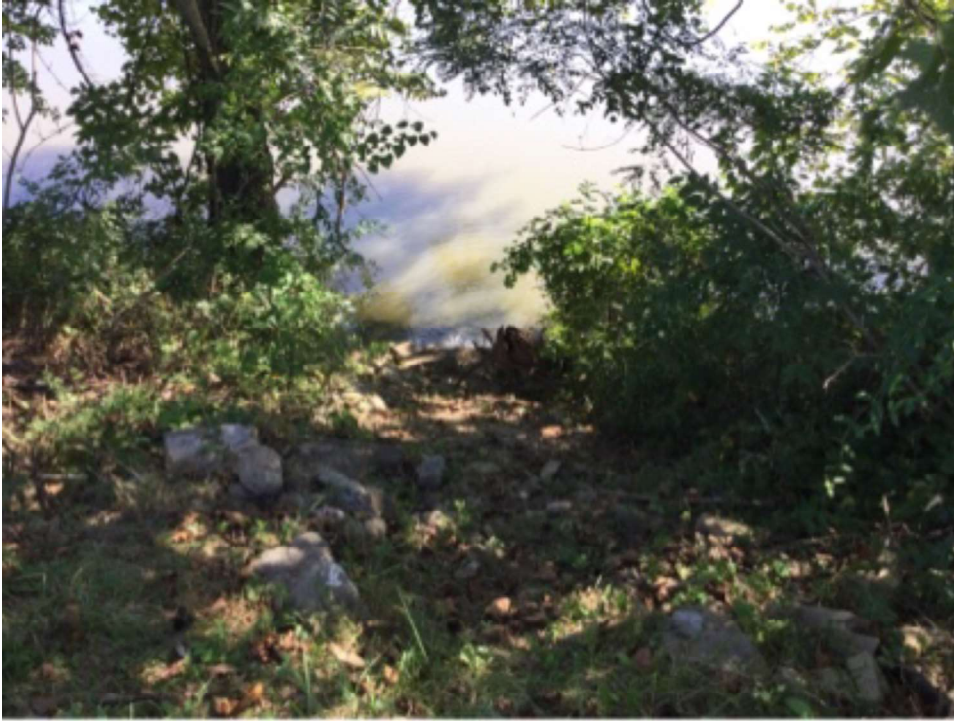
Photo #: 65

- (vii) The overflow decant structure concrete, access deck, and walkway stairs appeared good, stable, and functioning as designed.
- (viii) The Outfall located adjacent to the Clearwater Pond that discharges water to the Ohio River appeared well protected from erosion and in satisfactory condition with proper outflow. Access to the outfall was difficult due to steep slope and difficult terrain.

Notes: Clearwater pond discharge outfall to Ohio River

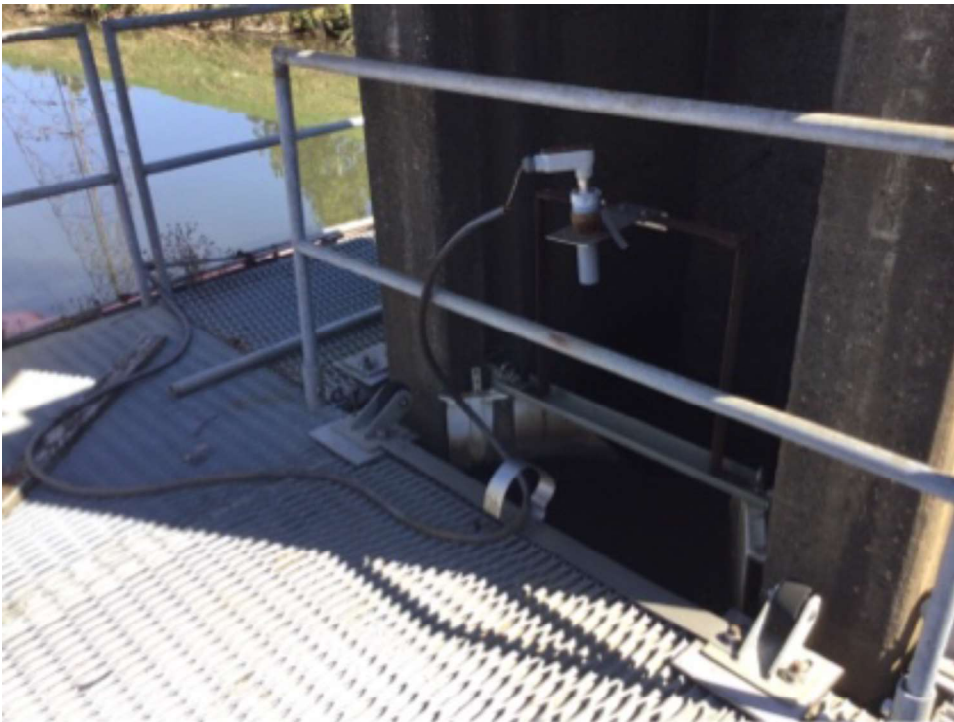
Photo #: 66

Notes: Outfall structure in Clearwater Pond

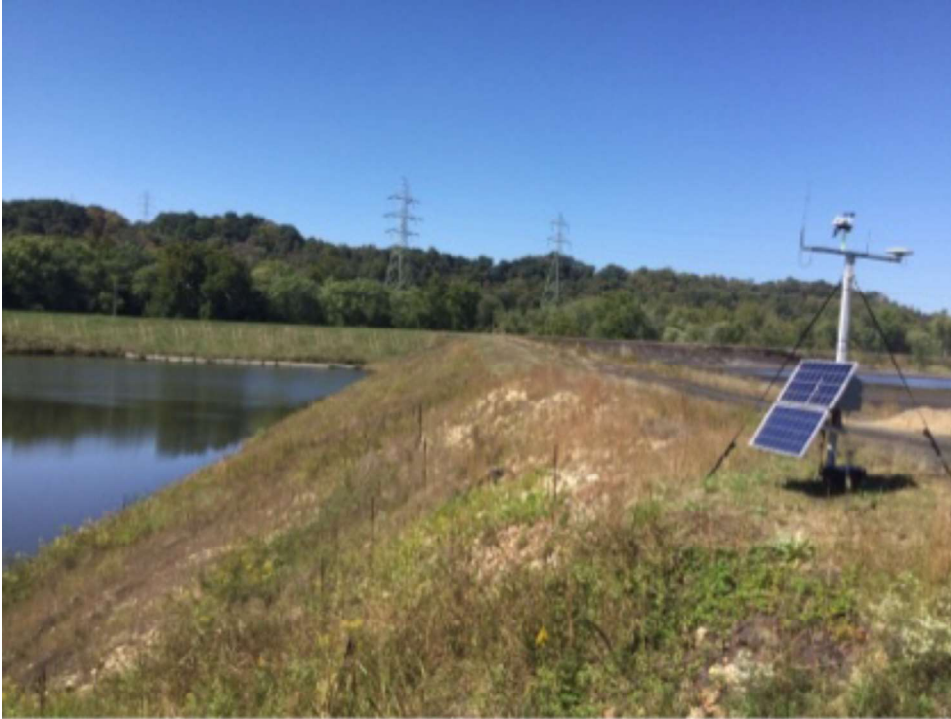
General condition of south slope of splitter dike looking west.

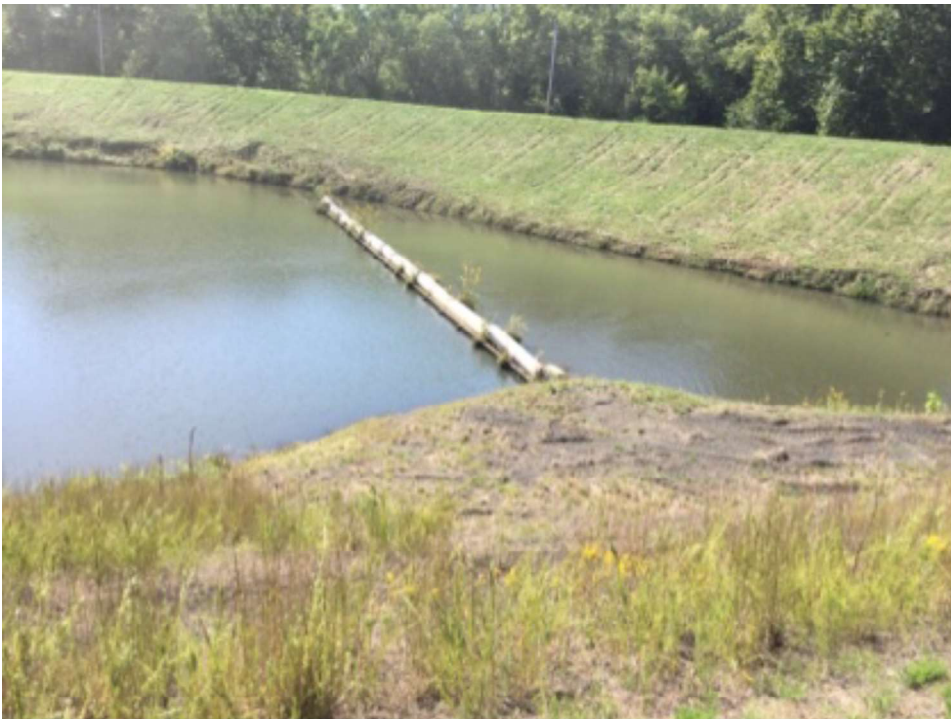
Photo #: 70

- (v) The decant structure between the Bottom Ash Pond and the Clearwater Pond appear in good condition. The discharge pipe into the Clearwater Pond appeared to be functional.

General condition of discharge structure into Clearwater Pond from BAP

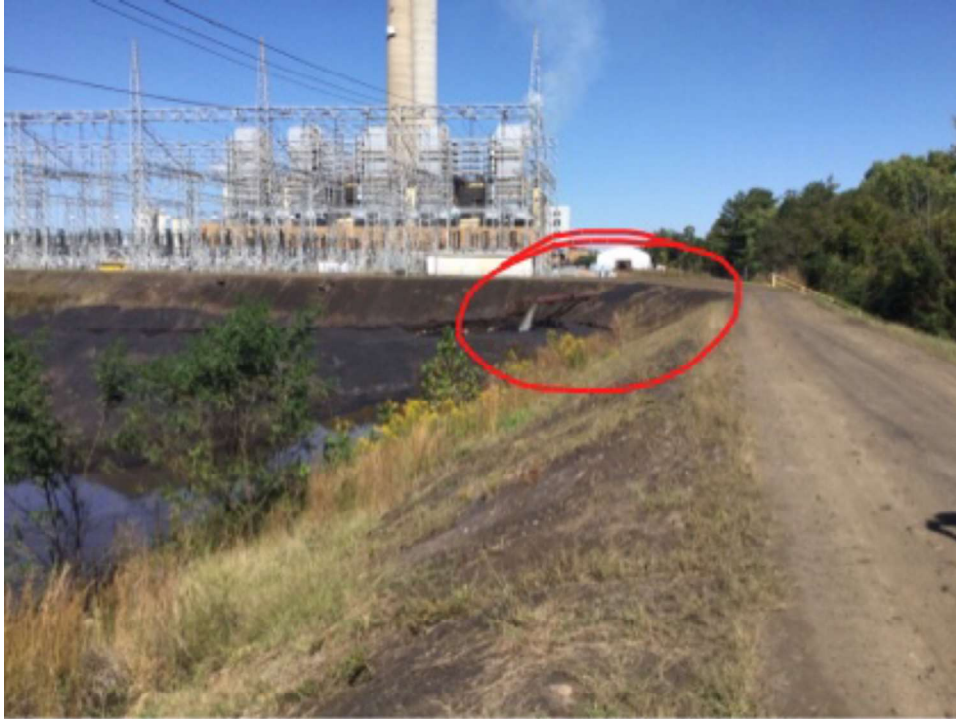
Photo #: 75

Notes: General condition of east dike interior slope looking north with east Discharge pipe in background

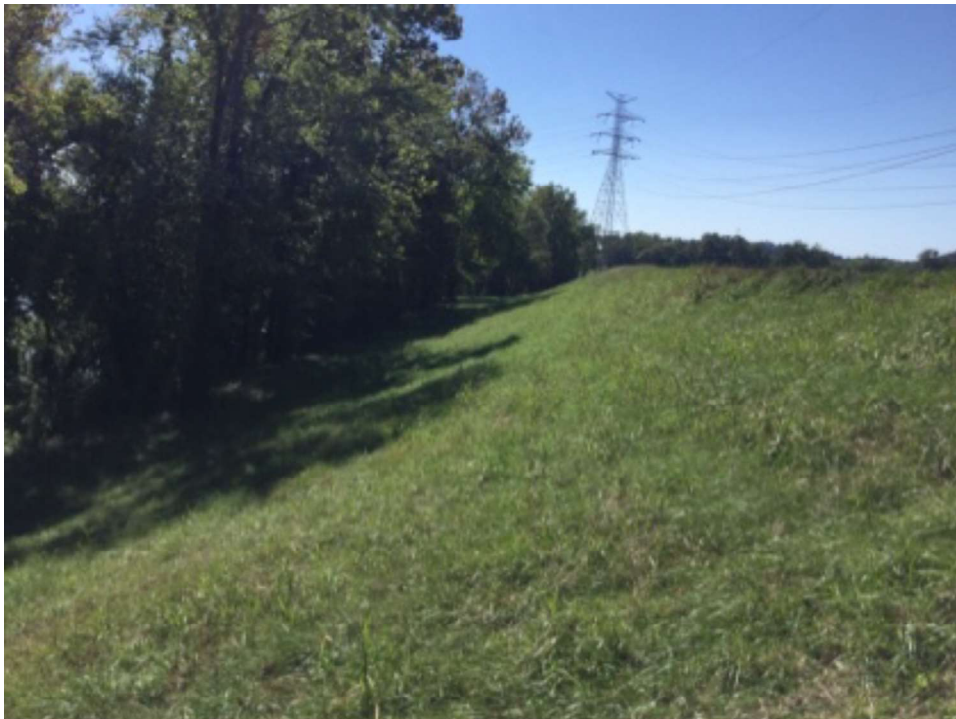
Photo #: 76

Notes: General condition of east dike exterior looking south

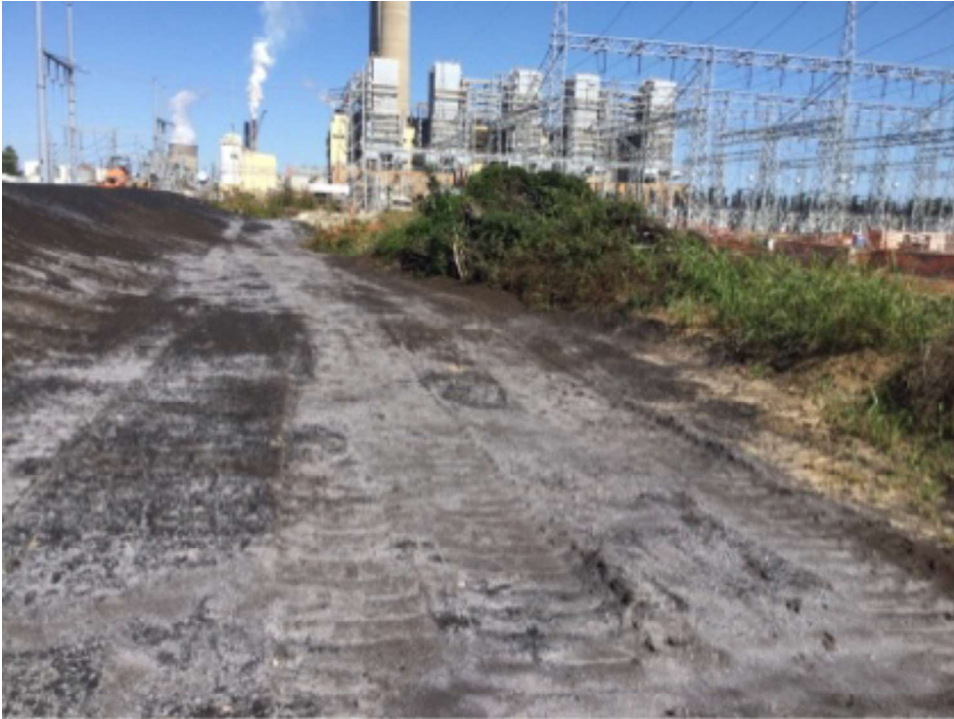
Photo #: 84

Notes: General condition of north dike interior slope looking north
