**Re: Ohio Valley Electric Corporation
Kyger Creek Station
Notification of CCR Rule Information Posting
Annual Certified CCR Dam and Dike (Surface Impoundment)
Inspection Report Posting**

**2024 CCR Rule – Surface Impoundments
Kyger Creek Dam/Dike Inspections**

Kyger Creek Generating Station
Cheshire, Ohio
Gallia County

January 19, 2025

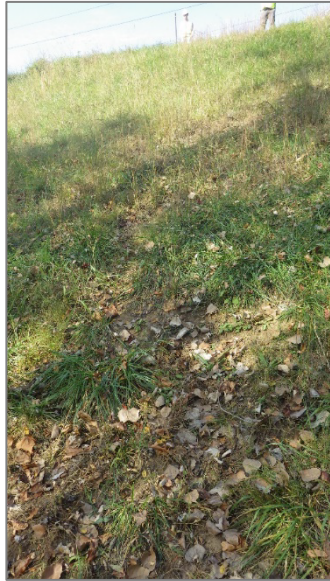
- The exterior slopes are mowed, vegetated, and uniform along the northwest and southwest perimeter of the pond. The southeastern slope was obscured by higher vegetation limiting observations (Photos 1, 15, 19, and 23; Appendix D).
- Surface erosion and erosion rills are noted, particularly as the material changes from the road surfacing to the grassy slopes near the crest along the perimeter embankment (Points 2 through 7 and 15 through 17, Appendix A; Photos 2 through 7 and 15 through 17, Appendix D).
- Surface erosion is noted near the toe of the perimeter embankment on its southeast side (Point 1, Appendix A; Photo 1, Appendix D).

Photo 1, Point 1
Boiler Slag Pond – Southeast
Exterior Slope – Erosion gully
near the toe.

- Regrade and repair erosion gullies as noted. Reseed barren areas noted on the exterior slope and establish uniform vegetation coverage in areas of need.
- Backfill the documented animal burrows with compacted native soils or a mud-pack of soil and cement, ensuring all voids are filled and the entrance(s) are properly sealed.

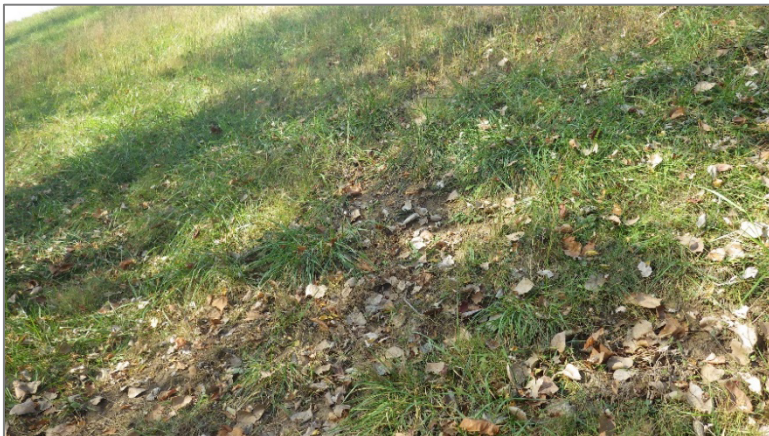
Photo 2, Point 2
Boiler Slag Pond – Southeast
Exterior Slope – Erosion gully
near the crest.

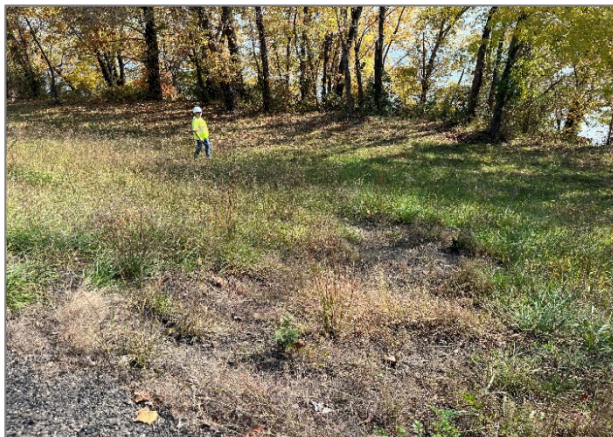
Photo 3, Point 3
Boiler Slag Pond – Southeast
Exterior Slope – Erosion gully
near the crest.

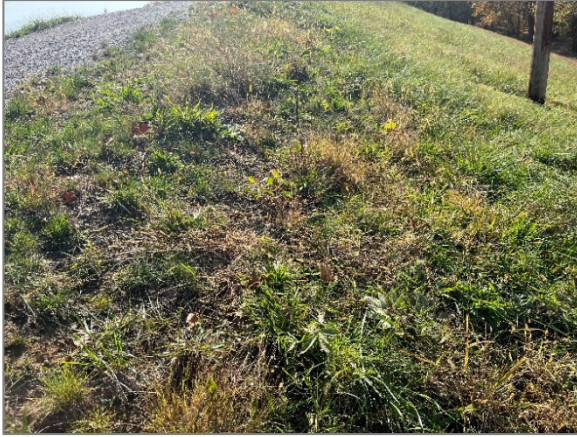
Photo 4, Point 4

Boiler Slag Pond – Southeast Exterior Slope – Erosion gully near the crest.

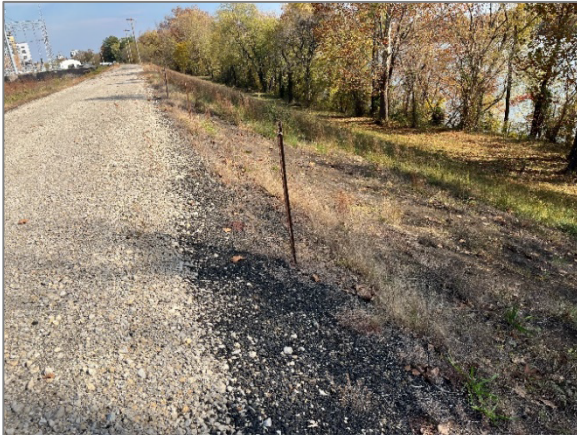
Photo 5, Point 5

Boiler Slag Pond – Southeast Exterior Slope – Erosion gully and bare area near the crest.

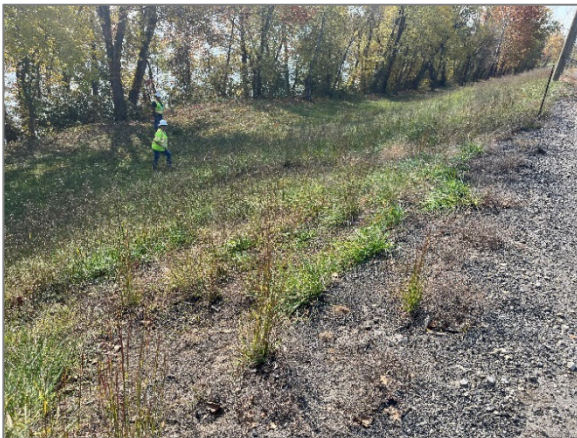
Photo 6, Point 6

Boiler Slag Pond – Southeast Exterior Slope – Erosion gully and bare area near the crest.

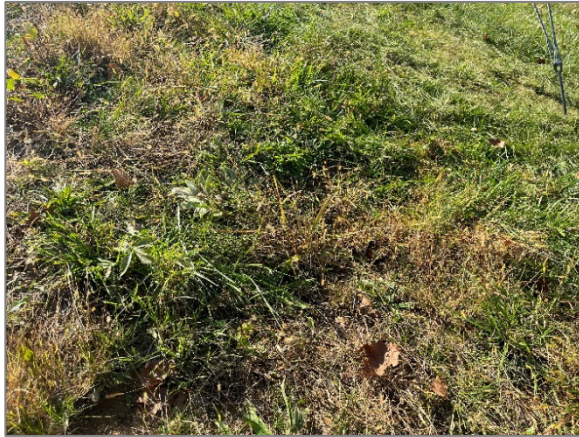
Photo 7, Point 7
Boiler Slag Pond – Southeast
Exterior Slope – Erosion gully
near the crest.

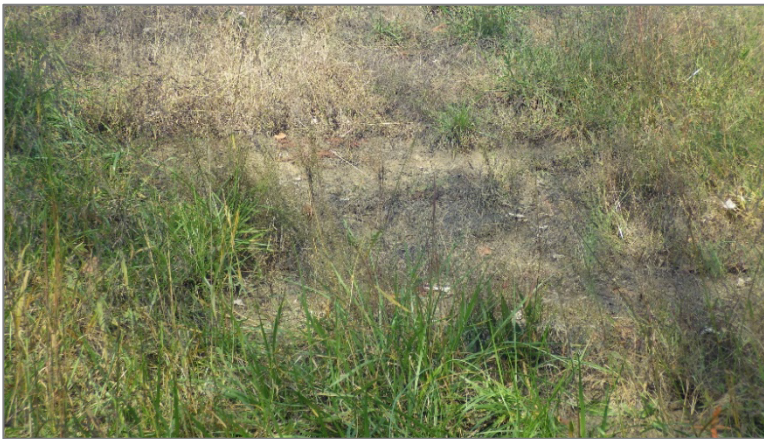
Photo 8, Point 8
Boiler Slag Pond – Southeast
Exterior Slope – Bare spot near
the toe.

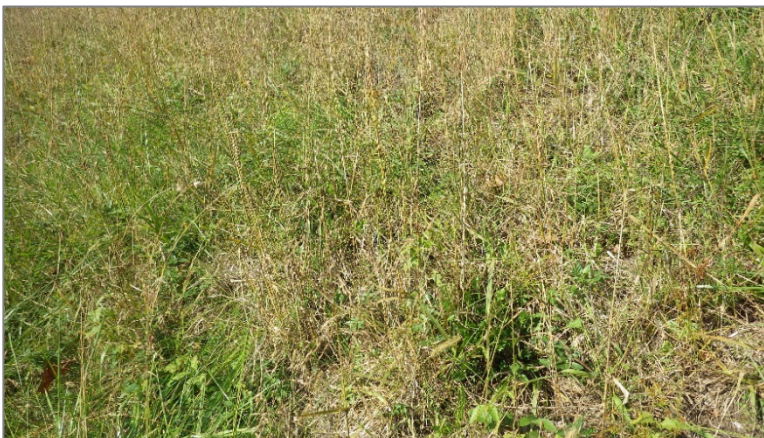
Photo 9, Point 9
Boiler Slag Pond – Southeast
Exterior Slope – Animal burrow
near the toe.

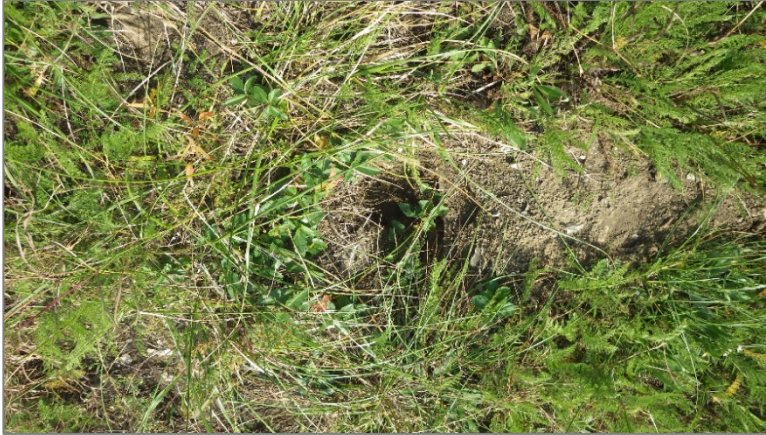
Photo 10, Point 10
Boiler Slag Pond – Southeast
Exterior Slope – Animal burrow
near the toe.

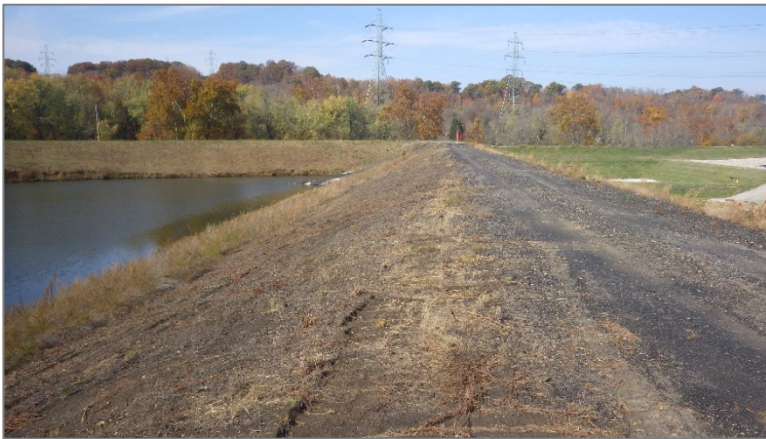
- Erosion rills were documented on both sides of the Splitter Dike near its crest and along the slopes of the dike (Points 11 and 13, Appendix A; Photos 11 and 13; Appendix D).
- Vegetation is thin and areas of exposed earth were noted in areas along the perimeter embankment (Points 5, 8, 18, 19, 21 through 25, Appendix A; Photos 5, 8, 18, 20, and 22; Appendix D).
- Animal burrows are observed in the perimeter embankment surrounding the pond (Points 9 and 10, Appendix A; Photos 9 and 10, Appendix D).
- Seepage was noted as the CCR dewatered within the BSP closure area. Flow was visible in three locations along the dike (Points 12 and 14, Appendix A; Photos 12 and 14, Appendix D).

Photo 11, Point 11
Boiler Slag Pond – Southwest
Divider Dike – Erosion gully
and rutting in exterior slope.

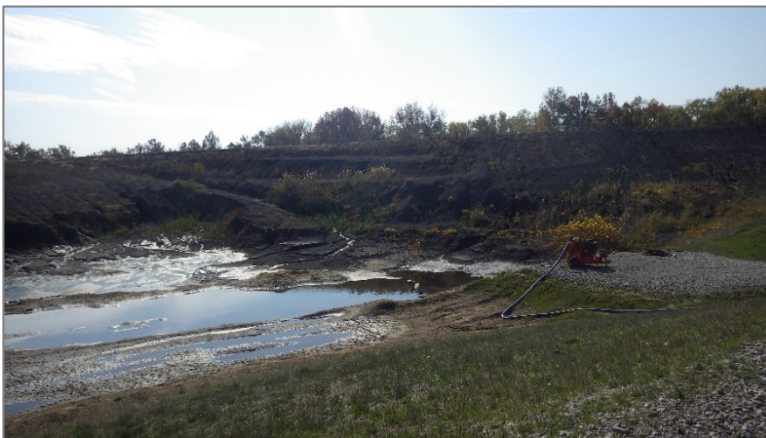
No operational flows were noted during the site visit into the boiler slag pond closure area. Pounded water was limited to an area at the toe of the LVWTS within the BSP closure area (Photos 12 and 14, Appendix D). A pump and hose were present at the southern end.

Photo 12, Point 12
LVWTS Secondary Basin –
Interior dike elevation.

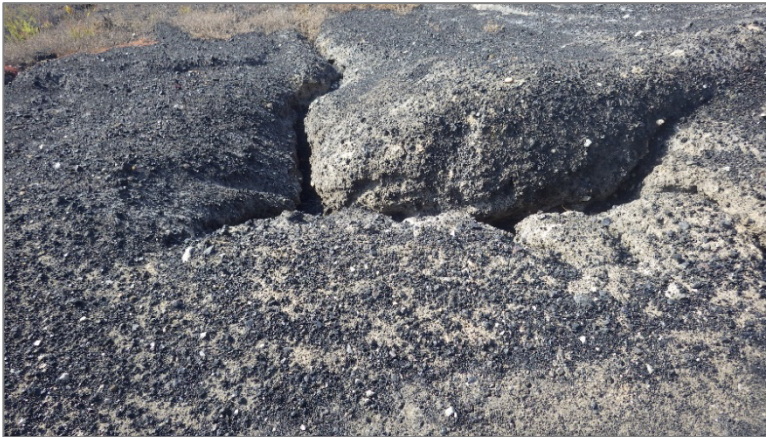
Photo 13, Point 13
Boiler Slag Pond – Southwest
Divider Dike – Erosion gully at
the crest.

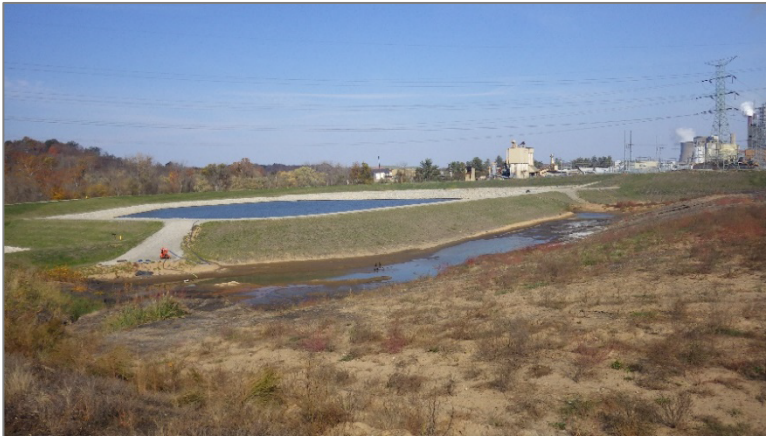
Photo 14, Point 14
Boiler Slag Pond – Southwest
Divider Dike – Divider dike
elevation looking at LVWTS
basins.

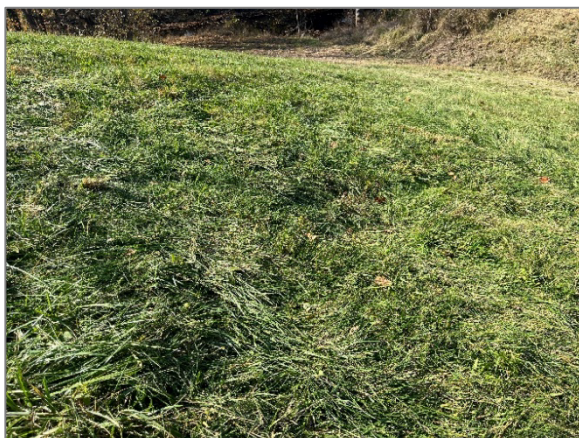
Photo 15, Point 15
Boiler Slag Pond – West Exterior
Slope – Erosion gully near the
crest.

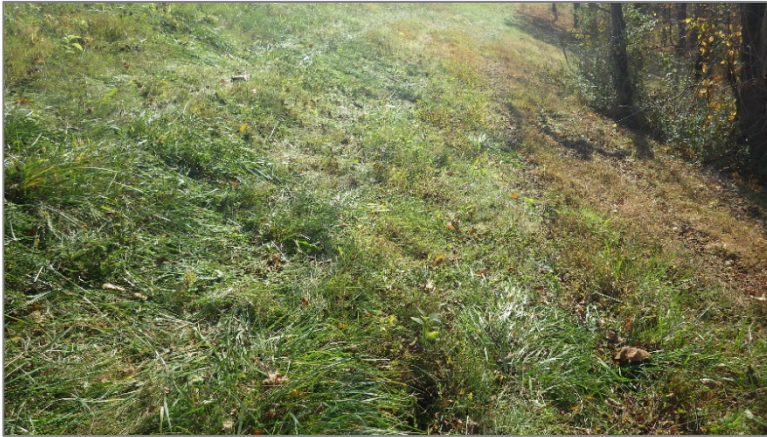
Photo 16, Point 16
Boiler Slag Pond – West Exterior Slope – Erosion gully near the crest.

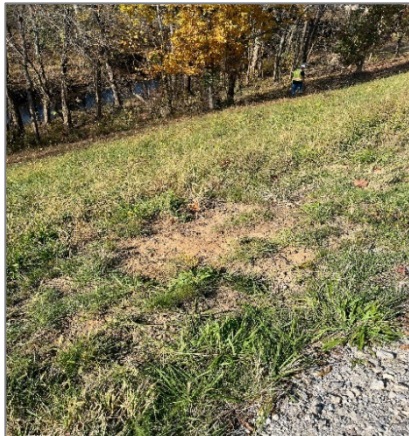
Photo 17, Point 17
LVWTS Secondary Basin – West Exterior Slope – Erosion gully near the crest.

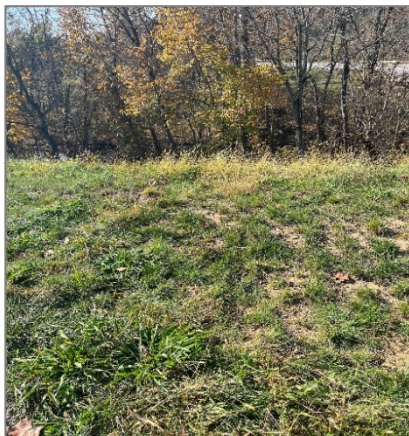
Photo 18, Point 18
LVWTS Secondary Basin – West Exterior Slope – Bare spot near the crest.

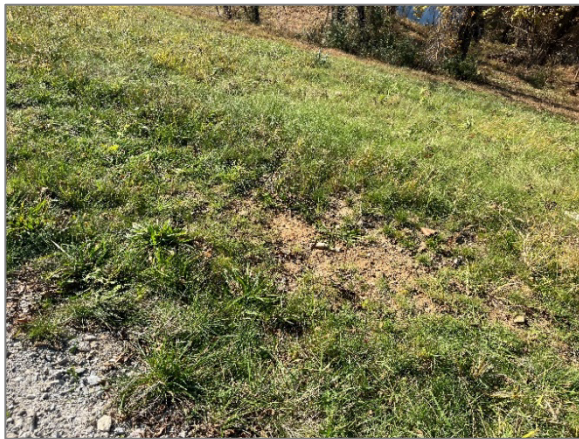
Photo 20, Point 19
LVWTS – West Exterior Slope –
Bare spot near the crest.

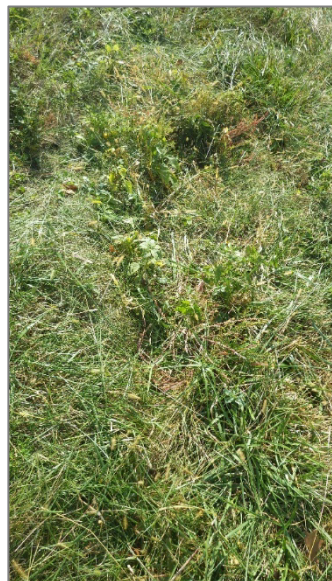
Photo 21, Point 20
LVWTS – West Exterior Slope –
Depression in the slope near
the toe.

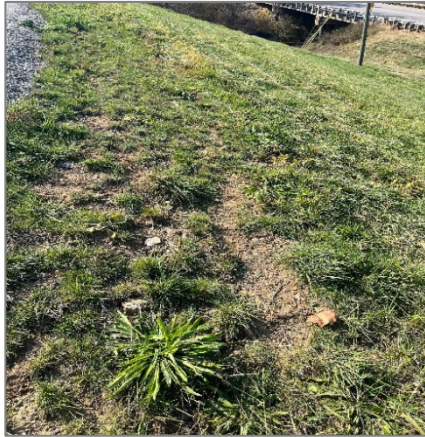
Photo 22, Point 21
LVWTS – West Exterior Slope –
Bare spot near the crest.

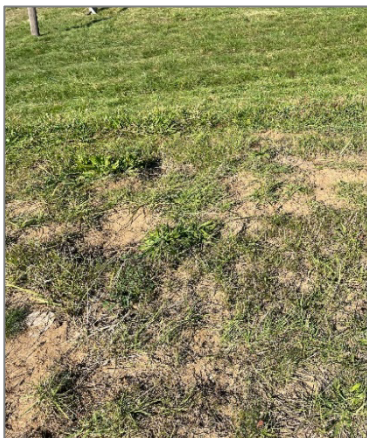
Photo 24, Point 23
LVWTS – West Exterior Slope-
Bare spot near the toe.

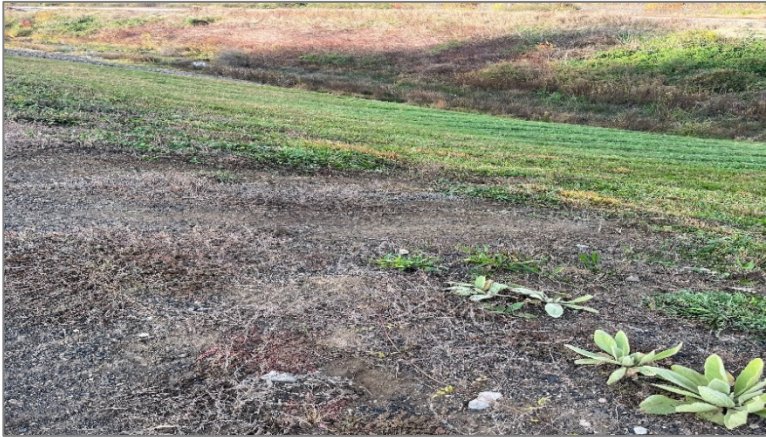
- No operational flow was evident at the time of the inspection at the inlet to the SFAP at the southeastern corner.
- Surficial erosion and bare spots are observed at multiple locations along the exterior slope of the perimeter embankments (Points 26, 33, 34, 41, and 42, Appendix A; Photos 25, 32, 33, 40, and 41, Appendix D).

Photo 25, Point 24
Northwest Exterior Slope – Bare spot near the crest.

- Regrade and repair erosion gullies as noted. Reseed barren areas noted on the exterior slope and establish uniform vegetation coverage in areas of need.
- Backfill the documented animal burrows with compacted native soils or a mud-pack of soil and cement, ensuring all voids are filled and the entrance(s) are properly sealed.
- Repair the sloughing surface on the west corner of the pond near the toe. Additionally, determine the cause of the small depressions on the southeast exterior slope and repair them as needed. Additional riprap rock in these areas may be necessary to protect the slope.

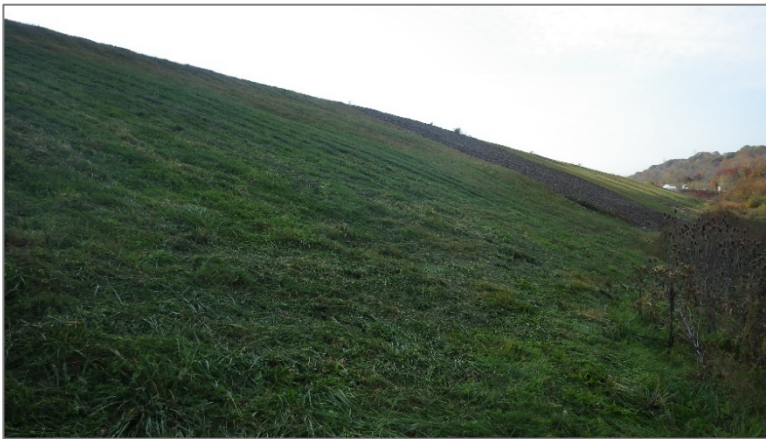
Photo 26, Point 25
Northwest Exterior Slope – Depression in lower half of slope.

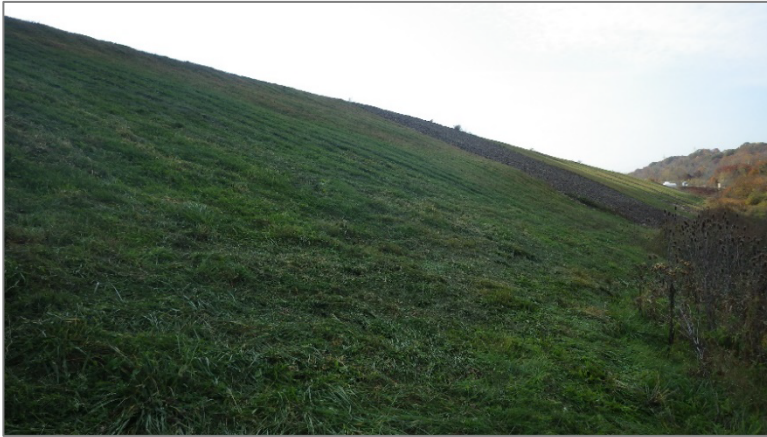
Photo 28, Point 27
Northwest Exterior Slope –
Depression in lower half of
slope.

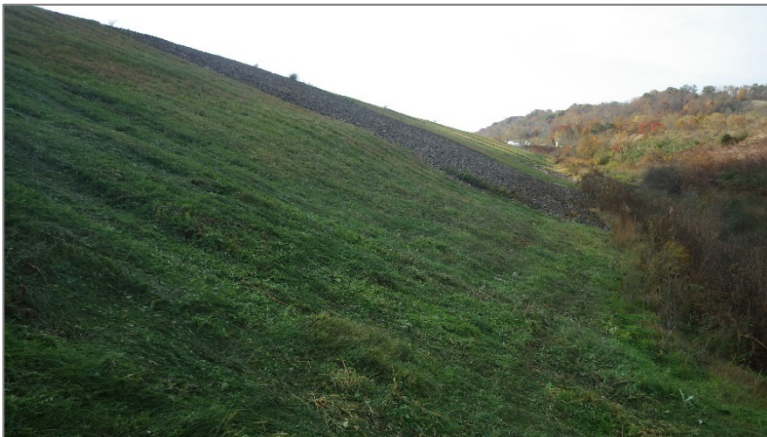
Photo 29, Point 28
Northwest Exterior Slope –
Depression in lower half of
slope.

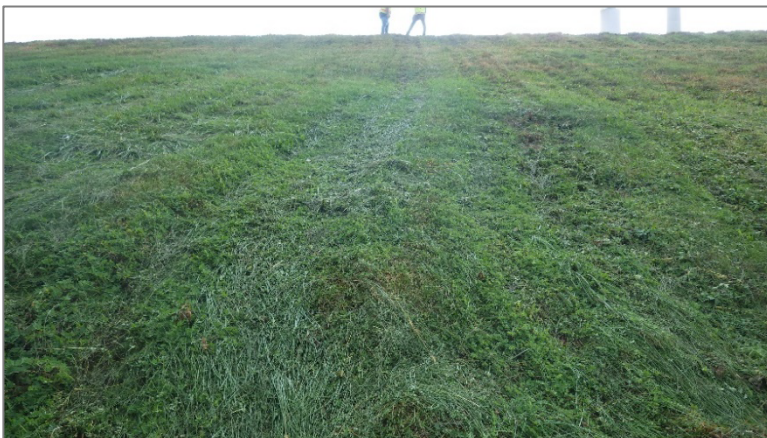
Photo 30, Point 29
Northwest Exterior Slope –
Depression in lower half of
slope.

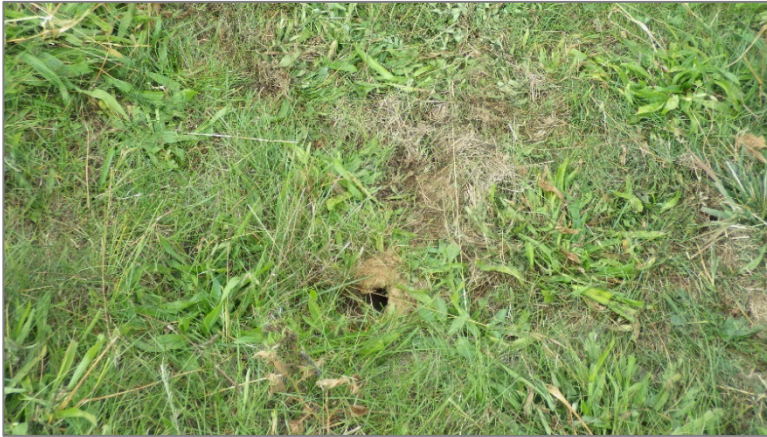
- Animal burrows are observed in the perimeter embankment surrounding the pond at two locations (Points 32 and 45, Appendix A; Photos 31 and 44, Appendix D).

Photo 31, Point 30
Northwest Exterior Slope –
Animal burrow near the toe.

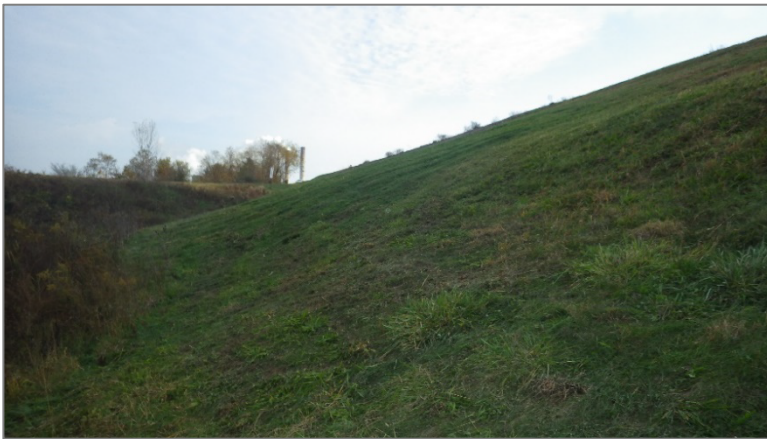
Photo 32, Point 31
Northwest Exterior Slope – Bare
spot on the slope near mid-
height.

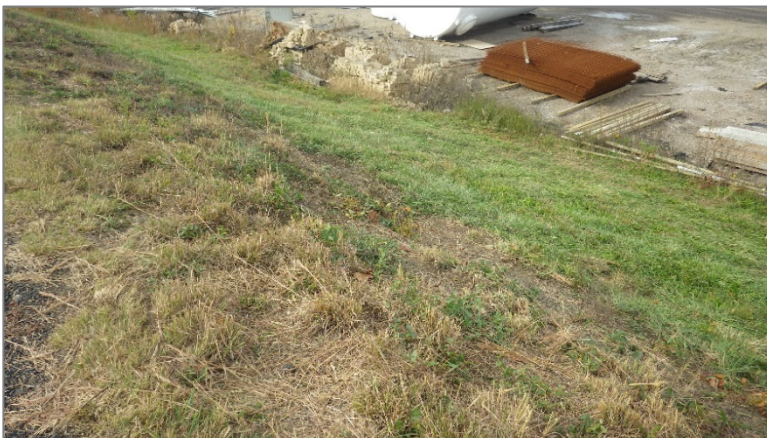
Photo 33, Point 32
West Exterior Slope – Bare spot
on slope near the crest.

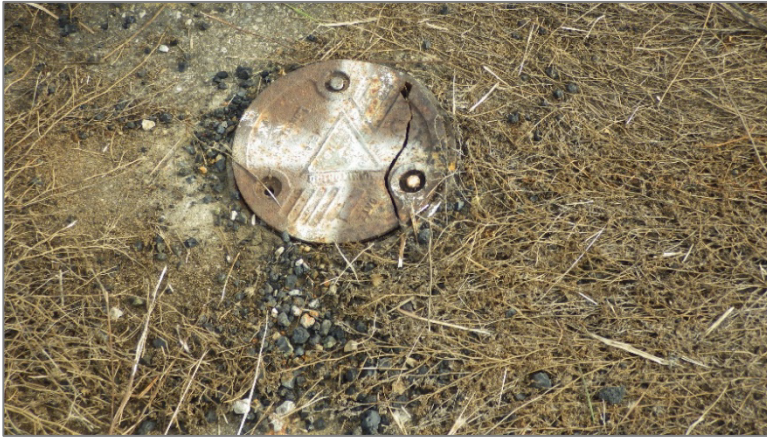
- The ground surface metal cover to a piezometer at the toe of the perimeter embankment at the west corner has been damaged, exposing the piezometer to moisture from the ground surface (Point 35, Appendix A; Photo 34, Appendix D).

Photo 34, Point 33
West Exterior Slope – Damaged
well lid on instrumentation.

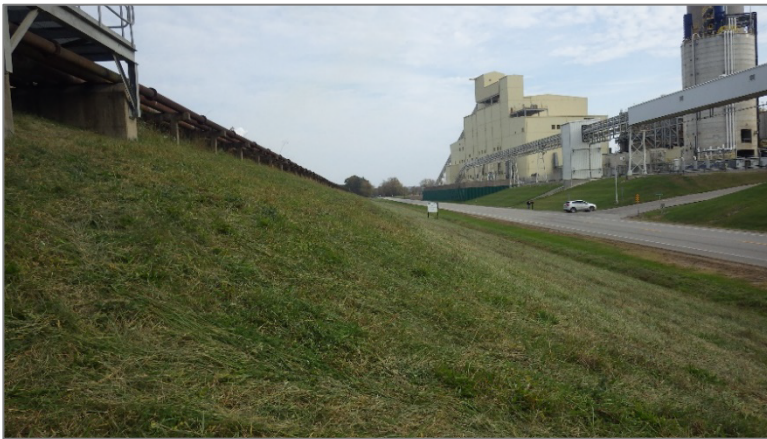
- In general, the downstream slopes appear to be in good condition with established, mowed grass and limited woody vegetation (Points 36 and 38, Appendix A; Photos 35 and 37, Appendix D). The southeastern slope was obscured by higher vegetation limiting observations.

Photo 35, Point 34
Southeast Exterior Slope –
Looking northwest.

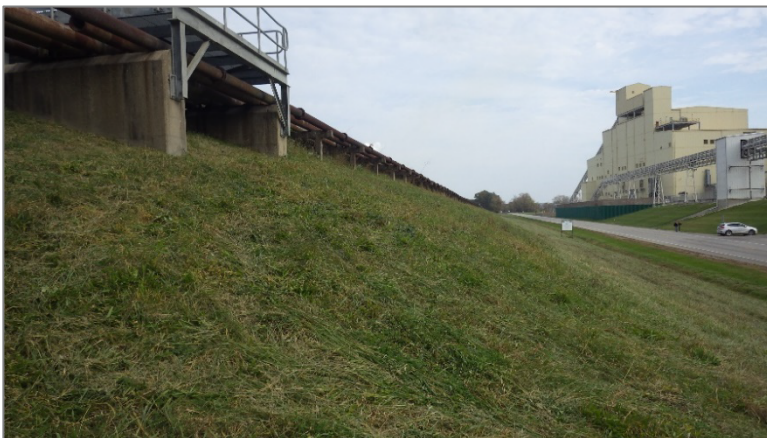
- Small-diameter surficial depressions are noted along the southeast exterior embankment (Points 37 and 39, Appendix A; Photos 36 and 38, Appendix D). An outward bow in the slope is also observed among these depressions (Point 40, Appendix A; Photo 39, Appendix D).

Photo 36, Point 35
Southeast Exterior Slope –
Depression at mid-height of the
slope.

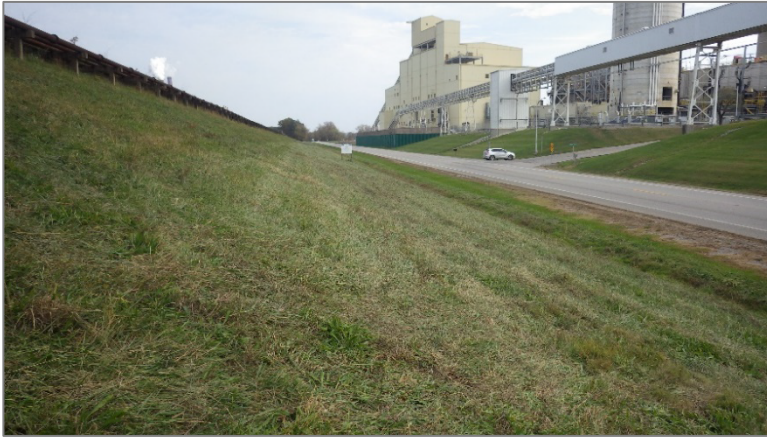
Photo 37, Point 36
Southeast Exterior Slope –
Looking northeast.

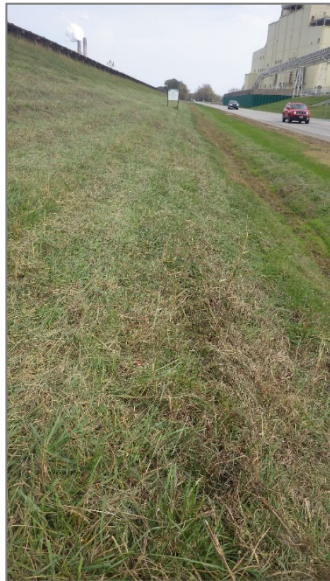
Photo 38, Point 37
Southeast Exterior Slope –
Depression in slope near the
toe.

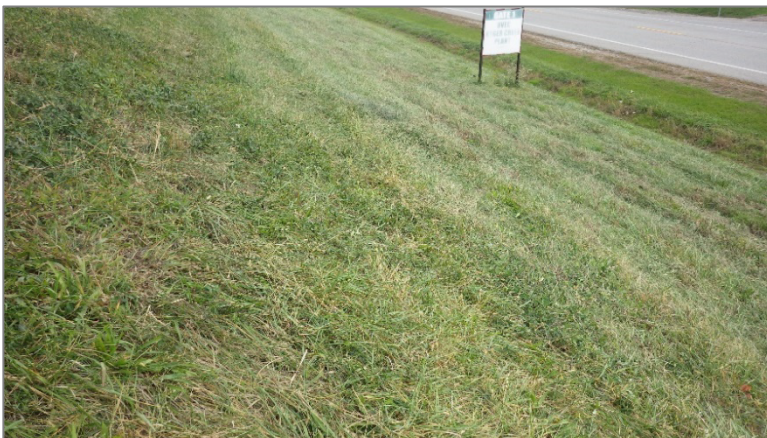
Photo 39, Point 38
Southeast Exterior Slope – Bow
in the slope at mid-height.

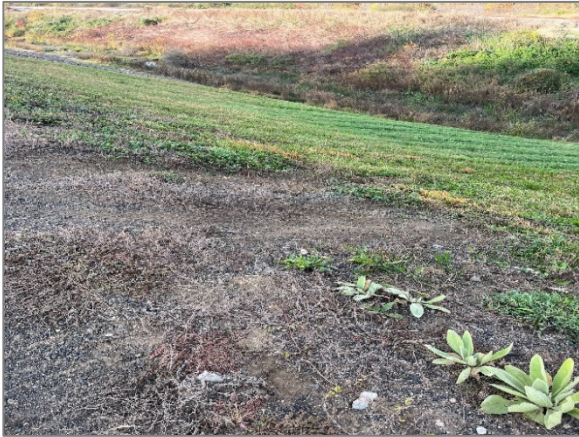
Photo 40, Point 39
Southeast Exterior Slope –
Erosion gully near the crest.

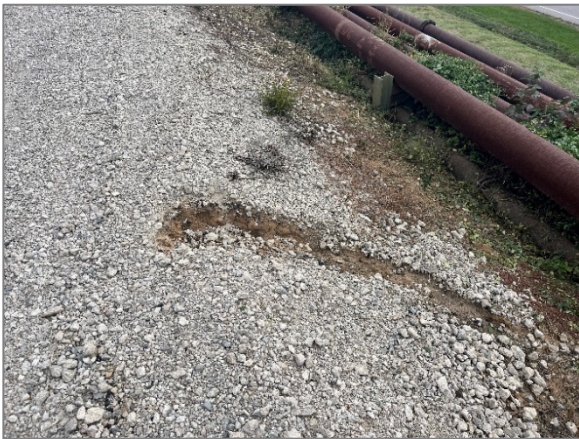
Photo 41, Point 40
Southeast Exterior Slope –
Erosion gully near the crest.

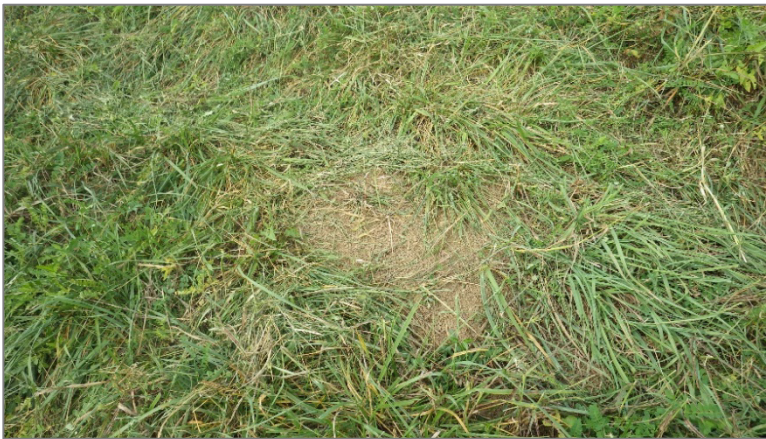
Photo 44, Point 43
Northeast Exterior Slope –
Animal burrow near the toe.

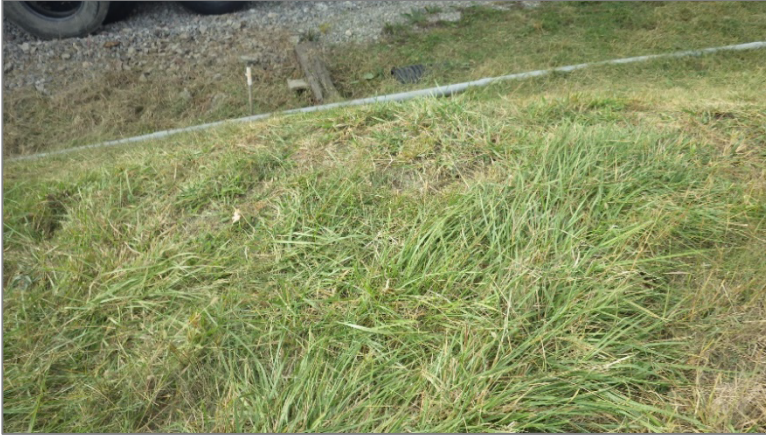
Photo 46, Point 45
Southwest Exterior Slope –
Slough on slope.
