**RE:     Periodic Structural Stability Assessment  
          Boiler Slag Pond  
          EPA Coal Combustion Residuals (CCR) Rule  
          Kyger Creek Station  
          Cheshire, Gallia County, Ohio**

**RE: Initial Structural Stability Assessment  
Boiler Slag Pond  
EPA Final Coal Combustion Residuals (CCR) Rule  
Kyger Creek Station  
Cheshire, Gallia County, Ohio**

## **Initial Structural Stability Assessment**

Kyger Creek Station  
Boiler Slag Pond  
Cheshire, Gallia County, Ohio

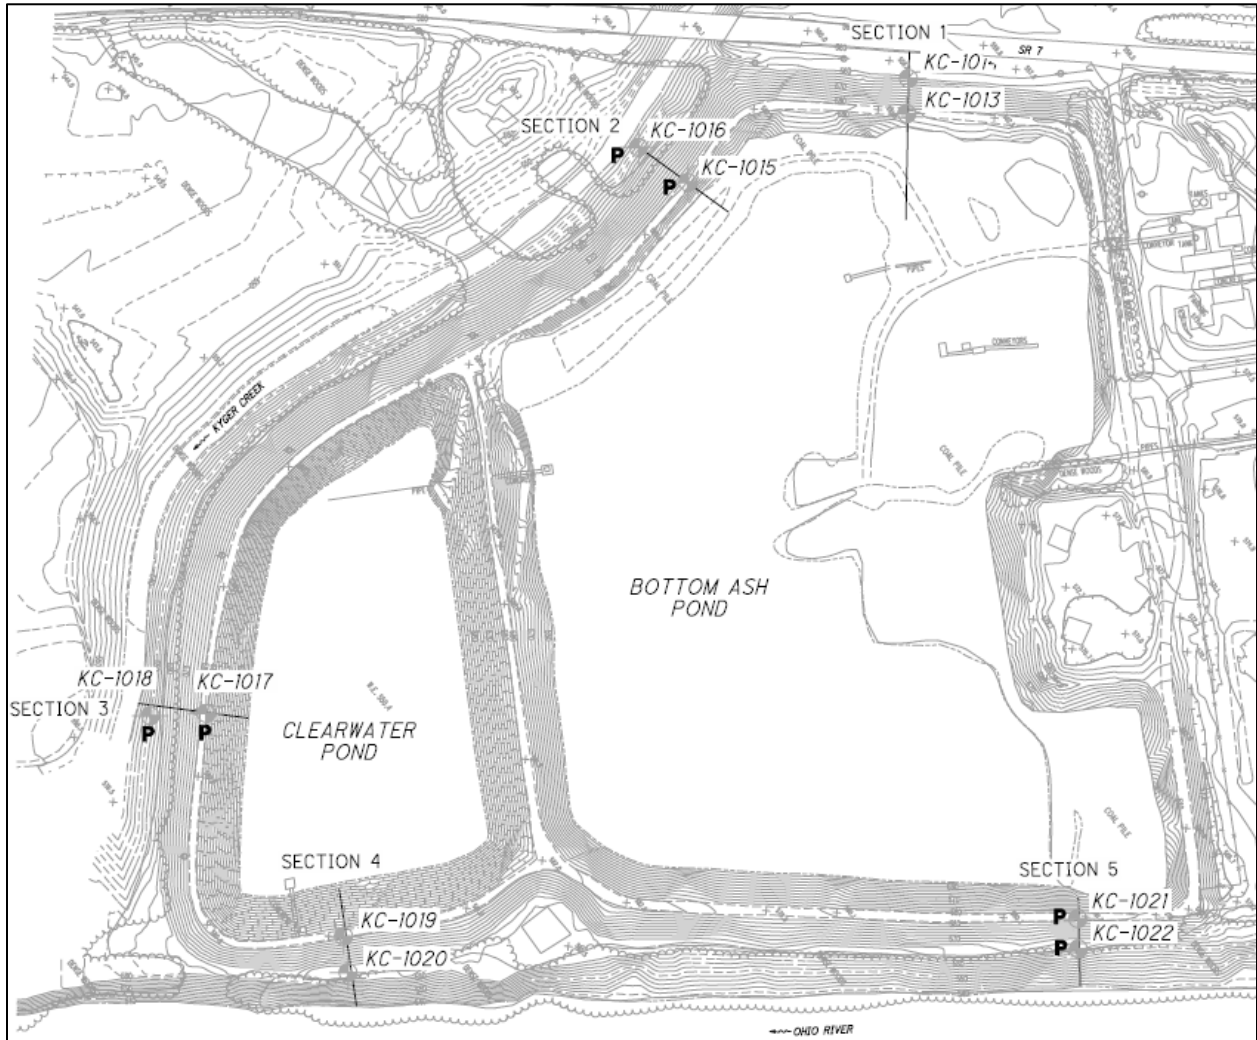
Figure 1 Kyger Creek Station Boiler Slag Pond – Plan View of Cross Sections (DLZ, 2015)

Slope stability analyses were available from DLZ (2011 and 2015). Five cross sections from the Boiler Slag Pond (including the Clearwater Pond) were analyzed under static, steady-state conditions using the maximum surcharge pool. The five sections that were analyzed were labeled Sections 1 through 5 and are shown below in Figure 1.

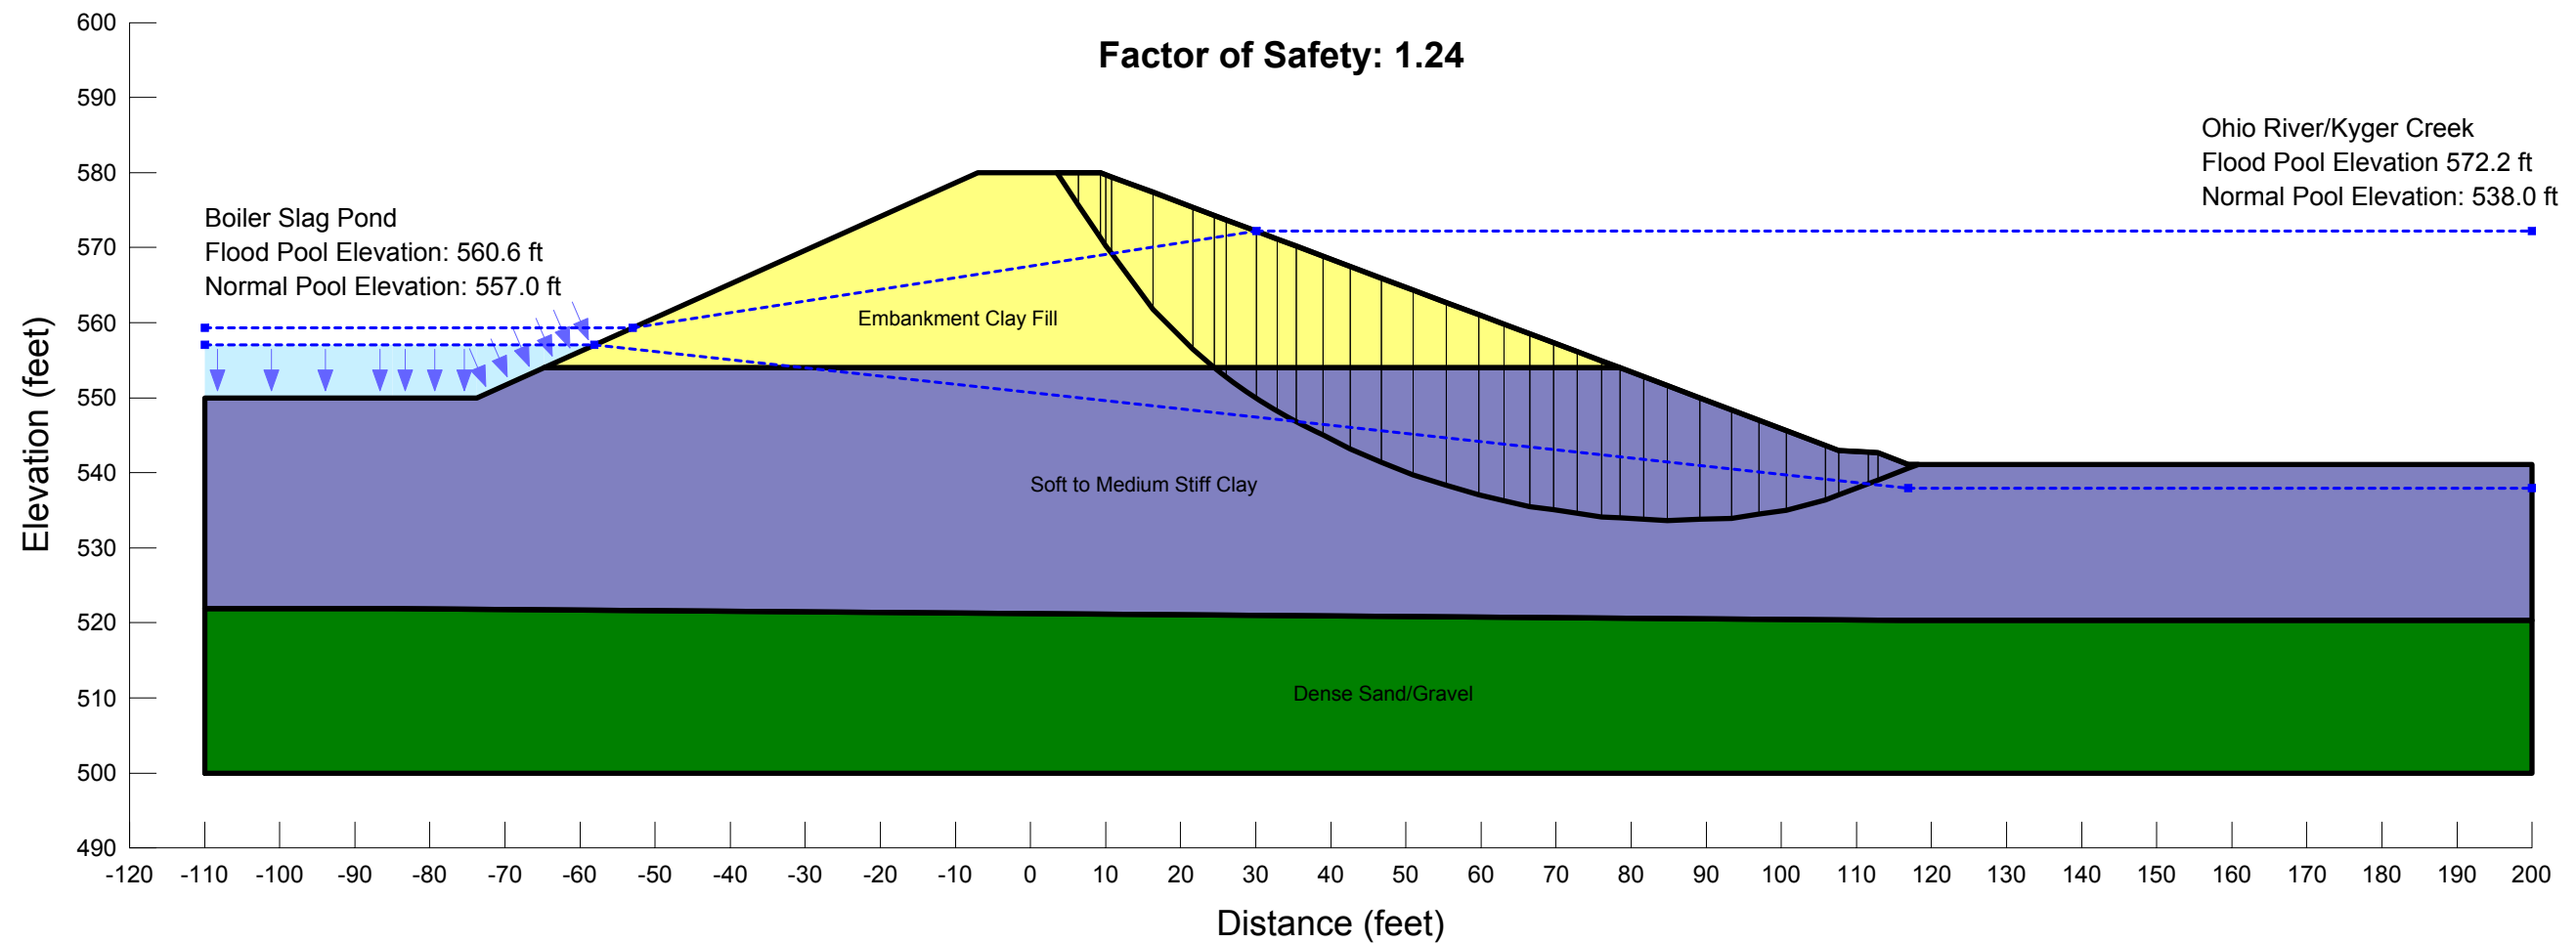
Facility	Cross Section	EPA Final CCR Rule Criteria	Recommended Factor of Safety Criteria	Calculated Factor of Safety
Boiler Slag Pond	2	Sudden Drawdown	1.1	1.2

Material Type	Unit Wt.	Effective Cohesion	Effective Friction Angle	Total Cohesion	Total Friction Angle
Embankment Clay Fill	125 pcf	100 psf	32 °	350 psf	20 °
Soft to Medium Stiff Clay	125 pcf	100 psf	28 °	300 psf	16 °
Dense Sand/Gravel	125 pcf	0 psf	30 °	0 psf	35 °

Note:  
The results of this analysis are based on available subsurface information, field and laboratory test results and approximate soil properties. The drawing depicts approximate subsurface conditions based on historical drawings or specific borings at the time of drilling. No warranties can be made regarding the continuity of subsurface conditions between the borings.
