**Reference: 2016 CCR Rule Inspection  
Annual Landfill Inspection  
Kyger Creek Generating Station  
Cheshire, Ohio**

**2016 CCR Rule Inspection  
Kyger Creek Landfill**

Kyger Creek Generating Station  
Cheshire, Ohio  
Gallia County

January 11, 2017

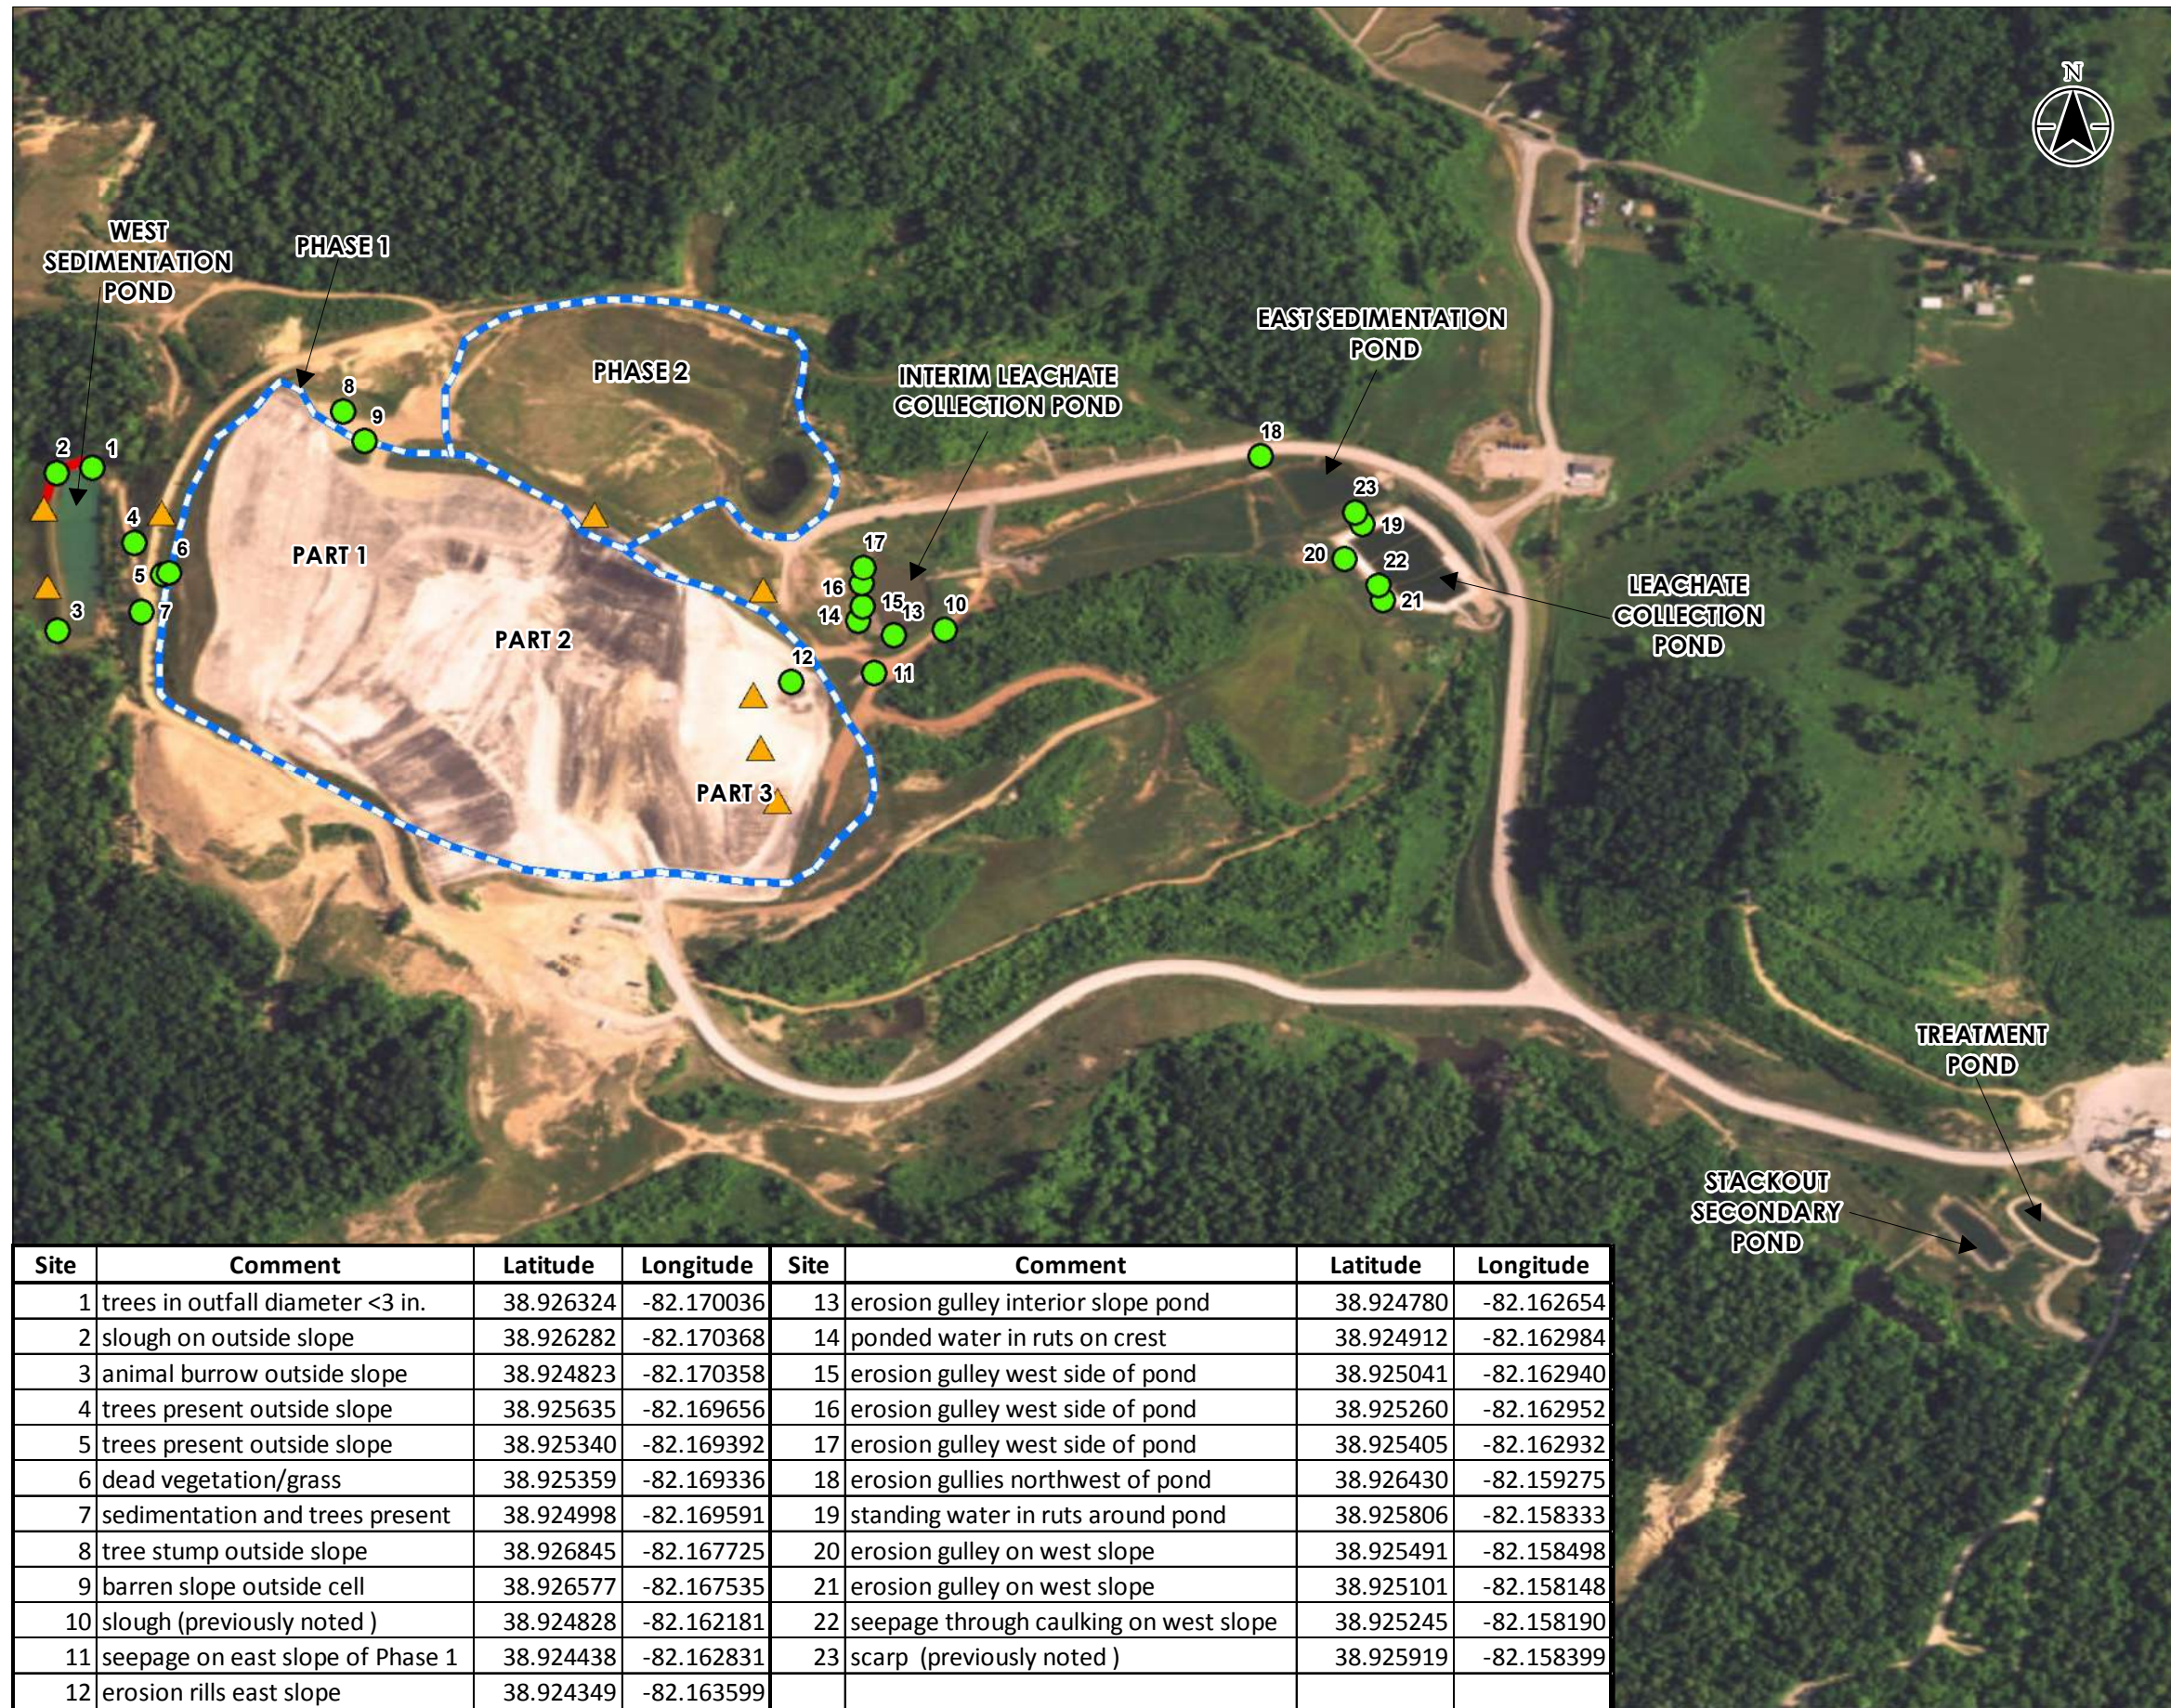
**2016 Annual CCR Landfill Inspection**

Site	Comment	Latitude	Longitude	Site	Comment	Latitude	Longitude
1	trees in outfall diameter <3 in.	38.926324	-82.170036	13	erosion gully interior slope pond	38.924780	-82.162654
2	slough on outside slope	38.926282	-82.170368	14	ponded water in ruts on crest	38.924912	-82.162984
3	animal burrow outside slope	38.924823	-82.170358	15	erosion gully west side of pond	38.925041	-82.162940
4	trees present outside slope	38.925635	-82.169656	16	erosion gully west side of pond	38.925260	-82.162952
5	trees present outside slope	38.925340	-82.169392	17	erosion gully west side of pond	38.925405	-82.162932
6	dead vegetation/grass	38.925359	-82.169336	18	erosion gullies northwest of pond	38.926430	-82.159275
7	sedimentation and trees present	38.924998	-82.169591	19	standing water in ruts around pond	38.925806	-82.158333
8	tree stump outside slope	38.926845	-82.167725	20	erosion gully on west slope	38.925491	-82.158498

9	barren slope outside cell	38.926577	-82.167535	21	erosion gully on west slope	38.925101	-82.158148
10	slough (previously noted )	38.924828	-82.162181	22	seepage through caulking on west slope	38.925245	-82.158190
11	seepage on east slope of Phase 1	38.924438	-82.162831	23	scarp (previously noted )	38.925919	-82.158399
12	erosion rills east slope	38.924349	-82.163599

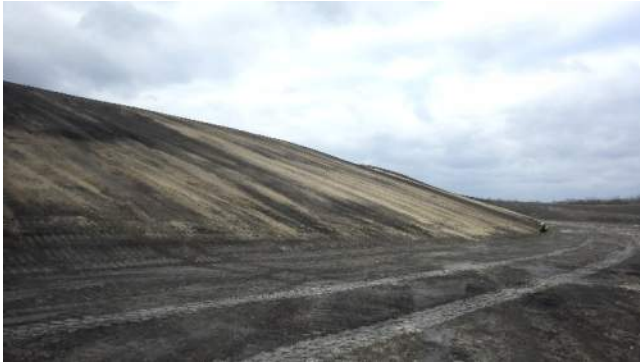
**Photo 1**

- Temporary CCR slopes within the landfill are being placed at a slope between 2.5H:1V (horizontal to vertical) and 2.7H:1V on the interior slope of western active cell of Part 1, Phase 1. (Photo 1). The eastern temporary slope of Part 3, Phase 1 was estimated as 2.1H:1V to 2.7H:1V. (Photo 2) Signs of instability such as sloughs or slides were not noted on the temporary internal slopes.

CCRs (2.5H:1V to 2.7H:1V slopes) on interior of the landfill on eastern active face of Area 1, Part 1.

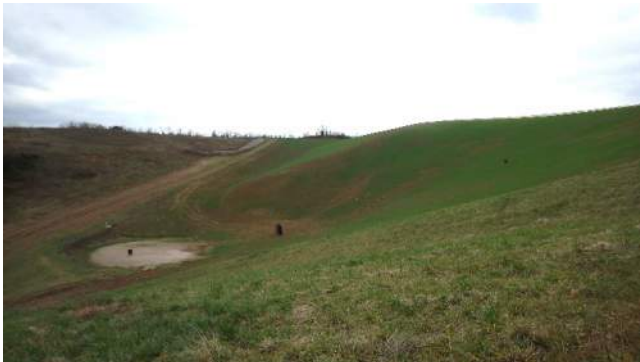
**Photo 2**

CCRs (3H:1V slopes) on interior of the landfill on eastern active face of Area 1, Part 3.

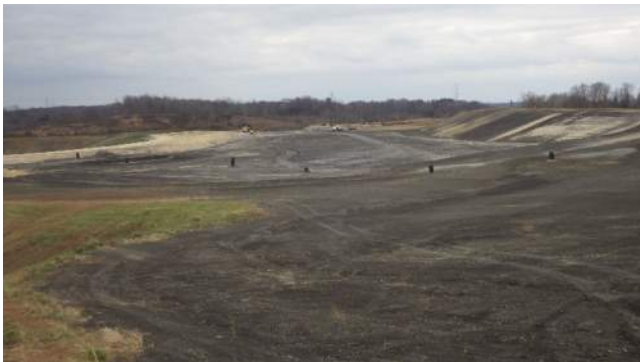
**Photo 3**

- A series of chimney drains was observed on the interior of the phase. (Photo 3)
- The temporary exterior slopes along the anchor trench on the south side and the west side are mowed with vegetation less than 6 inches. The trees noted in the 2015 inspection report have been cut flush with the ground. (Photos 4 and 5; Point 5, Appendix A)

Series of chimney drains within the active area of Phase 1.

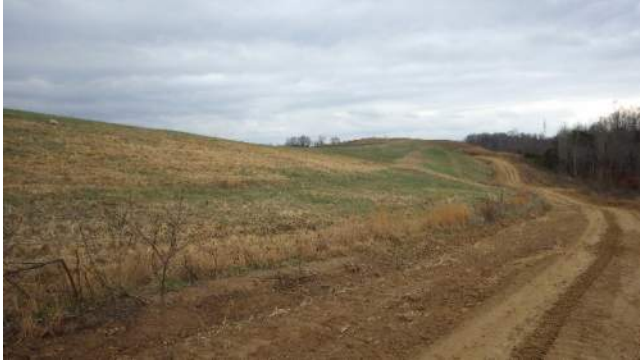
**Photo 4**

The exterior temporary slopes along the anchor trench on the south side of Phase 1, Parts 1 and 2.

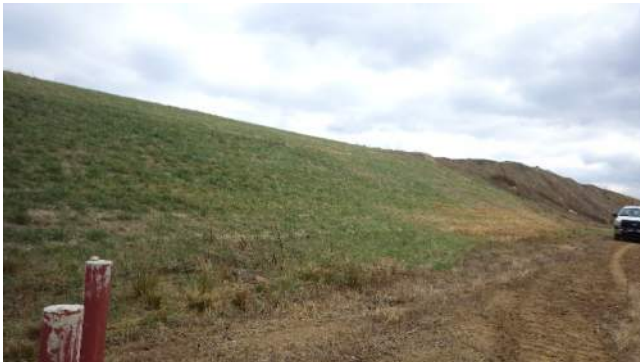
**Photo 5**

The exterior temporary slope on the west side of Phase 1, Part 1.

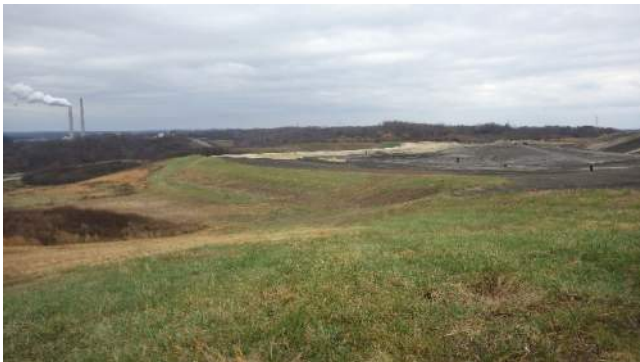
**Photo 6**

- The exterior temporary north slope of Phase 1, Parts 1 and 2, is mowed with vegetation less than 6 inches. The trees noted in the 2015 inspection report have been cut flush with the ground. (Photo 5; Point 8, Appendix A)

The exterior temporary north slope of Phase 1, Parts 1 and 2.

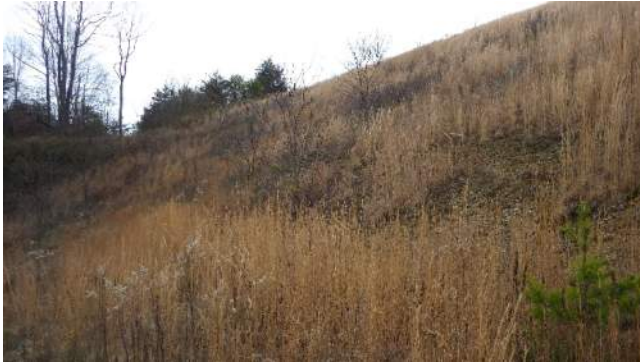
**Photo 7**

- Small diameter trees and taller vegetation (12 to 48 inches) were observed on the temporary slope on the west side of the landfill, between Phase 1 and the West Sedimentation Pond. (Photo 6; Points 4 and 6, Appendix A)

Small diameter trees and taller vegetation on the temporary slope on east side of the landfill.

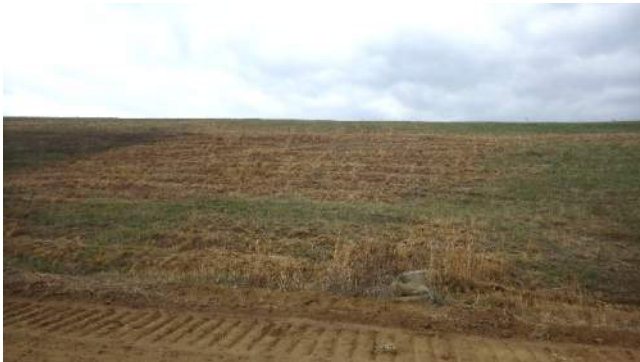
**Photo 8**

Minimal vegetation on the western exterior slope of Phase 1, Part 1.

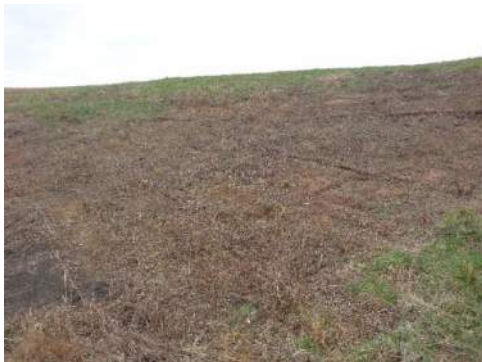
**Photo 9**

- The temporary exterior slope on the east side of Phase 1, near Phase 2, appears unchanged from the 2015 annual inspection.
- Two areas with minimal vegetative cover were noted during the December site visit. Both are located on the exterior temporary slopes, one on the western slope and one on the northern slope. (Photos 8 and 9; Points 6 and 9, Appendix A)

Minimal vegetation on the northern exterior slope of Phase 1, Parts 1 and 2.

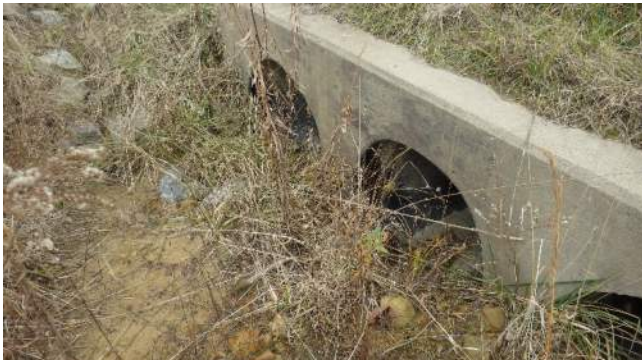
**Photo 10**

HDPE pipe inlets between the western slope of Phase 1, Part 1, and the West Sedimentation Pond.

- Continue to repair erosion gullies, reestablish grass vegetation, and continue to monitor in future inspections.
- Remove the vegetation and sediment restricting flow through the five HDPE pipes flowing from the Phase 1, Part 1 western temporary slope to the West Sedimentation Pond. Repair the erosion at the pipe outlets to protect from traffic.

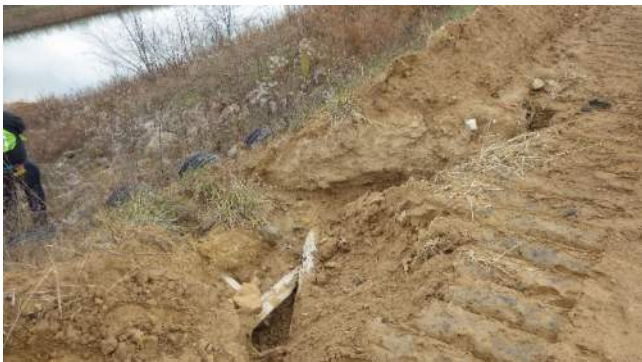
**Photo 11**

- Rock check dams were noted in the storm water channel along the western slope of Phase 1, Part 1.
- Five 24-inch high-density polyethylene (HDPE) pipes were observed on the west side of Phase 1, underlying the access road on the exterior slope. The pipes outlet into a riprap-lined channel that leads to the West Sedimentation Pond. The pipe inlets are partially blocked due to erosion of the road and temporary Phase 1 slope. The roadway above the pipe outlets has eroded. (Photos 10 and 11; Point 7, Appendix A)

Erosion of the roadway above the HDPE pipe outlets between the western slope of Phase 1, Part 1, and the West Sedimentation Pond.

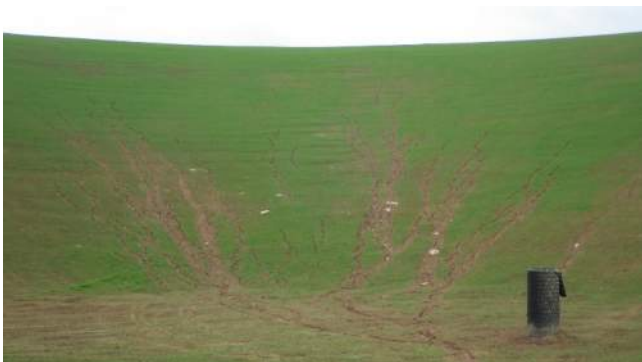
**Photo 12**

- The exterior temporary slope of Phase 1, Part 3, located on the east side of the active cell shows erosion rills near the toe. This is a maintenance issue for observation. (Photo 12; Point 12, Appendix A)

Erosion rills at toe of the exterior temporary slope on the eastern side of Phase 1, Part 3.

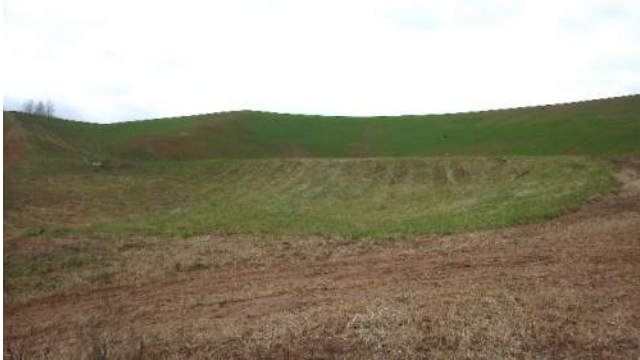
**Photo 13**

The regraded area east of Phase 1, Part 3, near the outlet of the underdrain piping.

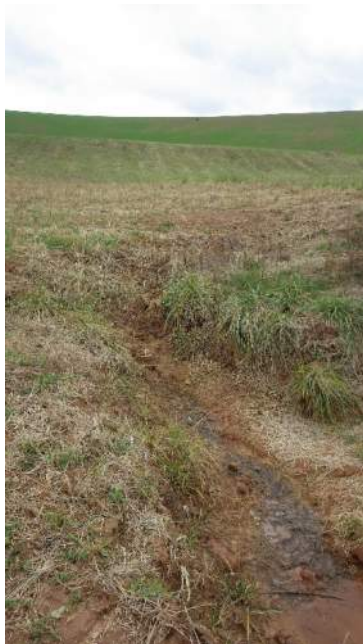
**Photo 14**

- The area beyond the eastern edge of the active Phase 1, Part 3 cell has been regraded and vegetated to address sloughing and erosion around the outlet of the underdrain pipe noted in the 2015 inspection report. The area remains spongy with visible clear flow eastward. (Photos 13 and 14; Point 11, Appendix A)

Spongy earth and visible clear flow east of the Phase 1, Part 3, near the outlet of the underdrain piping.

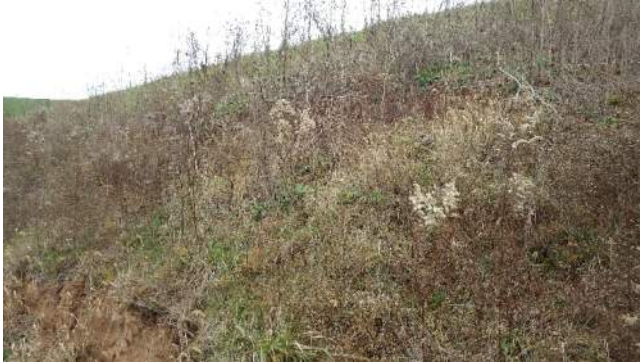
**Photo 15**

- A steepened exterior slope, with sloughing, was observed at the perimeter road on the south side of the Interim Leachate Collection Pond. (Photo 15; Point 10, Appendix A) The slough was noted as part of the 2015 inspection report and appears unchanged, though visual observation is obscured by vegetation. The grade of the exterior slope appeared unchanged from the 2015 inspection report.

The slough noted along the southern exterior slope of the Interim Leachate Collection Pond.

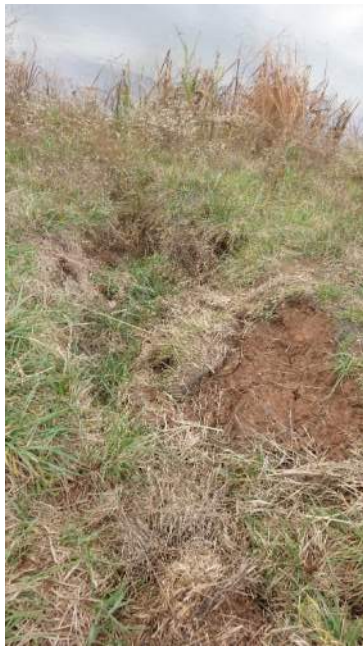
**Photo 16**

- Sloughing and deep erosion gullies were noted on the interior slopes of the Interim Leachate Collection Pond. Typical depth was 30 inches (Photo 16; Points 13, 15, 16, 17, Appendix A)

Erosion gully on the interior slope of the Interim Leachate Collection Pond.

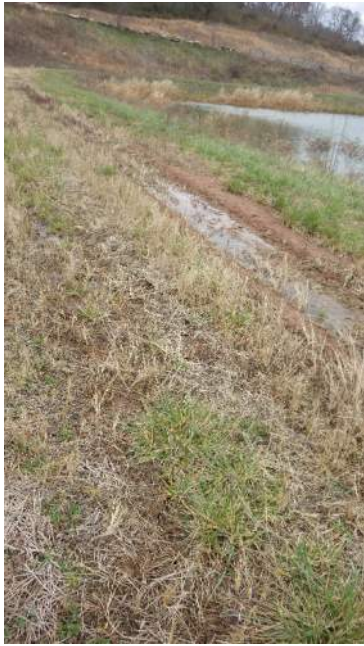
**Photo 17**

- Ponded water was present in the equipment ruts on the crest of the Interim Leachate Collection Pond. (Photo 17; Point 15, Appendix A)

Ponded water in equipment ruts on the crest of the Interim Leachate Collection Pond.

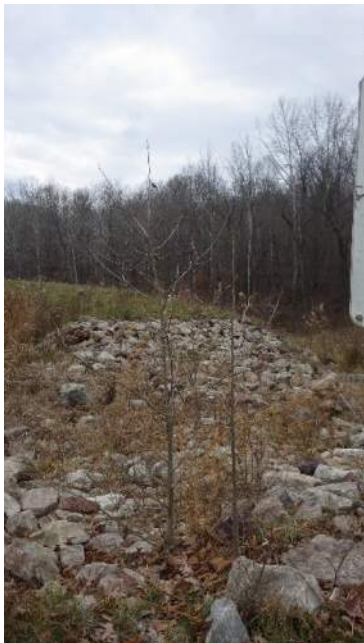
**Photo 18**

Small trees in the spillway of the West Sedimentation Pond.

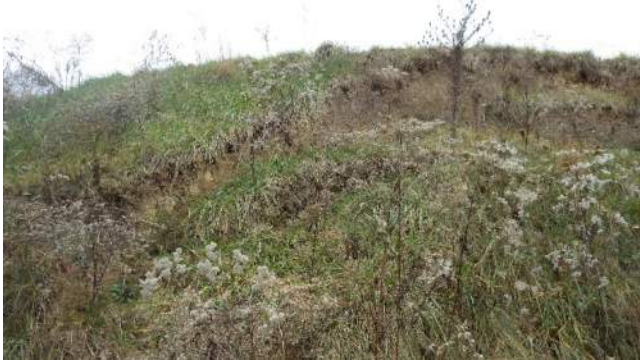
**Photo 19**

- Small trees (diameter <2 inches) were noted in the pond spillway (Stormwater Outfall 034). (Photo 1; Point 1, Appendix A)
- A scarp has developed on the outside slope of the pond adjacent to the Stormwater Outfall 034 channel. It is a progressive failure estimated as 25 feet wide at the top, spreading out to about 200 feet wide at the toe. The head scarp begins at the edge of the outside crest, and the estimated change in height is 8 feet. It begins west of the spillway and curves around the pond to north of Sediment Trap No. 13. (Photos 19 and 20; Point 2, Appendix A)
- Vegetation growth to a height of 12 to 48 inches was observed on the western exterior slope of the West Sedimentation Pond, obscuring visual observation.
- An animal burrow (estimated at 4 inches in diameter) was noted at the southwestern toe of the pond embankment. (Point 3, Appendix A)

Head scarp west of the spillway of the West Sedimentation Pond.

- A scarp on the northwestern exterior slope of the West Sedimentation Pond should be characterized and addressed as needed.
- Maintain the vegetation along the exterior slope of the Interim Leachate Collection Pond. Characterize the slough identified during the field visit, and address stability concerns of the existing slopes, if needed.
- Characterize and address the seepage occurring near the underdrain pipe at the east side of Phase 1. Take measures to control the flow, minimize sediment transport, and review the design to verify that it is performing as designed. Continue to monitor the toe of the active waste slope.

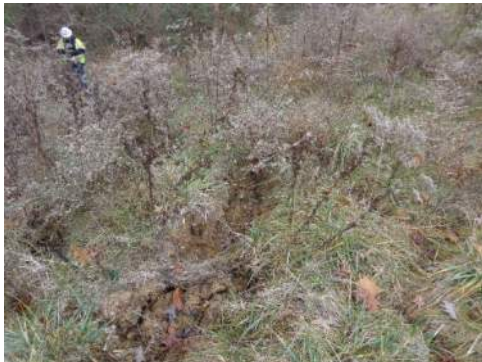
**Photo 20**

Toe of scarp on the northwestern exterior slope of the West Sedimentation Pond.

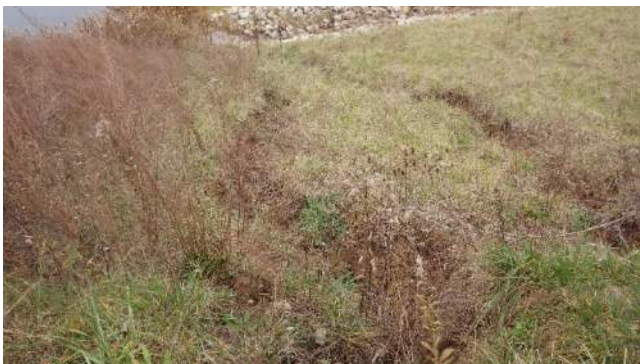
**Photo 21**

- Several erosion gullies are located along the northwest slope of the pond connecting the East Sedimentation Pond to the paved haul road. (Photo 21, Point 18, Appendix A)
- The inlet of the 36-inch CPP west of the East Sedimentation Pond is unobstructed and riprap lined. The vegetation and small tree growth observed during the 2015 inspection report has been removed.

Erosion gullies at northwest corner of the East Sedimentation Pond, starting near the haul road.

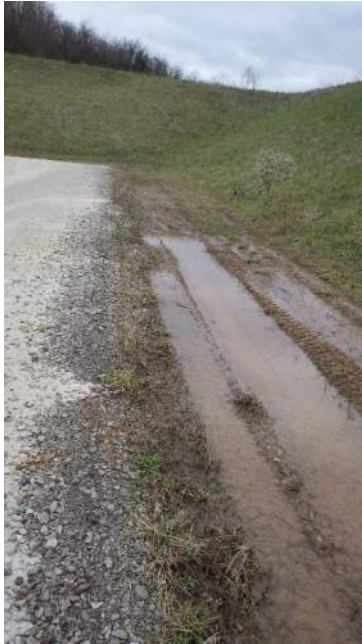
**Photo 22**

Pondered water in equipment ruts around the crest of the Leachate Collection Pond.

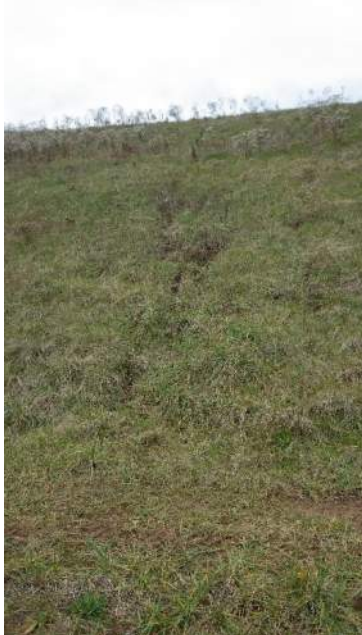
**Photo 23**

Erosion rills were observed on the west interior slope of the Leachate Collection Pond.

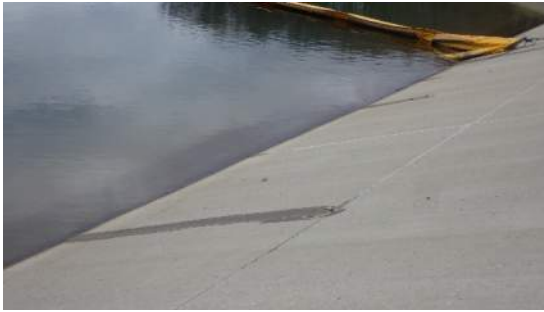
**Photo 24**

Seepage through the caulked joints of the concrete-lined Leachate Collection Pond.

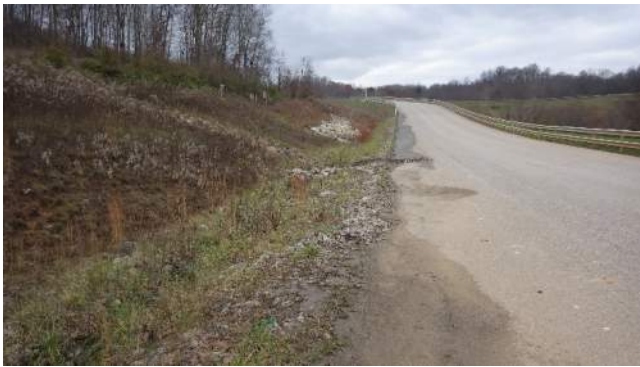
**Photo 25**

- A riprap diversion has been placed along surface water channel on the east side of the perimeter road near Sediment Trap No. 26. It appears to capture storm water runoff along the paved haul road, diverting it to the sedimentation trap. (Photo 25)

Riprap diversion to capture storm water runoff from the haul road near Sediment Trap No. 26.
