**Re: Ohio Valley Electric Corporation
Kyger Creek Station's 2019 Annual Landfill Inspection**

**Reference: 2019 CCR Rule Inspection
Annual Landfill Inspection
Kyger Creek Generating Station
Cheshire, Ohio**

**2019 CCR Rule Inspection
Kyger Creek Landfill**

Kyger Creek Generating Station
Cheshire, Ohio
Gallia County

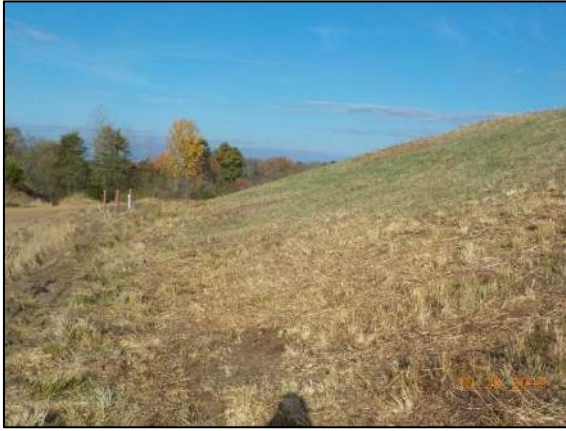
Photo 1

- The exterior temporary northern, western, and eastern slopes of Phase 1 are mowed sufficiently for a visual inspection, uniform, and vegetated (Point 30, Appendix A; Photos 1, 8, 9, 10 to 13, 20, 21, 23 Appendix B).

Photo of temporary slope of west side of active phase showing uniform and vegetated 2.75H:1V slope. (Point 30, Appendix A)

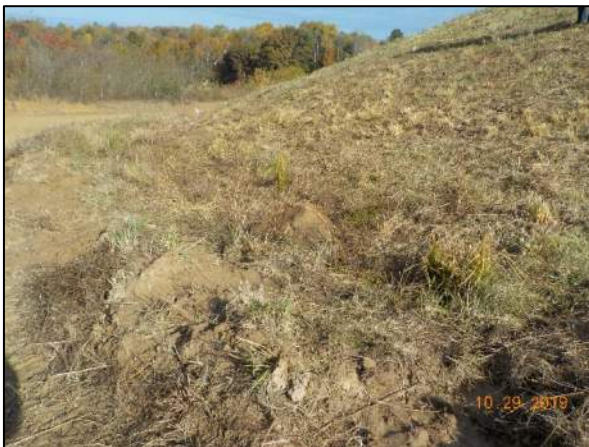
Photo 2

- There were several instances of boulders, erosion, and heavy vegetation in the ditches at the toe of the western exterior temporary slopes that may reduce the effectiveness of the ditches. (Points 30, 31, 34, 37, 45, Appendix A; Photos 2, 4, 6; 9, Appendix B)

One of several locations of boulders in ditch on west side of active phase. (Point 31, Appendix A)

- Remove the sediment and vegetation restricting flow through the five HDPE pipes flowing from the Phase 1 western slope to the West Sedimentation Pond. Repair and maintain the stormwater best management practices (BMPs) for the channels flowing to the pipes. Remediate the eroded area at the pipe outlets to protect the access road for Phase 1.
- Maintain the vegetation along the exterior slopes and within the surface drainage channels to facilitate inspections by removing taller weeds and trees as needed.

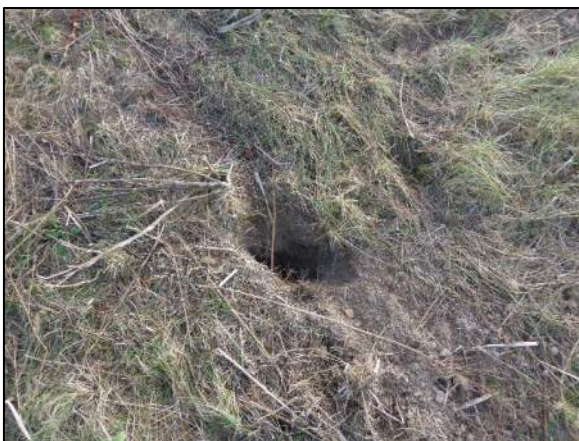
Photo 3

- A few small animal burrows were observed on the west side of the active phase. (Points 32, 46, 47, Appendix A; Photos 3,10, Appendix B)
- Dense vegetation and small trees block the inlets of five pipe culverts that underlie the access road west of Phase 1. (Point 34, Appendix A; Photos 4, Appendix B)

Animal burrow on temporary slope of west side of active phase. (Point 32, Appendix A)

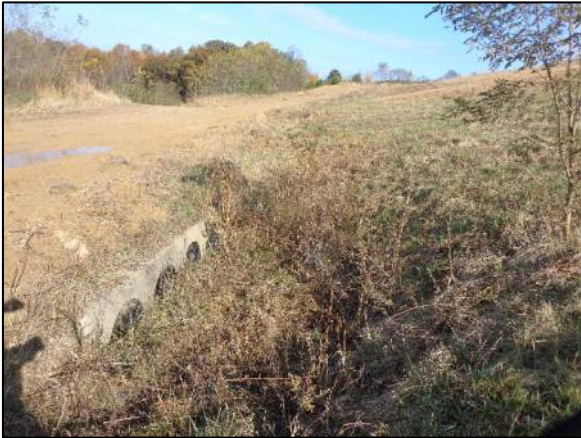
Photo 4

Inlet of five HDPE pipes on the west side of the active phase, with dense vegetation, including 3-inch diameter trees. (Point 34, Appendix A)

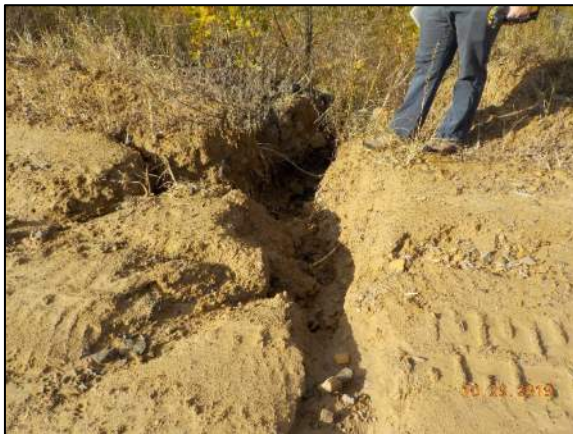
Photo 5

- A severe erosion feature (3 feet deep and 2 feet wide) affecting the road was observed on the west perimeter road above the outlets of the 5-pipe culvert. (Point 36, Appendix A; Photo 5, Appendix B)

Erosion feature in road above outlet of five HDPE pipes on west side of active phase. (Point 36, Appendix A)

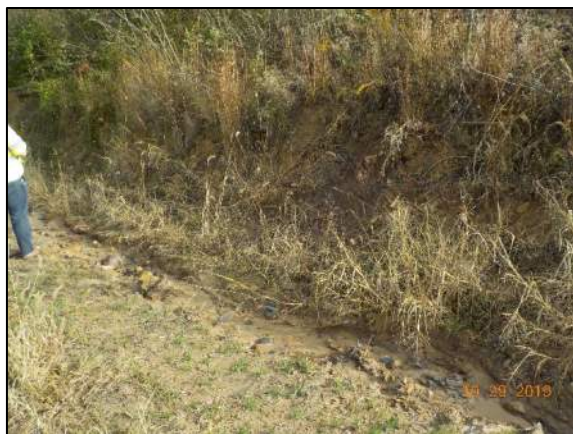
Photo 6

- An erosion gully is forming on the north side of the access road to the West Sedimentation Pond (Point 37, Appendix A; Photo 6, Appendix B).
- The scarp on the slope above the access road to the West Sediment Pond appears to have enlarged. (Point 38, Appendix A; Photo 7, Appendix B)
- Scarps and cracks are forming in the surface of the recent slope repair at the north end of the exterior slope of the West Sediment Pond. (Points 42, 43, Appendix A; Photo 8, Appendix B)

Erosion along access road to West Sediment Pond. (Point 37, Appendix A)

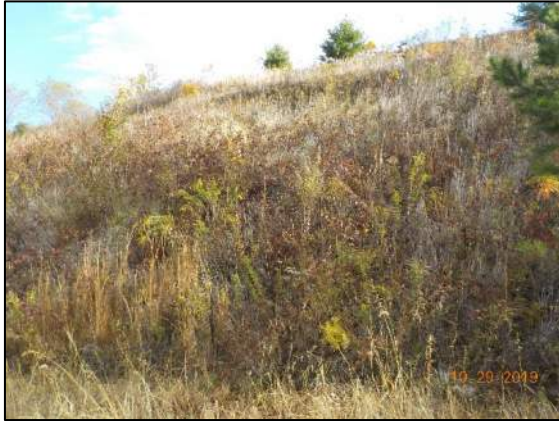
Photo 7

Scarp above access road to West Sediment Pond. (Point 38, Appendix A)

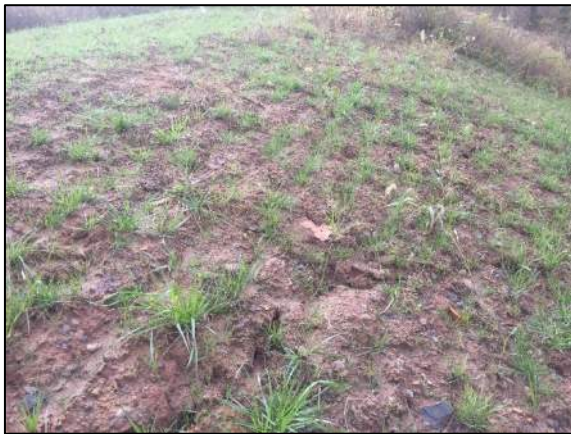
Photo 8

Scarps and rills forming along the west side of the West Sediment Pond embankment. (Points 42 to 43, Appendix A)

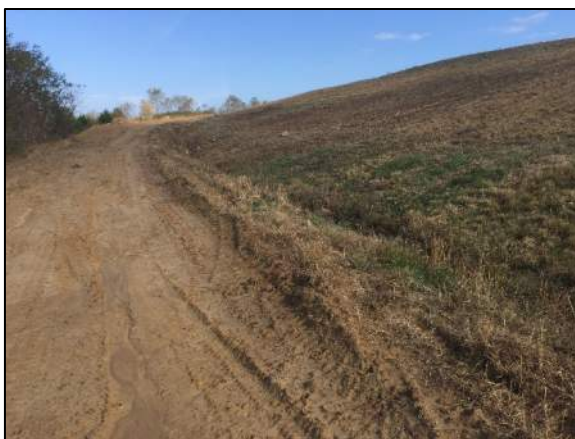
Photo 9

Erosion and occasional boulder along east side of access road west of active phase and above West Sediment Pond access road. (Point 45, Appendix A)

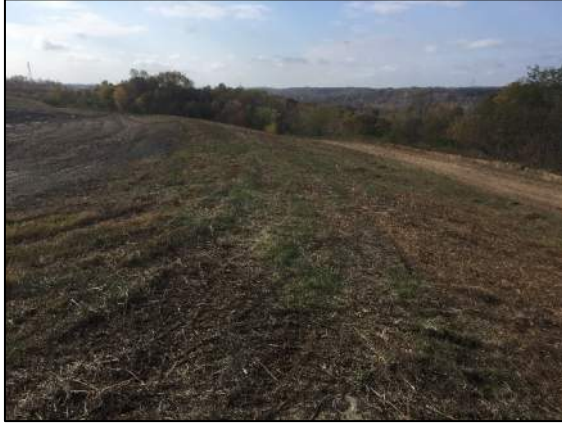
Photo 10

Temporary slope on west end of active phase with few animal burrows and small areas of exposed ash. (Points 46 to 47 Appendix A)

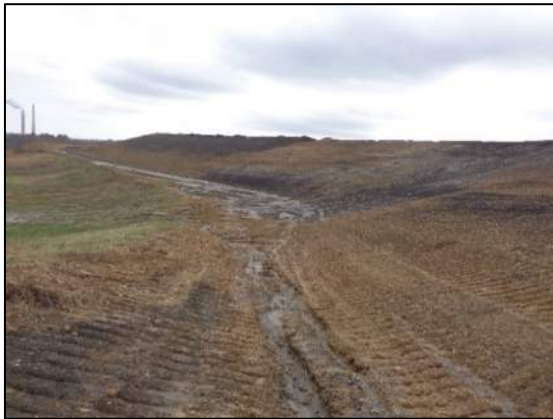
Photo 11

- The Phase 1/Phase 2 separation/transition berm on the north side of the active phase has been regraded and improved from last year, but erosion and standing water were observed in this area. (Points 49–55, Appendix A, Photos 11 to 13, Appendix B)

Standing water and erosion north of active phase. (Points 54 to 55, Appendix A)

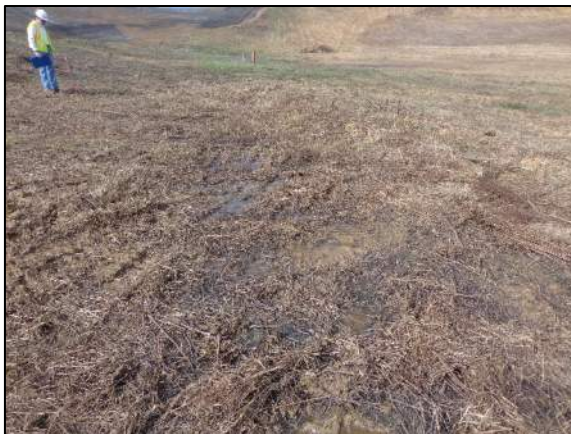
Photo 12

Standing water below erosion. (Point 53, Appendix A)

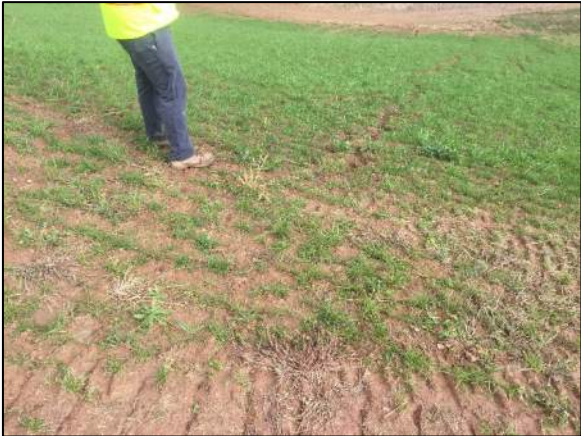
**Photo 13**

Erosion rills on the new slopes and standing water at toe on the north side of the active phase. (Points 49 to 52, Appendix A)

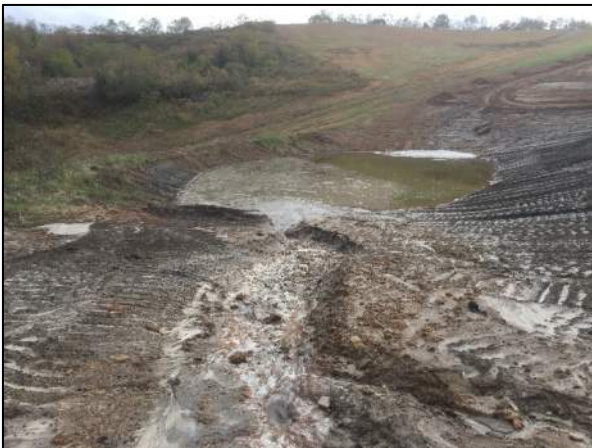
**Photo 14**

Eroded drainageway to temporary sediment pond at base of east external temporary slope of active phase. (Point 66, Appendix A)

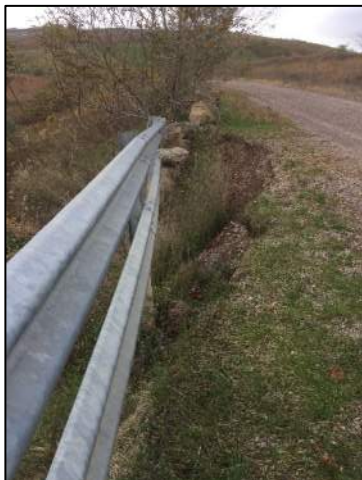
**Photo 15**

Erosion/scarp along south side of northern access road. (Point 57, Appendix A)

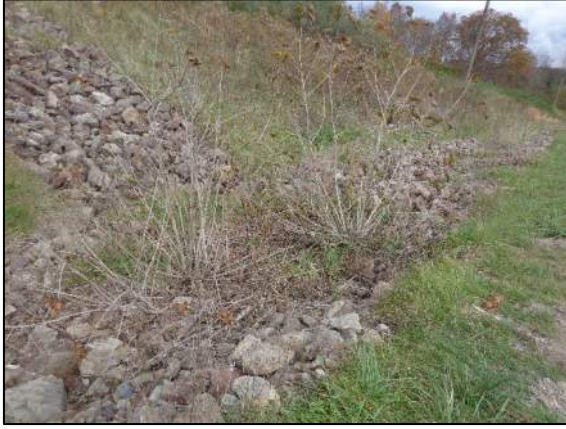
Photo 16

- Erosion and washout were observed in a ditch adjacent to the perimeter road to the stacker. (Near Point 72, Appendix A; Photo 25, Appendix B)
- There is a slip forming along the perimeter road to the stacker. (Point 72, Appendix A; Photo 26, Appendix B)
- A scarp that undermines the guardrail and boulder barrier has formed on the downhill side of the north perimeter road. (Point 57, Appendix A; Photo 15, Appendix B)
- A vegetation-filled inlet of a pipe culvert beneath the northern access road was observed. (Point 57, Appendix A; Photo 16, Appendix B)

Vegetation-filled inlet of road culvert on north side of northern access road across from Point 57 (Appendix A).

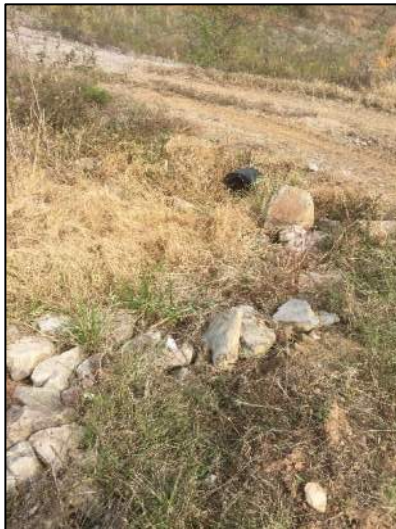
Photo 17

- Erosion, standing water, and vegetation were observed in the ditch from the Interim Leachate Collection Pond crossing the access road to the pond at the base of the east temporary slope of the active phase. (Point 58, Appendix A; Photo 17, Appendix B)

Erosion and standing water at access road to Interim Leachate Collection Pond. (Point 58, Appendix A)

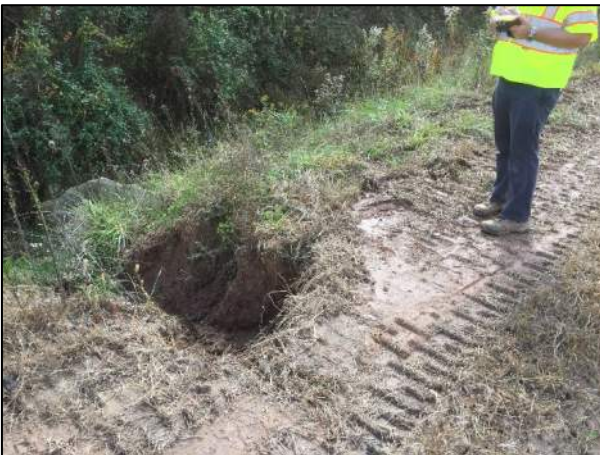
Photo 18

- An erosion gully affects the access road to the Interim Leachate Collection Pond. (Point 59, Appendix A; Photo 18, Appendix B)
- The scarp in the embankment above the access road to the Interim Leachate Collection Pond has enlarged with visible signs of seepage. (Point 59, Appendix A; Photo 19, Appendix B)

Erosion gully affecting access road to Interim Leachate Collection Pond. Road was wet in this area. (Point 59, Appendix A)

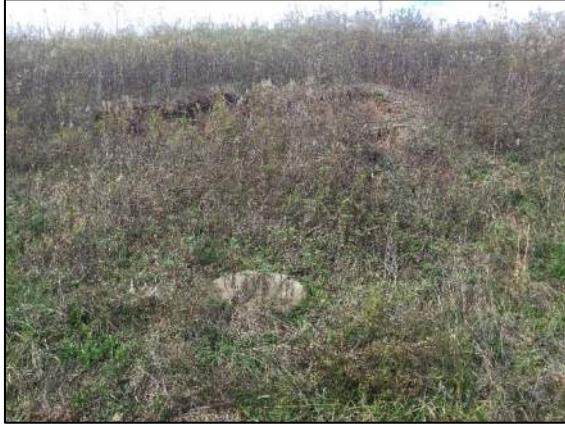
Photo 19

Scarp on Interim Leachate Collection Pond external slope of embankment (near Point 59, Appendix A)

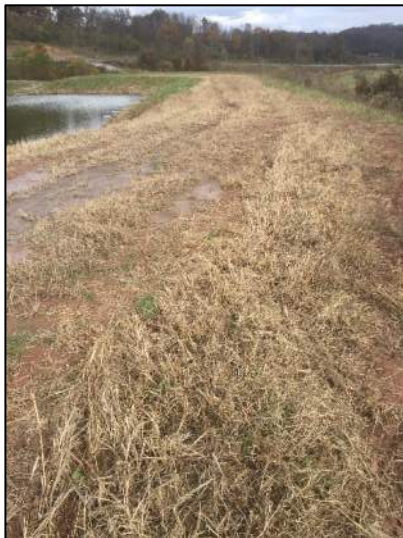
Photo 20

same vicinity of the existing scarp. This may indicate instability of this embankment, with failure of the slope progressing into the impoundment. Attention to this area should be immediate.

- A scarp along the crest of the Interim Leachate Collection Pond has formed in the vicinity of the existing scarp. There is standing water on the crest. This may be a sign that the soil embankment is saturated thereby reducing its strength. (Points 61 to 62, Appendix A; Photo 20, Appendix B)

Scarp along length of Interim Leachate Collection Pond embankment. (Points 61 to 62, Appendix A)

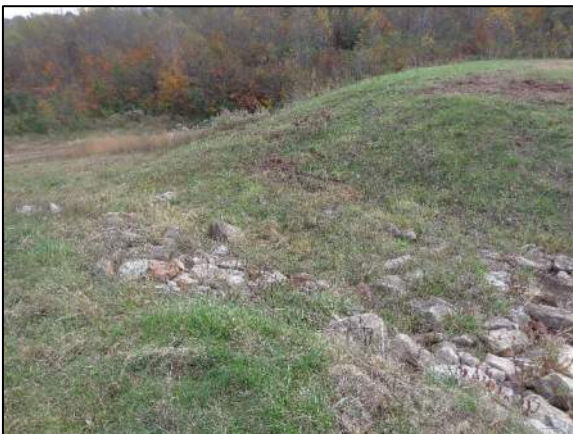
Photo 21

Sparse riprap in exit channel of Interim Leachate Collection Pond. (Point 63, Appendix A)

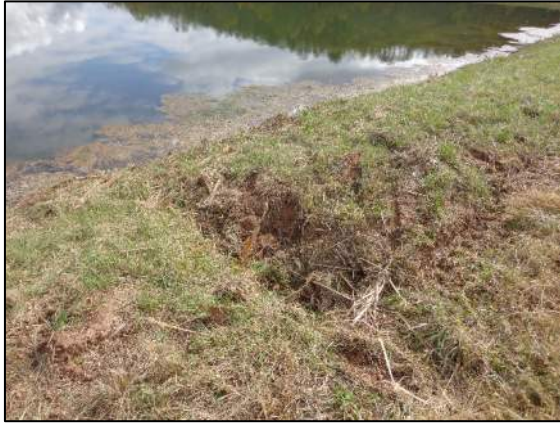
Photo 22

- Erosion gullies on the western and southern interior slopes of the Interim Leachate Collection Pond were observed, similar to the 2018 annual inspection. (Point 65, Appendix A; Photo 22, Appendix B) Small animal burrows were observed on the west exterior slope.

Gully on west side of Interim Leachate Collection Pond embankment. (Point 65, Appendix A)

- Continue to repair erosion gullies, reestablish grass vegetation, and monitor in future inspections.
- A cover grate is recommended for the overflow pipe at the Interim Leachate Collection Pond to minimize debris carried into the pipe.
- Small landslides beside the perimeter road should be monitored and regraded as necessary to maintain the integrity of the road.

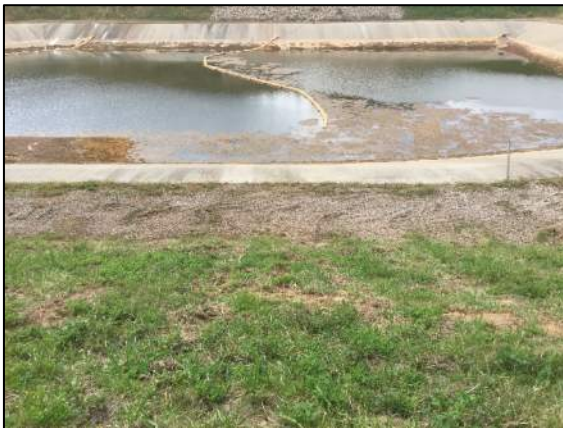
Photo 23

- Small areas void of vegetation were observed on the interior of the embankment (east side) at the Leachate Collection Pond. (Points 67, 68, Appendix A; Photo 23, Appendix B)
- Standing water and vehicle rutting were observed on the west side of Leachate Collection Pond (Points 70, 71, Appendix A; Photo 24, Appendix B). Evidence of seepage through the concrete joints, as in years past, was observed.

Bare spots on interior of embankment (east side) at Leachate Collection Pond. (Points 67 to 68, Appendix A)

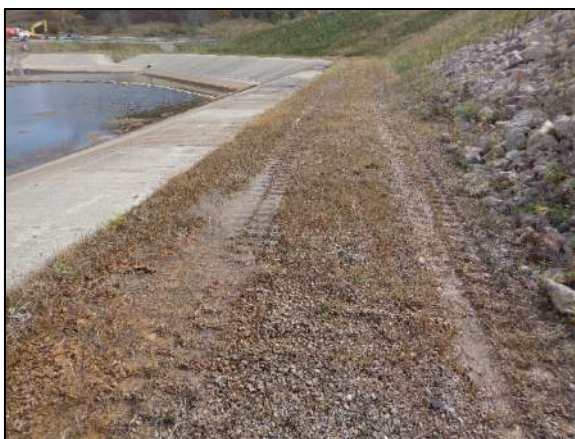
Photo 24

Standing water and rutting on west side of Leachate Collection Pond. (Points 70 to 71, Appendix A)

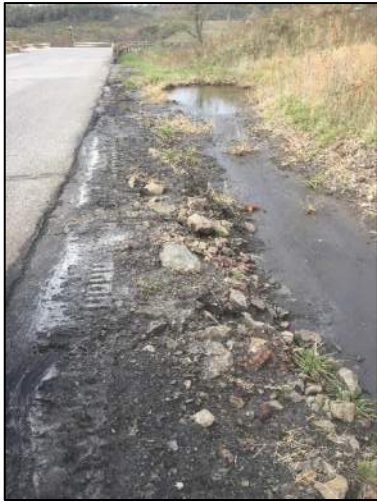
Photo 25

Erosion/washout on uphill side of perimeter access road to stacker. (near Point 72, Appendix A)

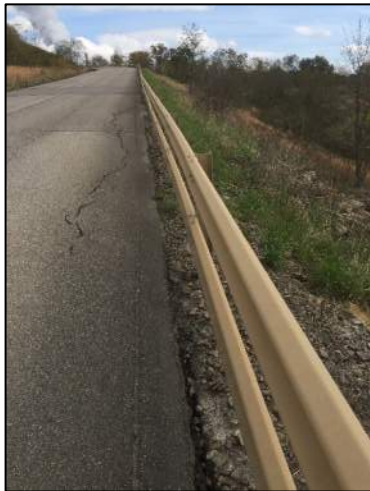
Photo 26

Slip forming on downhill side of perimeter access road to stacker. (Point 72, Appendix A)

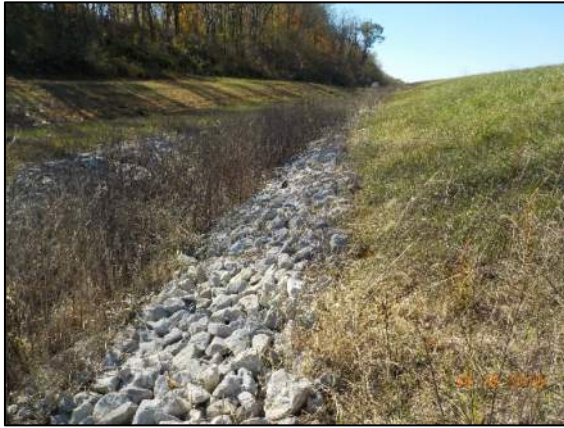
Photo 28

Dense vegetation along invert of drainage ditch along south side of landfill.

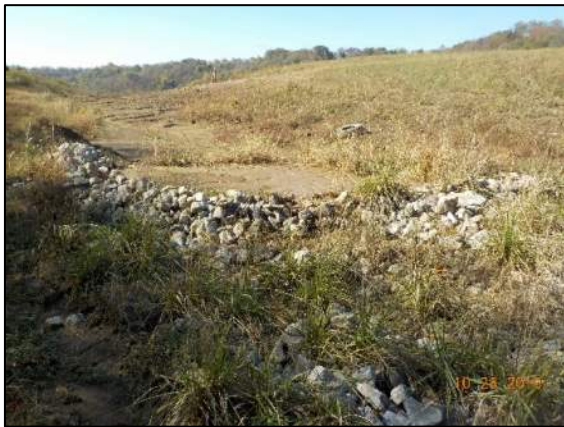
Photo 29

Rock check dam at capacity on south side of landfill near top of active area. (Point 64, Appendix A)

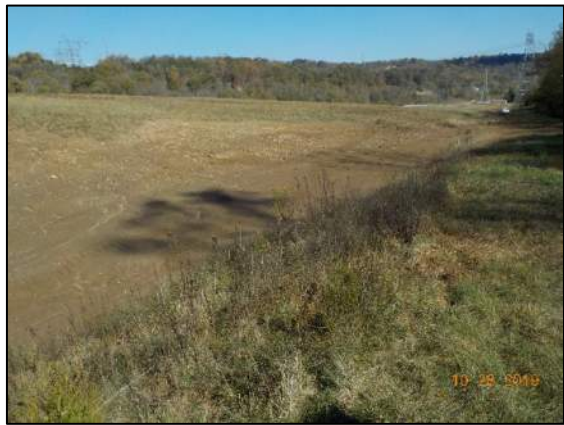
Photo 30

Unseeded/bare area above full rock check dam at southeastern edge of active ash area on south side of landfill. (Point 65, Appendix A)

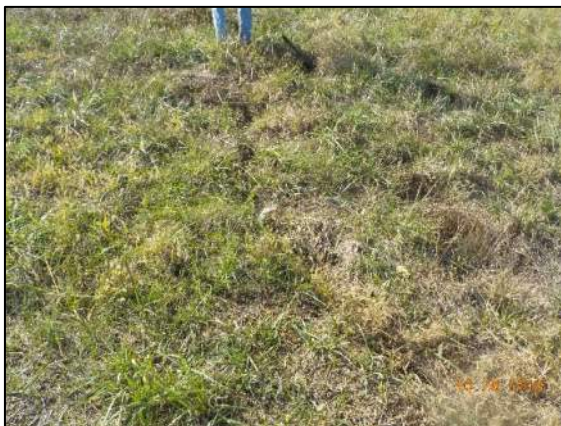
Photo 33

Erosion rills and/or small animal
burrowing at eastern toe of landfill.
(Point 55, Appendix A)

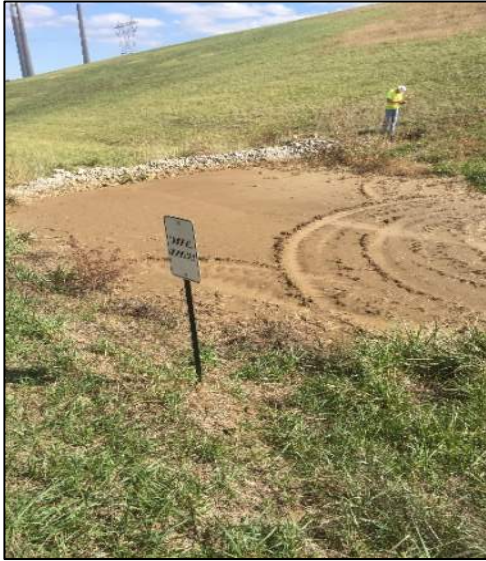
Photo 34

Rock check dam at capacity on northeast corner of active landfill. (Point 73, Appendix A)

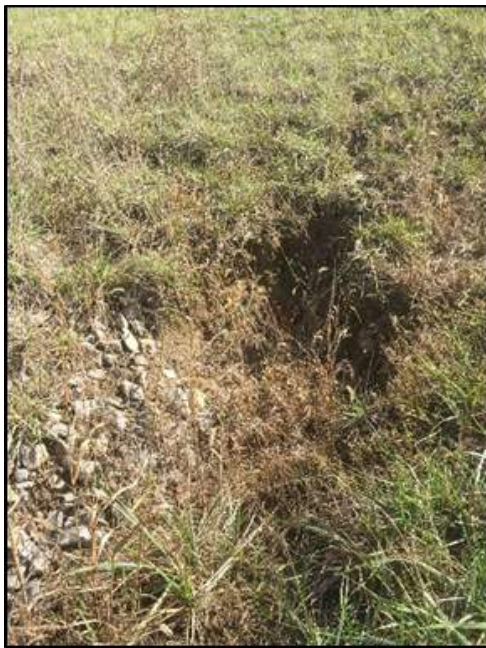
Photo 35

Erosion feature at south edge of check dam on northeast corner of active landfill (Point 74, Appendix A)

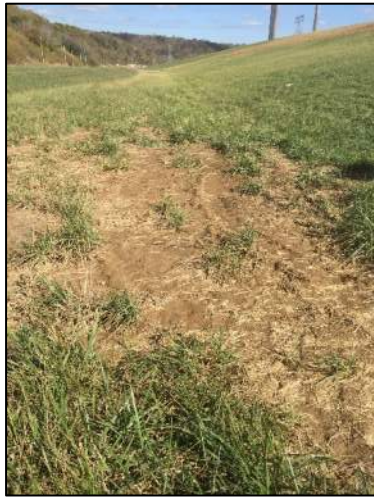
Photo 36
Unseeded area on north side of active landfill. Sediment apparently from regrading/revegetation of slope above. (Point 79, Appendix A)

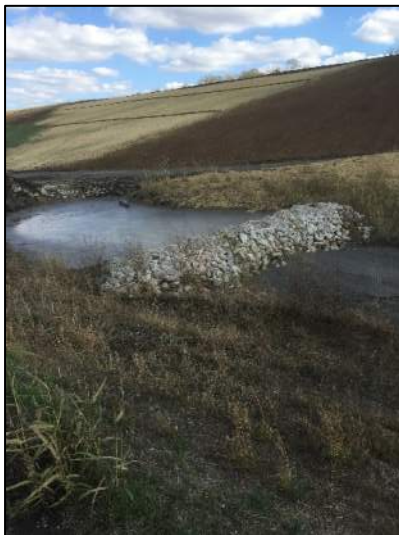
Photo 37
Full rock check dam on north side of active landfill. (Point 87, Appendix A)
