**Re: Ohio Valley Electric Corporation
Kyger Creek Station's 2020 Annual Landfill Inspection**

**Reference: 2020 CCR Rule Inspection
Annual Landfill Inspection
Kyger Creek Generating Station
Cheshire, Ohio**

**2020 CCR Rule Inspection
Kyger Creek Landfill**

Kyger Creek Generating Station
Cheshire, Ohio
Gallia County

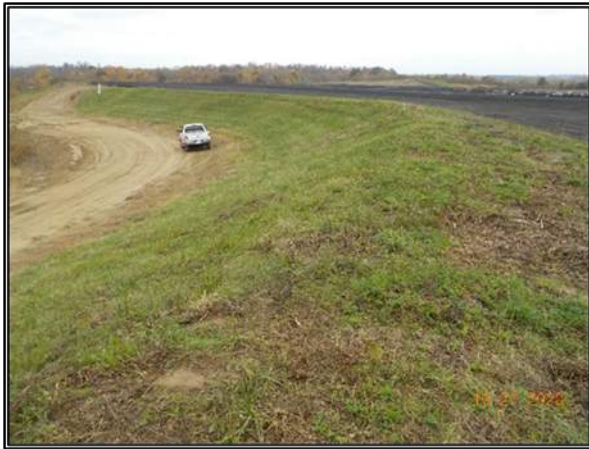
**Photo 1**

- The exterior temporary northern, western, and eastern slopes of Phase 1 are mowed sufficiently for a visual inspection, uniform, and vegetated. (Points 1, 46 to 56, Appendix A; Photos 1, 8, and 9, Appendix B)

Temporary slope of west side of active phase showing uniform and vegetated 2.75H:1V slope, top. (Point 30, Appendix A)

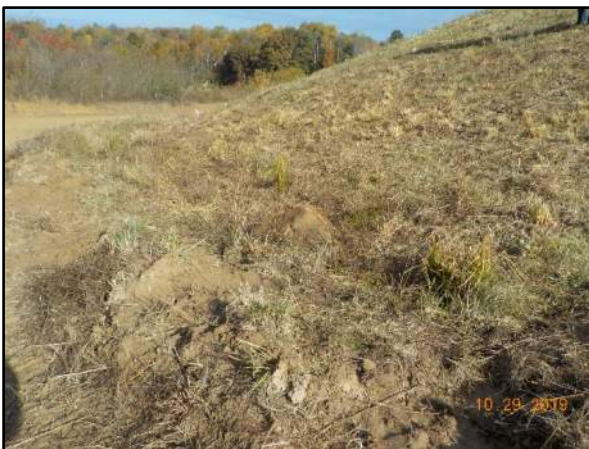
**Photo 2**

- There are still several boulders and erosion features along with heavy vegetation in the ditches at the toe of the western exterior temporary slopes that may reduce the effectiveness of the ditches. (Points 2 and 51, Appendix A; Photos 2 and 10, Appendix B)

Boulders in ditch on west side of active phase. (Point 31, Appendix A)

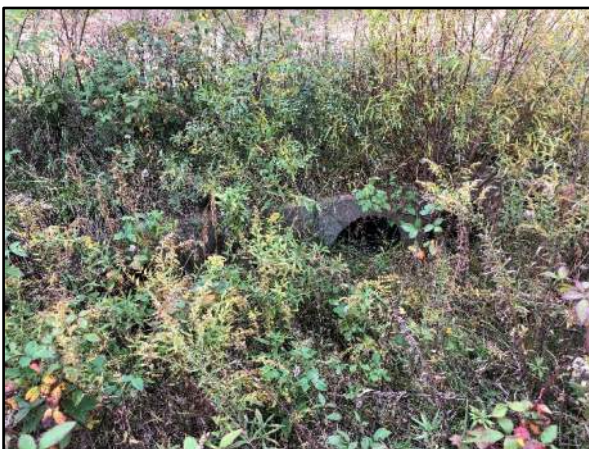
**Photo 3**

- Dense vegetation and small trees block the inlets of five pipe culverts that underlie the access road west of Phase 1. (Point 34, Appendix A; Photo 3, Appendix B)

Inlets of five HDPE pipes on the west side of the active phase, with dense vegetation, showing larger trees removed since 2019 (Point 34, Appendix A)

- Remove the sediment and vegetation restricting flow through the five HDPE pipes flowing from the Phase 1 western slope to the West Sedimentation Pond. Repair and maintain the stormwater best management practices (BMPs) for the channels flowing to the pipes. Remediate the eroded area at the pipe outlets to protect the access road for Phase 1.
- Maintain the vegetation along the exterior slopes and within the surface drainage channels to facilitate inspections by removing taller weeds and trees as needed.
- Continue to repair erosion gullies, reestablish grass vegetation, and monitor in future inspections.
- A cover grate is recommended for the overflow pipe at the Interim Leachate Collection Pond to minimize debris carried into the pipe.
- Small landslides beside the perimeter road should be monitored and regraded as necessary to maintain the integrity of the road.

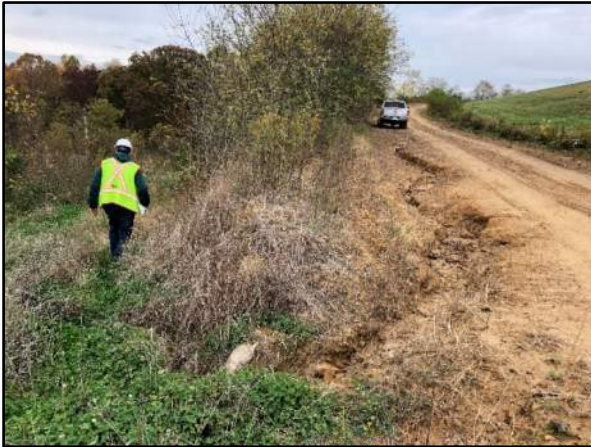
**Photo 4**

- The severe erosion feature affecting the access road west of Phase 1 has enlarged. This feature is affecting the outlet area of the 5-pipe culvert. The storm water runoff through the feature likely contributed to slope slippage at the top of the west pond access road. (Points 36 and 37, Appendix A; Photos 4 and 5, Appendix B)

Erosion feature in road above outlet of five HDPE pipes on west side of active phase, bottom. (Point 36, Appendix A)

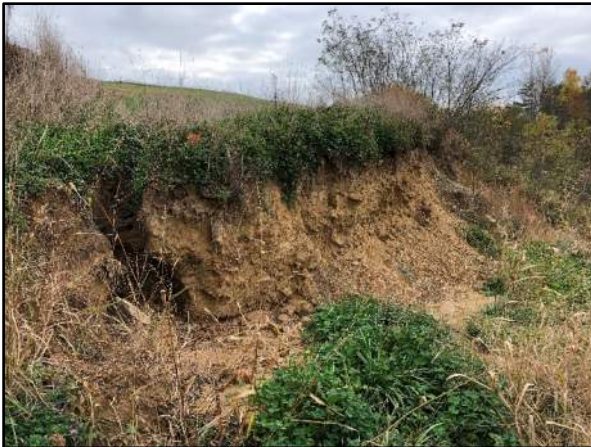
**Photo 5**

Erosion along access road to West Sedimentation Pond. Erosion, slippage, and dense ground cover have compromised the road. (Point 37, Appendix A)

- The access road to the West Sedimentation Pond is compromised and can no longer be traversed by maintenance vehicles. Repair road or establish alternative route to provide access for maintenance equipment.

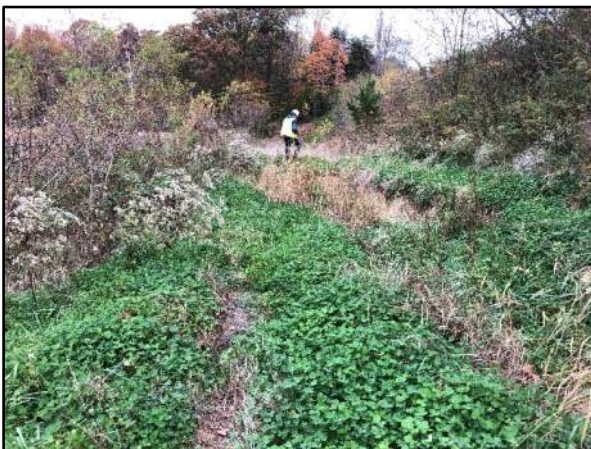
**Photo 6**

- The access road to the West Sedimentation Pond has been compromised by erosion and slope slippage and is overgrown with vegetation. (Points 38 and 73, Appendix A; Photo 6, Appendix B)

Scarp above access road to West Sedimentation Pond, top. Access road to pond and hillside above showing slippage, 3-foot deep erosion gullies, and dense ground cover, bottom. (Point 38, Appendix A)

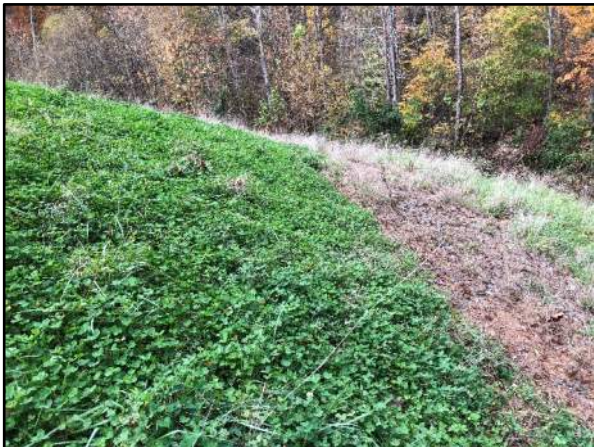
**Photo 7**

- Vegetation growth to a height of 12 to 48 inches was observed on the western exterior slope of the pond, somewhat obscuring visual observation. (Points 42 to 43, Appendix A; Photo 7, Appendix B)

Denser vegetation along west side of the West Sedimentation Pond embankment, bottom, (Points 42 to 43, Appendix A)

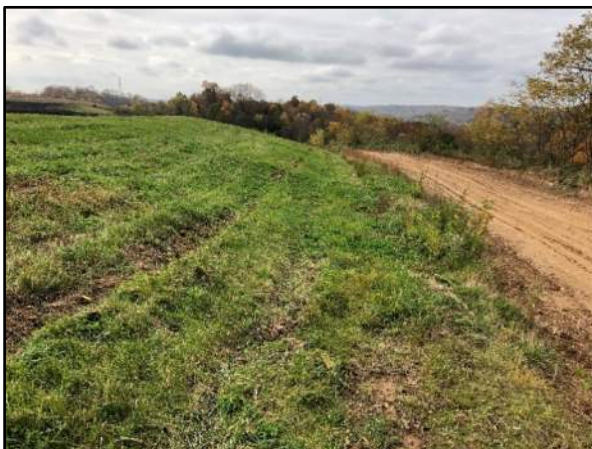
**Photo 8**

Temporary slope on west end of active phase showing vegetated slope and ditch, bottom. (Points 46 to 47 Appendix A)

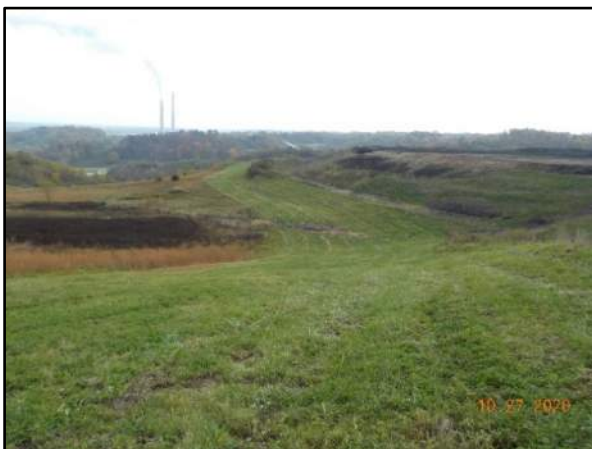
**Photo 9**

Overview of north side of active area showing vegetated slopes. (Points 49 to 56, Appendix A)

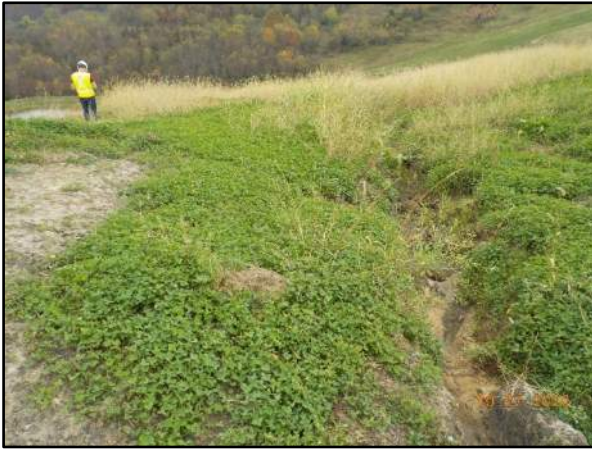
Photo 10

Vegetated erosion feature on north side temporary slope of active area. (Point 51, Appendix A)

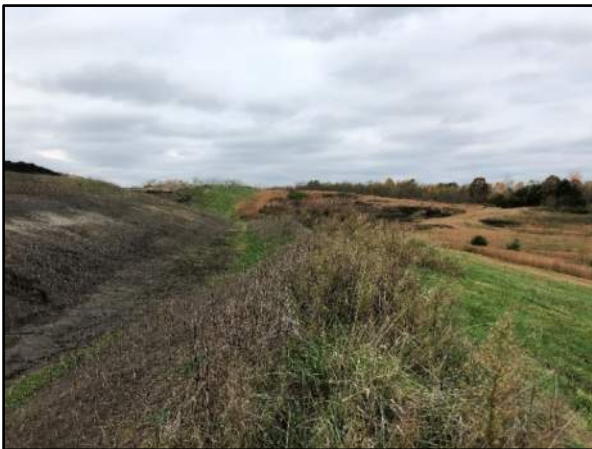
Photo 11

Edge of active area at top of north side temporary slope. (Point 74, Appendix A)

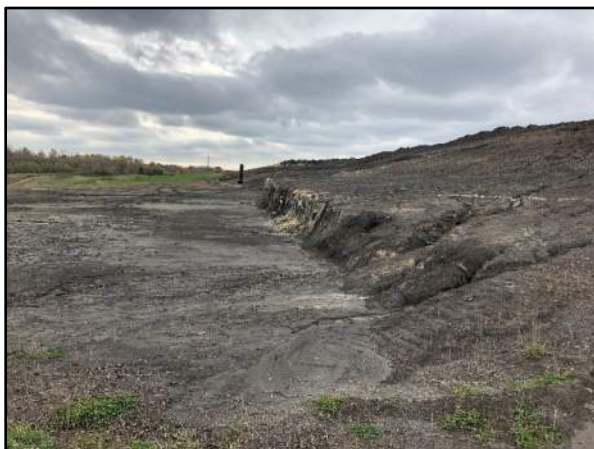
Photo 12

North face of active phase. (Point 74, Appendix A)

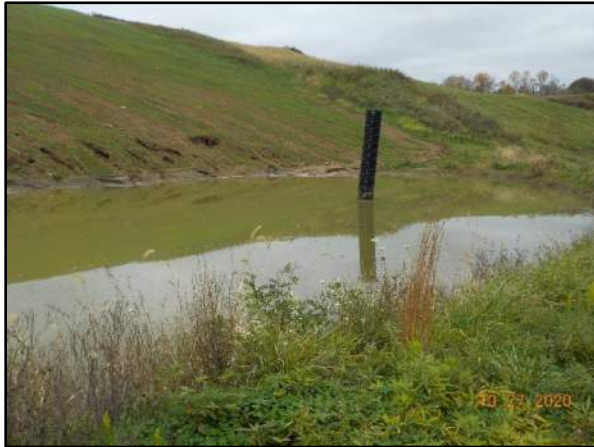
**Photo 13**

Slope above temporary sediment pond at base of east external temporary slope of active phase. (Point 77, Appendix A)

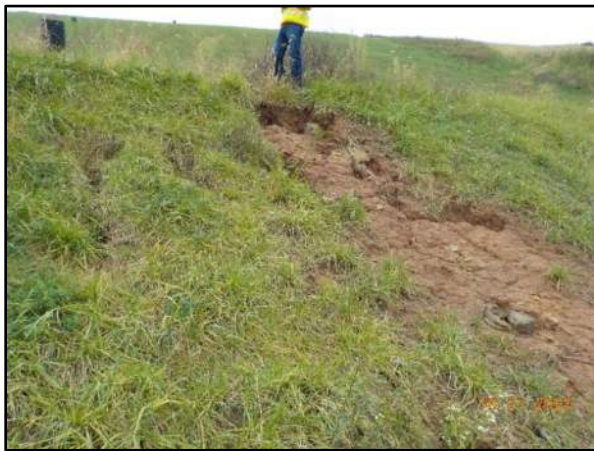
**Photo 14**

- Erosion, standing water, and vegetation were observed in the ditch from the Interim Leachate Collection Pond crossing the access road to the pond at the base of the east temporary slope of Phase 1. (Points 51, 58, and 77, Appendix A; Photos 10, 18, and 14, Appendix B)

- Erosion was observed at the crest and slope of the embankment of the temporary sediment pond located at the base of the east external temporary slope of the active phase. The erosion appears to have been the result of the pond water overtopping of the embankment. About 1 to 2 feet of freeboard to the standing pool was observed along the crest of the embankment. (Point 77, Appendix A; Photo 14, Appendix B)

Erosion of slope of embankment of temporary sediment pond at base of east external temporary slope of active phase likely caused by pond water level overtopping embankment (Point 77, Appendix A)

- Repair erosion on crest and slope of the temporary sediment pond embankment at the base of the east temporary slope of Phase 1. Check inlet structure for blockage and consider adding overflow spillway.

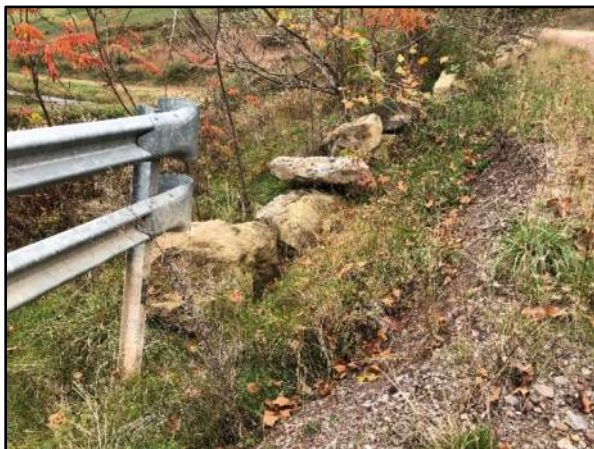
**Photo 15**

Erosion/scarp along south side of northern access road, bottom. (Point 75, Appendix A)

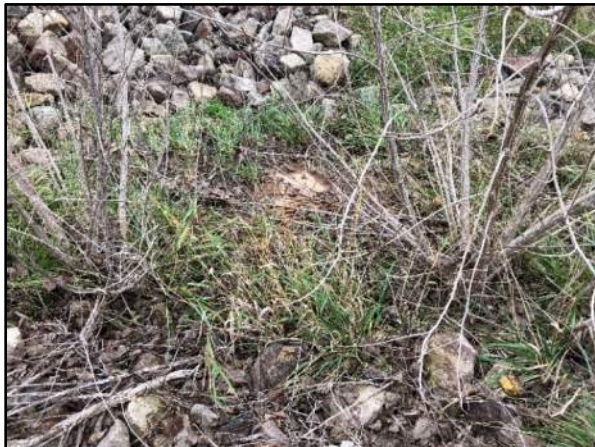
Photo 16

Vegetation-filled inlet of road culvert on north side of northern access road across from Point 57, (Appendix A), bottom.

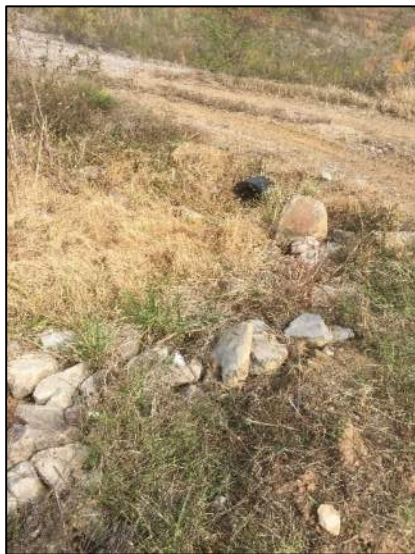
Photo 17

Erosion and standing water at access road to Interim Leachate Collection Pond. (Point 58, Appendix A)

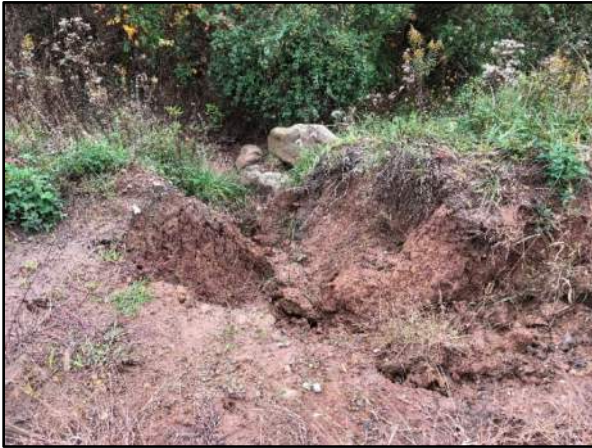
Photo 18

- Erosion gullies on the western and southern interior slopes of the Interim Leachate Collection Pond were observed. (Points 65, 59, and 76, Appendix A; Photos 18 and 21, Appendix B)

Erosion gully affecting access road to Interim Leachate Collection Pond. Road was wet in this area. (Point 59, Appendix A)

- Maintain the vegetation along the interior and exterior slopes of the Interim Leachate Collection Pond. Redress the interior gullies as needed and characterize the slough on the southern side. The scarp on the south side of the embankment of the Interim Leachate Collection Pond appears unchanged from 2019 to 2020. However, the formation of a scarp on the crest may mean the embankment is unstable. A program of exploration and stability analyses leading to stability improvement is recommended.

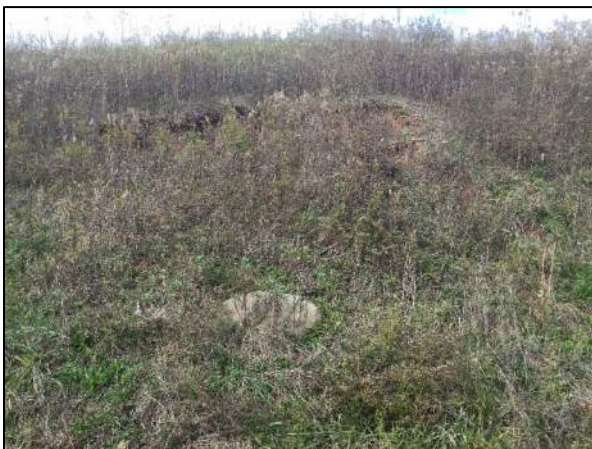
Photo 19

Scarp on Interim Leachate Collection Pond external slope of embankment (near Point 59, Appendix A)

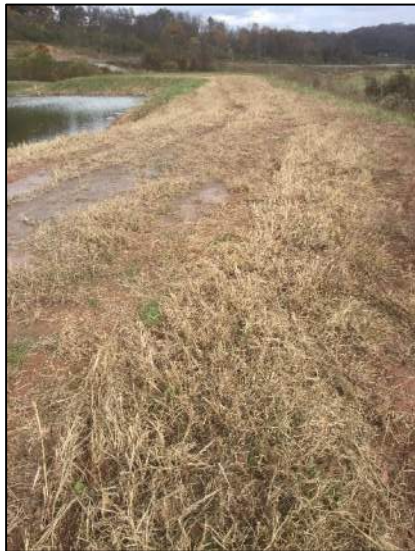
Photo 20

- A scarp along the crest of the Interim Leachate Collection Pond is still visible but appears unchanged from 2019. No standing water was observed. (Points 61 to 62, Appendix A; Photo 20, Appendix B)

Scarp along south side of Interim Leachate Collection Pond embankment. (Points 61 to 62, Appendix A)

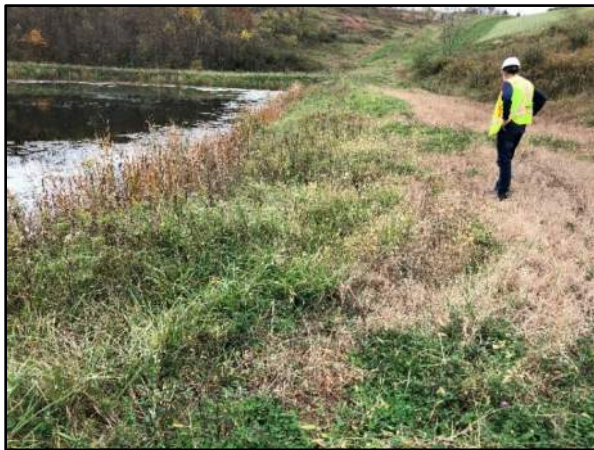
Photo 21

West side of Interim Leachate Collection Pond Embankment in area of erosion features and ground apparently saturated from seepage from cut slope to west not in photo. (Point 76, Appendix A)

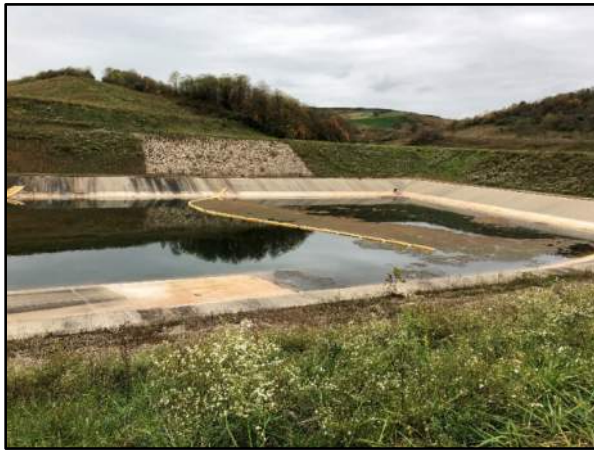
Photo 22

- Small areas void of vegetation were observed on the interior of the embankment (east side) at the Leachate Collection Pond. (Points 67 and 68, Appendix A; Photo 22, Appendix B)

Leachate Collection Pond showing little change in 2020, bottom. Slopes appeared well-vegetated and stable. (Points 67 to 68, Appendix A)

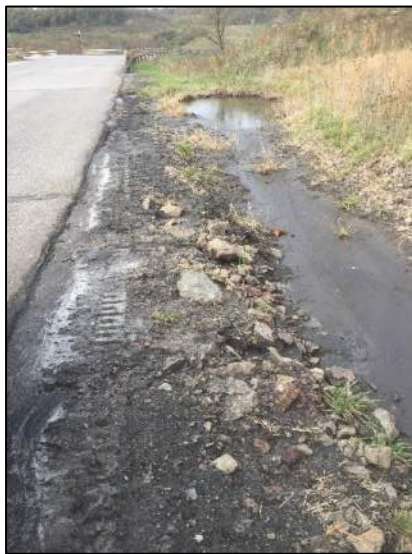
Photo 23

- Erosion and washout were observed in a ditch adjacent to the perimeter road to the stacker. (Near Point 72, Appendix A; Photos 23 and 24, Appendix B)
- The slip observed in 2019 forming along the perimeter road to the stacker has not developed further. (Point 72, Appendix A; Photo 24, Appendix B)
- A scarp that undermines the guardrail and boulder barrier on the downhill side of the north perimeter road and observed in 2019 has increased in size and effect on the guardrail and slope. (Points 57 and 75, Appendix A; Photo 15, Appendix B)
- A vegetation-filled inlet of a pipe culvert beneath the northern access road was still observed during the 2020 inspection. The larger vegetation appears dead but has not been removed. (Point 57, Appendix A)

Erosion/washout on uphill side of perimeter access road to stacker. (near Point 72, Appendix A)

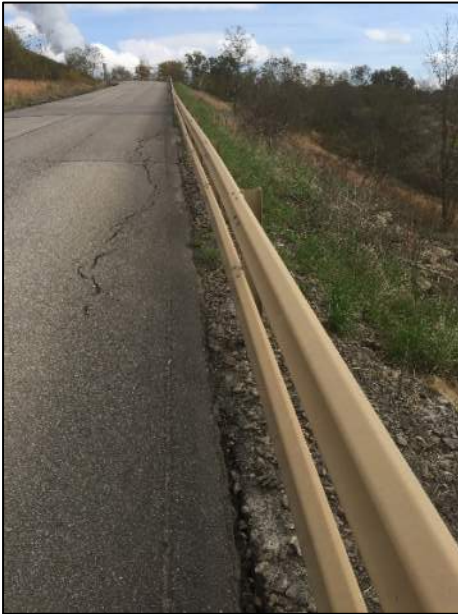
Photo 24

Slip forming on downhill side of perimeter access road to stacker. (Point 72, Appendix A)
