**Re: Ohio Valley Electric Corporation
Kyger Creek Station's 2021 Annual Landfill Inspection**

2021 CCR Rule Inspection
Kyger Creek Landfill

Kyger Creek Generating Station
Cheshire, Ohio
Gallia County

February 2, 2022

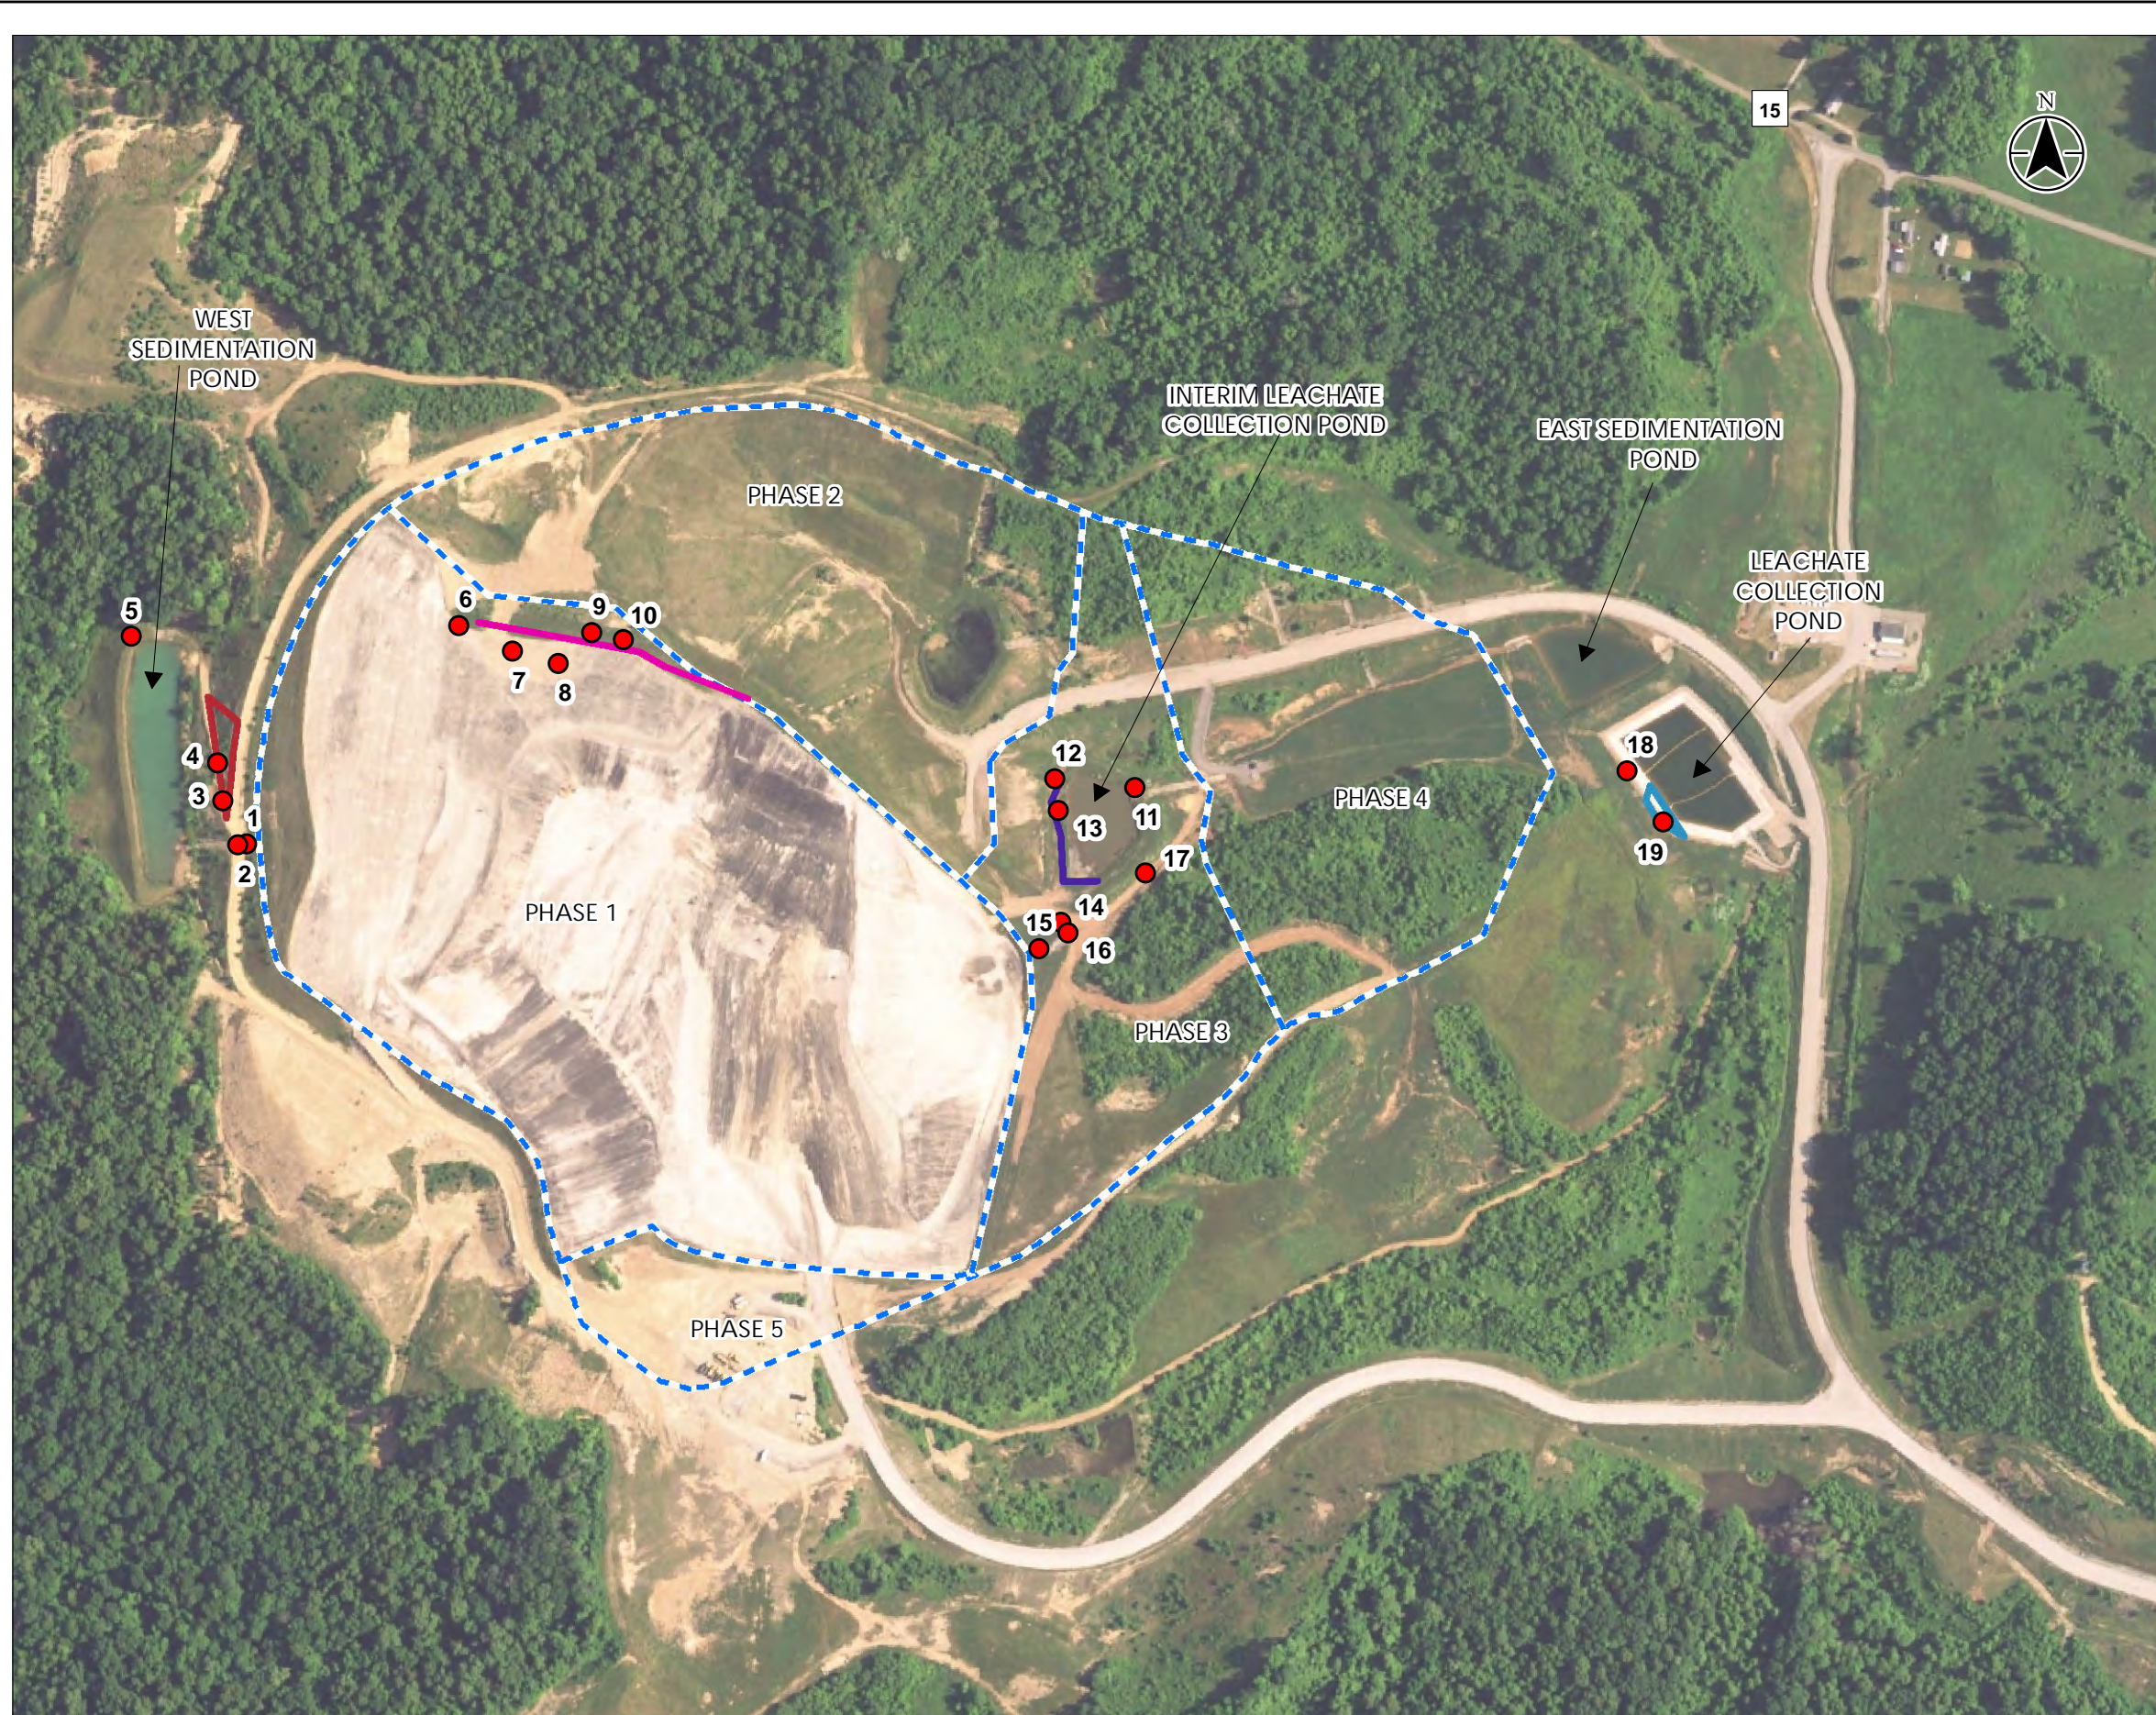
Figure No.: 1
 Title: 2021 Annual CCR Landfill Inspection

2021 Inspection Data Points				
ID No.	Year	Comment	Latitude	Longitude
1	2021	heavy woody veg at 5-pipe inlet	38.9250088785178	-82.1694436966968
2	2021	erosion gully - 40in W 28 in deep	38.9250083981773	-82.1695157095724
3	2021	west sediment pond - road failed	38.9252815100138	-82.1696296592562
4	2021	secondary scarp 3 ft in wsp road	38.9255175754487	-82.1696761401787
5	2021	bare spot bottom of principal spillway near riprap buttress	38.9263077760352	-82.1703560586692
6	2021	phase 2 north slope measurement top 3.5H:1V	38.9263694100255	-82.1677429280704
7	2021	phase 2 north slope measurement top 3.7H:1V	38.9262079475012	-82.1673152006252
8	2021	phase 2 north slope measurement top 3.5H:1V	38.9261317065214	-82.1669495225984
9	2021	ash edge - phase 2/ phase 1 berm	38.9263216019978	-82.1666774123023
10	2021	ash edge - phase 2/phase 1 berm	38.9262763157211	-82.1664257978632
11	2021	20 ft from outfall structure	38.9253441864176	-82.1623476933192

12	2021	wet area crest interim leachate pond NW corner	38.9253972608154	-82.1629885011508
13	2021	west edge interim leachate pond slope	38.9252030647292	-82.1629563141603
14	2021	toe phase 1 slope seepage	38.924506003053	-82.162941298336
15	2021	Overflow erosion SE phase 1 toe pond	38.9243383134561	-82.1631172643285
16	2021	seepage next to interim leachate pond south edge	38.9244403268719	-82.1628844835701
17	2021	slough - interim leachate pond	38.9248115888023	-82.1622623778511
18	2021	Leachate Pond - west crest wet	38.9254336073637	-82.1584178696759
19	2021	Leachate Pond - west crest wet	38.9251136317049	-82.1581254513507

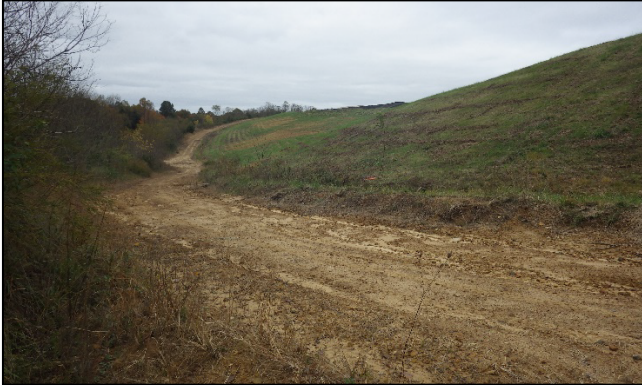
Photo 1

- The exterior temporary northern, western, and eastern slopes of Phase 1 are mowed sufficiently for a visual inspection, uniform, and vegetated. There are still several boulders and erosion features along with heavy vegetation in the ditches at the toe of the western exterior temporary slopes that may reduce the effectiveness of the ditches. The road is becoming more eroded. (Photos 1, 2, Appendix B)

Photo of perimeter road on west side of landfill near West Sedimentation Pond Road showing vegetated slopes and erosion of road, looking north.

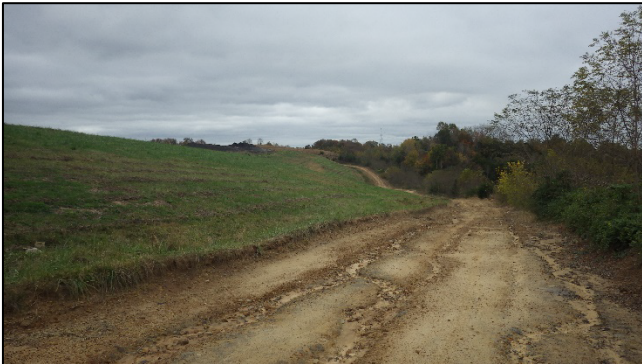
Photo 2

Photo of perimeter road on west side of landfill near West Sedimentation Pond Road showing vegetated slopes and erosion of road, looking south.

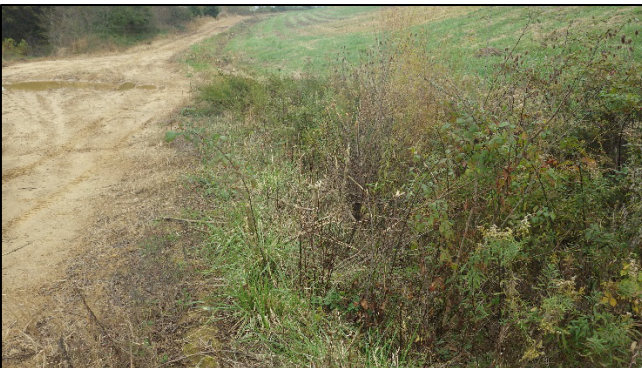
Photo 3

- Dense vegetation and small trees block the inlets of five pipe culverts that underlie the access road west of Phase 1. (Point 1, Appendix A; Photo 3, Appendix B)

Photo of perimeter road and ditch on west side of landfill near West Sedimentation Pond Road showing heavy vegetation in ditch, looking north.

- Remove the sediment and vegetation restricting flow through the five HDPE pipes flowing from the Phase 1 western slope to the West Sedimentation Pond. Repair and maintain the stormwater best management practices (BMPs) for the channels flowing to the pipes. Remediate the eroded area at the pipe outlets to protect the access road for Phase 1.
- Maintain the vegetation along the exterior slopes and within the surface drainage channels to facilitate inspections by removing taller weeds and trees as needed.
- Repair erosion gullies, re-establish grass vegetation, and monitor in future inspections.
- A cover grate is recommended for the overflow pipe at the Interim Leachate Collection Pond to minimize debris carried into the pipe.
- Small landslides beside the perimeter road should be monitored and regraded as necessary to maintain the integrity of the road.

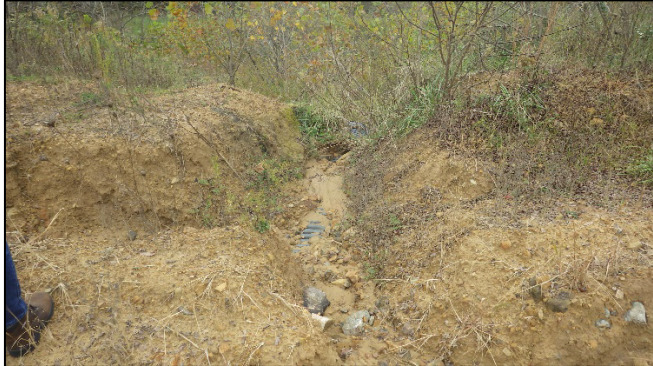
Photo 4

- The severe erosion feature affecting the access road west of Phase 1 has enlarged. This feature is affecting the outlet area of the 5-pipe culvert. The storm water runoff through the feature likely contributed to slope slippage at the top of the west pond access road. (Point 2, Appendix A; Photos 4 and 5, Appendix B)

Erosion feature at intersection of perimeter road and West Sedimentation Pond access road exposing pipes.

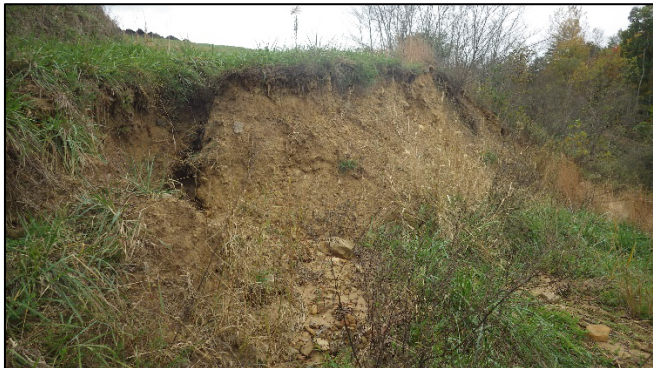
Photo 5

- The access road to the pond from the perimeter road continues to erode and is impassable to vehicles. (Photos 5 and 8, Appendix B)

Slippage of West Sedimentation Pond access road.

- The access road to the West Sedimentation Pond is impassable to vehicles. Repair road or establish alternative route to provide access for maintenance equipment.

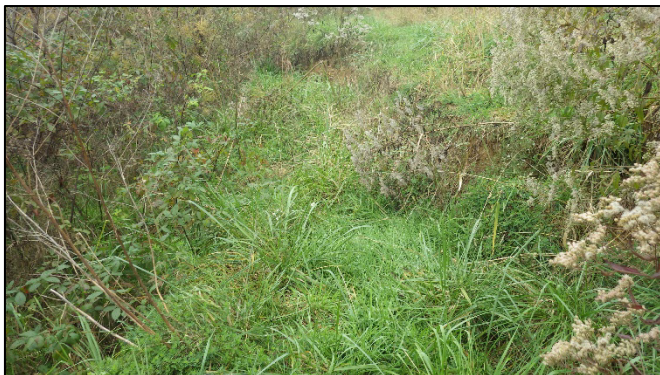
Photo 6

- The access road to the West Sedimentation Pond has been compromised by erosion and slope slippage and is overgrown with vegetation. (Point 3, Appendix A; Photo 6, Appendix B)

- A 3-foot deep scarp has developed in the access road to the West Sedimentation Pond. The road is heavily vegetated, eroded, and impassable. (Point 4, Appendix A; Photo 6, Appendix B)

Slippage of West Sediment Pond access road along with heavy vegetation.

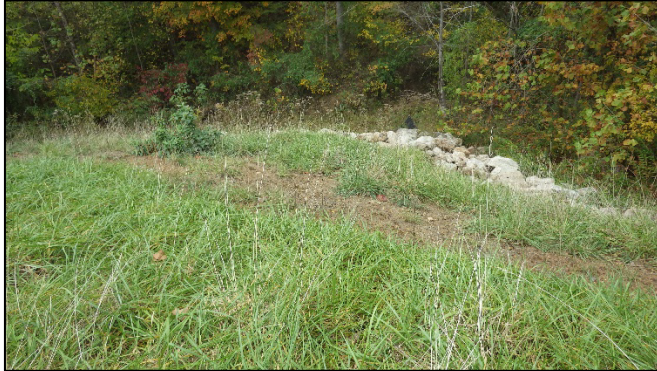
Photo 7

- A bare spot in the vegetation has developed below the principal spillway and above the riprap (Point 5, Appendix A; Photo 7, Appendix B)
- Access across the West Sedimentation Pond embankment is heavily vegetated and the pond is weed-choked. (Photo 8, Appendix B)

Bare spot below West Sedimentation Pond spillway.

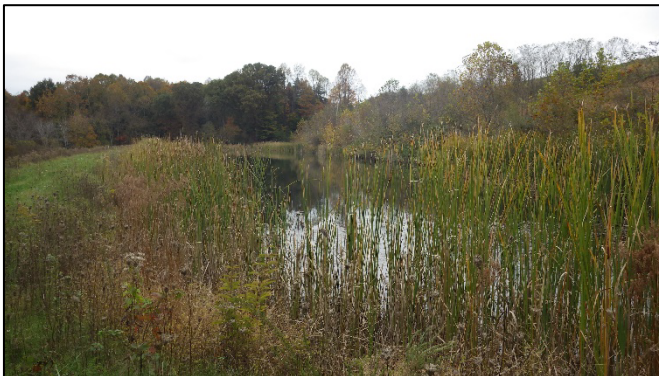
Photo 8

- Vegetation growth to a height of 12 to 48 inches was observed on the western exterior slope of the pond, somewhat obscuring visual observation. The pond is weed-choked around its perimeter. (Photo 8, Appendix B)

Access across the West Sedimentation Pond embankment is heavily vegetated and the pond is weed-choked.

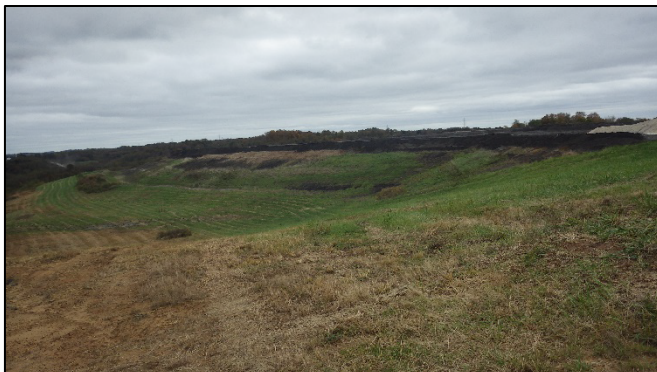
Photo 9

- The surface of the landfill northern slopes of Phase 1 are sufficient for a visual inspection, being uniform and vegetated. (Points 6, 7, and 8; Photo 9, Appendix B)

The surface of the Phase 1 landfill northern temporary slopes is sufficient for a visual inspection, being uniform and vegetated.

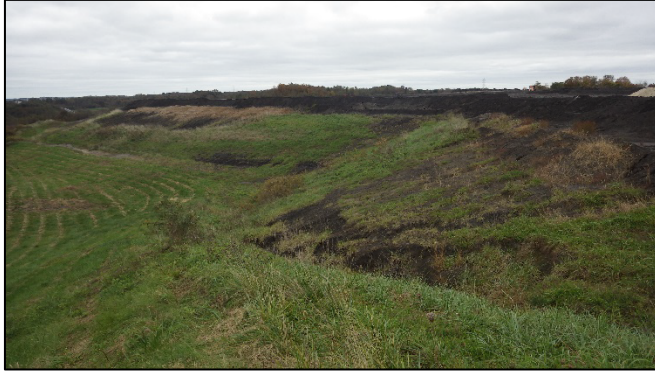
**Photo 10**

- The northern temporary slope of Phase 1 shows erosion rills near the toe. The zone is vegetated but not mowed. The slopes are approximately 3.5H:1V. The edge of ash is visible at the toe of the northern slope. (Points 6, 7, 8, Appendix A; Photo 10, Appendix B).
- Eastern temporary slope of Phase 1 is mowed sufficiently for visual inspection, being uniform and vegetated. (Photo 11, Appendix B)
- Temporary silt trap at toe of eastern temporary slope of Phase 1. (Points 14, 15, 16, Appendix A; Photos 12 and 13, Appendix B)
- Outslope showing erosion ditch from overflow of temporary silt trap at toe of eastern temporary slope of Phase 1. (Photo 14, Appendix B)
- Seepage on south side of Leachate Collection Pond at toe of slope. (Photo 15, Appendix B)

The northern temporary slope of Phase 1 shows erosion rills near the toe. The slopes are vegetated but not mowed. The slopes are approximately 3.5H:1V. The edge of ash is visible at the toe of the slope.

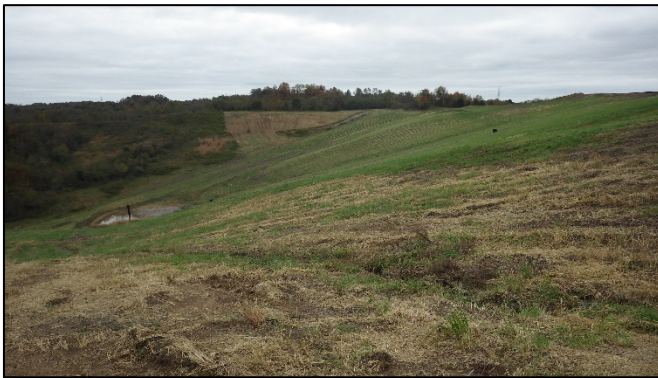
**Photo 11**

Eastern temporary slope of Phase 1 is mowed sufficiently for visual inspection, being uniform and vegetated.

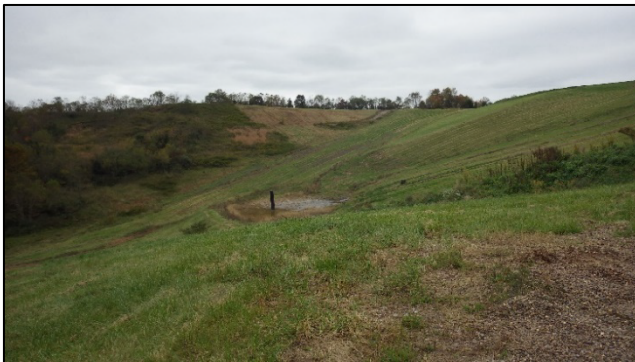
**Photo 12**

Temporary silt trap at toe of eastern temporary slope of Phase 1.

- Repair erosion on crest and slope of the temporary sediment pond embankment at the base of the east temporary slope of Phase 1. Check inlet structure for blockage and consider adding overflow spillway. Erosion has deepened the ditch carrying overflow from the pond towards the interim leachate collection pond.

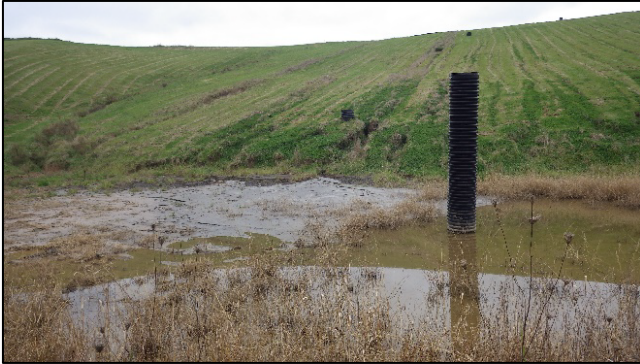
Photo 13

Condition of temporary silt trap at toe of Phase 1 temporary eastern slope of landfill.

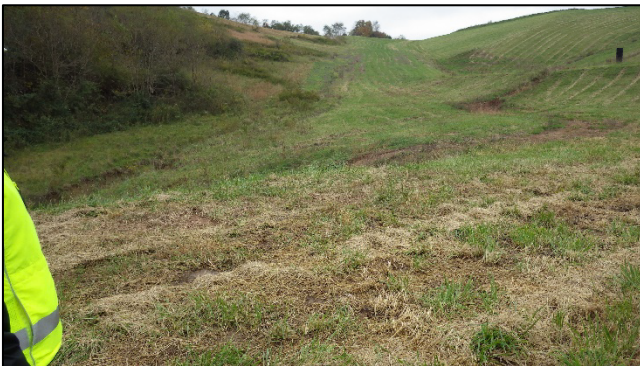
Photo 14

Eroded ditch conveying storm water overflow from silt trap at toe of Phase 1 temporary eastern slope of landfill.

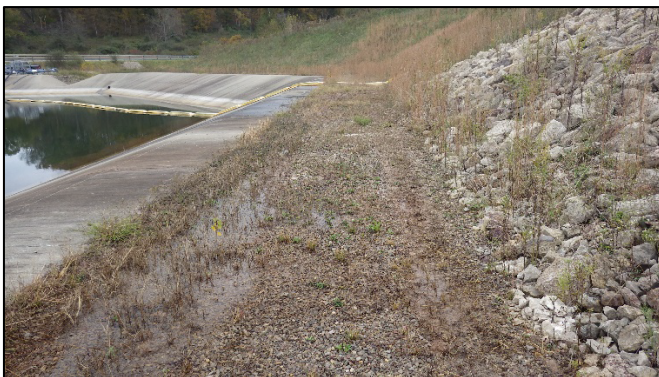
Photo 15

- The earthen slopes above the concrete slopes appear well vegetated and uniform on all sides of the interior of the embankment at the Leachate Collection Pond.
- Temporary pumps have been removed. Stationary pumps have been installed on the south end.
- Slope and berm on southwest side of leachate collection pond showing seepage below riprap (Points 18 and 19, Appendix A; Photo 15, Appendix B)

Seepage on south side of Leachate Collection Pond at toe of slope.

- Maintain the vegetation along the interior and exterior slopes of the Interim Leachate Collection Pond. Redress the interior gullies as needed and characterize the slough on the southern side. The scarp on the south side of the embankment of the Interim Leachate Collection Pond appears unchanged from 2020 to 2021 but appears better vegetated. However, the formation of a scarp on the crest may mean the embankment is unstable. A program of exploration and stability analyses leading to stability improvement is recommended.
