**Re: Ohio Valley Electric Corporation  
Kyger Creek Station's 2022 Annual Landfill Inspection**

**2022 CCR Rule Inspection  
Kyger Creek Landfill**

Kyger Creek Generating Station  
Cheshire, Ohio  
Gallia County

Stantec Consulting Services Inc.  
Cincinnati, Ohio

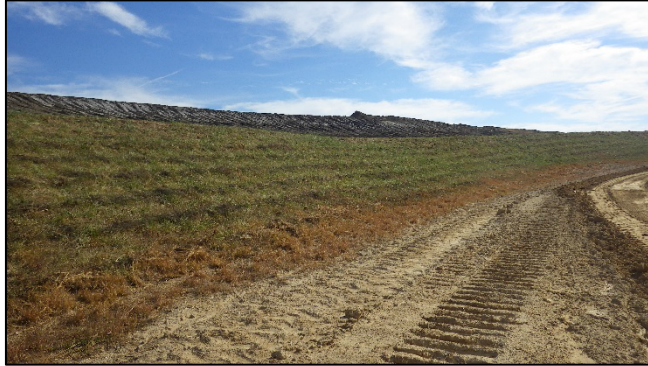
**Photo 1**

- Southern exterior temporary slope of Phase 1 is mowed, vegetated, and uniform. A stormwater ditch is located at toe of slope adjacent to the southern access road. CCRs above the temporary slope are uniform and compacted. Slopes in this area are estimated at 2.9 horizontal (H) to 1 vertical (V). (Photos 1-3, Appendix B)

Photo of southwest outer slope of Phase 1, looking southwest. Near the Phase 1/Phase 5 juncture on the southern access road.

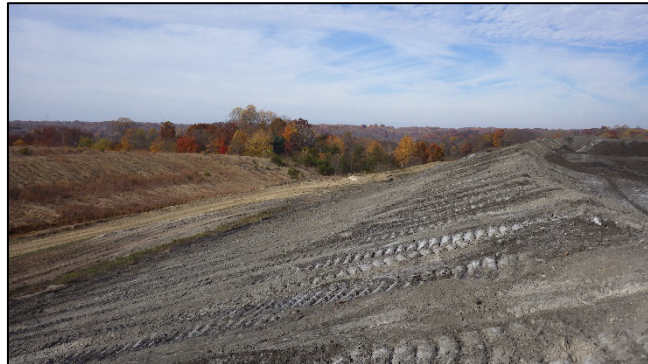
**Photo 2**

- Stormwater ditch maintenance is needed at the toe of slope between the exterior slope and the access road. Deeper erosion (20 inches deep) and a couple of large boulders present near Point 4. Three monitoring wells are located across the access road near Point 5. (Points 1 and 4, Appendix A; Photos 2 and 7, Appendix B)

Photo from top of CCRs on south side of Phase 1, looking west. Soil stockpile on far side of southern access road. (Point 1, Appendix A)

- Re-establishment stormwater channels as needed between the perimeter access road and the temporary slope of the active landfill.

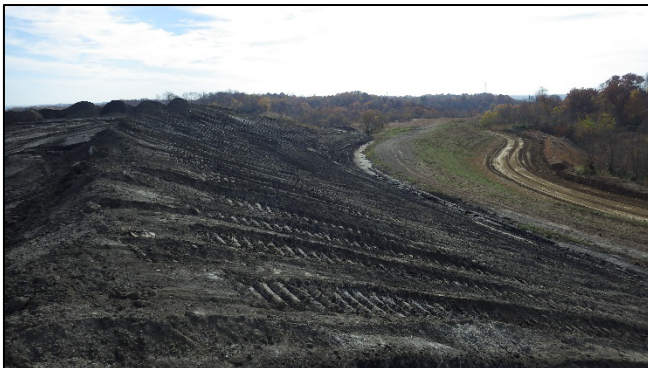
**Photo 3**

Photo from top of CCRs on southwest side of Phase 1, looking southeast. Southern access road on right side.

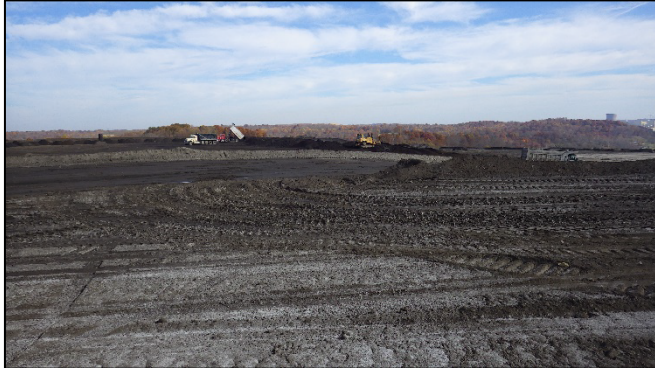
**Photo 4**

- Active CCR placement was occurring in the southeastern portion of Phase 1. Chimney drains are visible along the centerline of Phase 1. (Photos 4-5, Appendix B)

Active CCR placement within the southeastern portion of Phase 1, looking southeast.

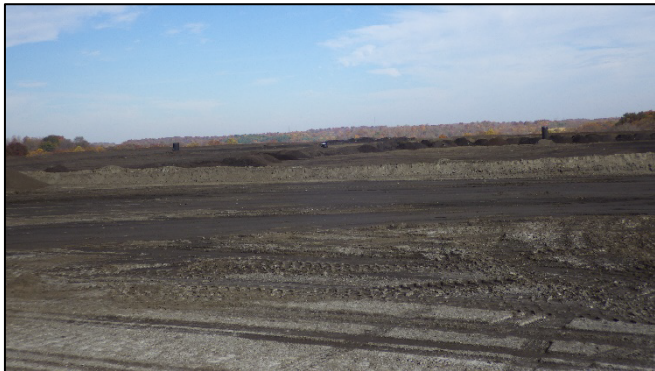
**Photo 5**

Chimney drains visible along the centerline of Phase 1, looking north.

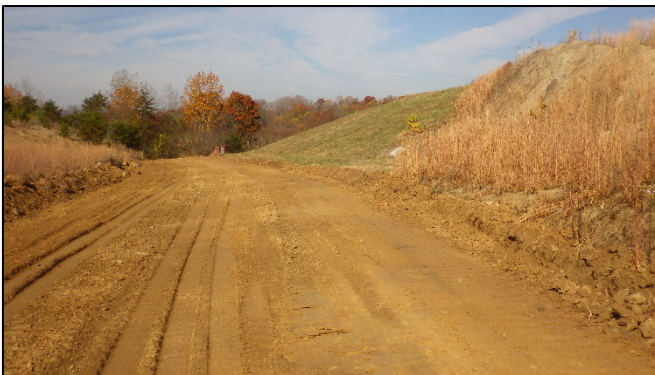
**Photo 6**

- Slopes along southwestern side of Phase 1 estimated as 2.6H:1V in the temporary cover area and 5.1H:1V within the CCR area. (Points 2-3, Appendix A; Photo 6, Appendix B)

Southwestern edge of Phase 1 near Points 2, 3, 4, and 5, looking west from southern access road. (Points 2-3, Appendix A)

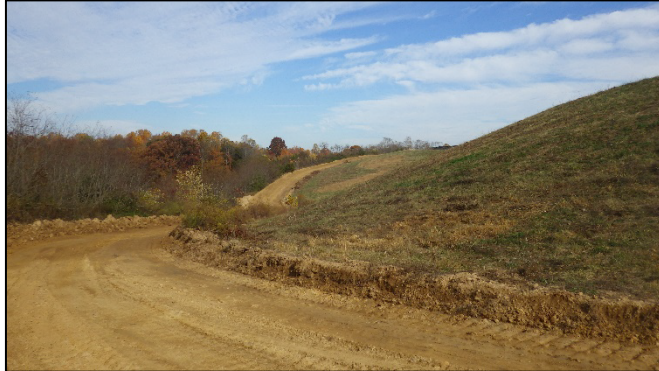
**Photo 7**

Stormwater ditch maintenance needed between exterior temporary slope and access road, looking northwest. (Point 4, Appendix A)

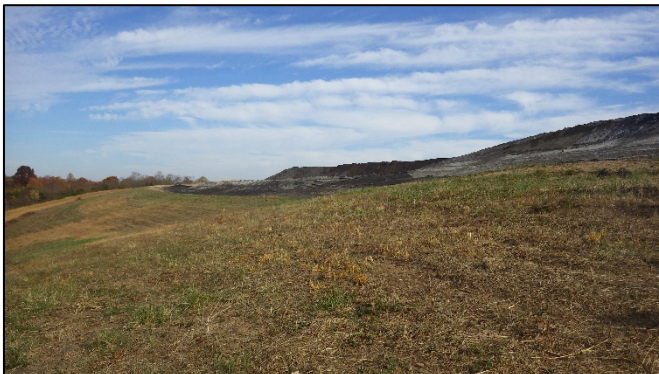
**Photo 8**

- Dormant vegetation and bare areas noted on the western exterior temporary slope. Points 9-11 and 14 show the length of the zone. (Appendix A; Photos 8-9, Appendix B)

Western exterior temporary slope and CCR within Phase 1, looking north. (Point 8, Appendix A) Note dormant vegetation and bare areas on the left side of photo. (Points 9-11 and 14, Appendix A)

- Maintain the vegetation along the exterior slopes and within the surface drainage channels to facilitate inspections by removing taller weeds and trees as needed.

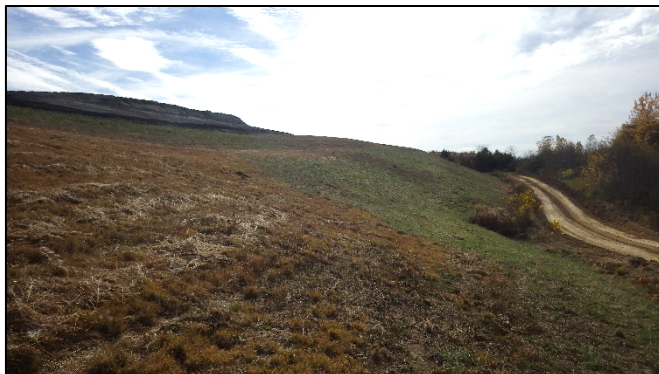
**Photo 9**

Western exterior temporary slope, looking south. Dormant vegetation and bare areas noted. (Points 9-11 and 14, Appendix A)

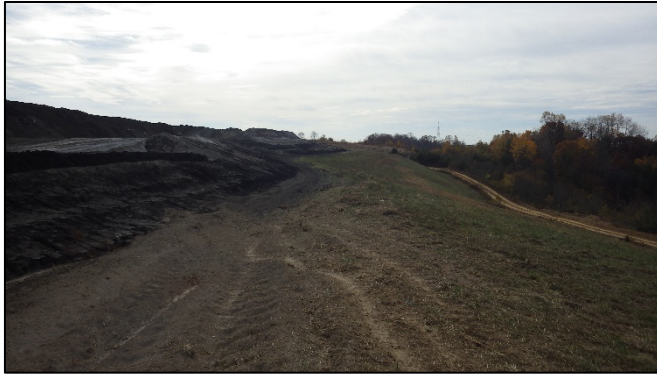
- Stormwater ditch maintenance is needed at the toe of the CCR slope near point 15. (Appendix A; Photo 10, Appendix B)
- Segregated CCR pile (potentially gypsum) at northern end of Phase 1 near access road. (Points 16-17, Appendix A; Photos 11-12, Appendix B)

**Photo 10**  
Stormwater ditch maintenance at toe of CCRs near Point 15, looking south.  
(Appendix A)

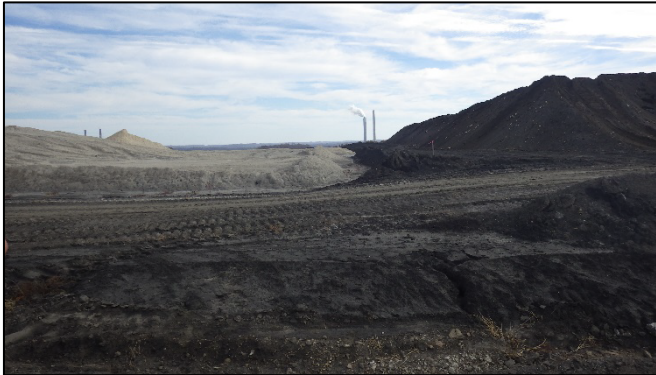
**Photo 11**  
Segregated materials near Point 16, looking east. (Appendix A)

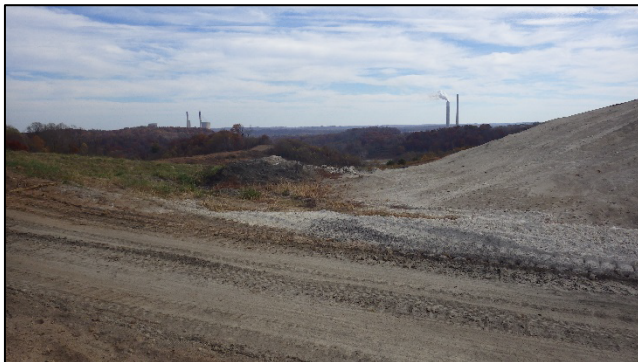
**Photo 12**  
End of segregated materials near Point 17, looking east. (Appendix A)

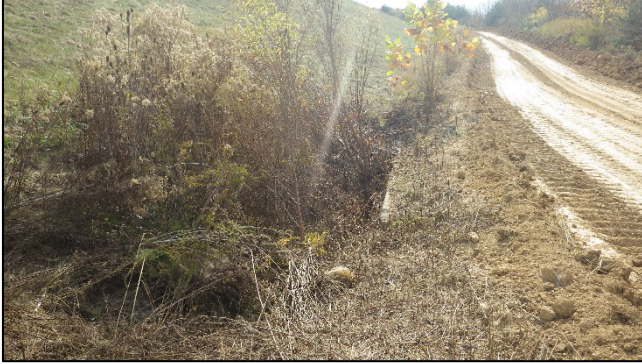
**Photo 13**

- Five plastic culverts connect the stormwater channel of the Phase 1 exterior temporary slope to the West Sedimentation Pond. Heavy woody vegetation at the upstream end inhibits inspection. Soil and debris limit the culvert capacity. Erosion gullies are present at the pipe outlets on the western side of the road. (Points 18-19, Appendix A; Photos 13-15, Appendix B)
- The eastern temporary slope of Phase 1 is mowed, uniform, and vegetated with a temporary silt trap at toe of slope. (Photo 23, Appendix B)
- A temporary silt trap is located at the toe of the eastern slope of Phase 1. (Photo 24, Appendix B)
- Erosion rills are noted above the temporary silt trap at the eastern Phase 1 slope toe. (Point 27, Appendix A; Photo 25, Appendix B)

Headwall at the upstream end of the culverts from Phase 1 to the West Sedimentation Pond, looking south. (Point 18, Appendix A)

- Remove the sediment and vegetation restricting flow through the five HDPE pipes flowing from the Phase 1 western slope to the West Sedimentation Pond. Repair and maintain the stormwater best management practices (BMPs) for the channels flowing to the pipes. Remediate the eroded area at the pipe outlets to protect the access road for Phase 1.

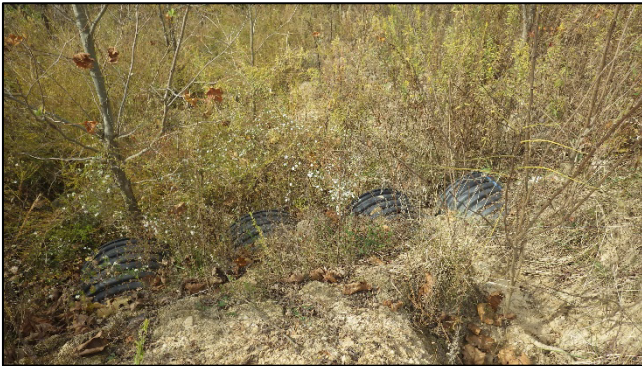
**Photo 14**

Pipe outlets of the culverts under the access road flowing to the West Sedimentation Pond, looking west. (Point 19, Appendix A)

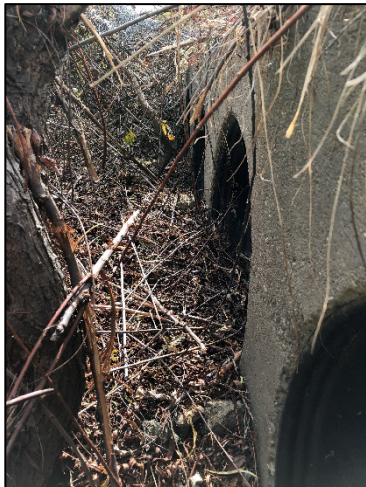
**Photo 15**

Soil and debris at headwall of culverts accessing the West Sedimentation Pond. (Point 18, Appendix A)

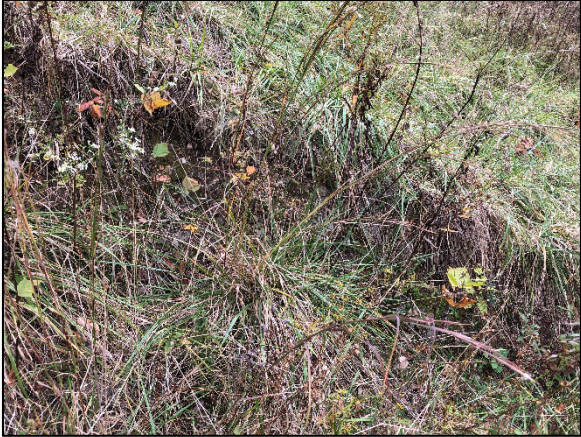
**Photo 16**

- Tall, dense vegetation limits inspection of the slopes of the West Sedimentation Pond.
- Small trees (3-10 inches trunk diameter) and a 7-inch diameter animal burrow are noted on the exterior slope of the pond at Points 20-22. (Appendix A)
- Points 23-26 note a 25-foot diameter slough with a 3-foot head scarp at the northwest exterior corner of the West Sedimentation Pond. Three boils (2 to 3 feet in diameter) were noted at the toe of slope. (Photos 16-18, Appendix A; Appendix B)
- The emergency spillway of the pond was moist, but no flowing water was visible.
- A new access road to the pond has been created at the southern edge near the monitoring wells noted at Point 5. The previous access road on the east side of the pond is impassable.

Head scarp of slough at northwest exterior corner of West Sedimentation Pond. (Points 25-28, Appendix A)

- Keep the vegetation around the West Sedimentation Pond mowed to understand the ongoing stability concerns in this area. This affects the access road around Phase 1 of the landfill and the northwestern exterior slope of the West Sedimentation Pond. Characterize and remediate the sloughs as needed.
- Repair erosion above and on the crest and slope of the temporary silt trap at the eastern Phase 1 toe. Check inlet structure for blockage and consider adding overflow spillway.

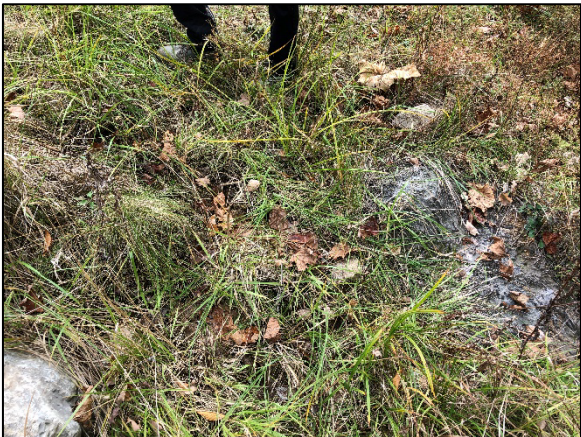
**Photo 17**

Boil at toe of exterior slope of northwest corner of West Sedimentation Pond. (Points 25-28, Appendix A)

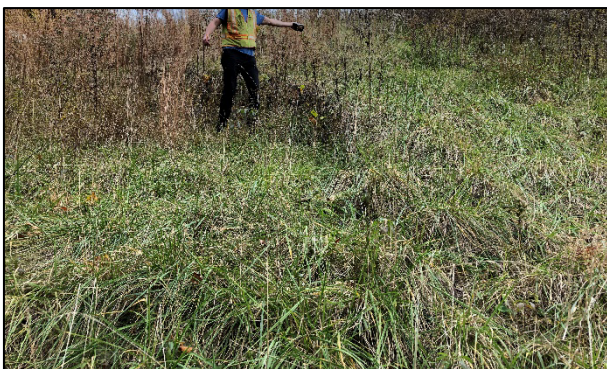
**Photo 18**

Head scarp of slough at northwest exterior corner of West Sedimentation Pond. (Points 25-28, Appendix A)

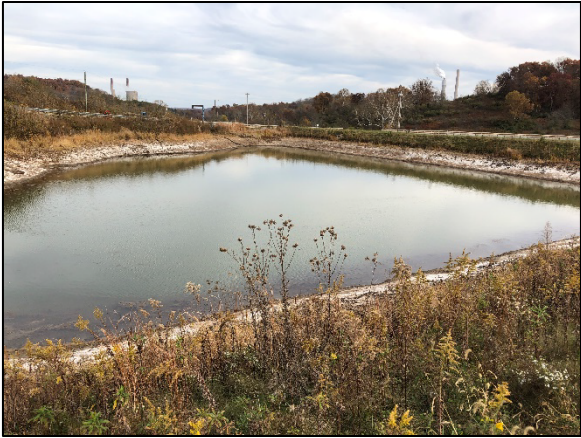
**Photo 19**

- The pool of the East Sedimentation Pond was low during the site visit.
- As observed in previous reports, several erosion gullies are located along the northwest slope of the pond connecting the East Sedimentation Pond to the paved haul road.
- Interior slopes of the pond appear stable.

The pool elevation was lowered at the East Sedimentation Pond during the site visit, looking northeast.

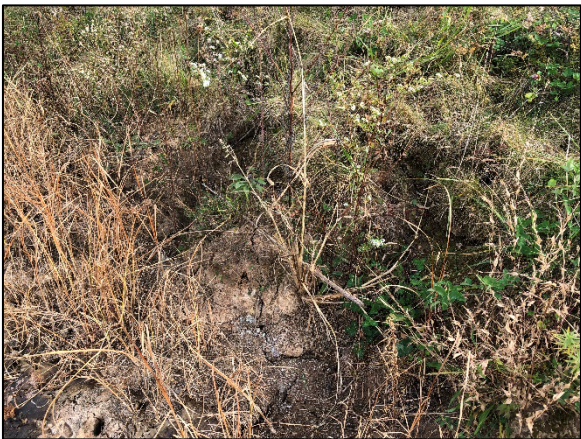
**Photo 20**

- Berm between East Sedimentation Pond and Leachate Collection Pond is well-vegetated and appears stable.
- Bank erosion was noted at Point 30 on the interior southeaster slope shared with the Leachate Collection Pond. (Appendix A; Photo 20, Appendix B)
- The Interim Leachate Collection Pond is located east of Phase 1. The crest was mowed, but the slopes are heavily vegetated. Cracks and small burrows were noted in the embankment. (Point 28, Appendix A; Photo 26, Appendix B)
- The access road and stormwater channel east of Phase 1 and south of the Interim Leachate Collection Pond is heavily vegetated. Erosion gullies were visible in this area. (Points 31-32, Appendix A; Photos 27-28, Appendix B)

Bank erosion on interior southeastern slope of East Sedimentation Pond. (Point 30, Appendix A)

- Repair erosion gullies, re-establish grass vegetation, and monitor in future inspections.
- Inspection points were within the limits of waste noted on the reference drawings (Appendix C). However, additional measures are needed to limit infringement of waste beyond the lined footprint.

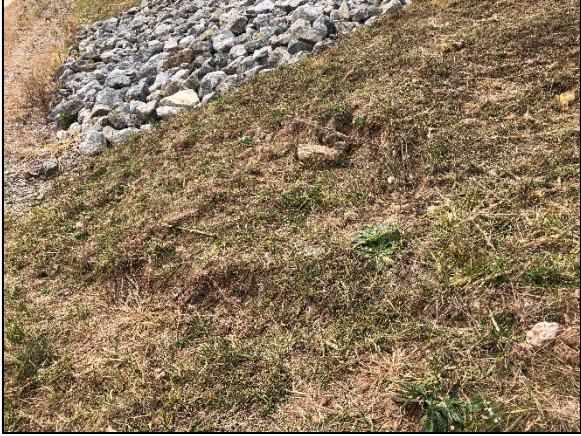
**Photo 22**

- The earthen slopes above the concrete slopes appear well vegetated and uniform on all sides of the interior of the embankment at the Leachate Collection Pond.
- Stationary pumps are present at the south end and pump through the eastern culvert.
- Seepage was not noted around the southwestern riprap zone during this site visit.
- A small slough was noted in the north corner. (Point 29, Appendix A; Photo 22, Appendix B)

Small slough in north corner of the Leachate Collection Pond. (Point 29, Appendix A)

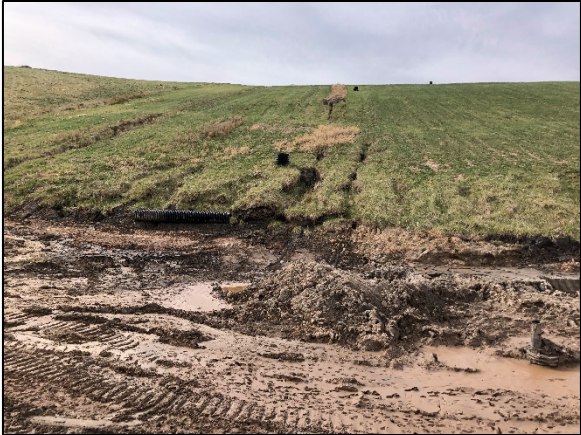
**Photo 25**

Erosion rills above temporary silt trap at toe of eastern Phase 1 slope. (Point 27, Appendix A)

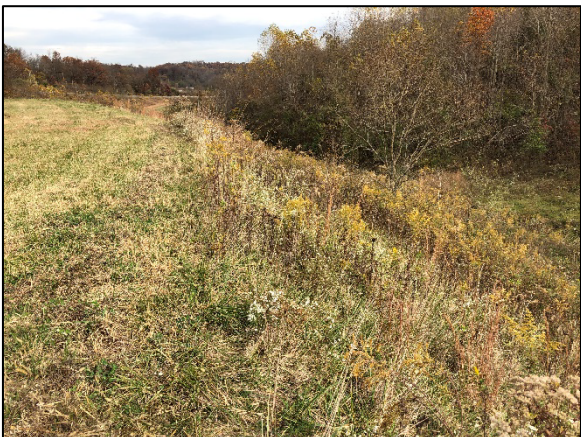
**Photo 27**

Access road and stormwater erosion east of the Phase 1 landfill, looking east. Interim Leachate Collection Pond on the left. (Points 31-32, Appendix A)

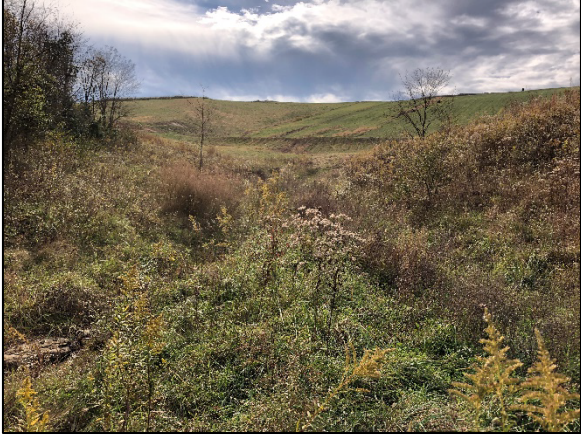
**Photo 28**

Access road and stormwater erosion east of the Phase 1 landfill, looking west. Interim Leachate Collection Pond on the right. (Points 31-32, Appendix A)
