**2024 CCR Rule - Landfill
Kyger Creek Landfill Inspection**

Kyger Creek Generating Station
Cheshire, Ohio
Gallia County

January 19, 2025

Stantec Consulting Services Inc.
Cincinnati, Ohio

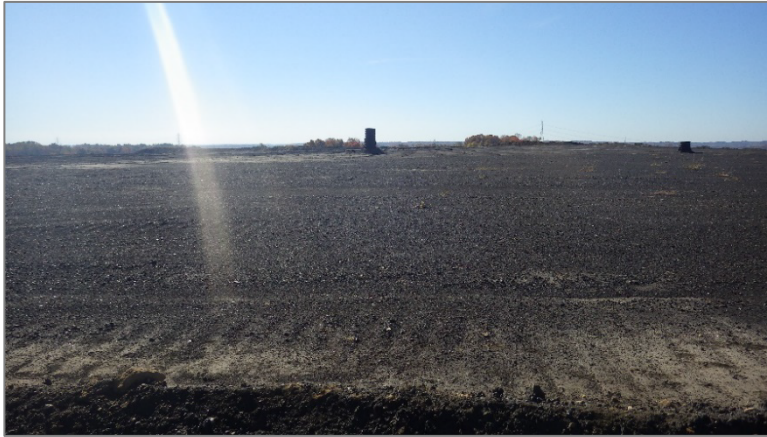
Photo 1
Phase 1 – Surface and chimney drains.

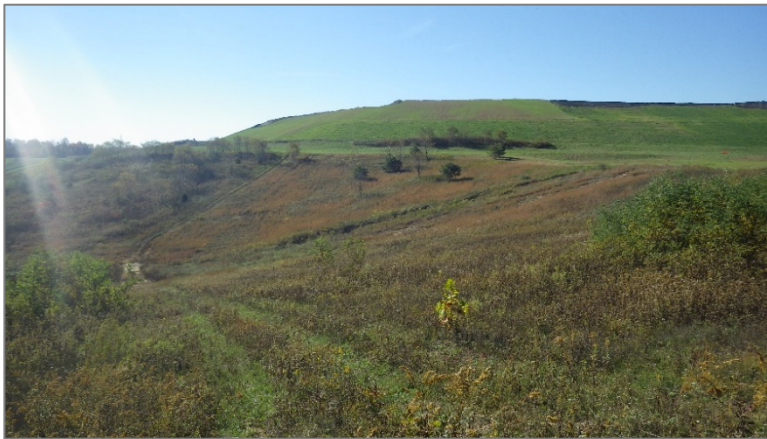
Phases 2, 3, 4, and 5 have yet to be constructed. Phase 2 has been used as a borrow area and is vegetated and inactive (Photo 2, Appendix B). A stockpile is located on the northern side of Phase 2. It is graded and hydroseeded.

Photo 2
Phase 2 – Historic soil borrow area.

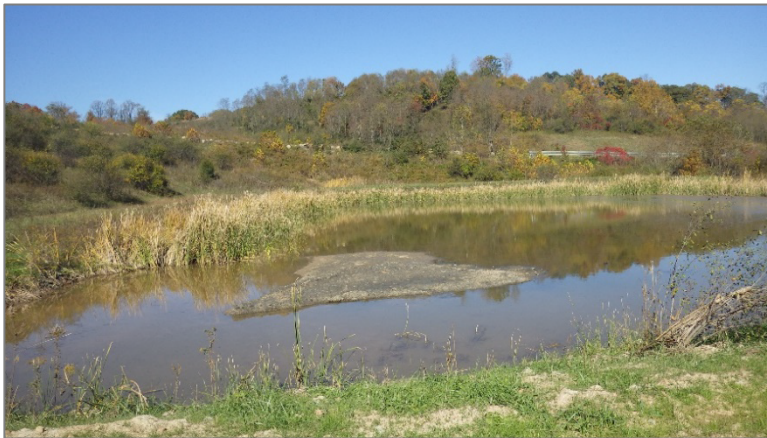
The Interim Leachate Collection Pond (ILCP) is in the Phase 3 footprint (Photo 3, Appendix B). Phase 4's footprint includes the capped Sediment Pond #1. The contractor trailer and laydown yard are in the Phase 5 footprint. See Appendix C for the landfill's general phasing plan.

Photo 3
Interim Leachate Collection Pond

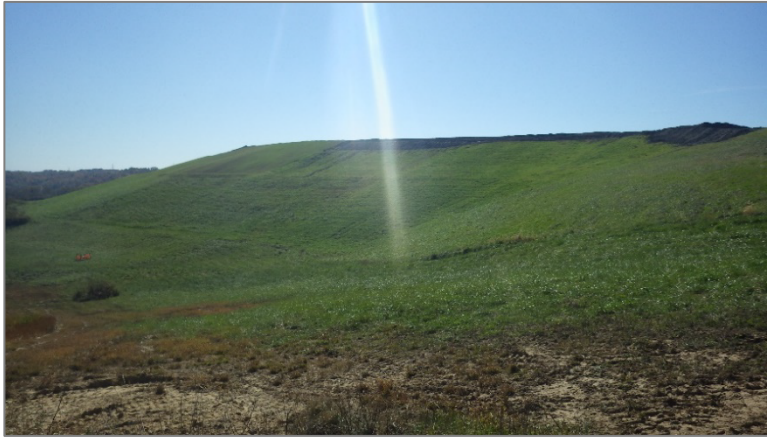
- The northeast outer temporary slope is mowed, vegetated, and uniform. Slopes in this area are estimated at 2.8H:1V (horizontal to vertical) (Points 6, 9, and 10, Appendix A; Photo 4 Appendix B).

Photo 4, Point 6
Phase 1 – Northeast temporary
slope, looking southeast.

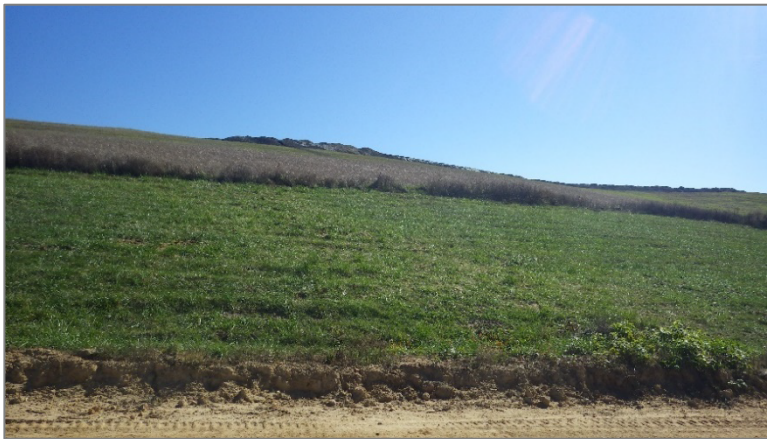
- The south and southwest outer temporary slopes are mowed, vegetated, and uniform. Slopes in these areas are estimated to be 2.8H to 3H:1V (Photos 5 and 6, Appendix B).

Photo 5
Phase 1 – South temporary
slope, typical.

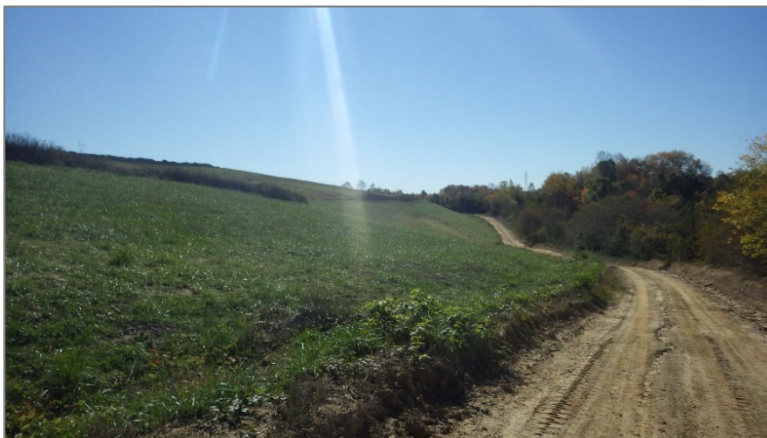
Photo 6
Phase 1 – Southwest
temporary slope, typical.

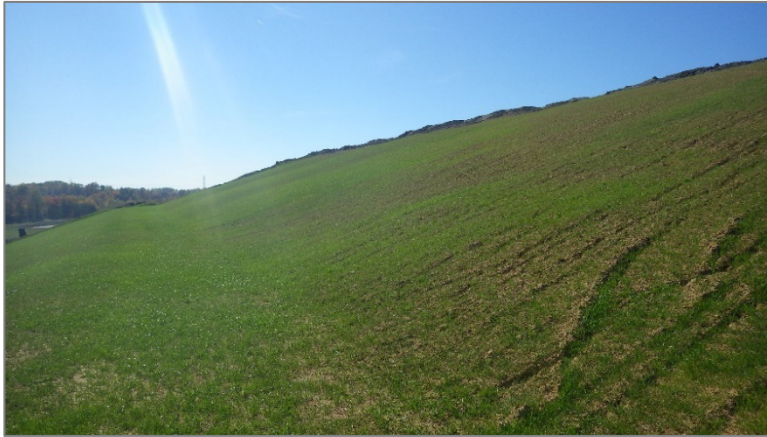
- The east outer temporary slope has been hydroseeded and is uniform. Shallow erosion gulleys are present throughout the slope (Photos 7, 8, and 9; Appendix B).

Photo 7
Phase 1 – East outer temporary slope hydroseed cover, typical.

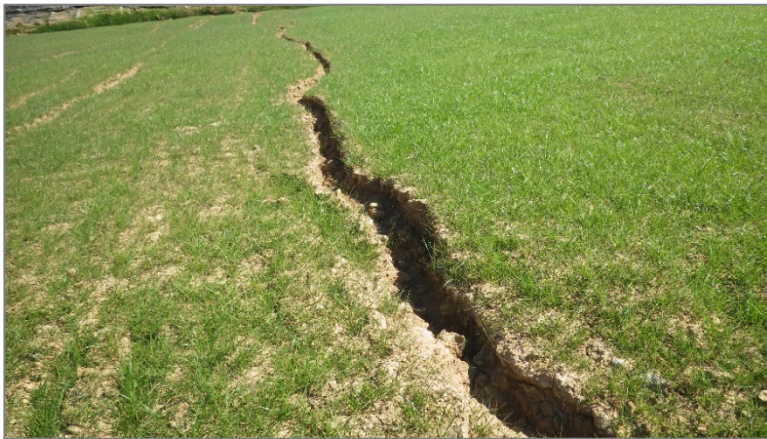
Photo 8
Phase 1 – East outer temporary slope, erosion gully in recently hydroseeded area.

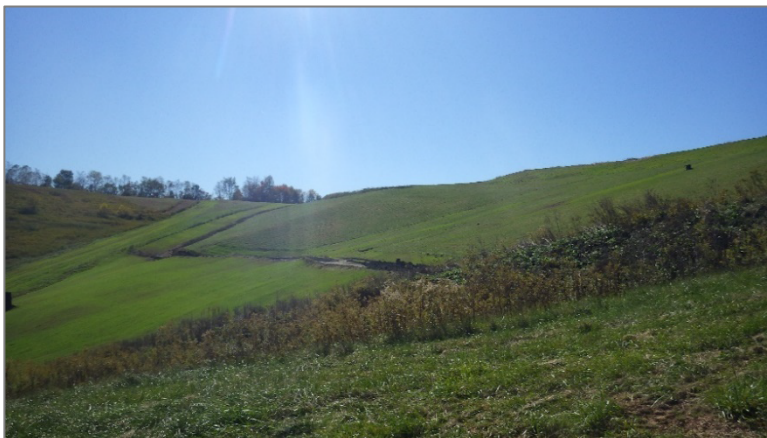
Photo 9
Phase 1 – East outer temporary slope.

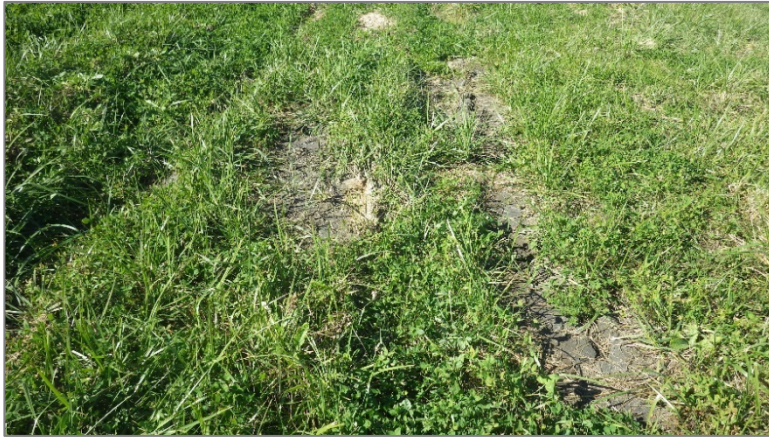
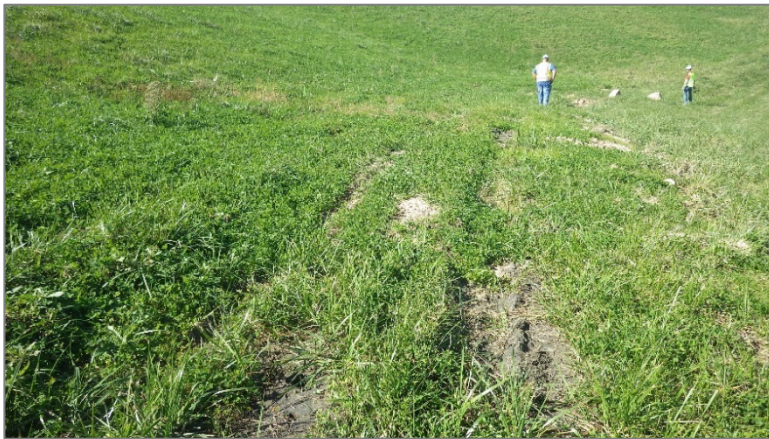
- Exposed earth and visible CCR at the ground surface were observed on the northeast slope at the Phase 1/Phase 2 interface (Point 5, Appendix A; Photos 10 and 11, Appendix B). It appears the cause is not from erosion but due to equipment rutting.

Photo 10, Point 5
Phase 1 northeast slope at the
Phase 2 interface, exposed ash
due to equipment rutting.

Photo 11, Point 5
Phase 1 northeast slope at the
Phase 2 interface, exposed ash
due to equipment rutting.

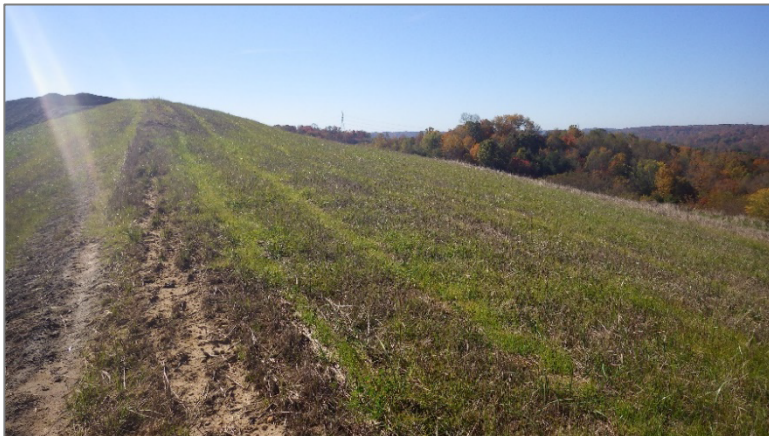
- Rutting was noted on the crest of the northeast slope of the landfill (Point 7, Appendix A; Photo 12, Appendix B). The depth of the rutting is surficial and has not caused erosion of the crest or slope.

Photo 12, Point 7
Phase 1 northeast slope,
surficial rutting along the crest.

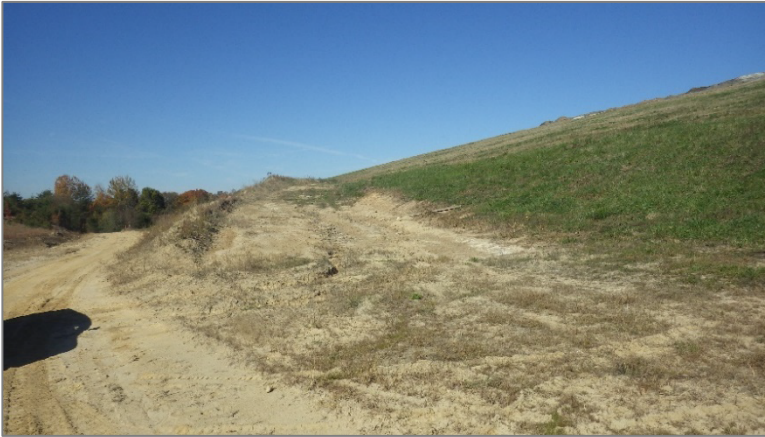
Photo 13

- Sparse vegetation cover was observed on the west slope near the West Sedimentation Pond upslope of the access road. Erosion and/or rutting is not present within this bare area (Photo 13, Appendix B).

Phase 1 west slope at the West Sedimentation Pond, sparse vegetation cover with no rutting or erosion.

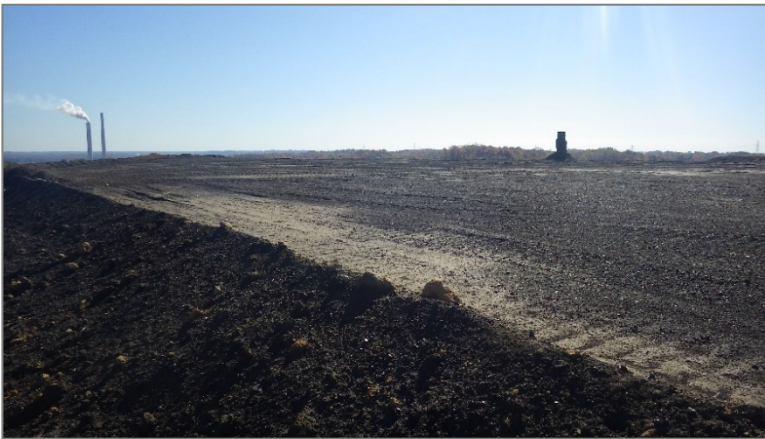
Photo 14, Point 8

- Active placement of CCR was not occurring on the day of the inspection, but the stockpile was observed from the northeast and east rims of active placement. CCR placement is in progress and thus there is no vegetation cover and grading in the active areas (Point 8, Appendix A; Photos 14 and 15, Appendix B).

Phase 1 surface conditions on northeast side, looking east.

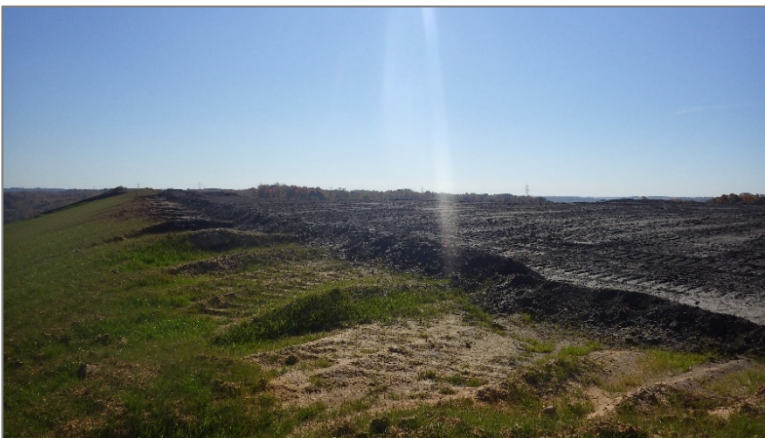
Photo 15, Point 8

Phase 1 surface conditions on the northeast side at the edge of placement, looking south.

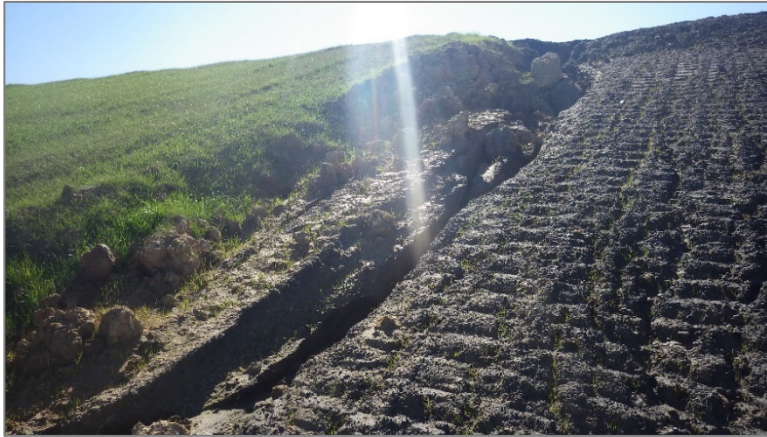
Photo 16

- CCR placement at the east side is in progress. The stockpile did not have a uniform slope and erosion gulleys were observed at the interface of the hydroseed and ash surfaces (Photo 16, Appendix B).

Phase 1 east slope edge of placement. An erosion gully is present at the interface of the new hydroseed placement.

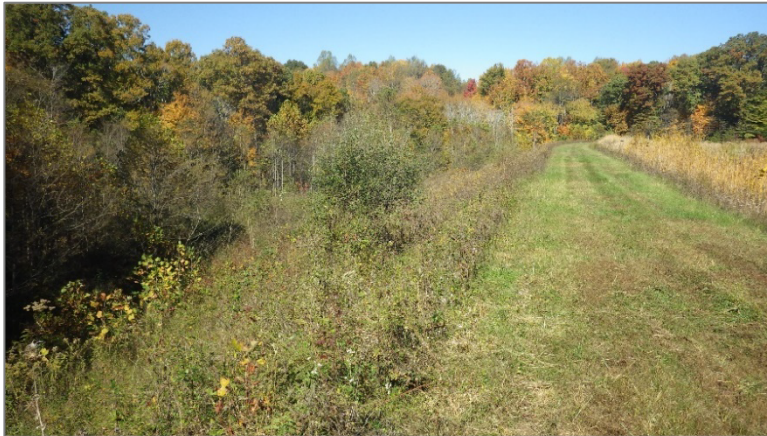
Photo 17

- Tall, dense vegetation with saplings along the south and west slopes prohibited a thorough inspection of those slopes (Photos 17 and 18, Appendix B).
- Two holes, possible animal burrows, approximately 6 inches diameter were observed on the crest of the west embankment (Photos 19 and 20, Appendix B).
- Multiple trees have taken root on the west slope with trunks varying in diameter of 4 to 6 inches (Points 11, 12, 13, and 14, Appendix A; Photos 18, 21, and 22; Appendix B).
- Dense vegetation and sediment accumulation at the inlet of the headwall prohibits the flow of stormwater from the west side of Phase 1 to the south side of the West Sedimentation Pond (Photos 23 and 24; Appendix B).

West Sedimentation Pond – dense vegetation and saplings along west and south slopes.

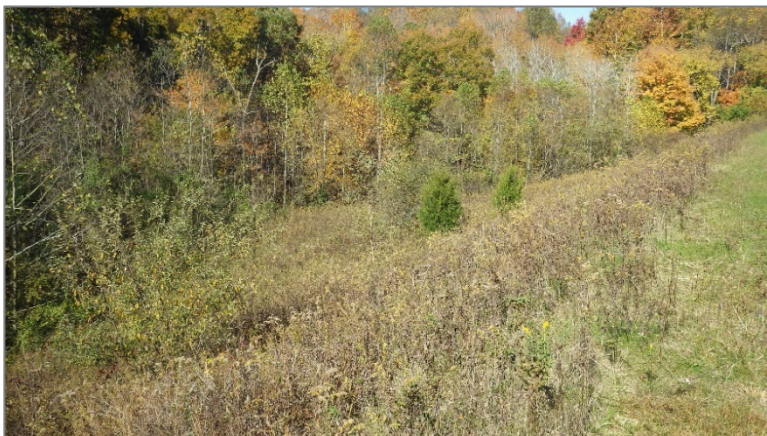
Photo 18, Points 11, 12, 13, and 14

West Sedimentation Pond– dense vegetation and saplings along west and south slopes.

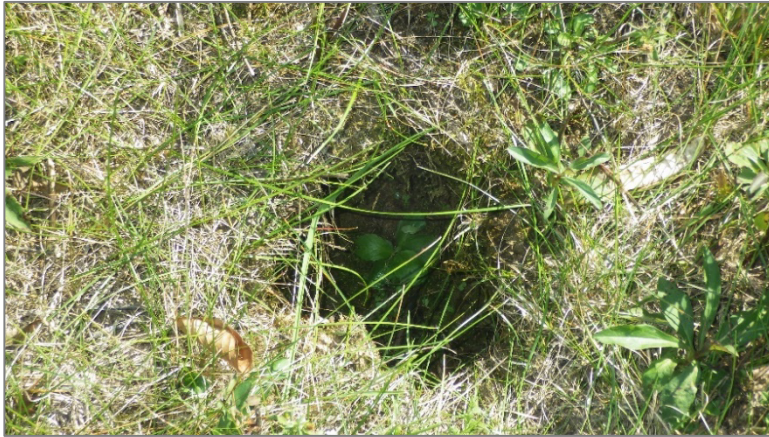
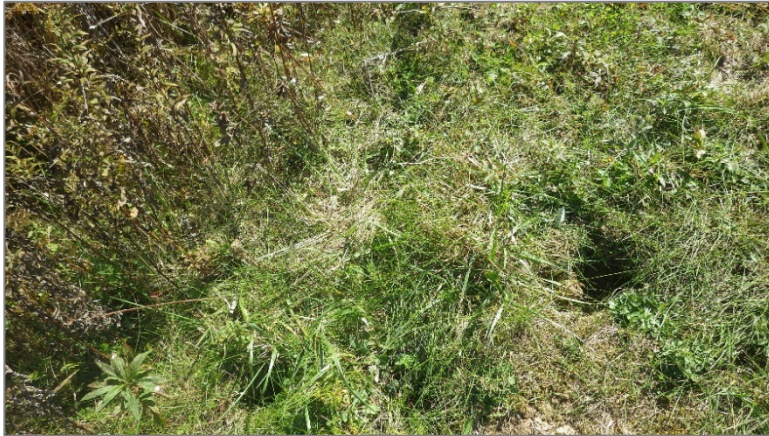
Photo 19
West Sedimentation Pond –
Possible animal burrow in the
crest of the west embankment.

Photo 20
West Sedimentation Pond –
Possible animal burrow in the
crest of the west embankment.

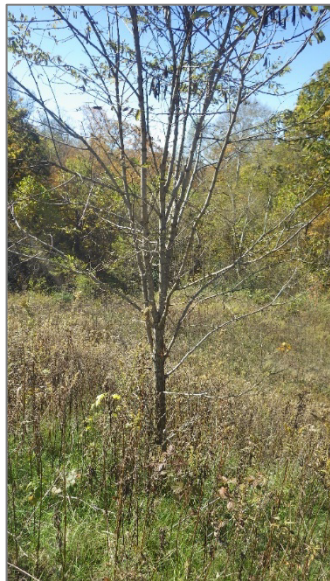
**Photo 21, Points 11, 12, 13,
and 14**
West Sedimentation Pond –
Approximately 6-inch
diameter tree growing in west
exterior slope.

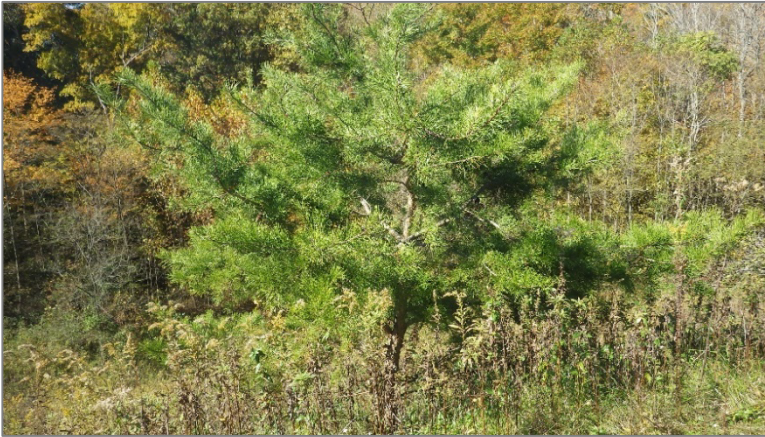
**Photo 22, Points 11, 12, 13,
and 14**
West Sedimentation Pond –
Approximately 5-inch
diameter tree growing in west
exterior slope.

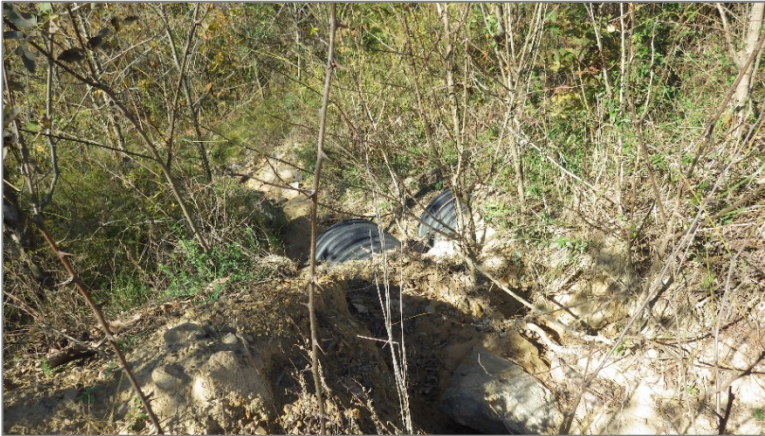
Photo 23
Phase 1 – West Slope at West
Sedimentation Pond –
Vegetation growth and
sediment buildup at outlet of
drain structure.

- Backfill and protect the stormwater culvert outlets near the West Sedimentation Pond to protect the access road for Phase 1. Clear vegetation near the culvert headwall to maintain flow into the culverts.
- Regrade and repair erosion gullies as noted.
- Backfill the documented animal burrows with compacted native soils or a mud-pack of soil and cement, ensuring all voids are filled and the entrance(s) are properly sealed.

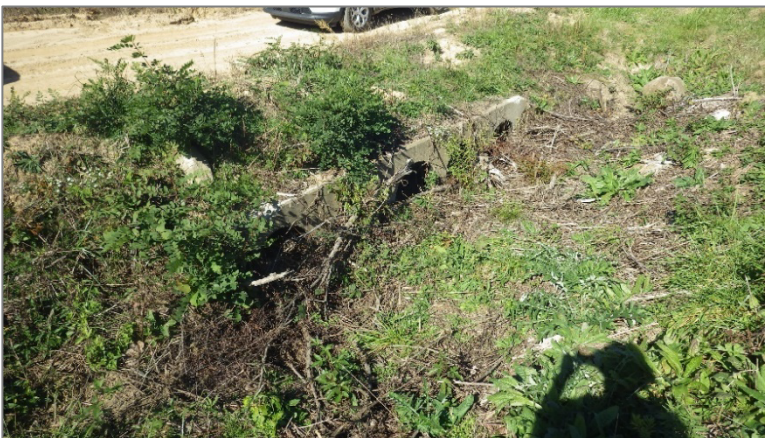
Photo 24
Phase 1 – West Slope at West
Sedimentation Pond –
Vegetation growth and
sediment buildup at inlet of
drain structure.

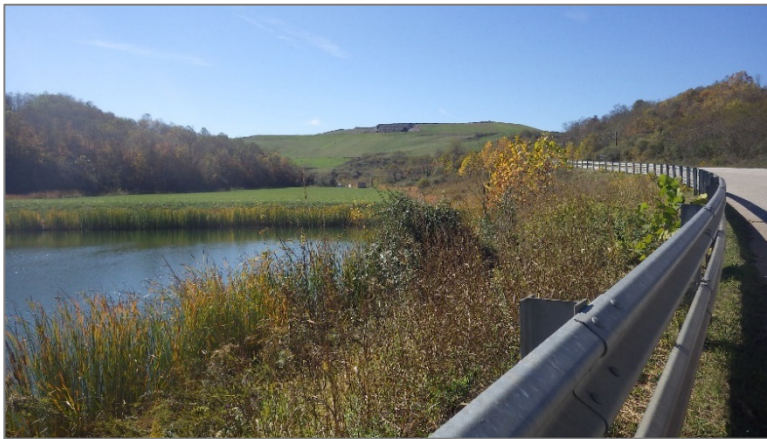
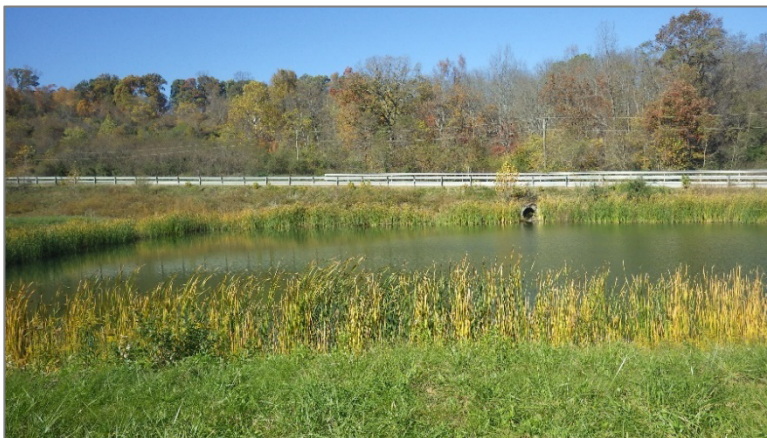
- Dense, woody vegetation obscured the inner slopes of the pond, which prevented a thorough inspection of those areas (Photos 26 and 27, Appendix B).

Photo 26
East Sedimentation Pond –
dense vegetation growth along
the perimeter of the pond
along the east and north sides.

Photo 27
East Sedimentation Pond –
dense vegetation growth along
the perimeter of the pond
along the east and north sides.

- Maintain the vegetation along the interior and exterior slopes of the Interim Leachate Collection Pond, West Sedimentation Pond, and the East Sedimentation Pond. Address the interior and exterior erosion as needed to maintain integrity of the ponds.
- Continue to conduct field surveys to measure current topography and compare to design geometry. Regrade surface to conform to design if needed. Areas near final completion grade are recommended to be capped, closed, and vegetated. Further engineering evaluation of slope stability may be warranted, if deformations, steepened slopes, or sloughing indicate potential for significant instabilities.

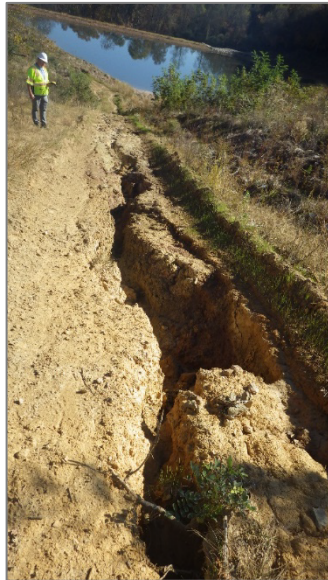
- An erosion gully was noted from the top of the slope to the toe of the access road west of the pond (Point 1, Appendix A; Photo 29, Appendix B).
- A wet area was observed on the slope on the west side of the pond, near the midslope bench (Point 2, Appendix A; Photo 30, Appendix B).
- An erosion gully, approximately 3 to 5 feet deep, was noted from the top of the slope to the midslope bench at the access road on the south side of the pond. (Point 3, Appendix A; Photo 31, Appendix B).
- A soil stockpile was documented on the west side of the pond. It is unclear when the stockpile was placed and for what purpose (Point 4, Appendix A; Photo 32, Appendix B).
- The slope on the south side of the pond is bare and sparsely vegetated, resulting in numerous small erosion gullies (Photos 33, Appendix B).

Photo 29, Point 1
North Sedimentation Pond –
erosion gulley on access road
from the top of the slope to its
toe.

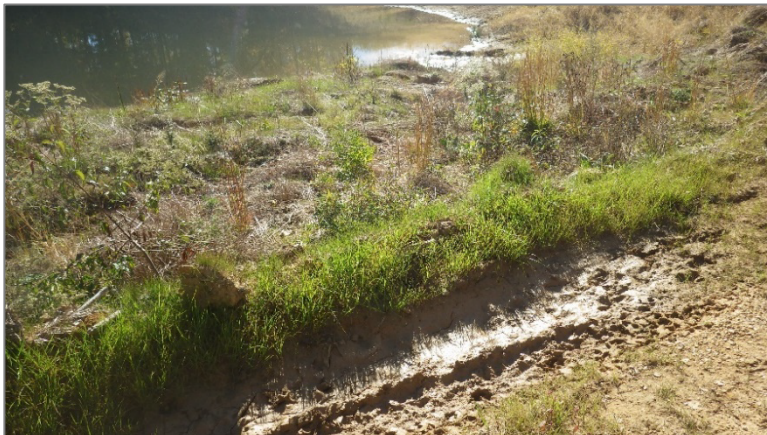
Photo 30, Point 2
North Sedimentation Pond –
wet area on the east side of
the pond.

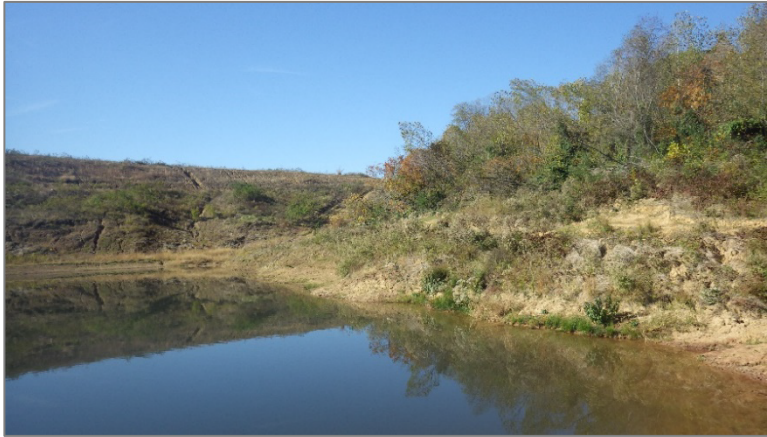
Photo 31, Point 3
North Sedimentation Pond –
erosion gullies from the top of
the slope to the bench at the
midslope on the south side of
the pond.

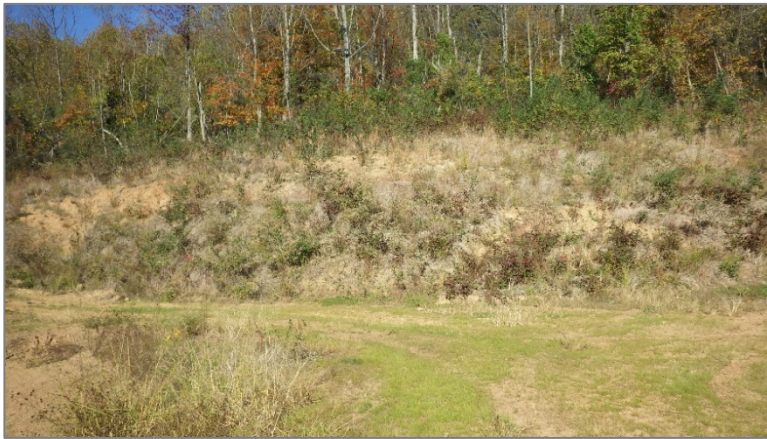
Photo 32, Point 4
North Sedimentation Pond –
soil stockpile on the west side
of the pond.

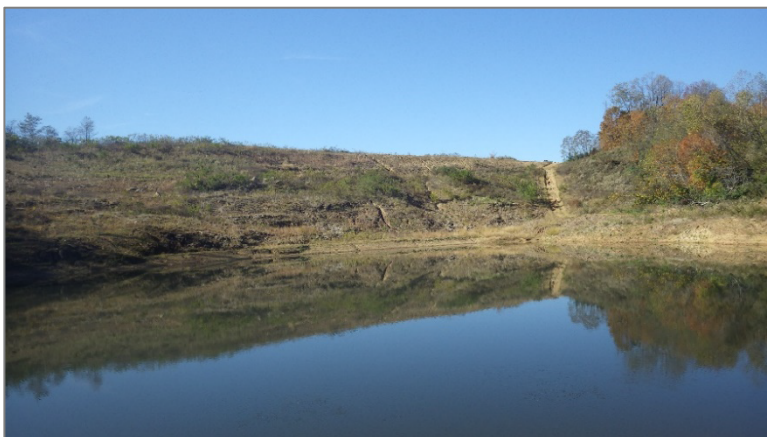
Photo 33, Points 21 and 22
North Sedimentation Pond –
south slope of pond is bare –
sparsely vegetated with
multiple erosion gullies.

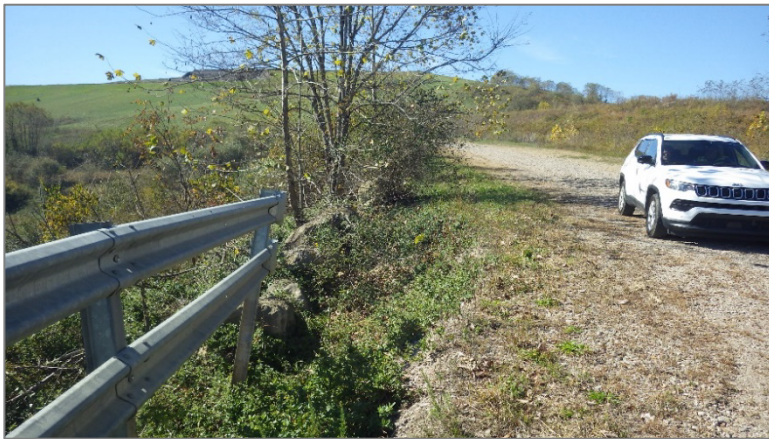
- The guardrail along the paved access road on the north side of the Interim Leachate Collection Pond has significant erosion at the base of the posts, resulting in the posts pulling away from the roadway (Point 15, Appendix A; Photo 35, Appendix B).

Photo 35, Point 15
Interim Leachate Collection
Pond – guardrail along the
paved access road on the north
side of the pond has pulled
away from the roadway.

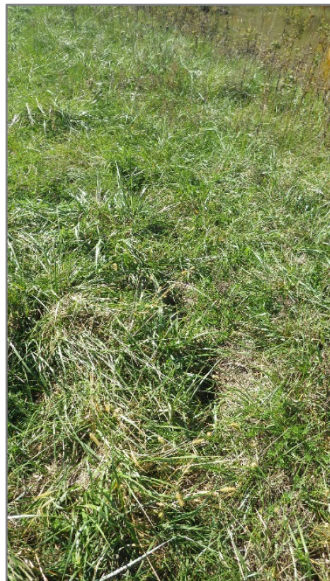
- The south and east interior slopes, approximately 8 feet from the centerline of the crest, appear to be separating from the crest and moving toward the pond. The movement is measured to be around 8 feet. Evidence of this movement starts at Points 16 and 17 (Appendix A; Photo 36, Appendix B) and ends at Points 18, 19, and 20 (Appendix A; Photo 37, Appendix B).

Photo 36, Points 16 and 17
Interim Leachate Collection
Pond – Separation at crest in
the south embankment.

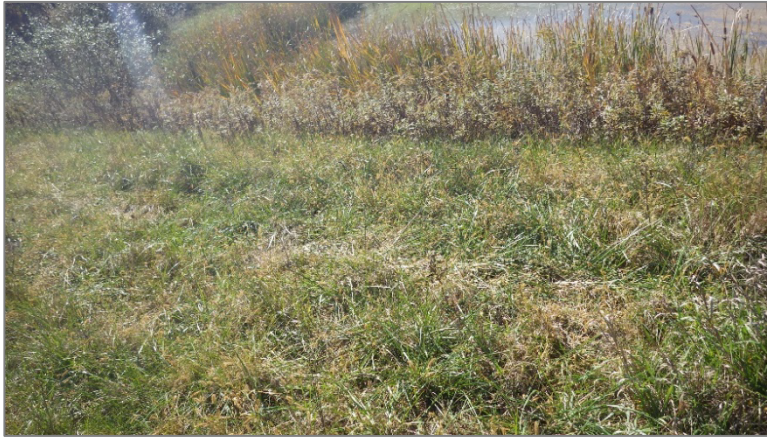
Photo 37, Points 18, 19, and 20

Interim Leachate Collection Pond – Separation at crest in the east embankment.

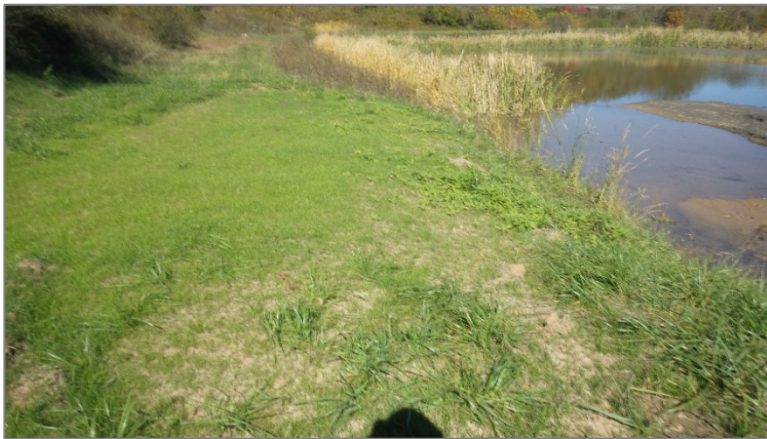
Photo 38

- Erosion along the bank on the north side of the pond. The erosion is surficial. (Point 21, Appendix A; Photo 38, Appendix B).
- Erosion of the interior and exterior slopes at the southwest corner of the pond was observed at the interface of the riprap and slope overlying the 12-inch reinforced concrete pipe (RCP) (Point 22, Appendix A; Photo 39, Appendix B). Geotextile fabric is also exposed because of the erosion within the riprap (Photo 40, Appendix B).

Interim Leachate Collection Pond – Erosion on north side of the pond.

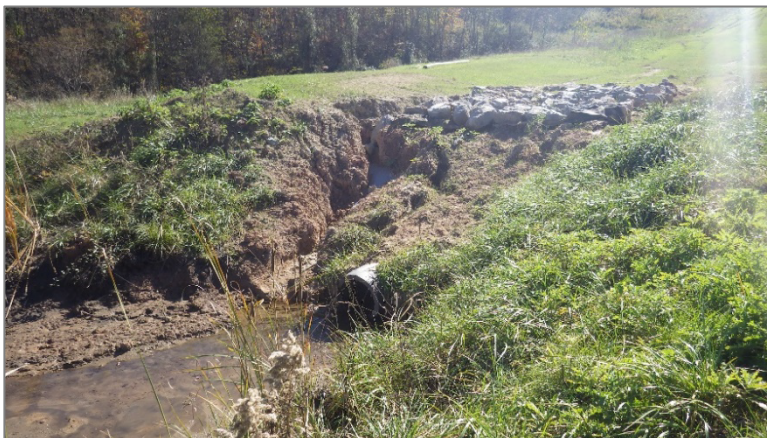
Photo 39

Interim Leachate Collection Pond – Erosion of the interior/exterior slope at the crest/riprap interface.

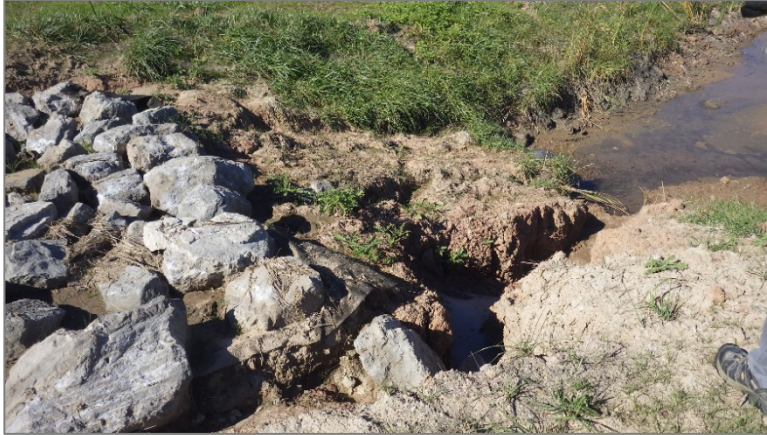
Photo 40
Interim Leachate Collection
Pond – Exposed geotextile
fabric exposed at exterior
riprap.

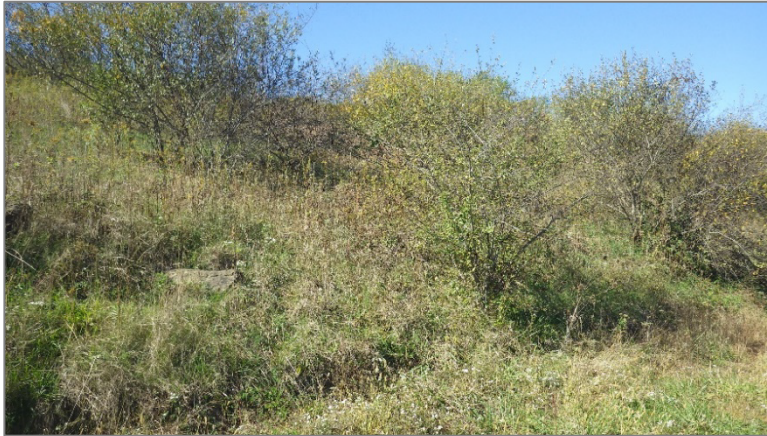
- Dense vegetation growth along the exterior slopes of the embankments surrounding the pond prohibited a thorough inspection of those slopes (Photo 41; Appendix B).

Photo 41
Interim Leachate Collection
Pond – Dense vegetation
growth on exterior slopes.

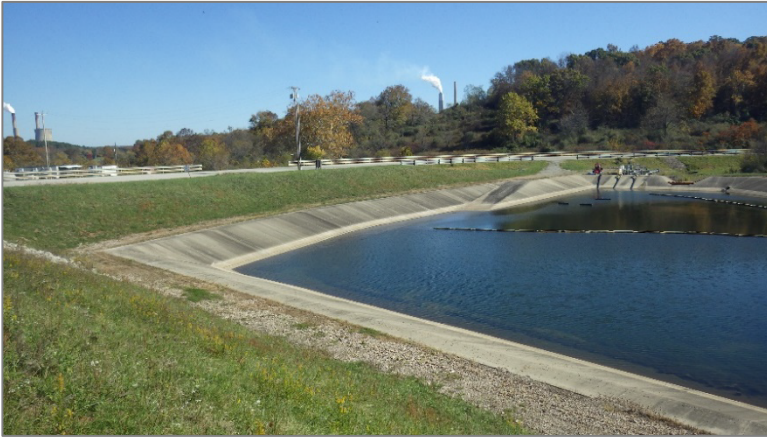
- The earthen slopes above the concrete appear well vegetated and uniform near the Leachate Collection Pond (Photo 43, Appendix B).
- The riprap seepage blankets on the west and southwest grass slope appear in good condition (Photos 44 and 45, Appendix B).

Photo 43
Leachate Collection Pond –
Earthen slopes.

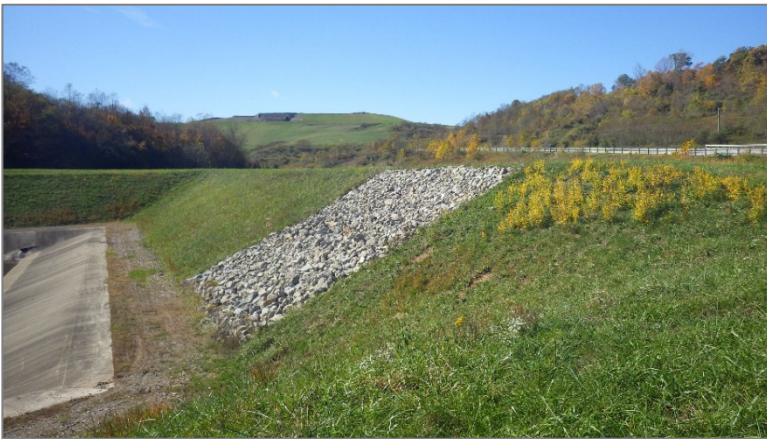
Photo 44
Leachate Collection Pond –
Riprap coverage on the west
slope.

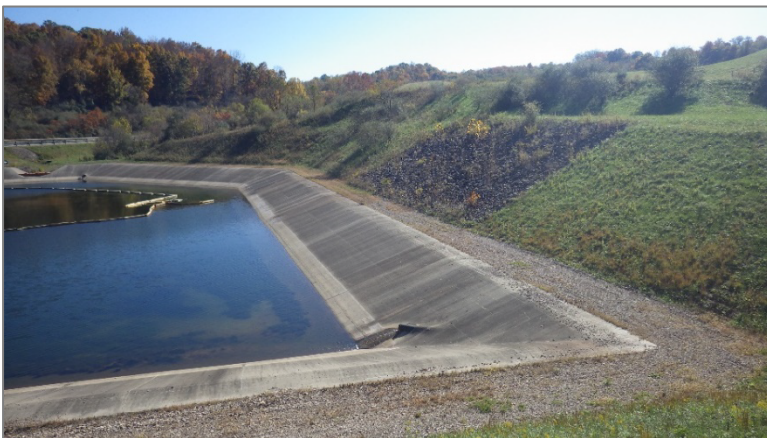
Photo 45
Leachate Collection Pond –
Riprap coverage on the
southwest slope.
