2016 Annual Dam and Dike Inspection Report

**Bottom Ash Pond Complex
South Fly Ash Pond**

**Kyger Creek Plant
Ohio Valley Electric Corporation (OVEC)
Gallia County, Ohio**

**Kyger Creek Plant
Bottom Ash Pond Complex
South Fly Ash Pond
Document Number: GERS-16-152**

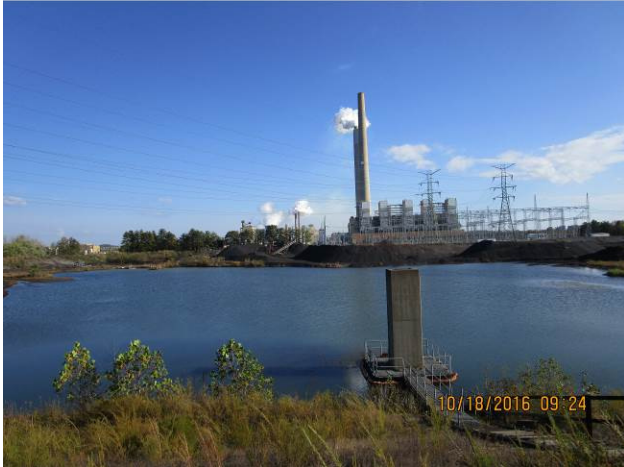
- 1) The outboard slopes, crest and inboard slopes of the embankment were generally in good condition. The embankments did not show any signs of structural weakness or instability. The vegetation along the embankments was recently mowed in most locations. The crest did not contain any ruts or other signs of instability. Specific maintenance and items to monitor are described in the subsequent sections of this report.
- 2) The hydraulic structures of the Boiler Slag Pond and the Clear Water Pond were generally in good condition. There were no signs of deterioration of the concrete or steel structures. Stop logs were available for use. Flow within the pipes appeared unobstructed. Specific maintenance and items to monitor are described in the subsequent sections of this report. (See Picture 1 and 2)

Picture 1 – Boiler Slag Pond, Overall view

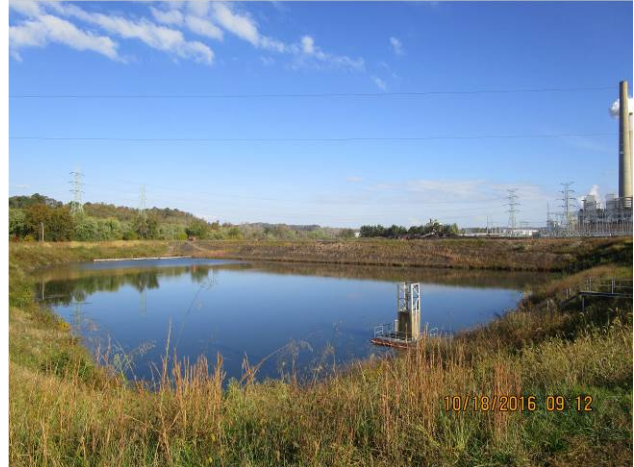
Picture 2 – Clear Water Pond, Overall view

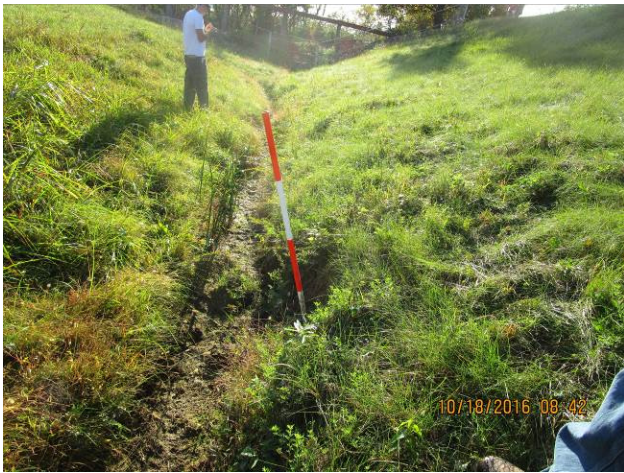
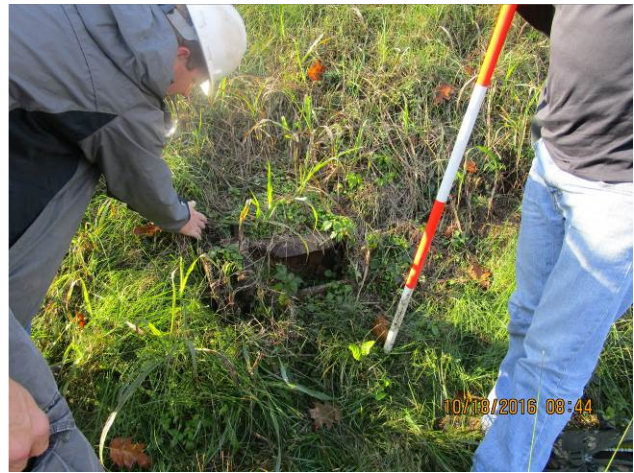
- 5) A small abandoned structure was found at the toe of the north dike and included a small cavity that went back into the dike approximately 24". This structure should be removed and the cavity should be filled. (See Pictures 3 and 4)
- 6) An erosion rill was discovered in the inboard slope south east portion of the Boiler Slag Pond. The erosion has occurred in the stockpiled boiler slag that is lining the inboard slope of the soil dike and is therefore not impacting the integrity of the dike. The erosion should be repaired. (See Pictures 5 and 6)
- 7) Vegetation was excessive along the inboard slopes of the Clear Water Pond. The vegetation should be periodically mowed to keep woody vegetation from growing and to allow for inspection. (See Picture 7)

Picture 3 – Boiler Slag Pond, abandoned appurtenance at north toe

Picture 4 – Boiler Slag Pond, abandoned appurtenance at north toe

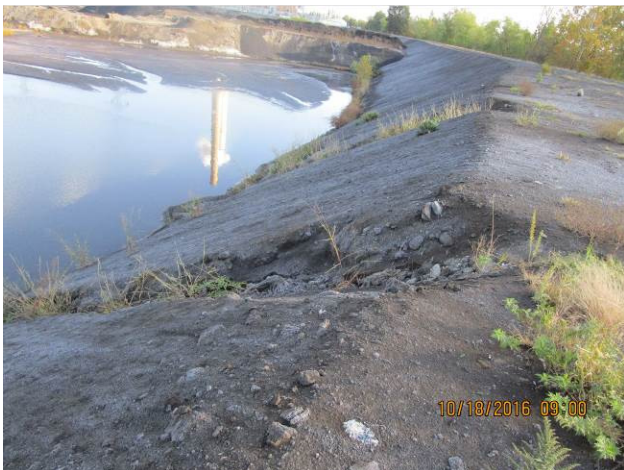
Picture 5 – Boiler Slag Pond, erosion on inboard slope

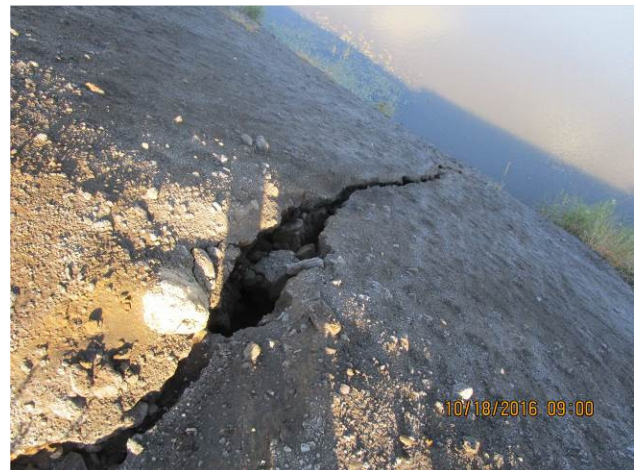
Picture 6 – Boiler Slag Pond, erosion on inboard slope

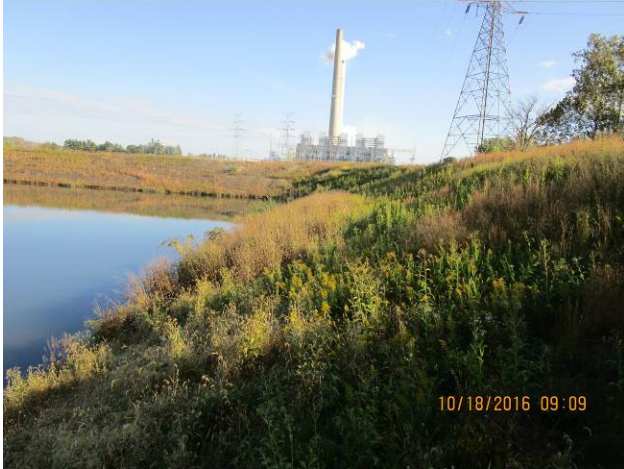
Picture 7 – Clear Water Pond, overgrown vegetation on inboard slope

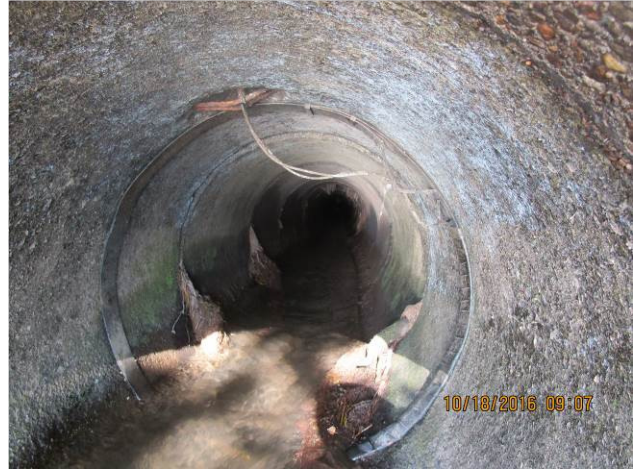
- 12) Root intrusion was observed in the discharge end of the Clear Water Pond outlet pipe. This condition has been observed previously and root masses have been periodically removed. This should be monitored during 7-day inspections to ensure the condition does not worsen. If flow is restricted or the pipe condition deteriorates please contact AEP Geotechnical Engineering. (See Picture 8)

Picture 8 – Clear Water Pond, root intrusion at end of discharge pipe

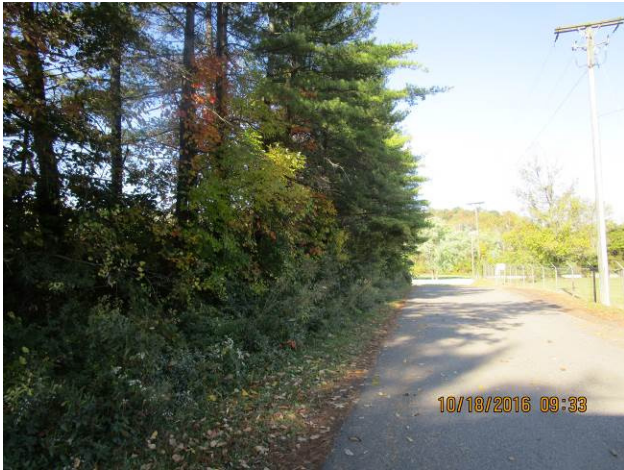
- 13) A portion of the north dike has trees and woody vegetation located on the outboard slope which serve as a wind break for the boiler slag reclaim operations. The trees are located on a portion of the dike that is well above the normal pool and maximum pool elevations of the impoundment therefore they are not currently being recommended for removal. This area should be monitored for instability in the event the trees are uprooted and for other movements in the embankment. In the future if the pool elevation of the pond is raised the removal of these trees should be re-evaluated. (See Picture 9)

Picture 9 – Boiler Slag Pond, trees on outboard slope

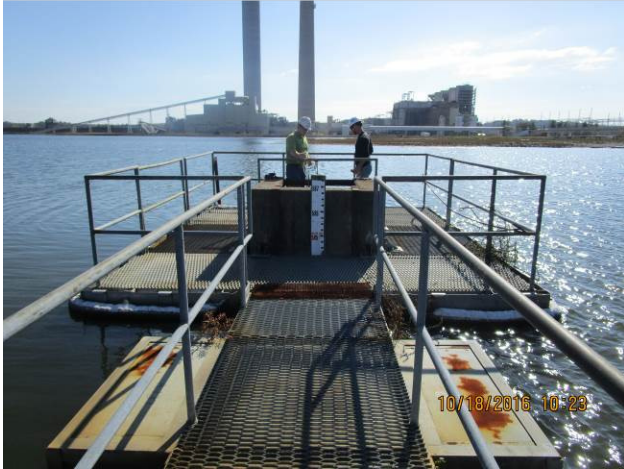
- 3) The outboard slopes, crest and inboard slopes of the embankment were generally in good condition. The embankments did not show any signs of structural weakness or instability. The vegetation along the embankments was recently mowed in most locations. The crest did not contain any ruts or other signs of instability. Specific maintenance and items to monitor are described in the subsequent sections of this report.
- 4) The hydraulic structures of the South Fly Ash Pond were in generally in good condition. There were no signs of deterioration of the concrete or steel structures. Stop logs were available for use. Flow within the pipes appeared unobstructed. (See Picture 10)

Picture 10 – South Fly Ash Pond, General View of Outlet structure

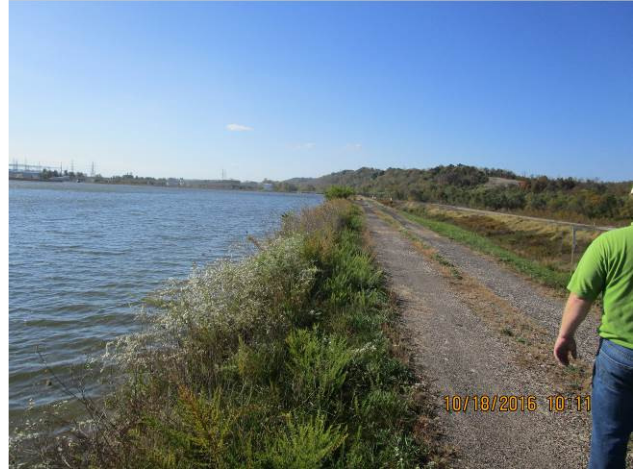
- 9) Excessive vegetation is located along the inboard slopes at several locations. Where it is safe to do so, the vegetation should be periodically mowed to prevent woody vegetation and to allow for better inspection. (See Picture 11)
- 10) Wave erosion of the inboard slope was observed at several locations of the west dike primarily near the vicinity of the outlet structure. This area should be repaired using rip rap similar to previous repairs. Please contact AEP Geotechnical Engineering for standard repair details. (See Pictures 16 and 17)
- 11) Minor erosion was observed beneath the sluice lines on the outboard slope of the dike. This area does not receive much direct sunlight therefore grass cannot grow easily. It is recommended that small riprap be placed in this area to prevent further erosion. Please contact AEP Geotechnical Engineering for repair details. (See Picture 20)

Picture 11 – South Fly Ash Pond, excessive vegetation along inboard slope

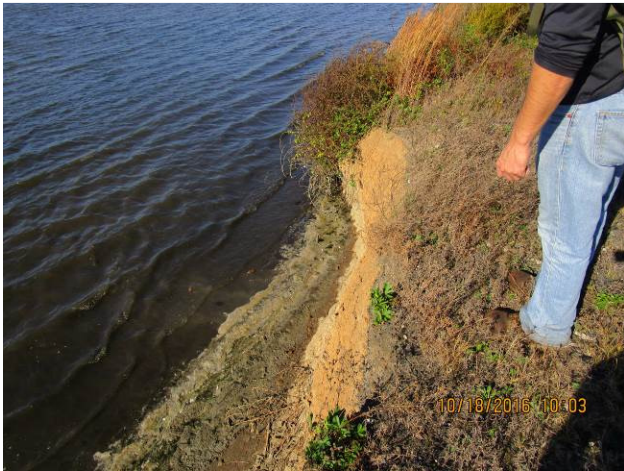
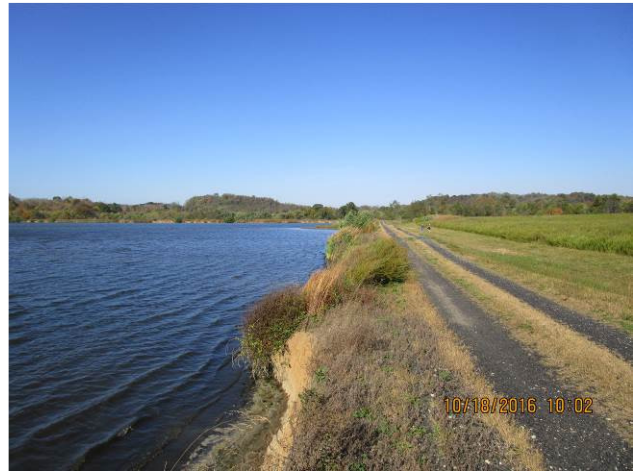
- 8) Wave erosion of the inboard slope was observed at several isolated areas of the north dike.

Picture 12 – South Fly Ash Pond, wave erosion at north dike inboard slope

Picture 13 – South Fly Ash Pond, wave erosion at north dike

Other areas of wave erosion noted in the 2015 annual inspection were repaired. These observed areas should be repaired in the same manner. Please contact AEP Geotechnical Engineering for standard repair details. (See Picture 12 and 13)

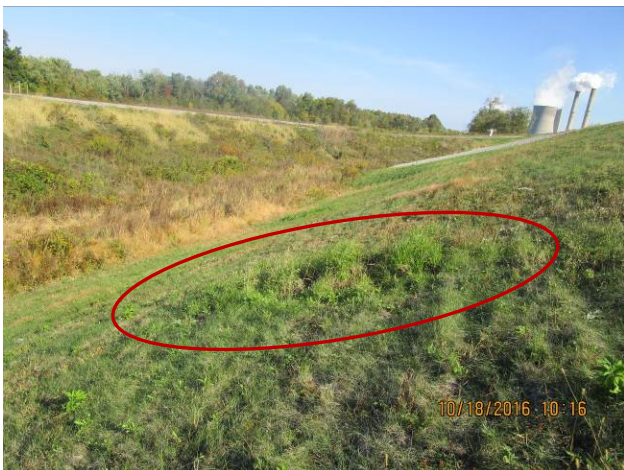
Picture 14 – South Fly Ash Pond, west dike wet area along outboard slope

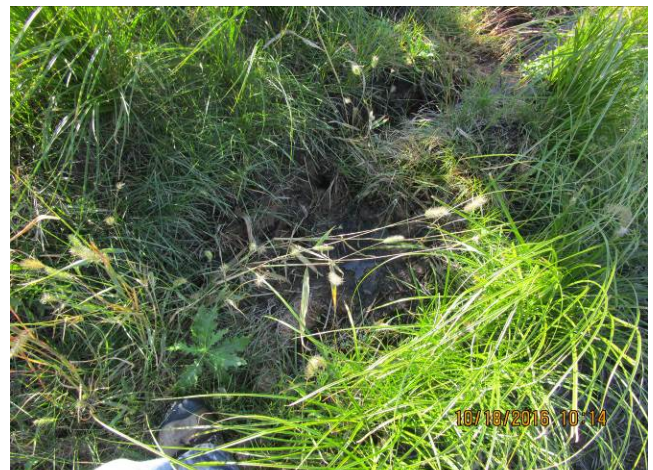
Picture 15 – South Fly Ash Pond, wet area along outboard dike

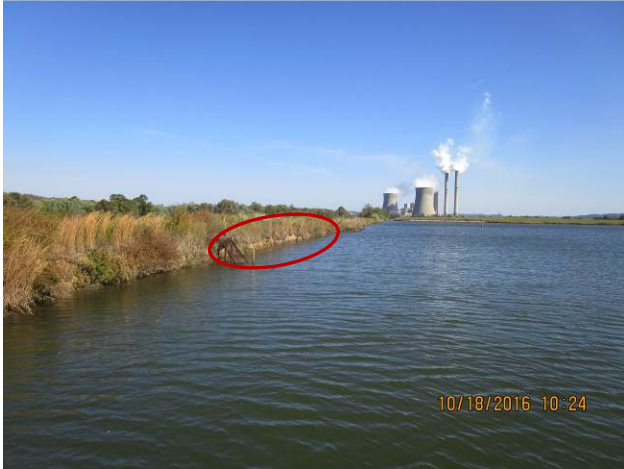
Picture 16 – South Fly Ash Pond, wave erosion at west dike inboard slope

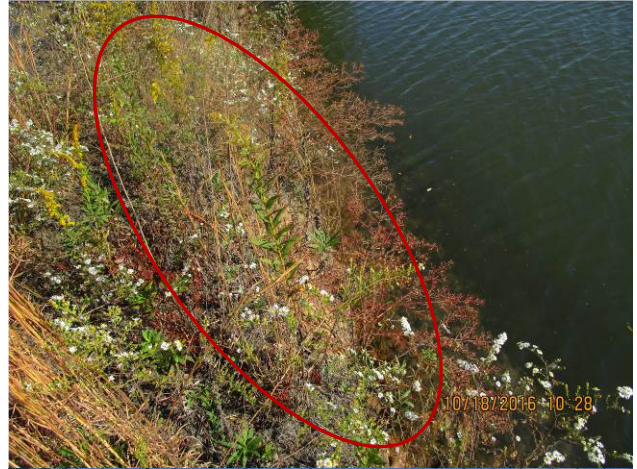
Picture 17 – South Fly Ash Pond, wave erosion at west dike inboard slope

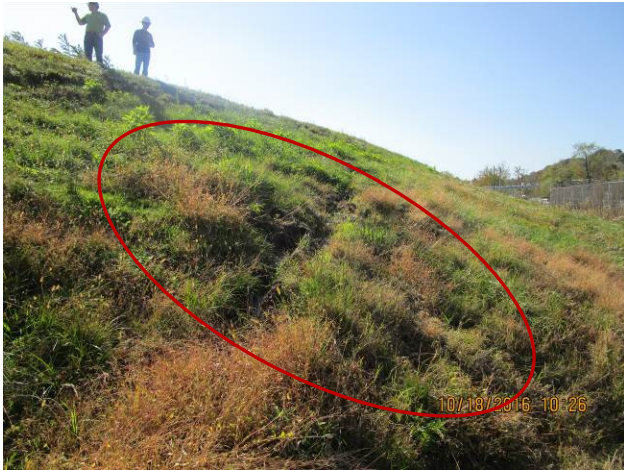
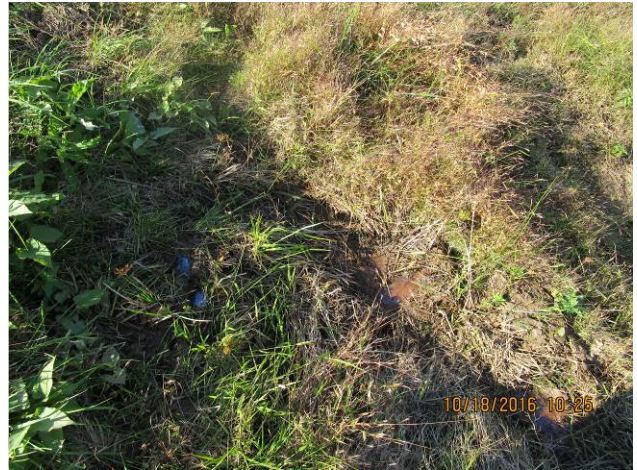
- 14) An isolated wet area was observed approximately half way up the west dike. This area should be monitored for flow rate and clarity of flow. The area did not appear to be flowing. The wet area could also be repaired using the same ODNR approved detail used for previous seepage areas along this dike. If the flow rate increases or the water coming from the seep is not clear it should be brought to the immediate attention of AEP-Geotechnical Engineering. (See Pictures 14 and 15)
- 15) A second wet area was observed in the same location as previous annual inspections, near the south-west corner of the impoundment. The condition did not appear to worsen since previous annual inspections. The area did not appear to be flowing. The wet area could also be repaired using the same ODNR approved detail used for previous seepage repairs along the dike. If the

Picture 18 – South Fly Ash Pond, wet area at south-west dike

Picture 19 – South Fly Ash Pond, wet area at south-west dike

flow rate increases or the water coming from the seep is not clear it should be brought to the immediate attention of AEP-Geotechnical Engineering. (See Pictures 18 and 19)

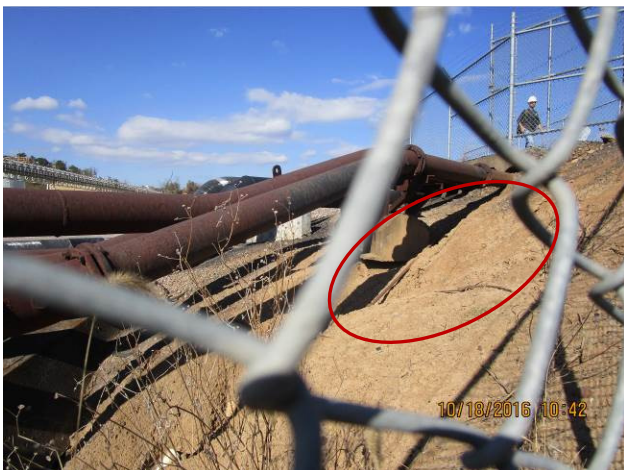
Picture 20 – South Fly Ash Pond, erosion at south dike outboard slope near the sluice line

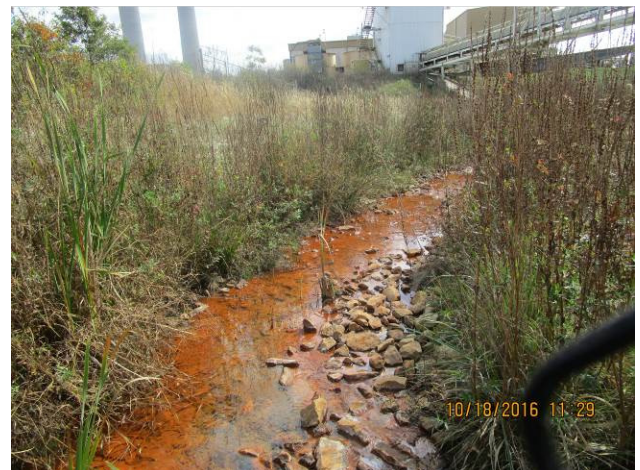
- 16) The seepage located beyond the south toe was observed to be similar flow rate to previous inspections. Weekly inspections have noted that the flow rate is steady at 24 gpm. The flow was clear and there was no accumulation of solids around the seepage areas. The flow rate and clarity of this seep should continue to be monitored during the 7 day inspections. If there is any change in condition it should be brought to the immediate attention of AEP-Geotechnical Engineering. (See Picture 21)

Picture 21 – South Fly Ash Pond, seepage area beyond south dike.
