# **2020 Annual Dam and Dike Inspection Report**

**Bottom Ash Pond Complex  
South Fly Ash Pond**

**Kyger Creek Plant  
Ohio Valley Electric Corporation (OVEC)  
Gallia County, Ohio**

**October 2020**

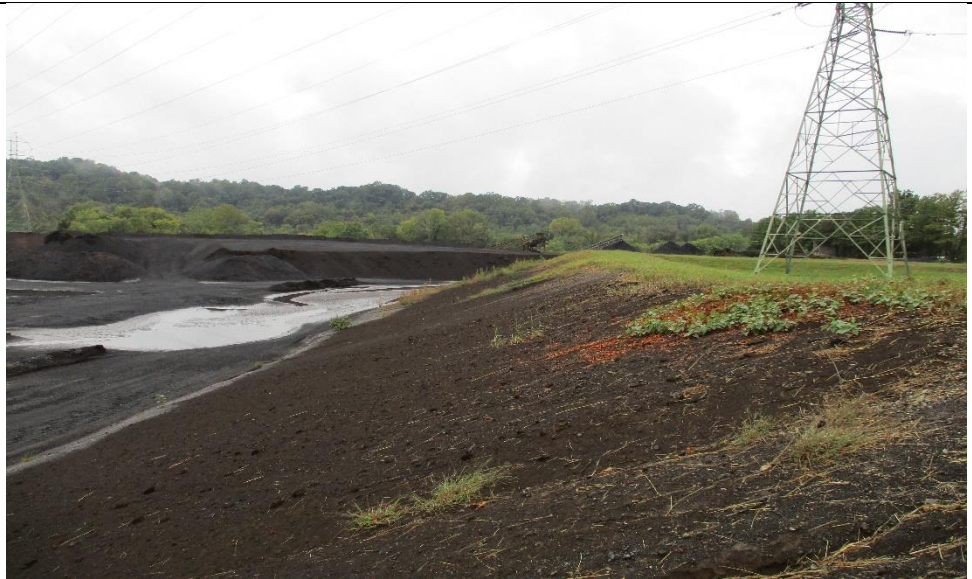
Photograph No. 1

- (i) A typical view of the north dike upstream slope is illustrated in Photographs No. 1-3. These photographs depicts the east section of the dike. Overall, the upstream slope is in good condition. Minor vegetation growth (Photograph No. 2) was present along an area of the dike. A significant area to the east and south of the bottom ash pond consists of stockpiles of bottom ash in the anticipation of the pond closure project.
- (ii) Photograph No. 4 illustrates the condition of the discharge pipe in the northeast corner of the pond. The pipes appeared to be in fair, stable, and functional condition.
- (iii) A typical view of the downstream slope (east dike section) is illustrated in Photograph No. 5. The slope appeared in good and stable condition with controlled vegetation. The toe ditch indicated positive flow and no standing water. The downstream slope and the crest

This photograph shows the upstream slope north dike, east section. The dike appeared in good condition with some erosion.

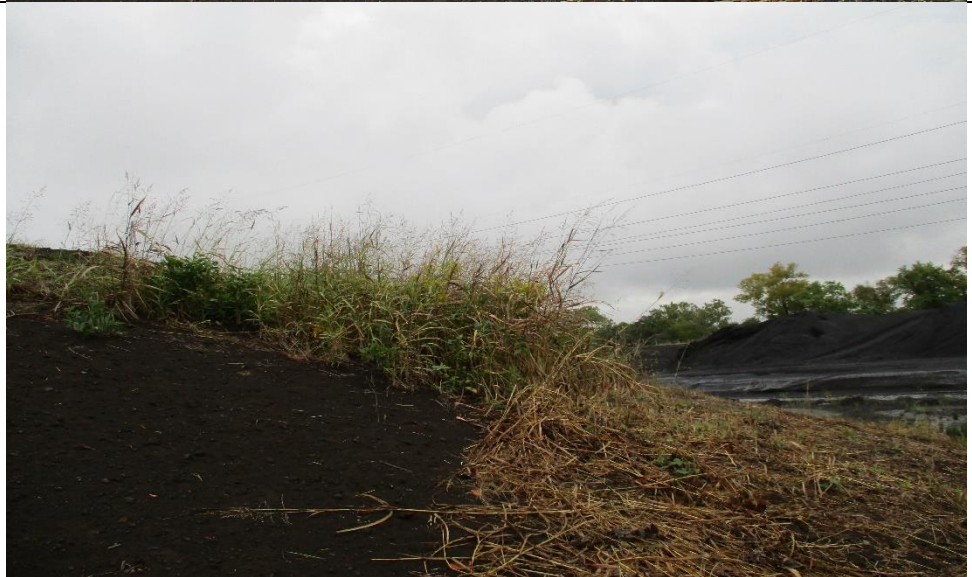
Photograph No. 2

Minor vegetation growth appeared along the upstream slope.

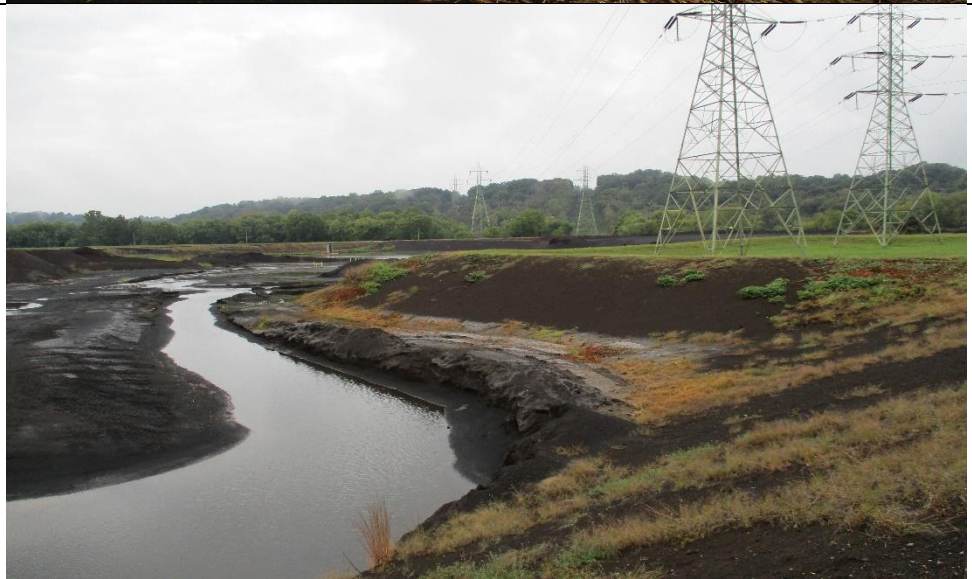
Photograph No. 3

Overall view of the upstream slope (looking south).

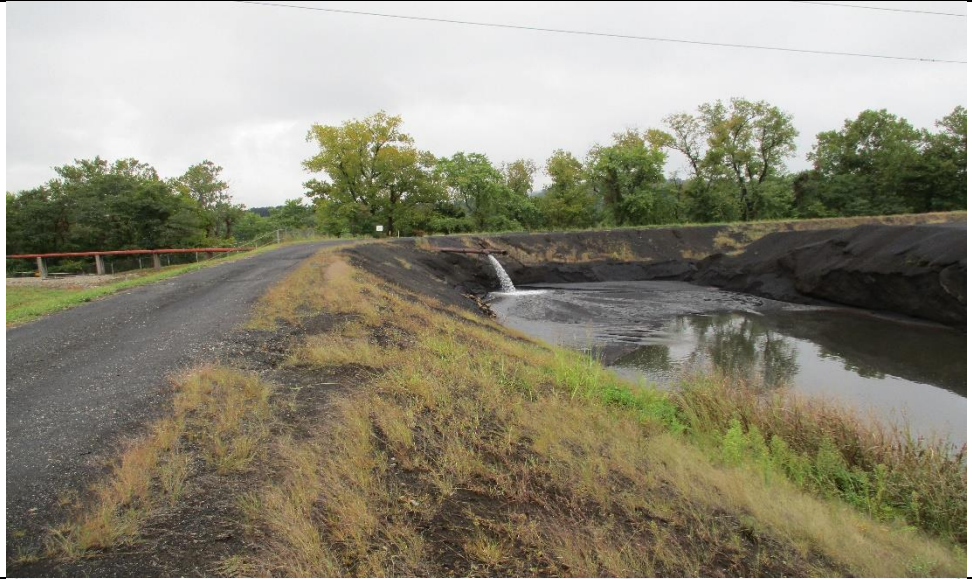
Photograph No. 4

This photograph illustrates ash sluice pipes in the northeast corner.

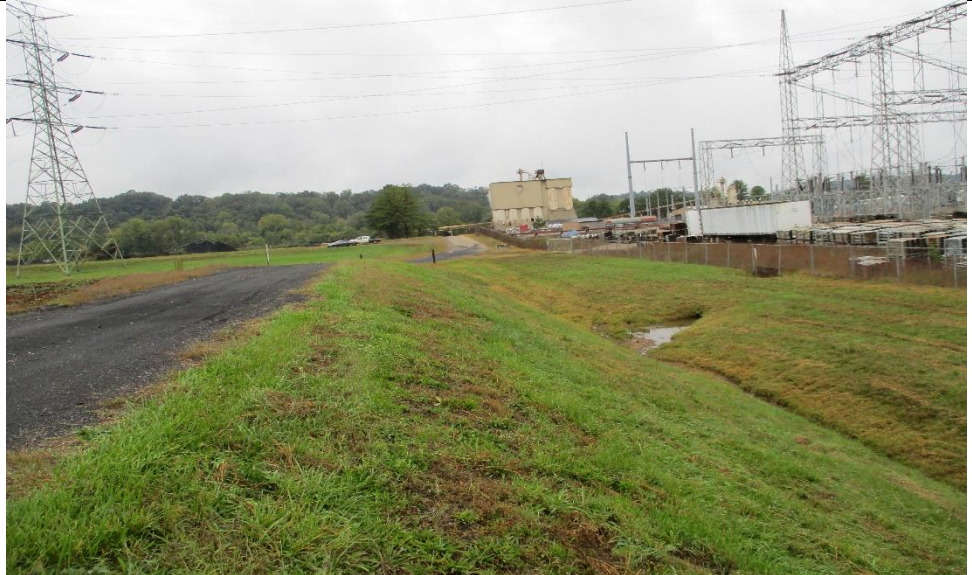
Photograph No. 5

This photograph illustrate the downstream slope (east section) of the north dike. The slope appeared stable and in good condition.

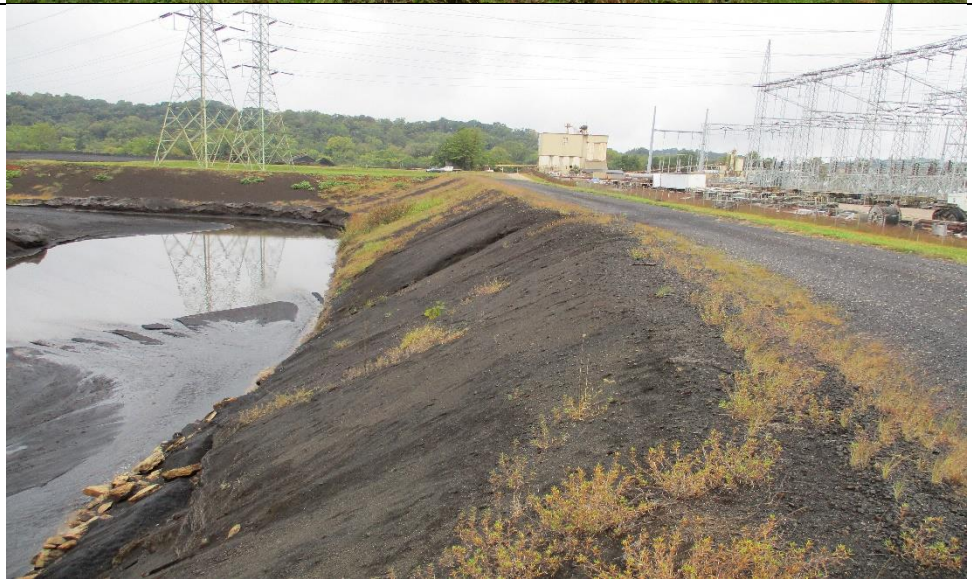
Photograph No. 6

is illustrated in Photograph No. 6. The crest appeared in good and stable condition, minor erosion gullies were noticed at the upstream slope. The downstream slope of the west dike section is illustrated in Photograph No. 7. Matured trees and significant vegetation were present at the slope and toe ditch.

This photograph shows the upstream slope east dike. The dike appeared in good condition with minor erosion.

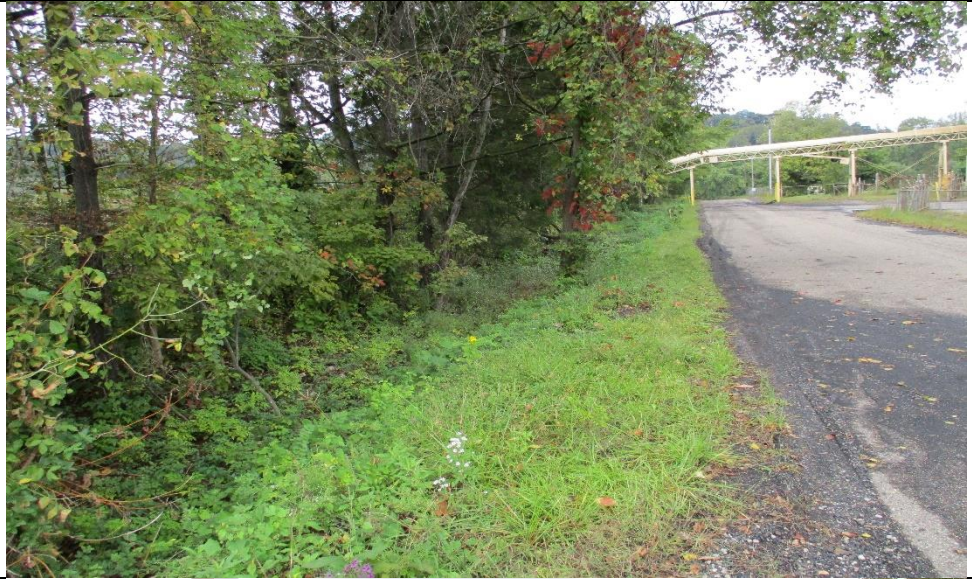
Photograph No. 7

This photograph illustrate the downstream slope (west section) of the north dike.

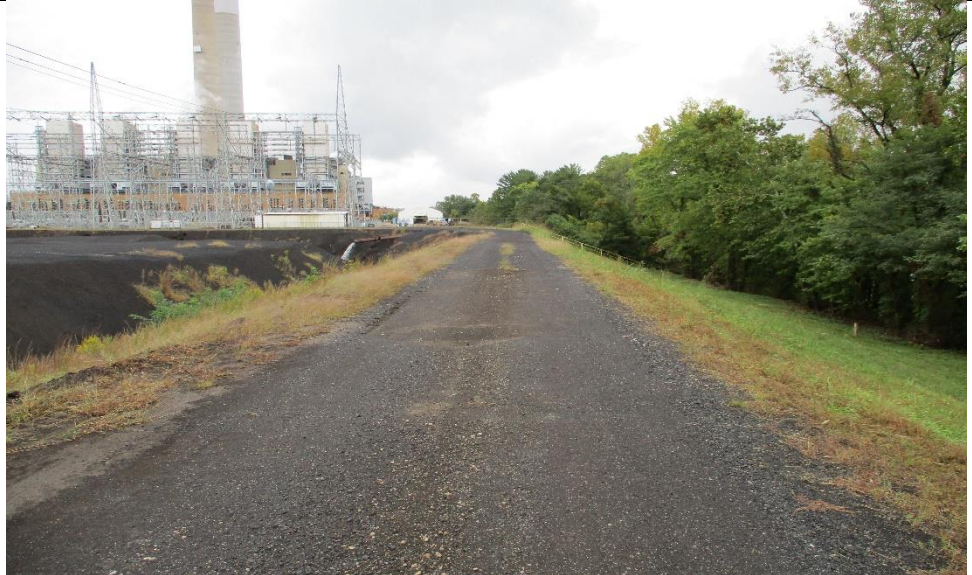
Photograph No. 8

- (iv) Photographs No. 8 and 9 illustrates the upstream, downstream slopes, and crest of the east dike. The slope appeared in good and stable conditions with good vegetation cover. Minor rutting of the crest was observed.

This photograph illustrates typical condition of the east dike crest.

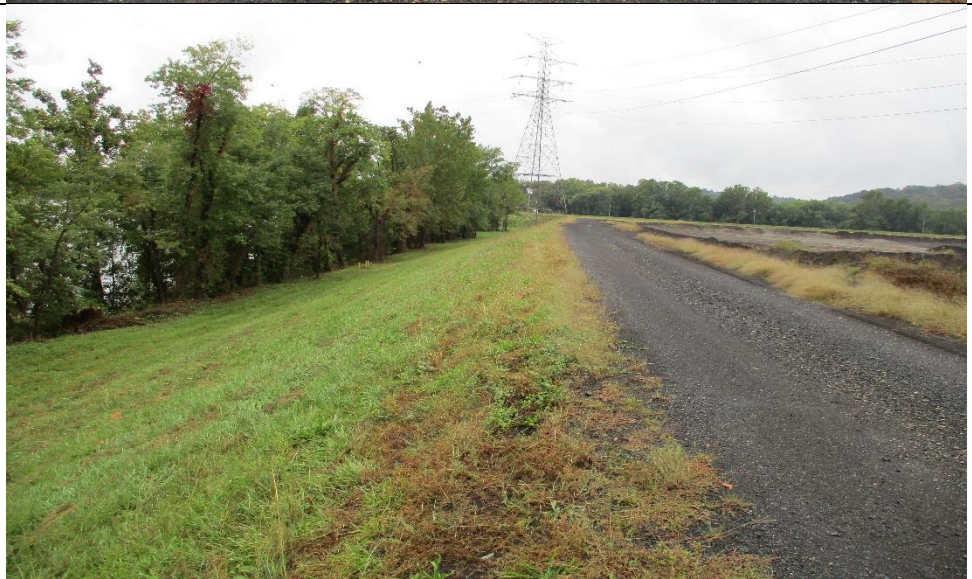
Photograph No. 9

The east dike downstream slope appeared in good condition with controlled vegetation.

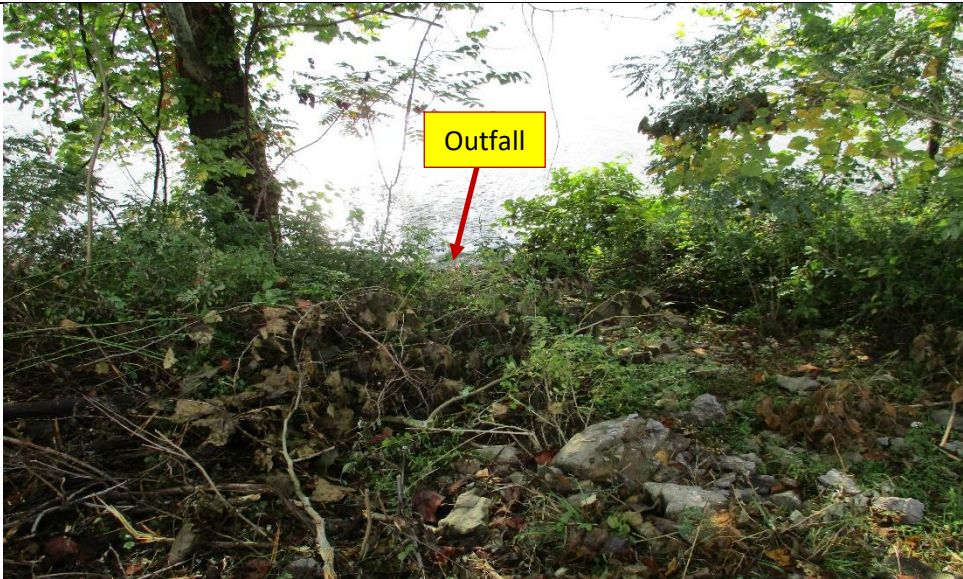
- (v) The Outfall located adjacent to the clear water pond (CWP) and discharge water to the Ohio River appeared well protected from erosion and in satisfactory condition with proper outflow (Photograph No. 10). Access to the outfall was difficult due to steep slope and difficult terrain.

<p><u>Photograph No. 10</u> Outfall to the Ohio River.</p>

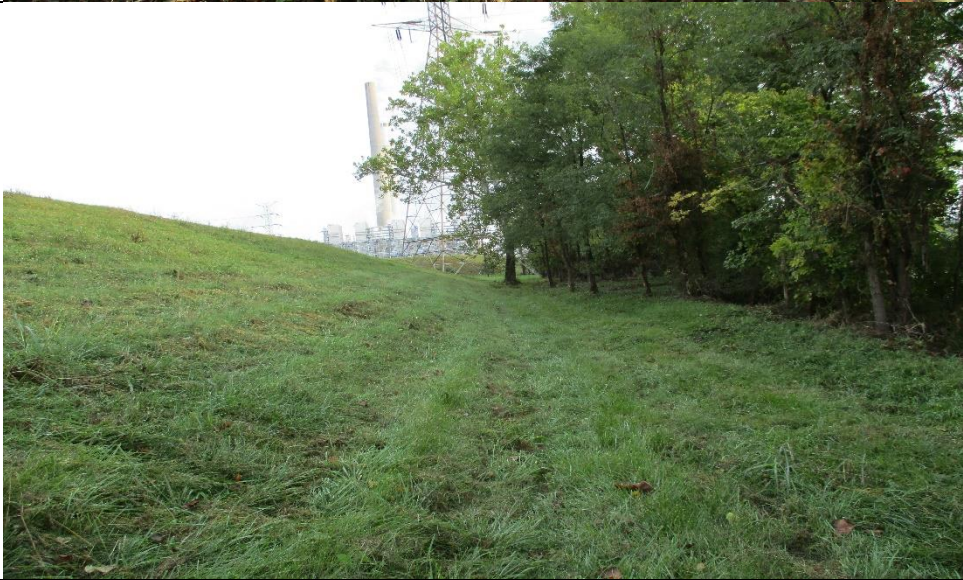
<p><u>Photograph No. 11</u> The east dike downstream slope appeared in fair condition with excessive vegetation.</p>

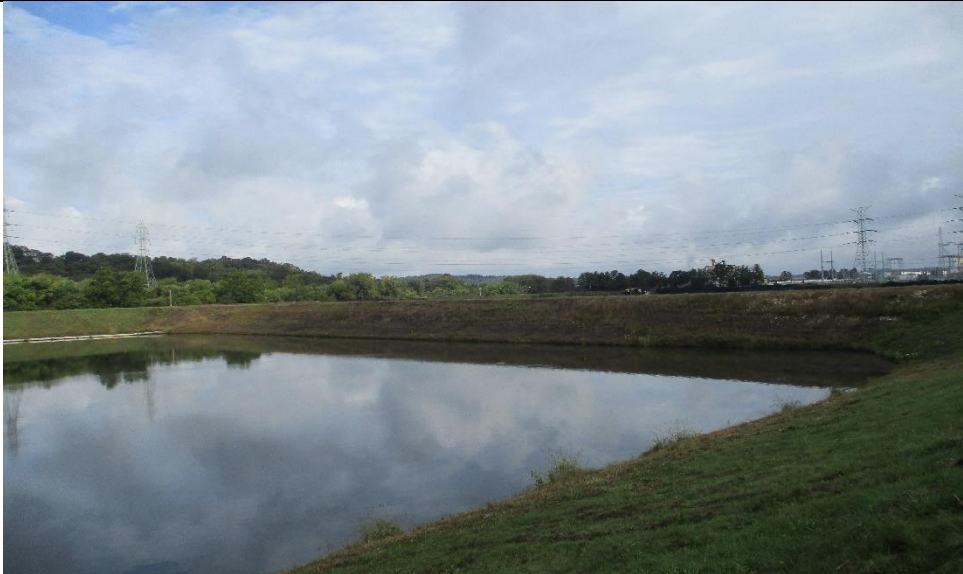
<p><u>Photograph No. 12</u> This photograph illustrates the upstream slope of the Clearwater pond. The slope appeared stable and in good condition.</p>

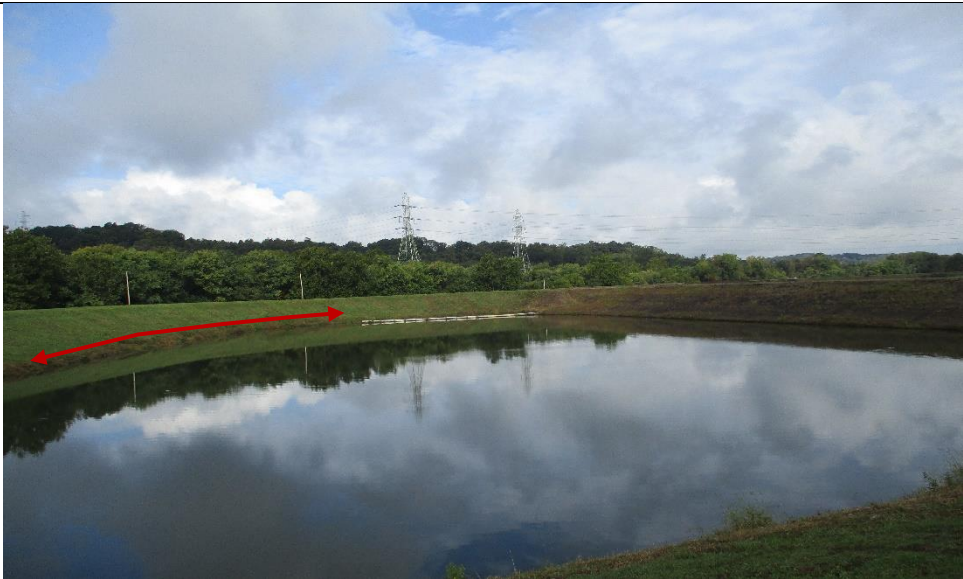
<p><u>Photograph No. 13</u></p> <p>Minor sloughing in the lower section of the upstream slope noticed.</p>

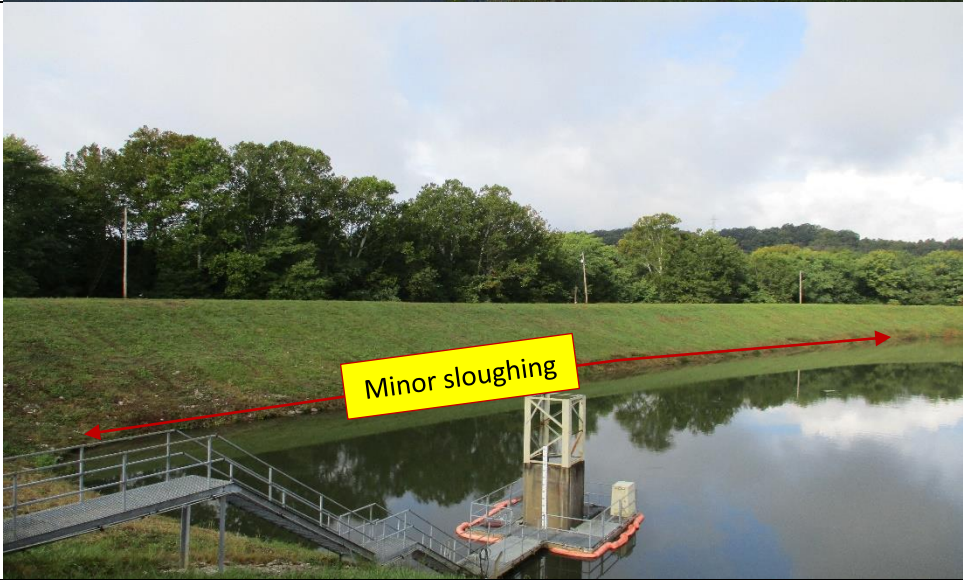
<p><u>Photograph No. 14</u></p> <p>The steps, railings, walkways, and visible concrete appears to be in good condition at the discharge structure.</p>

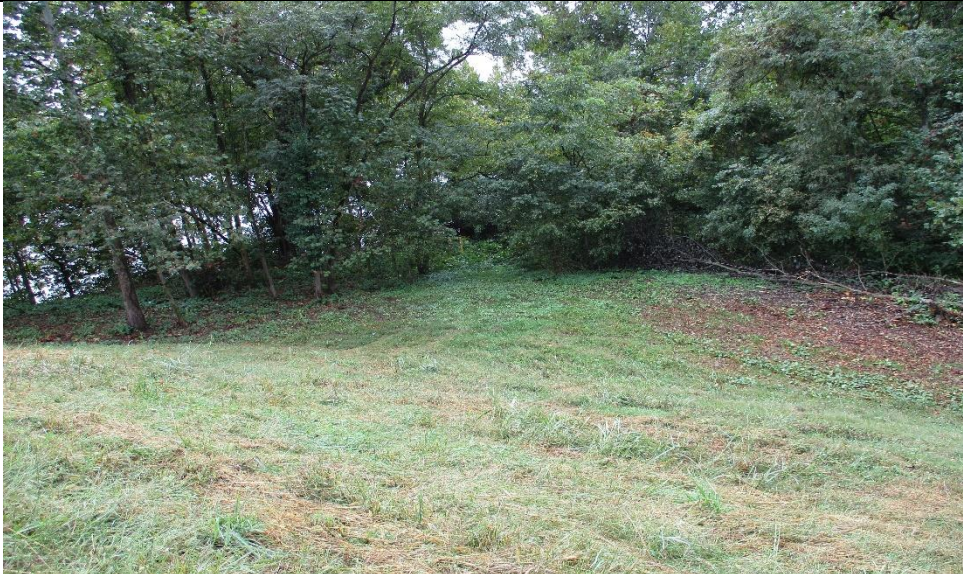
- (vii) An overall view of the south and west dikes crest and downstream slope is shown in the Photographs No. 15-17. The slope appeared in good, stable condition with controlled vegetation. Some of the full-grown, matured trees previously observed along the toe of the dike were removed.

<p><u>Photograph No. 15</u></p> <p>Typical view of the downstream slope of the south dike.</p>

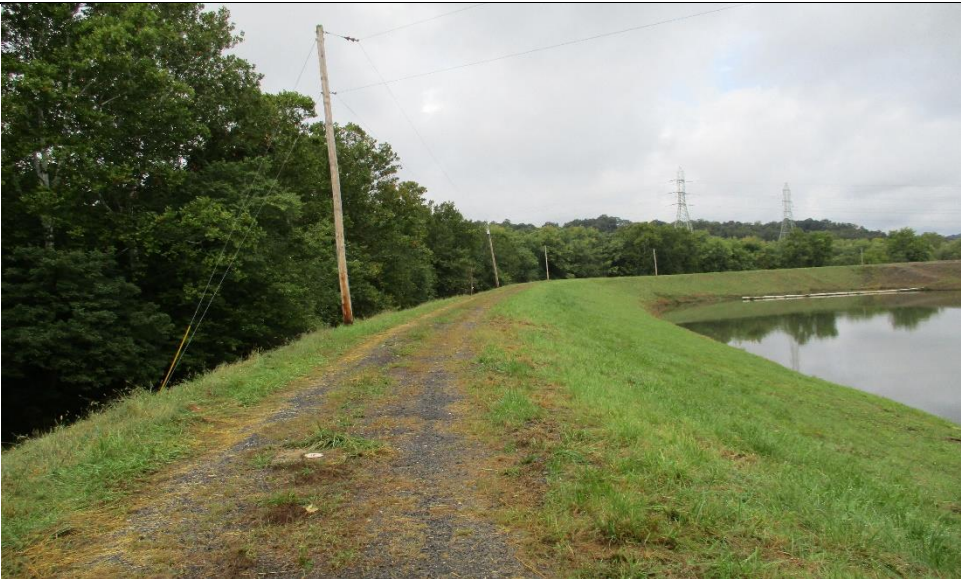
<p><u>Photograph No. 16</u></p> <p>A typical view of the crest and upstream slope of the west dike in good condition.</p>

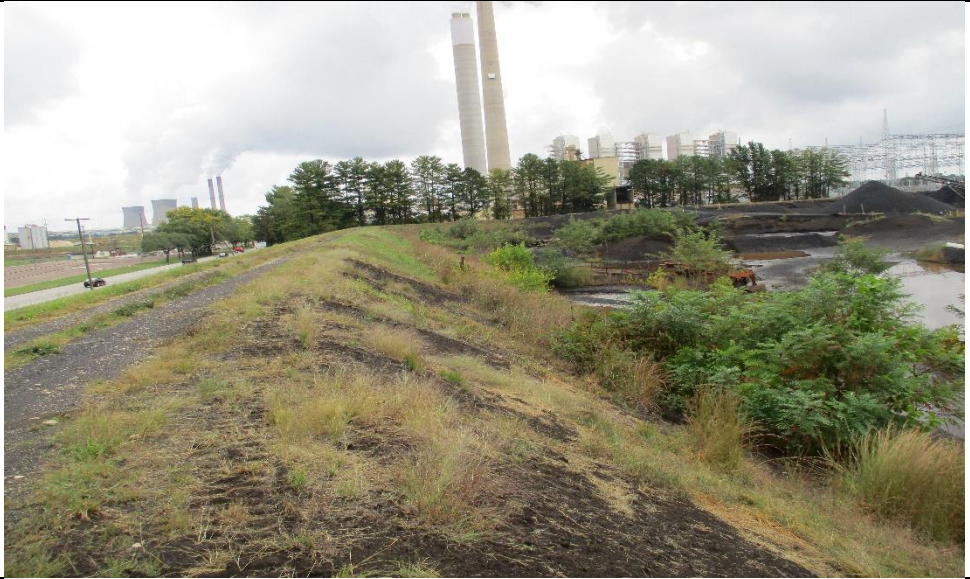
Photograph No. 19  
The upstream slope of the west dike illustrated in this photograph.

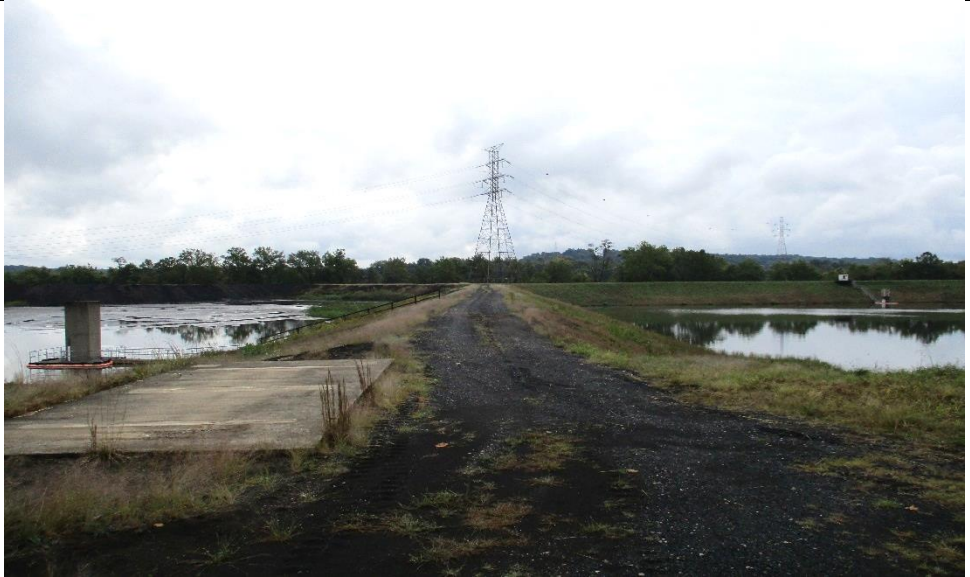
- (ix) A typical condition of the splitter dike crest is illustrated in Photograph No. 20. The crest of the dike appears to be in good and stable condition with no significant settlement, or misalignment.

Photograph No. 20  
This photo shows crest of the splitter dike (looking east).

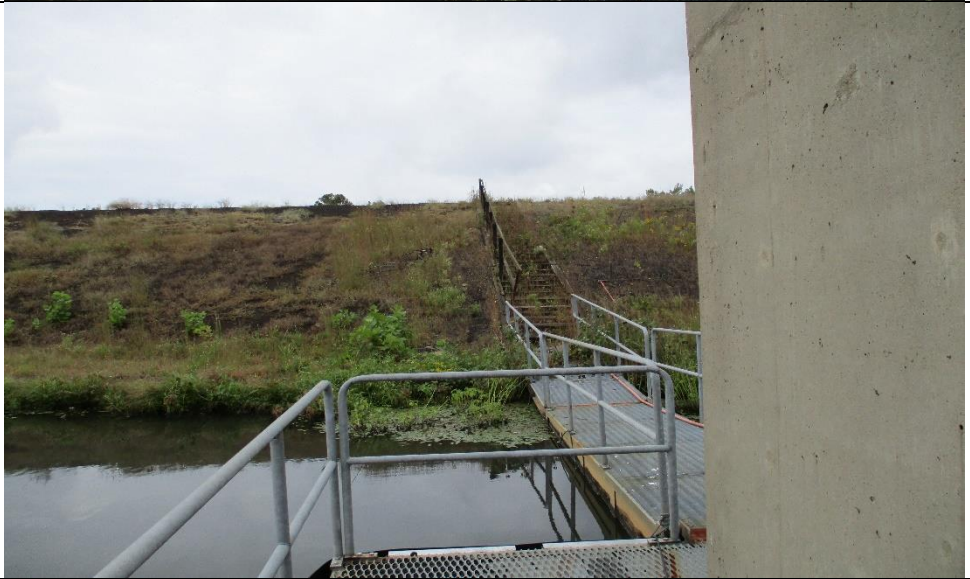
- (x) The decant structure at the splitter dike is illustrated in Photographs No. 21 and 22. The walkway, hand rail, metal walkway, visible concrete, floating deck, and stop logs appeared in fair and functioning conditions. The interior of the discharge structure is illustrated in Photograph No. 22 appeared to be functioning as designed

Photograph No. 21  
The access stairs and walkway to the decant structure appeared good.

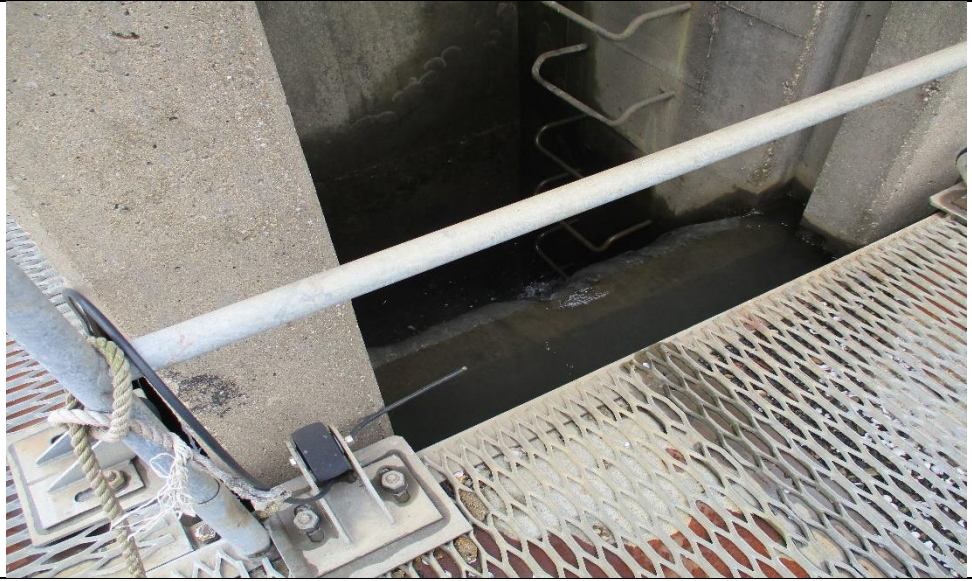
Photograph No. 22

Decant structure is shown in this photograph. Visible concrete, deck, and general water flow was in satisfactory condition.

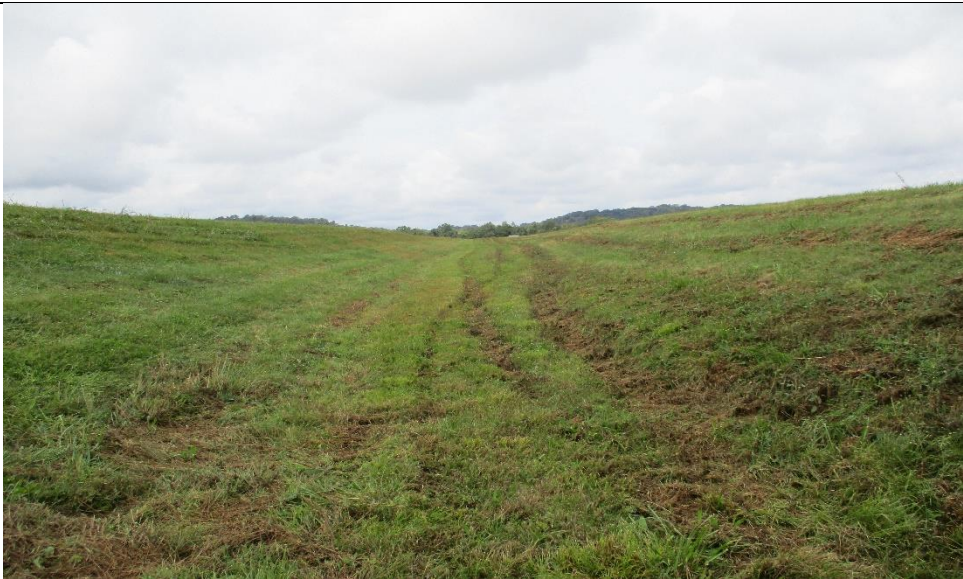
- (i) The downstream slope, crest, and upstream slope of the north dike between the north and south ponds are illustrated in Photographs No. 23-25. No signs of any significant settlement, deformation, or cracks were observed. The slopes were generally in satisfactory condition. The upstream slope consists of riprap protection (Photograph No. 25) and appeared in good and stable condition.

<p><u>Photograph No. 23</u></p> <p>This photograph shows a typical view of the north dike downstream slope (looking west).</p>

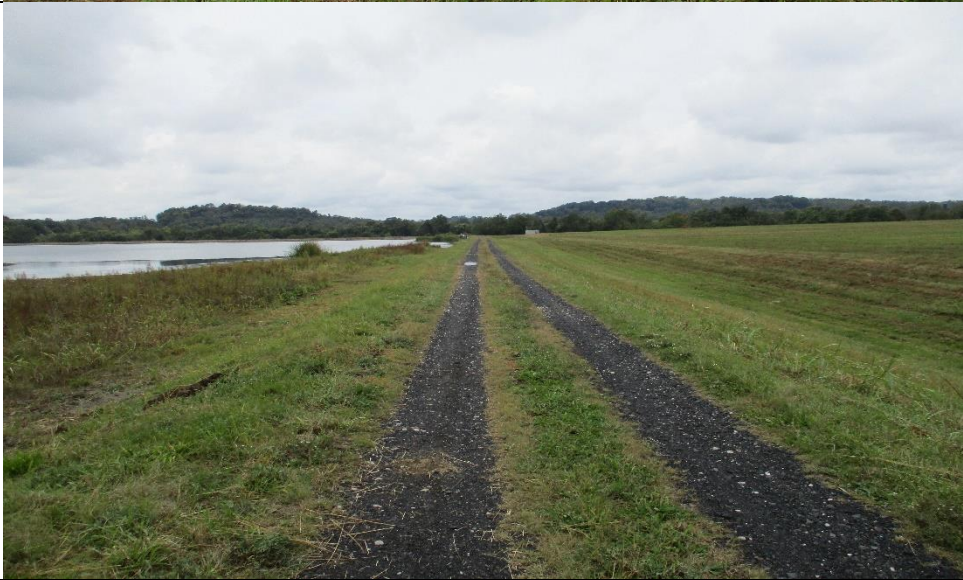
<p><u>Photograph No. 24</u></p> <p>This photograph illustrate the north dike crest. Also to the right is the partial view of the closed North Fly Ash Pond.</p>

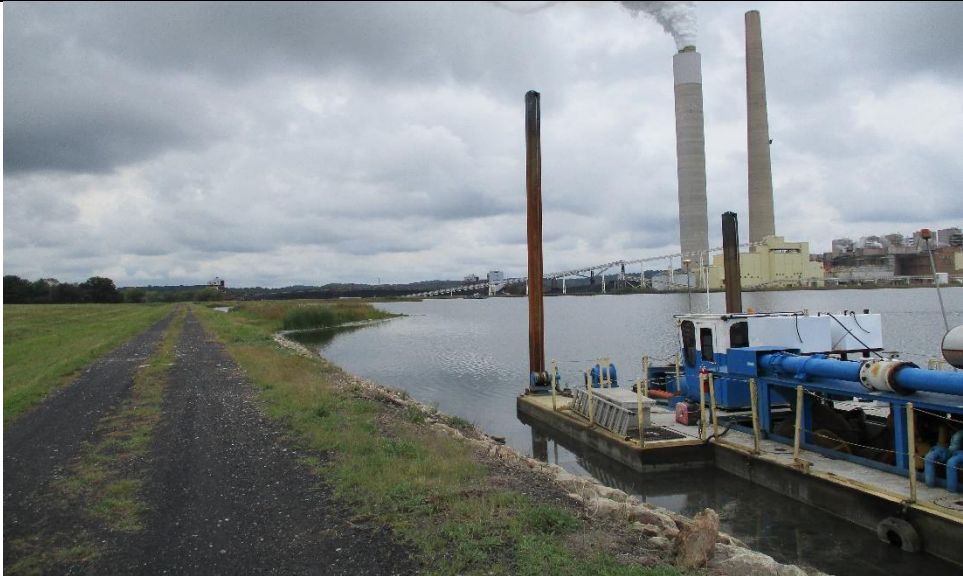
<p><u>Photograph No. 25</u></p> <p>View of the upstream slope of the north dike (looking east).</p>

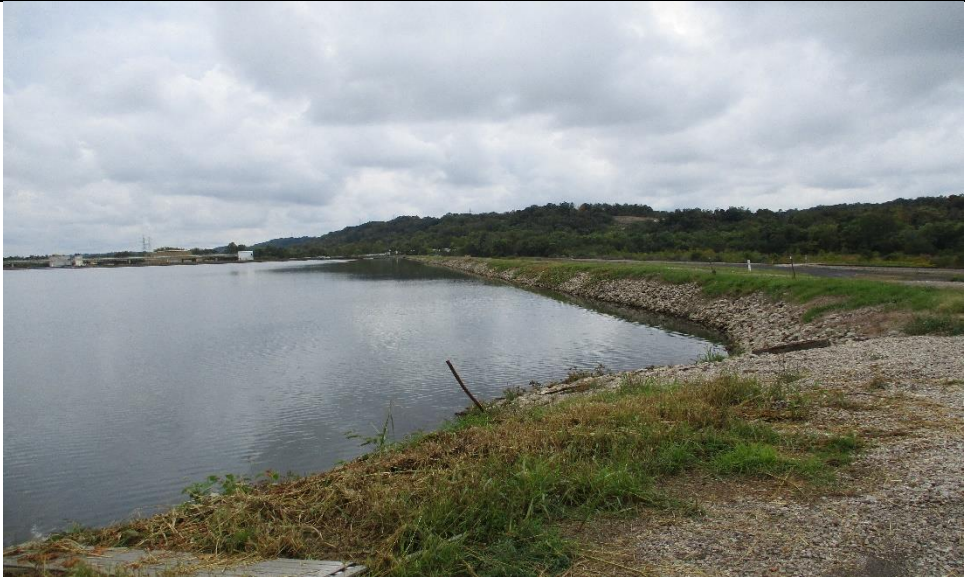
- (ii) The upstream slope of the west dike is illustrated in Photograph No. 26. The slope with riprap protection appeared in good condition with controlled vegetation in the upper section. The crest (Photograph No. 27) had no signs of distress and the access ramp (Photograph No. 28) to the perimeter road appeared good.

<p><u>Photograph No. 26</u></p> <p>The upstream slope of the west dike illustrated in this photograph. The slope appeared in good condition with riprap protection.</p>

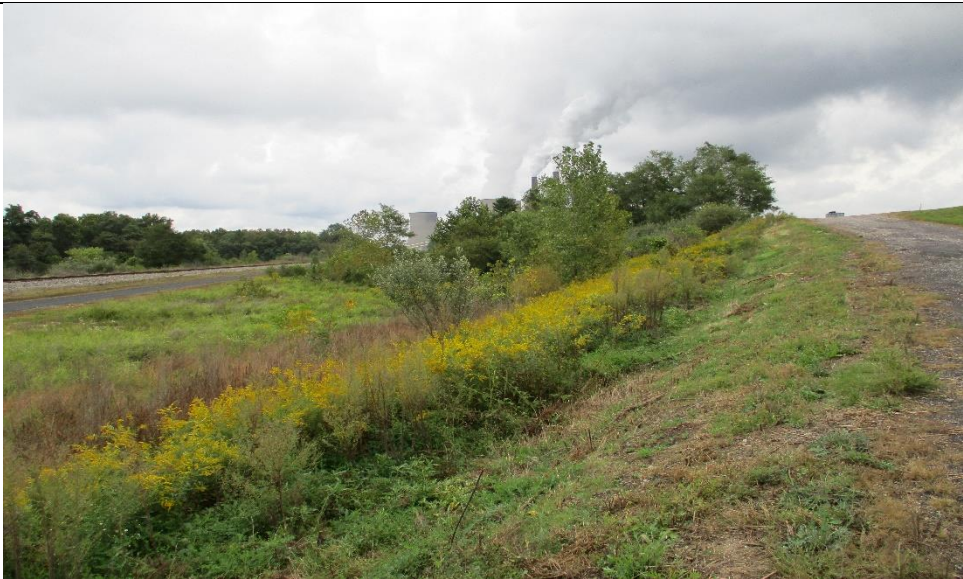
- (iii) The overall condition of the west dike downstream slope consists of several sections with riprap protection along the slope. The slope appeared in good and stable condition (Photograph No. 28). The drainage channel located at the toe of the slope indicated positive drainage but consists of thick brush and vegetation growth (Photographs No. 29

<p><u>Photograph No. 29</u></p> <p>The drainage ditch to the north illustrated in this photograph.</p>

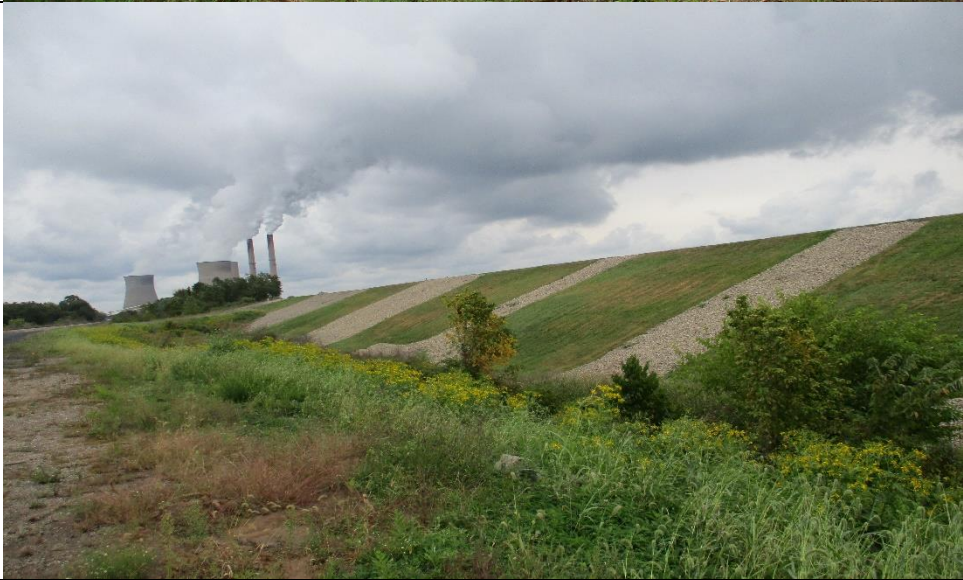
<p><u>Photograph No. 30</u></p> <p>Another view of the downstream slope and drainage ditch (looking north).</p>

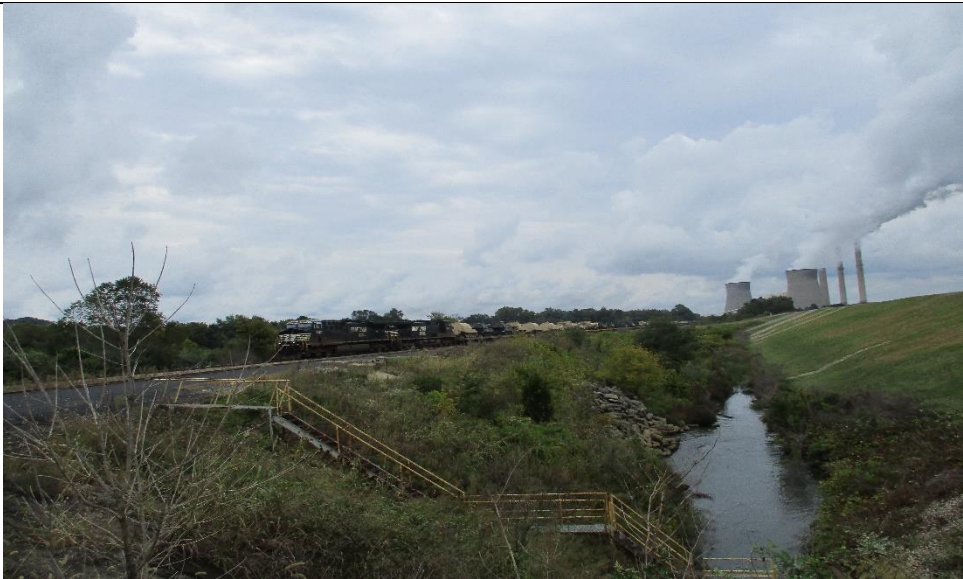
- (iv) The access structure platform, deck, and handrail to the drainage channel inlet of the outfall pipe (Photograph No. 32) appeared in fair and stable condition. The overflow decant structure is shown in Photographs No. 33. The visible concrete, security fence, railings, metal deck, stop logs, and accessories appeared in functional condition.

<p><u>Photograph No. 32</u></p> <p>This photograph illustrate the access way to the drainage ditch at the toe of the west dike. The access way deck, stair, handrail appeared in fair and functioning condition.</p>

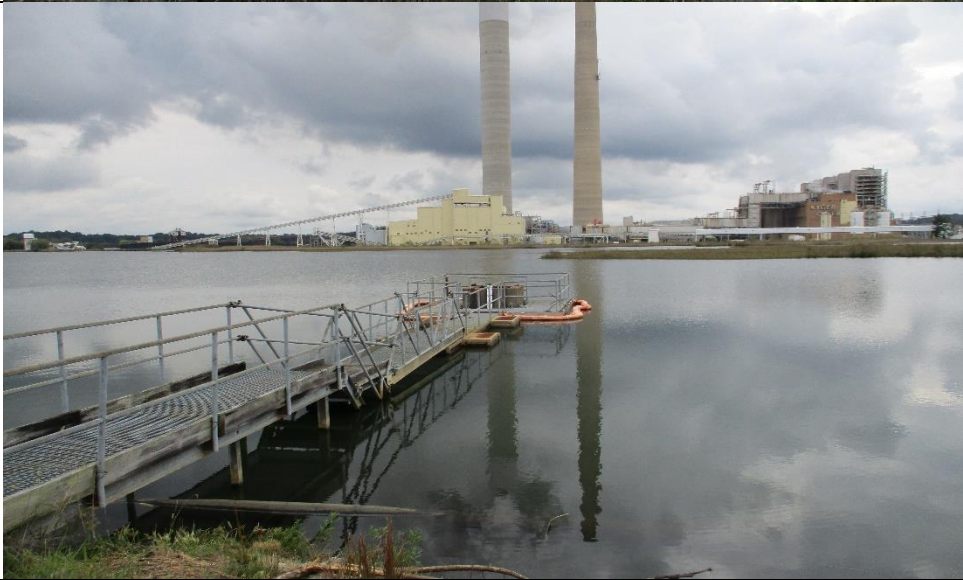
<p><u>Photograph No. 33</u></p> <p>This photograph illustrates overall view of the decant structure. The deck, handrail, walkway, and visible concrete appeared in good functional condition.</p>

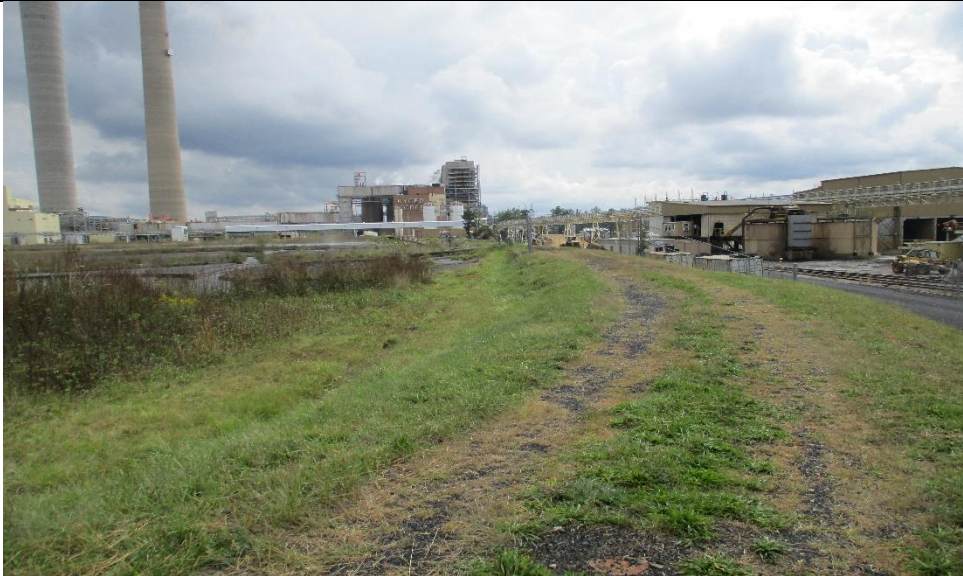
- (v) The condition of the south dike crest and downstream slope are illustrated in Photographs No. 34-36. The dike appeared in good and stable condition. A small area at the toe of the dike indicated minor water ponding (Photograph No. 35). The upstream slope of the south dike was covered due to ash fill (Photograph No. 34).

<p><u>Photograph No. 34</u></p> <p>This photograph illustrate the condition of the crest and upstream slope of the south dike.</p>

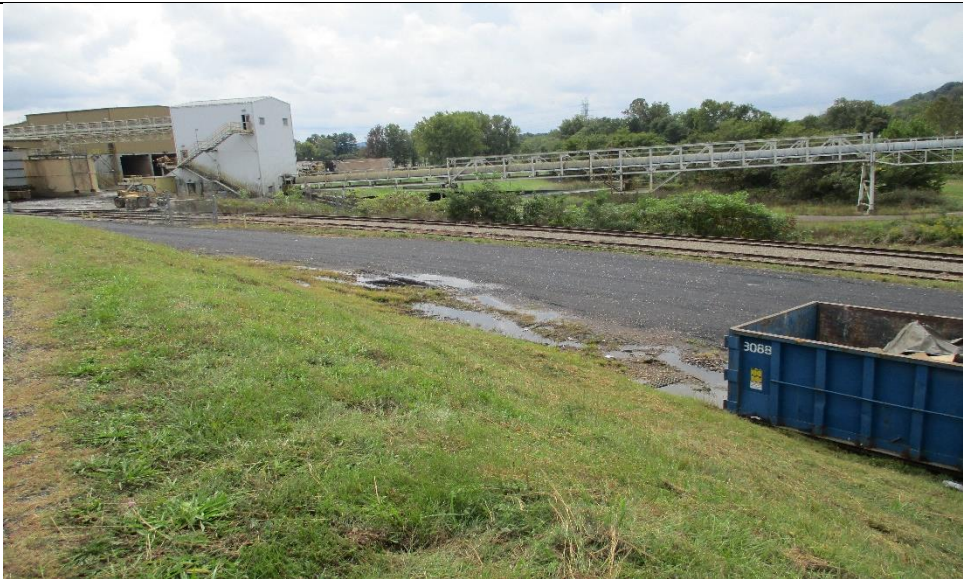
<p><u>Photograph No. 35</u></p> <p>The toe of the downstream slope indicated a small area with standing water.</p>

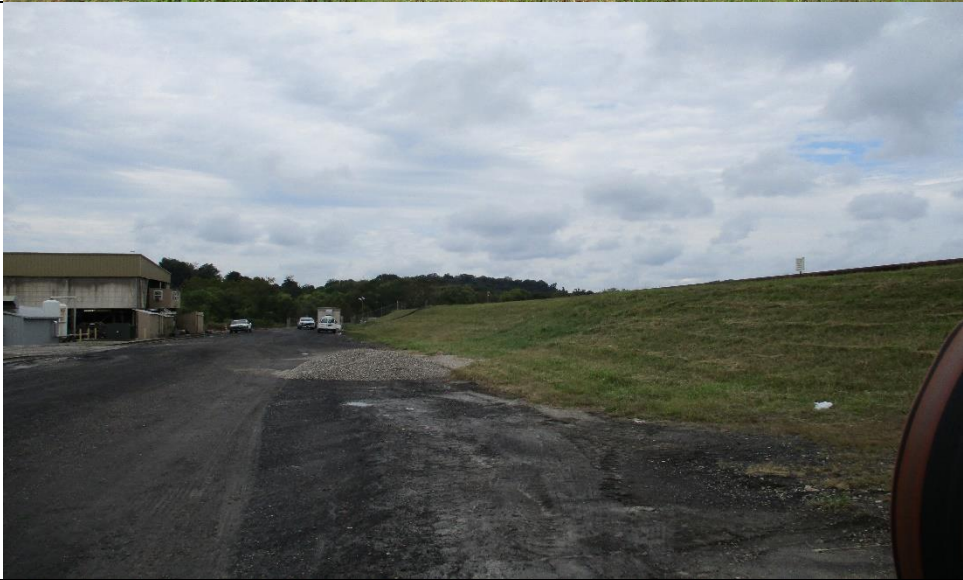
<p><u>Photograph No. 36</u></p> <p>This photograph illustrate downstream slope (looking west), appeared in good and stable condition.</p>

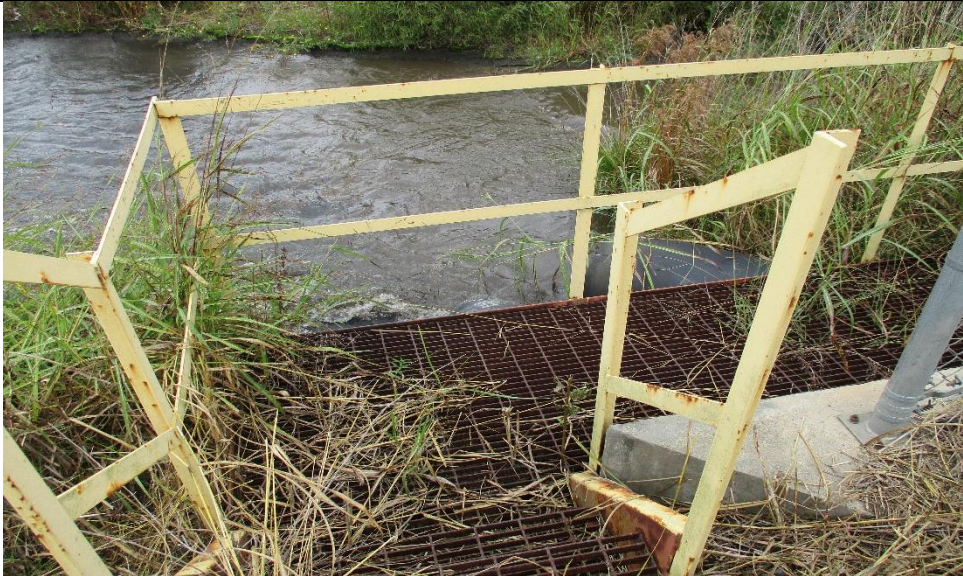
- (vi) The discharge pipe and its supported structure located at the southeast corner (Photograph No. 37) appeared in good and stable condition.
- (vii) Photographs No. 38 and 39 illustrates access structure and the outfall from the fly ash pond. The access structure was in fair and stable condition. The outfall from the pond to the Kyger Creek appeared well protected from erosion and was in satisfactory condition with proper outflow. Riprap around the exposed pipe and immediate channel area appeared in good condition with positive flow.

<p><u>Photograph No. 37</u></p> <p>The discharge pipes at the southeast corner appeared in functional condition.</p>

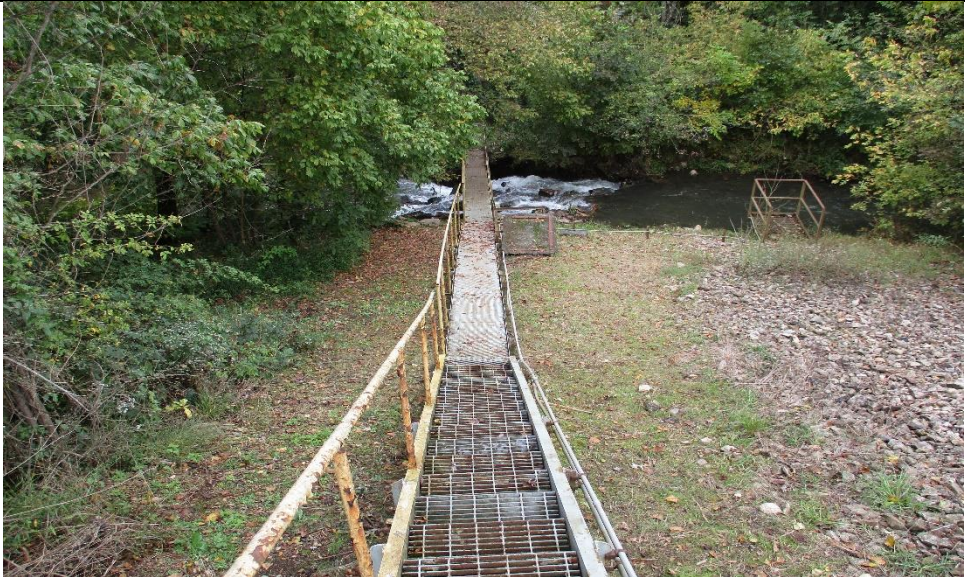
<p><u>Photograph No. 38</u></p> <p>This photograph illustrate the access way to the drainage ditch to the outfall pipe. The access way deck, stair, handrail appeared in fair and functioning condition.</p>

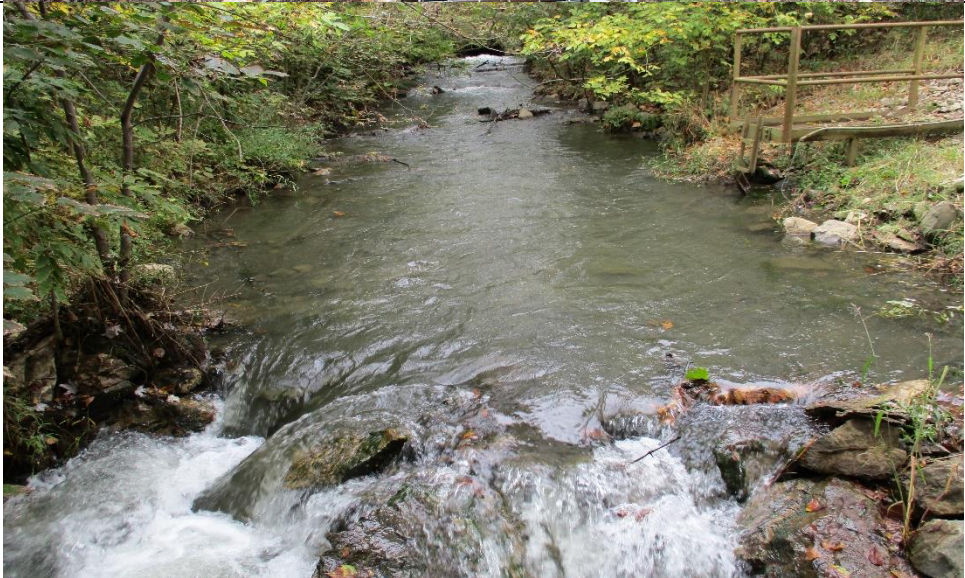
<p><u>Photograph No. 39</u></p> <p>The outfall from the fly ash pond is shown in this photograph. The concrete pipe, riprap, and surrounding slopes were found in good condition</p>

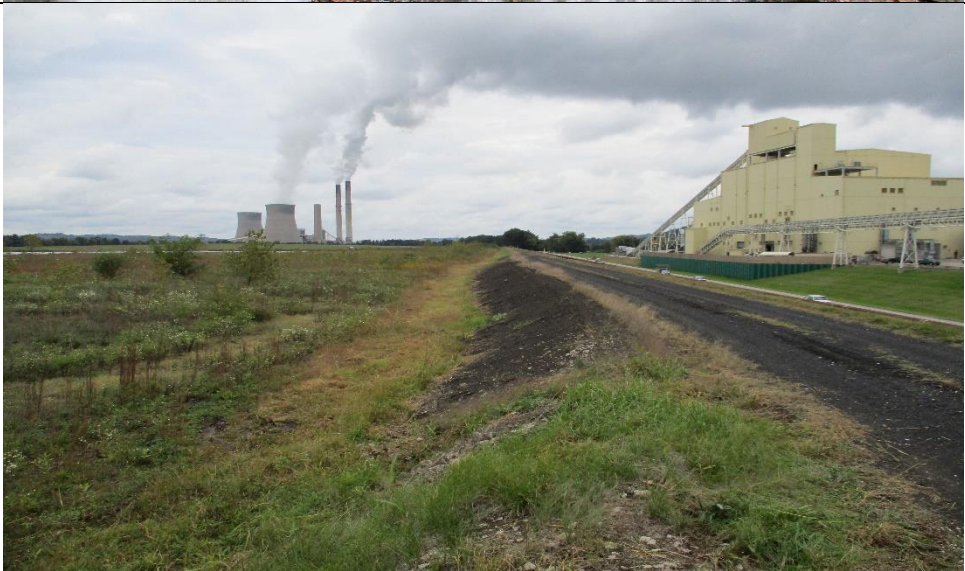
- (viii) The upstream slope and crest of the dike is illustrated in Photograph No. 40. The upstream slope of this dike was covered due to ash fill. The ash sluice pipe shown in Photograph No. 41 indicated unobstructed flow condition, but excessive vegetation was present in this area.

<p><u>Photograph No. 40</u></p> <p>Typical view of the upstream slope illustrated in this photograph (looking north).</p>

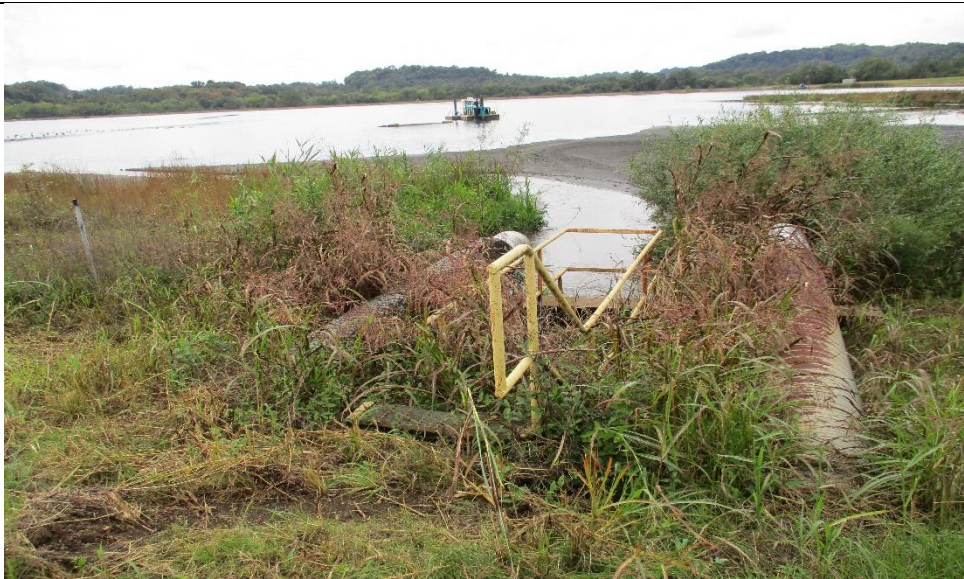
Photograph No. 41  
Ash discharge pipes at the east dike upstream slope appeared in good and functional condition.
