# **2020 Annual Dam and Dike Inspection Report**

**Bottom Ash Pond Complex  
South Fly Ash Pond**

**Kyger Creek Plant  
Ohio Valley Electric Corporation (OVEC)  
Gallia County, Ohio**

**October 2020**

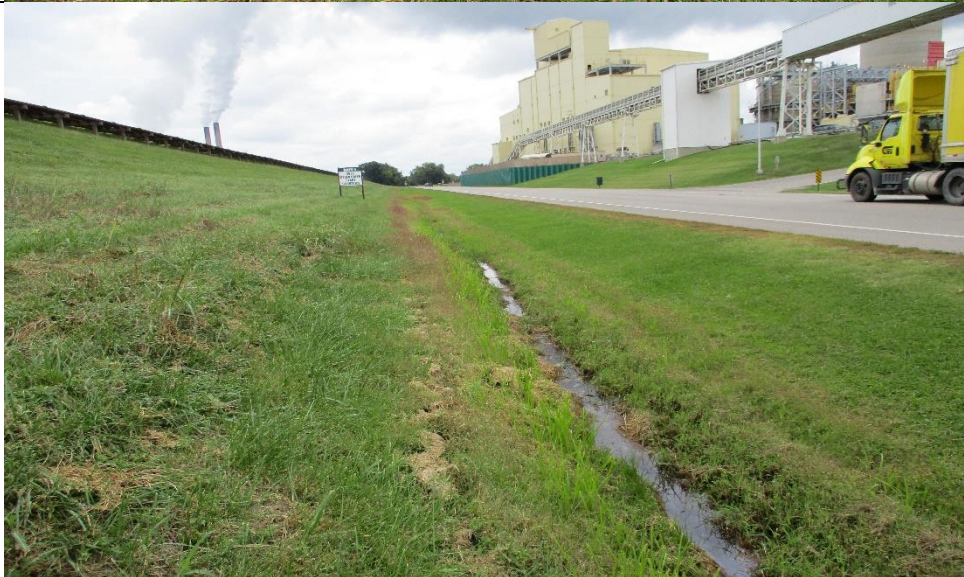
- (ix) The downstream slope is illustrated in Photograph No. 42. Overall, the slope appeared in good and stable condition with good vegetation control. Typical condition of the previously seepage section is shown in Photograph No. 43. These repaired areas along the slope were found to be stable and properly maintained. The toe ditch appeared to have unobstructed flow condition but stagnant water condition was noticed at the pipe culvert (Photograph No. 44).

Photograph No. 42  
The downstream slope illustrated in this photograph (looking north).

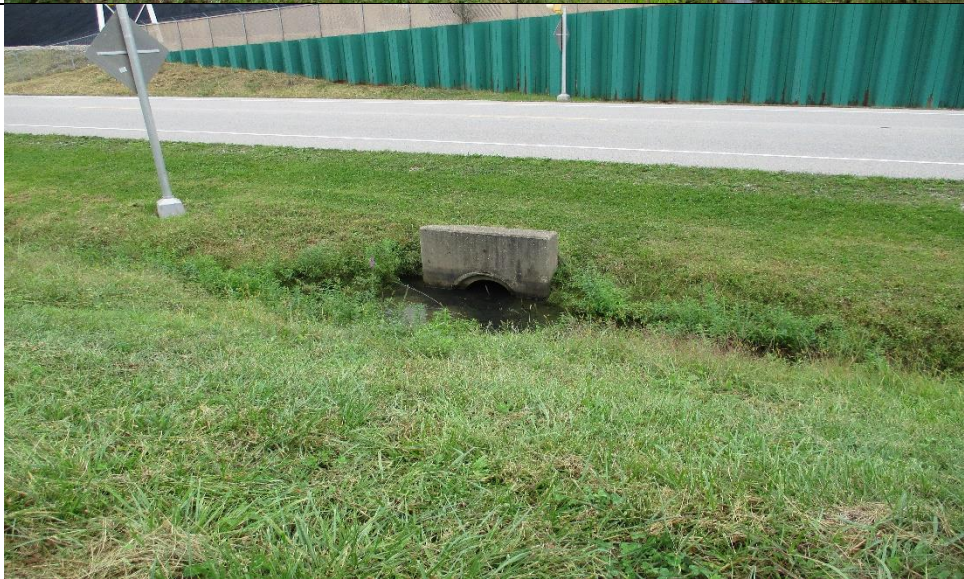
Photograph No. 43  
The toe ditch at the east dike downstream slope and the drainage pipe culvert.

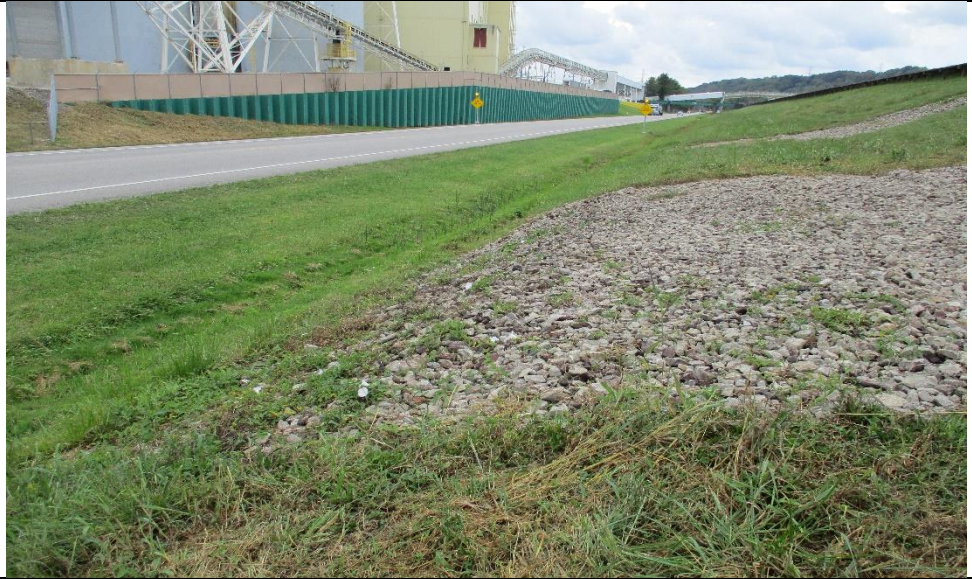
Photograph No. 44

Typical repair section with rock surface is illustrated in this photograph.

- (i) The plant is actively performing maintenance in controlling vegetation along the crest and the interior/exterior embankment slopes. A few small locations in close proximity to the lower section close to the drainage channel along the west embankment slope exhibited excessive vegetation. The vegetation should be periodically mowed to prevent woody vegetation or controlled growth through the application of herbicide to facilitate inspection of these areas.
- (ii) The root cause of poor drainage at the pipe culvert located at the east dike adjacent to the SR 7 shall be properly investigated. Based on the findings repair shall be performed so that the water is free flowing through the culvert.
