October 17, 2016
File: 175534017
Revision 0

**RE: Initial Structural Stability Assessment
South Fly Ash Pond
EPA Final Coal Combustion Residuals (CCR) Rule
Kyger Creek Station
Cheshire, Gallia County, Ohio**

Initial Structural Stability Assessment

Kyger Creek Station
South Fly Ash Pond
Cheshire, Gallia County, Ohio

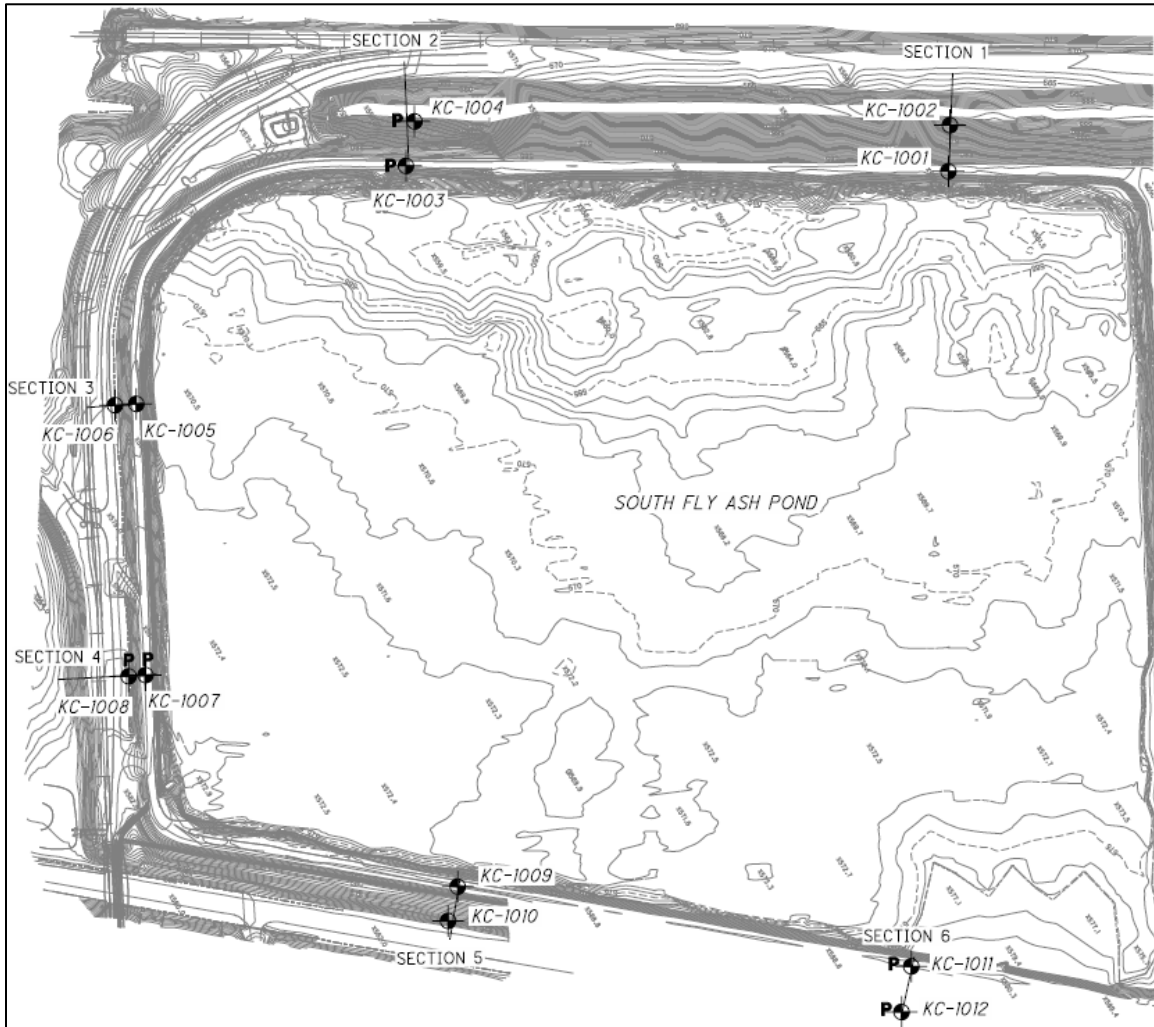
Figure 1 Kyger Creek Station South Fly Ash Pond – Plan View of Cross Sections (DLZ, 2015)

Slope stability analyses were available from DLZ (2015). Six cross sections from the South Fly Ash Pond were analyzed under static, steady-state conditions using the maximum surcharge pool. The six sections that were analyzed were labeled Sections 1 through 6 and are shown below in Figure 1.

The summary of the slope stability results from DLZ (2015) is listed in Table 2. The pond levels were set at the 50% PMF elevation (586.0 feet for the South Fly Ash Pond). The tailwater was set near the surface of the toe.

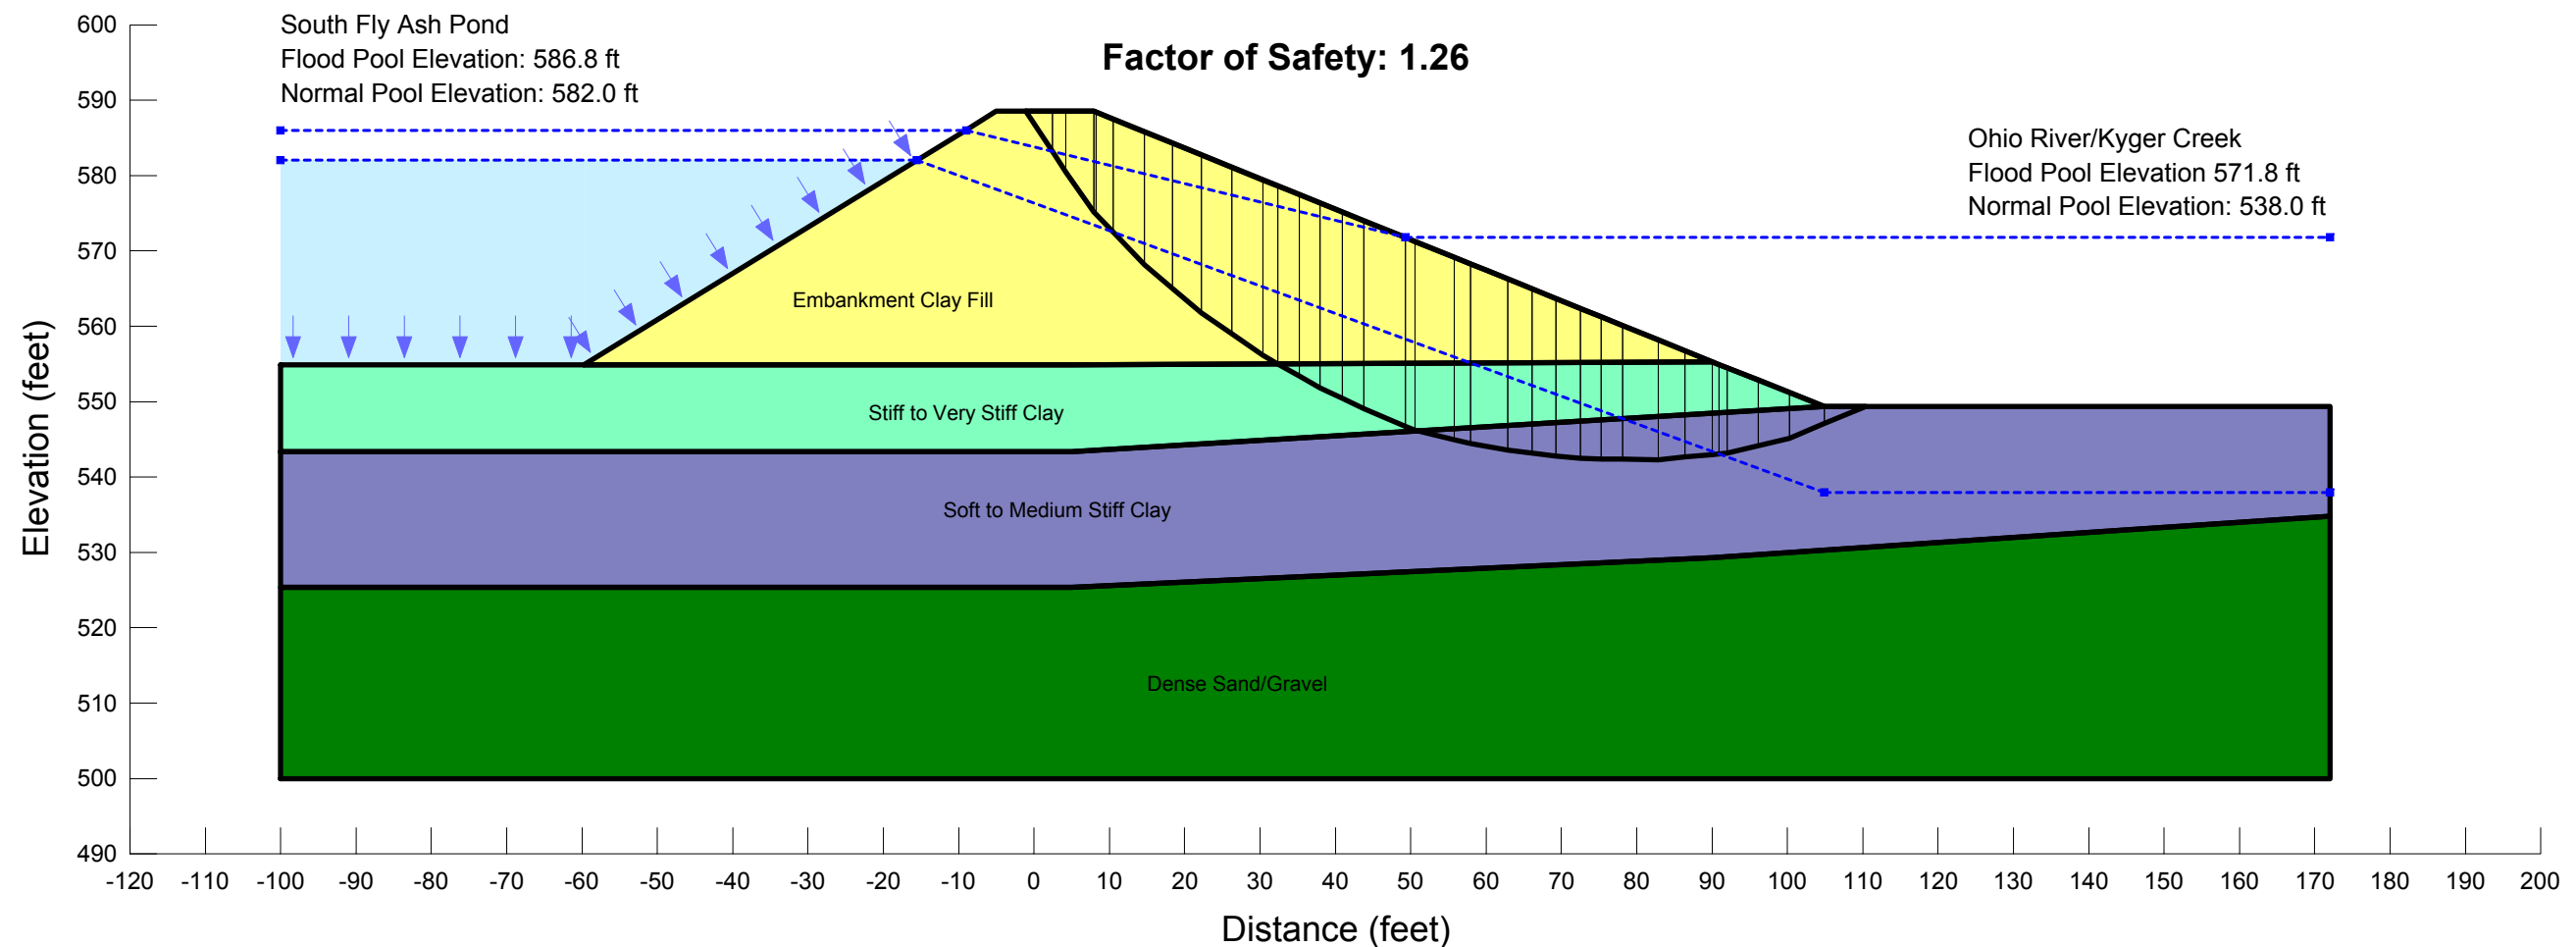
Ohio Valley Electric Corporation Kyger Creek Station South Fly Ash Pond Cheshire, Ohio Section 2

The slope stability assessment presented in this report is focused on the potential for slope failures of significant mass, which could directly impact potential release of water and CCR materials from the South Fly Ash Pond. The search for a critical slip surface in the slope stability assessments is thus restricted to consider only potential surfaces where the depth (measured at the base of at least one slice) is more than ten feet vertically below the ground surface. Table 4 summarizes the sudden drawdown safety factor evaluation results at the South Fly Ash.

Facility	Cross Section	EPA Final CCR Rule Criteria	Recommended Factor of Safety Criteria	Calculated Factor of Safety
South Fly Ash Pond	2	Sudden Drawdown	1.1	1.3
