**Re: Ohio Valley Electric Corporation
Kyger Creek Station
Notification of CCR Location Restrictions Posting**

**RE: Location Restrictions Compliance Demonstrations
South Fly Ash Pond
EPA Final Coal Combustion Residuals (CCR) Rule
Kyger Creek Station
Cheshire, Gallia County, Ohio**

**COMPLIANCE DEMONSTRATION REPORT – SEISMIC IMPACT ZONES
SOUTH FLY ASH POND
KYGER CREEK STATION**

**COMPLIANCE DEMONSTRATION REPORT –
UNSTABLE AREAS
SOUTH FLY ASH POND
KYGER CREEK STATION**

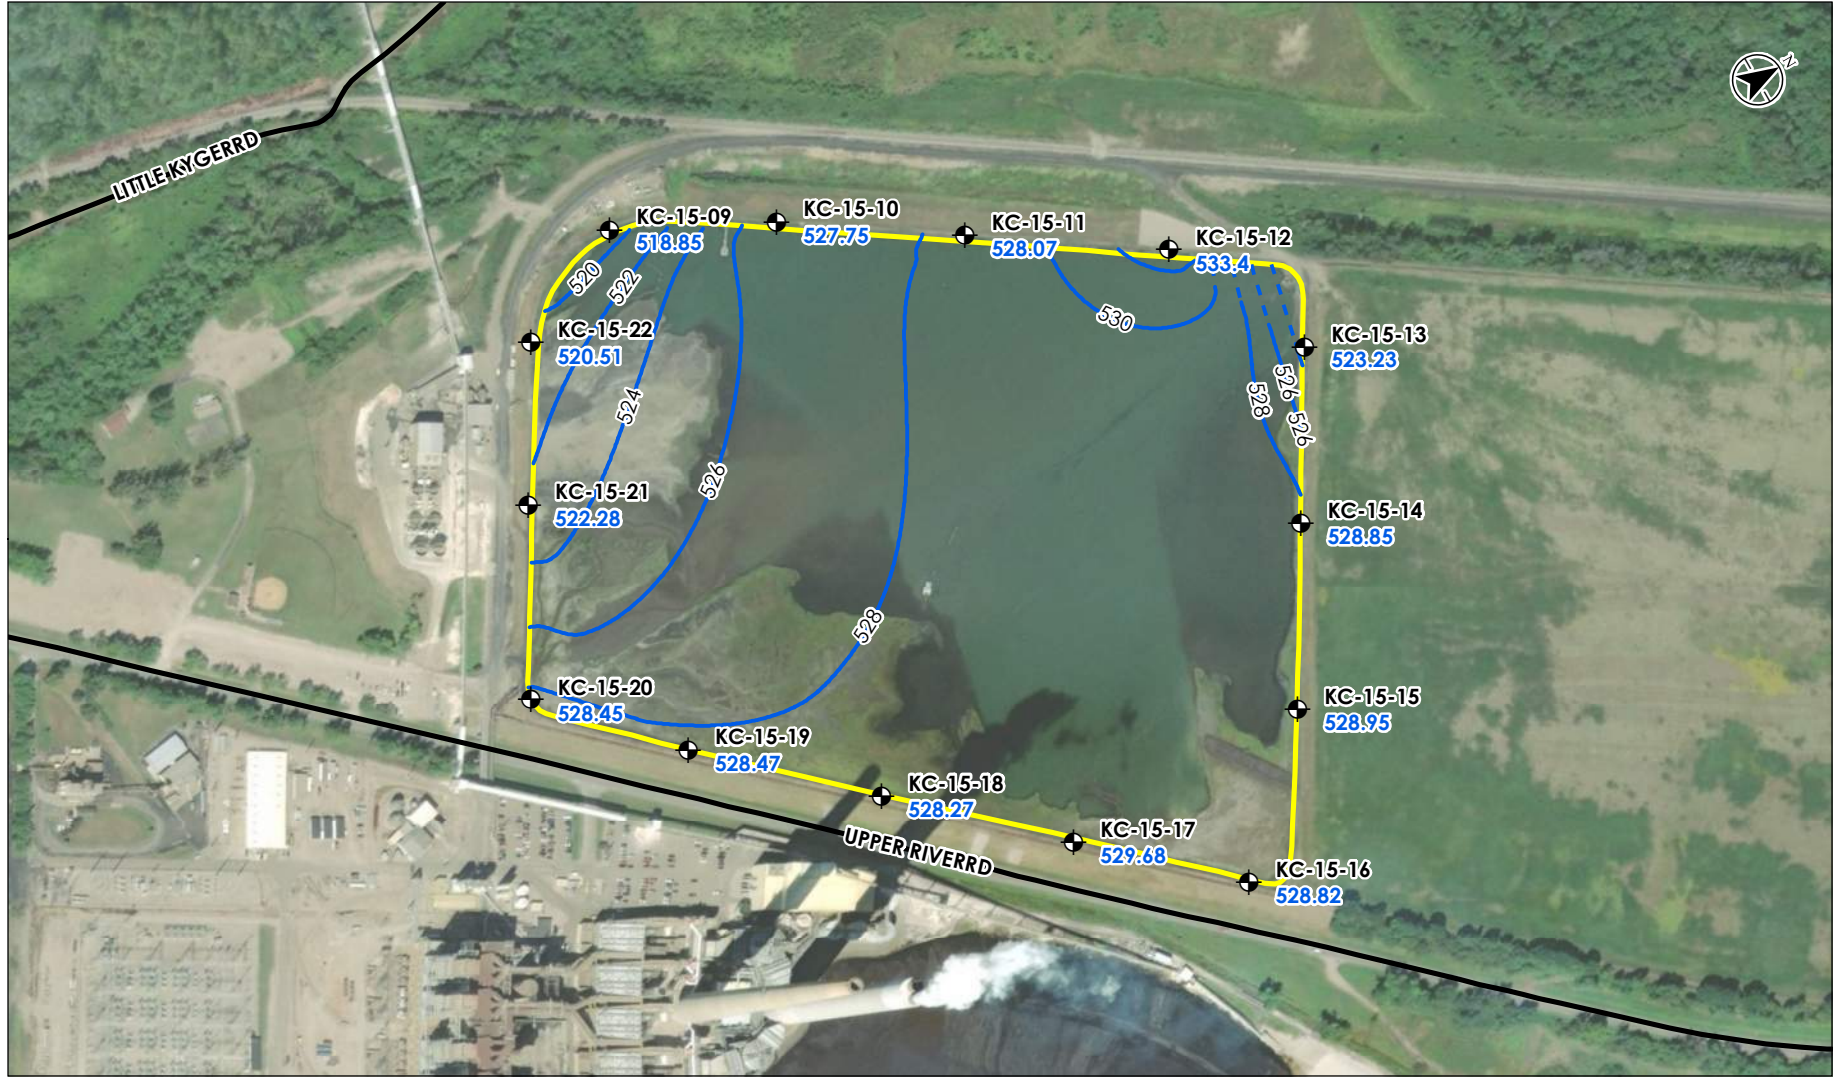
- Monitoring Well
- Interpolated top of Uppermost Aquifer (C.I. - 2 feet)
- Extrapolated top of Uppermost Aquifer (C.I. - 2 feet)
- Site Boundary
- Road

The review of groundwater elevation data indicates that groundwater within the UMA is generally present under confined conditions; therefore, the top of the UMA beneath the SFAP is defined based on the structure of the top of the UMA.

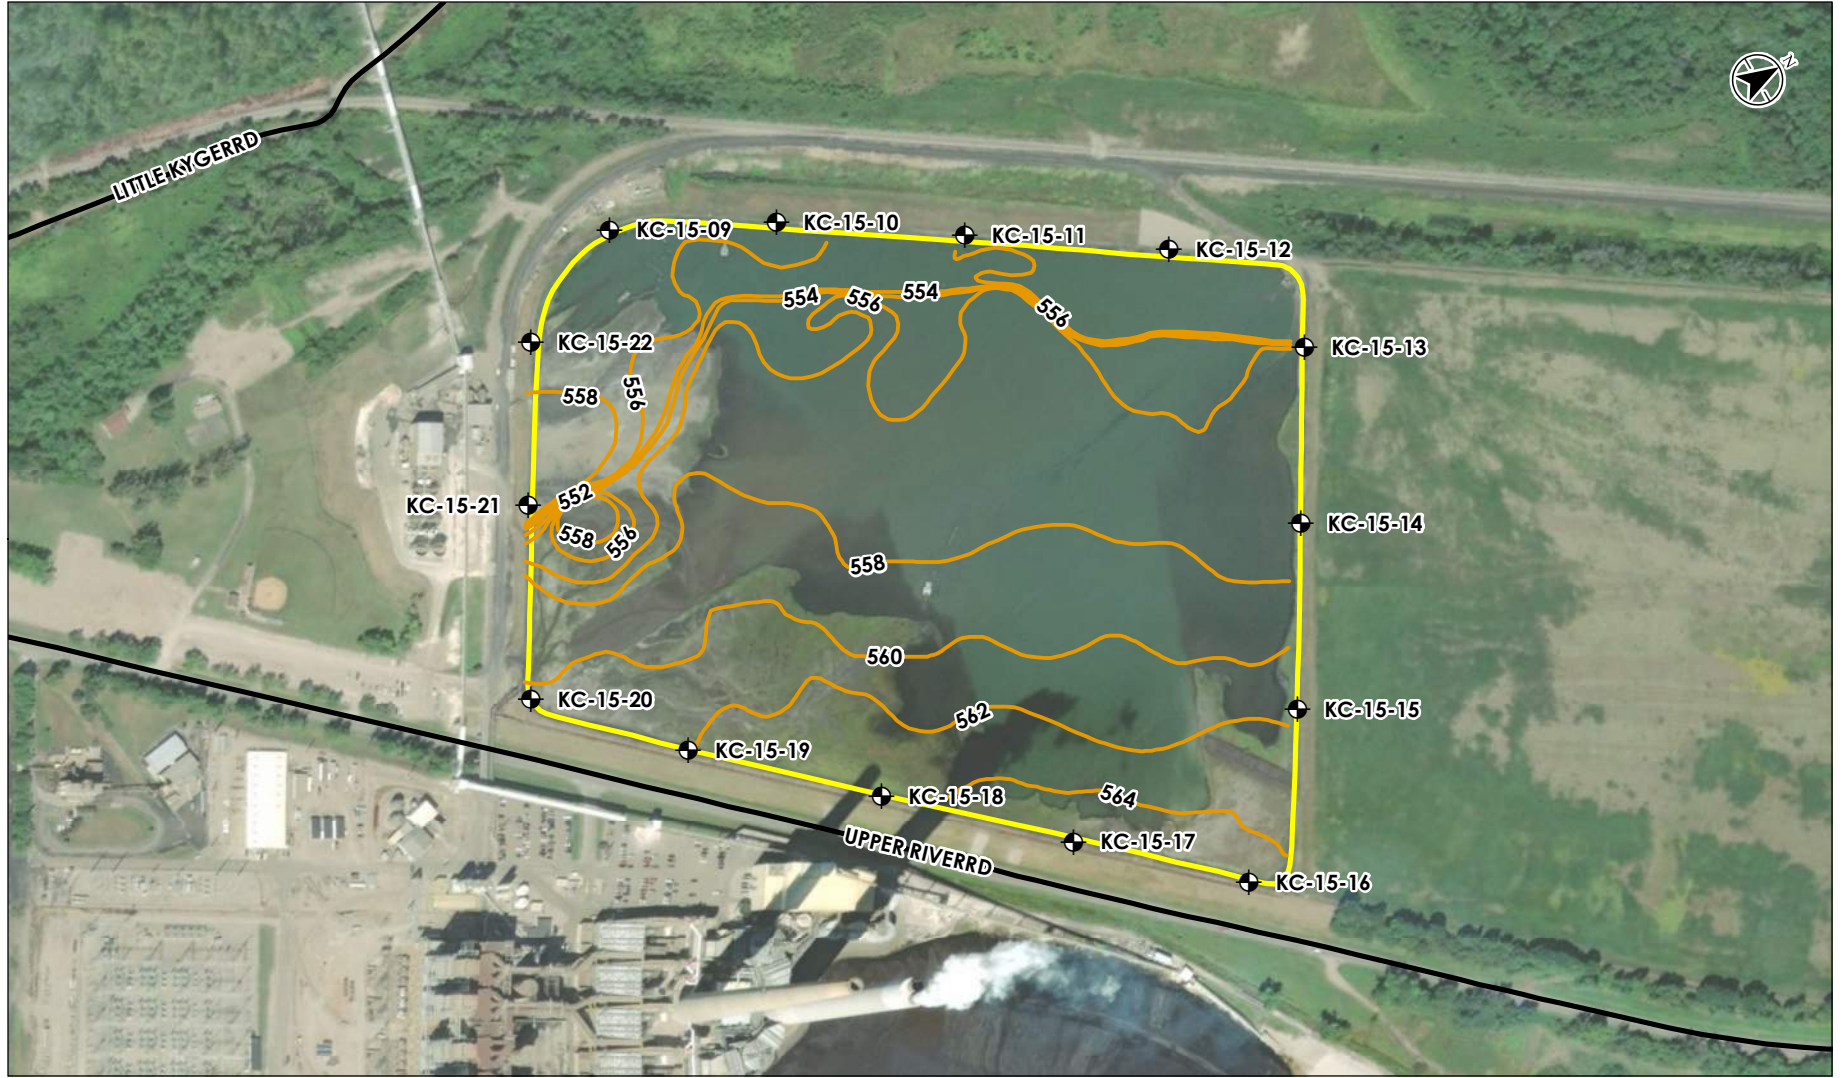
Title
**ESTIMATED AFFECTED BOUNDARY
 (BASE OF CCR UNIT)
 SOUTH FLY ASH POND**

- Monitoring Well
- Pre-Construction Ground Surface (AEP, 2016) (C.I. - 2 feet)
- Site Boundary
- Road

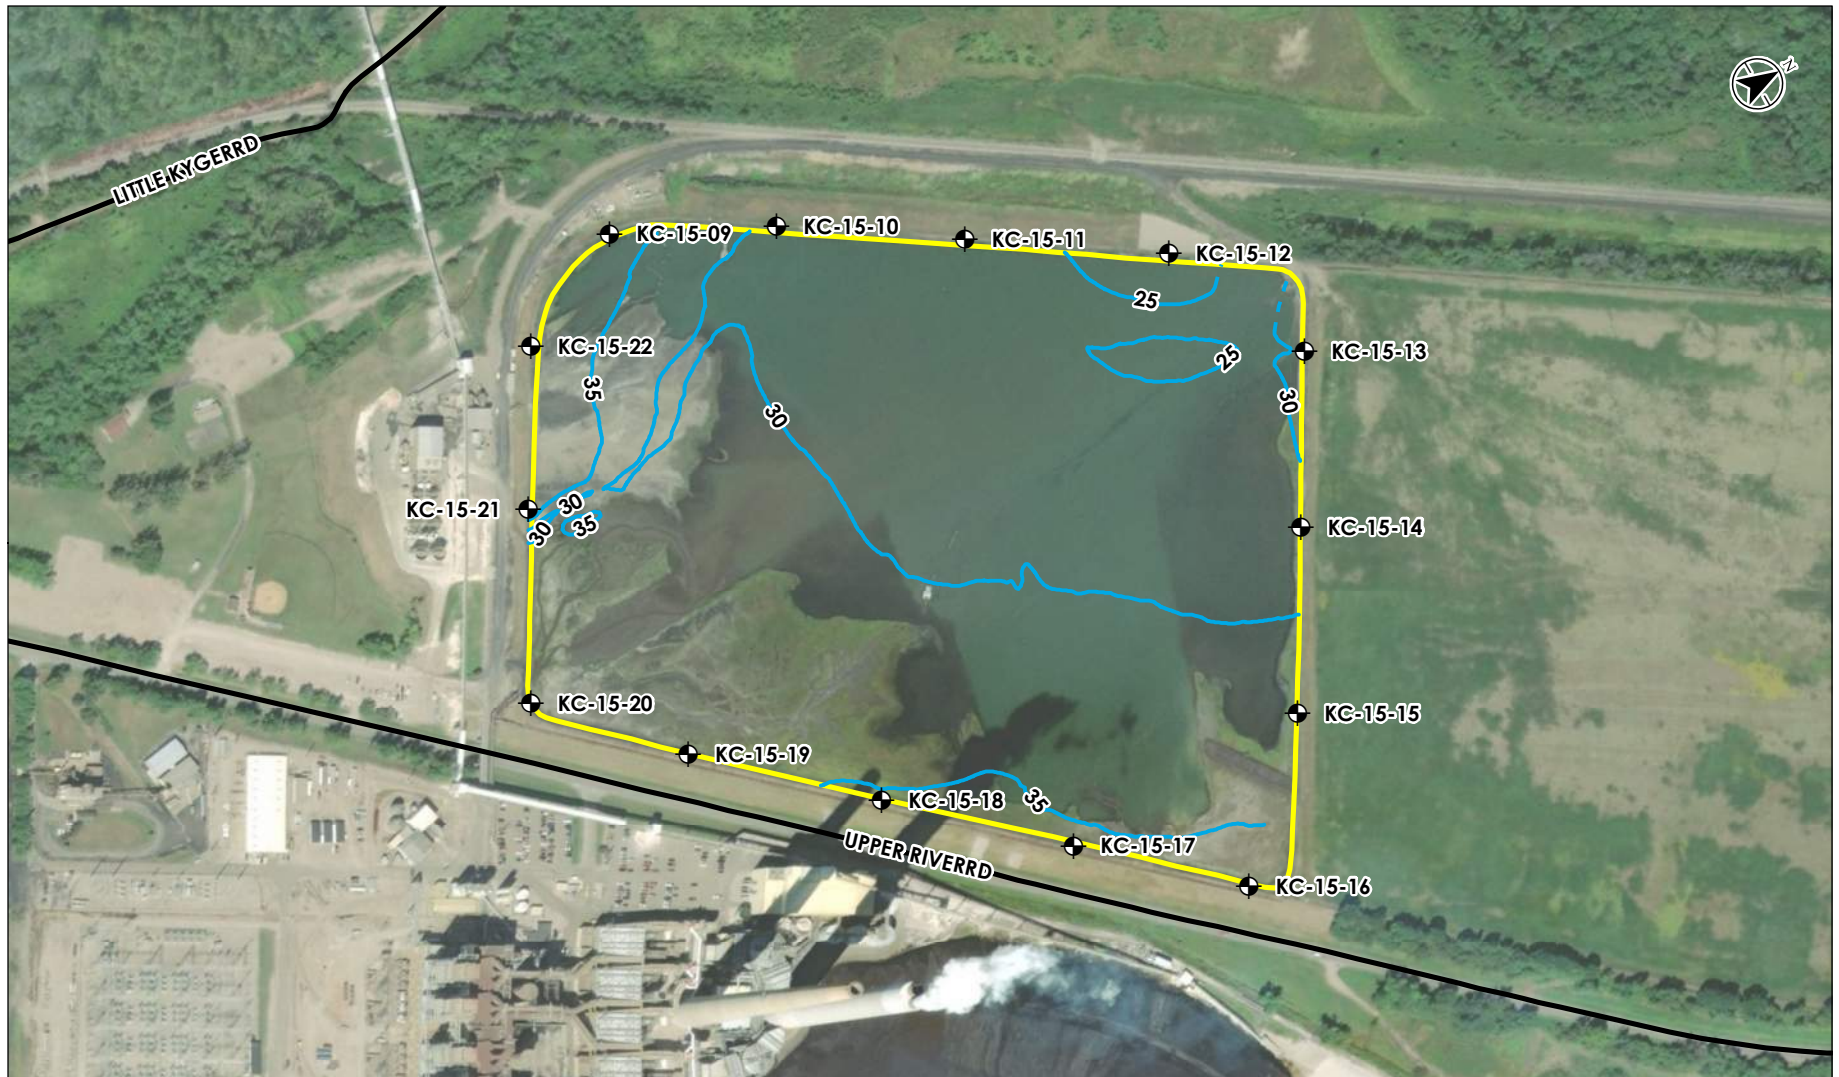
- Monitoring Well
- Interpolated Isopach Thickness of Separation (Bottom of CCR - Top of UMA) (C.I. = 5 feet)
- Extrapolated Isopach Thickness of Separation (Bottom of CCR - Top of UMA) (C.I. = 5 feet)
- Site Boundary
- Road

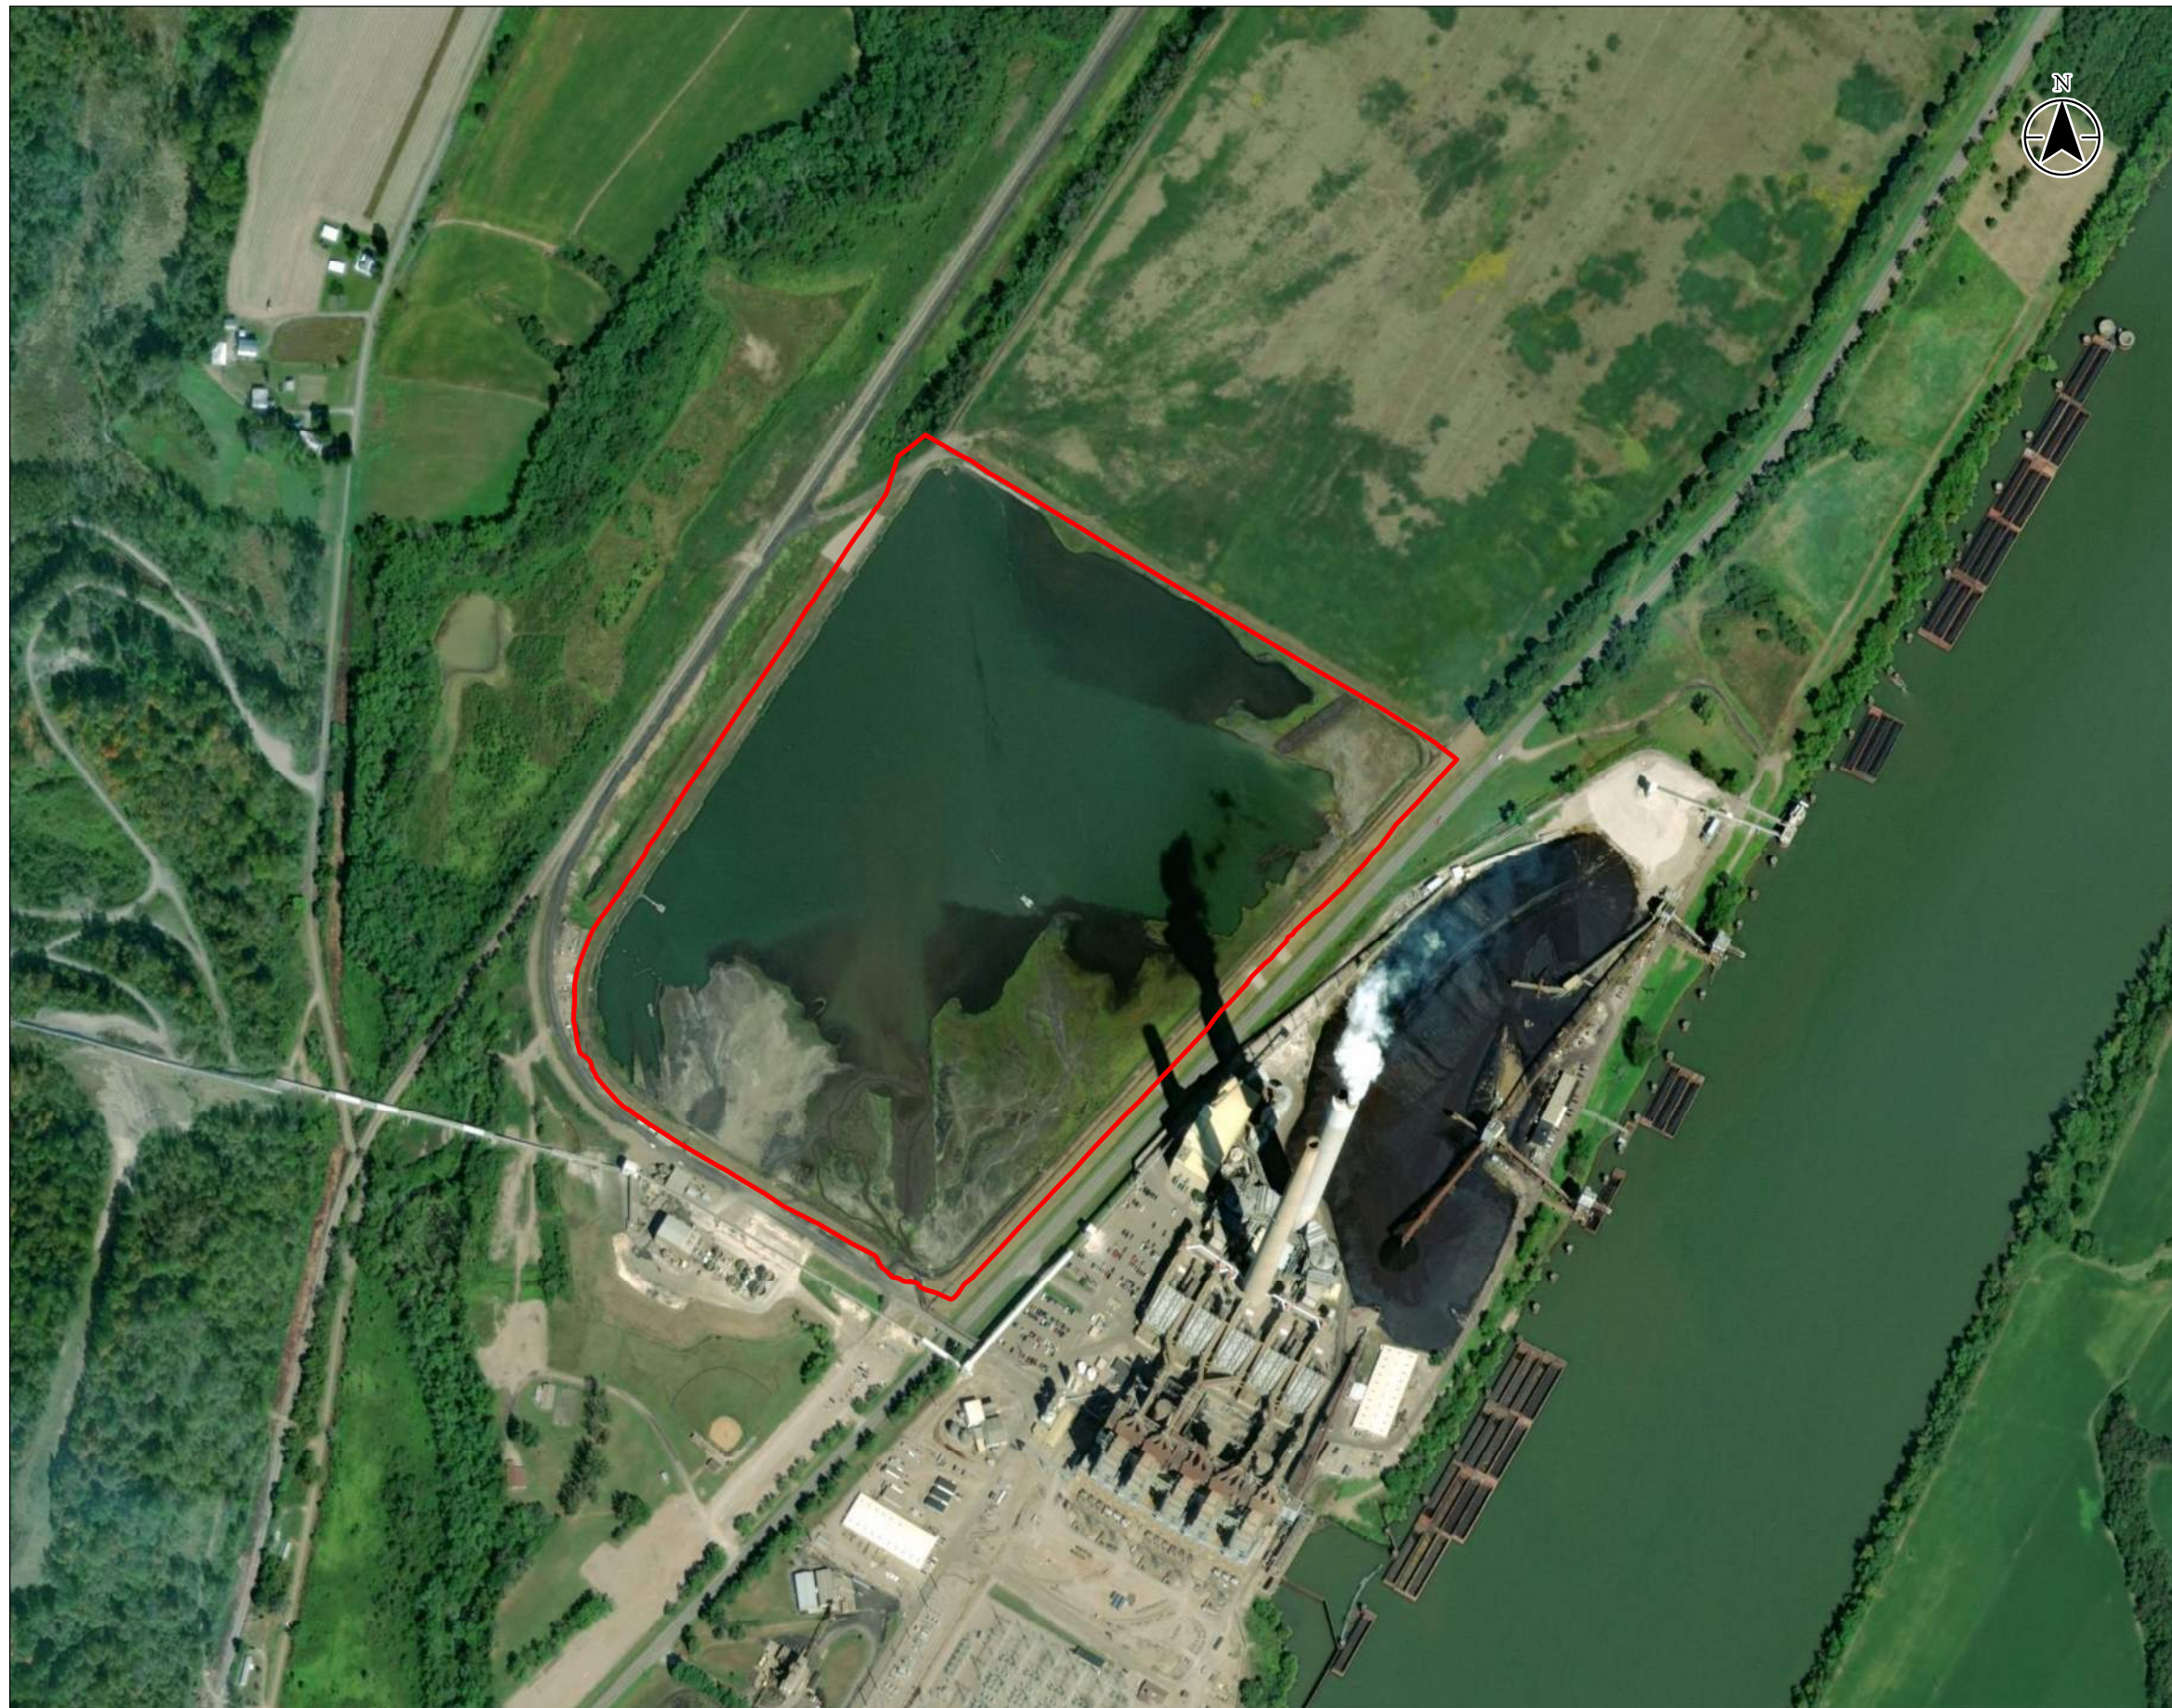
Study Area

- Notes
- 1. Coordinate System: NAD 1983 StatePlane Ohio South FIPS 3402 Feet
 - 2. ImagerySource: Esri, DigitalGlobe, GeoEye, Earthstar Geographics, CNES/Airbus DS, USDA, USGS, AEX, Getmapping, Aerogrid, IGN, IGP, swisstopo, and the GIS User Community
 - 3. No hydric soils are located within the project area

The reconnaissance investigation was conducted on May 9, 2018. Stantec biologists conducted a pedestrian survey to ascertain whether any areas of potential wetlands were present within the South Fly Ash Pond CCR Unit boundary. Upland plant communities typical of the region were the main species observed. Vegetation within the immediate vicinity of the unit boundary was predominately maintained grass turf vegetation. No wetland indicators were observed within the South Fly Ash Pond study area.

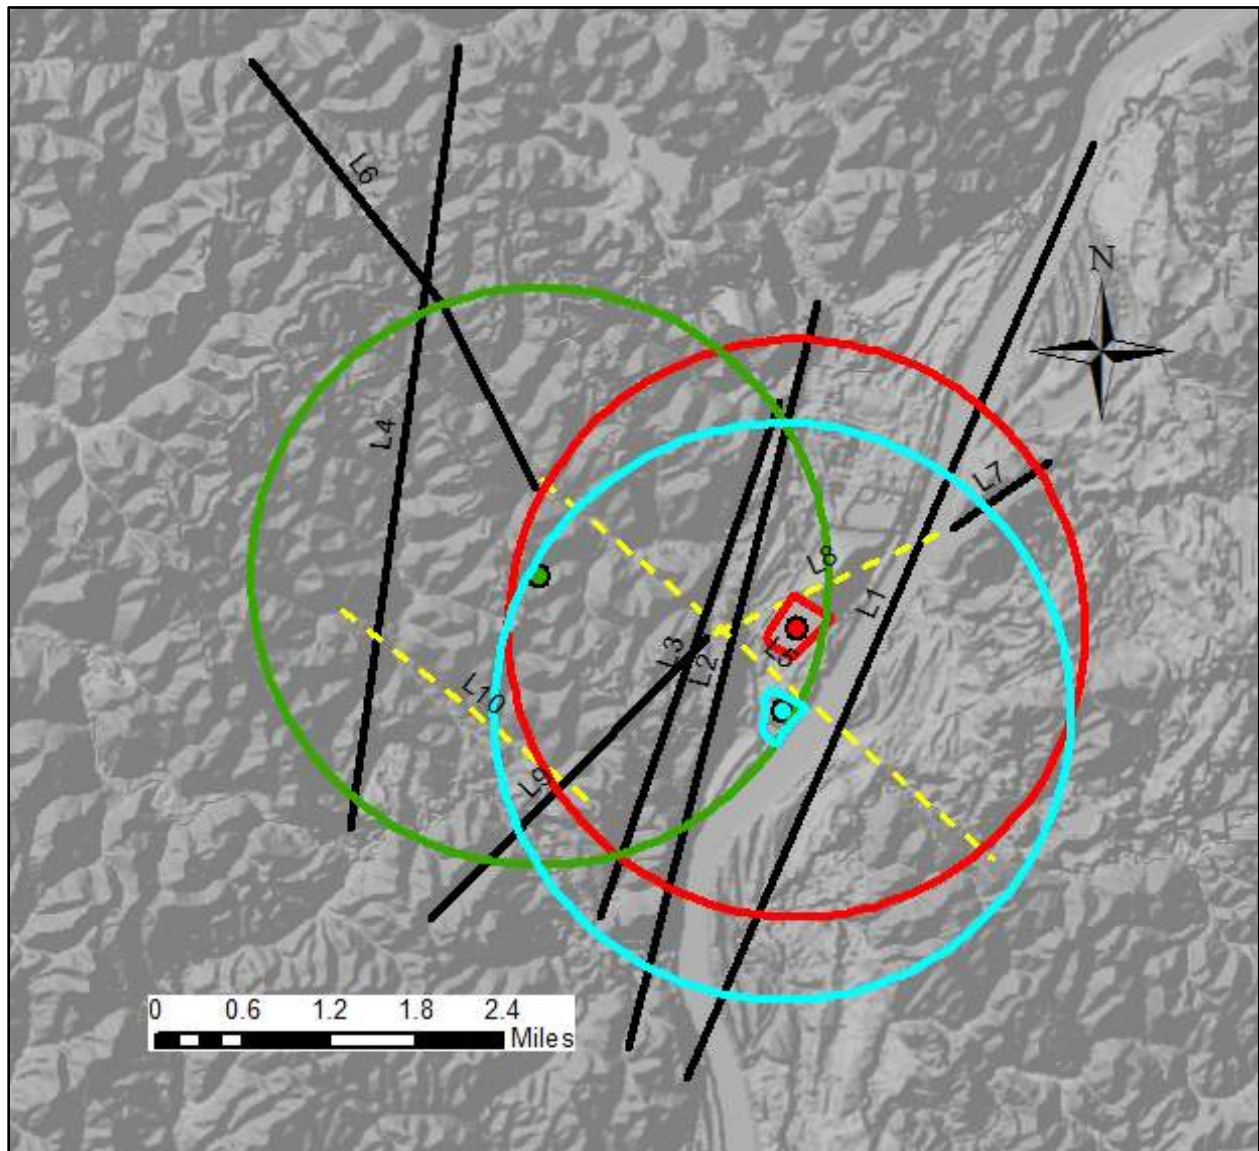
Figure 3-1 Mapped Lineaments (Black) and Inferred Lineaments (Yellow dashed) Overlain on LiDAR Image

Lineament	Trend	Comments
L1	SW-NE	Ohio River Valley
L2	NNE-SSW	Contact between Quaternary alluvium and Pennsylvanian bedrock
L3	NNE-SSW	Contact between Quaternary alluvium and Pennsylvanian bedrock
L4	N-S	No evidence of active faulting
L5	NW-SE	Inferred lineament near the SFAP and BSP obscured by Quaternary alluvium
L6	NW-SE	Prominent river valley
L7	SW-NE	Follows regional trend of faults and folds in the Appalachian Plateau
L8	SW-NE	Inferred, covered by Quaternary alluvium
L9	SW-NE	Follows regional trend of faults and folds in the Appalachian Plateau
L10	NW-SE	Prominent river valley

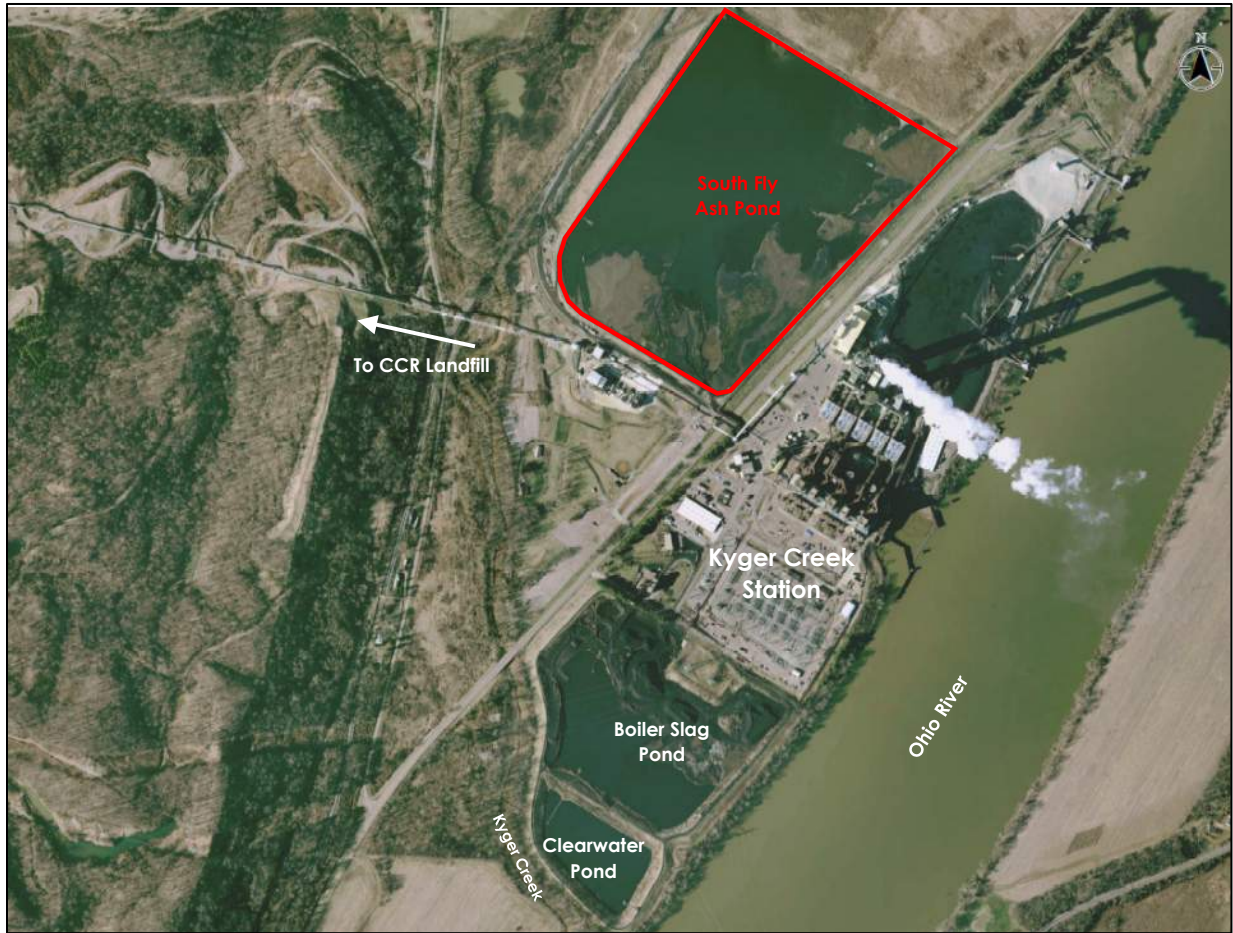
Figure 1. Aerial View of Kyger Creek Station

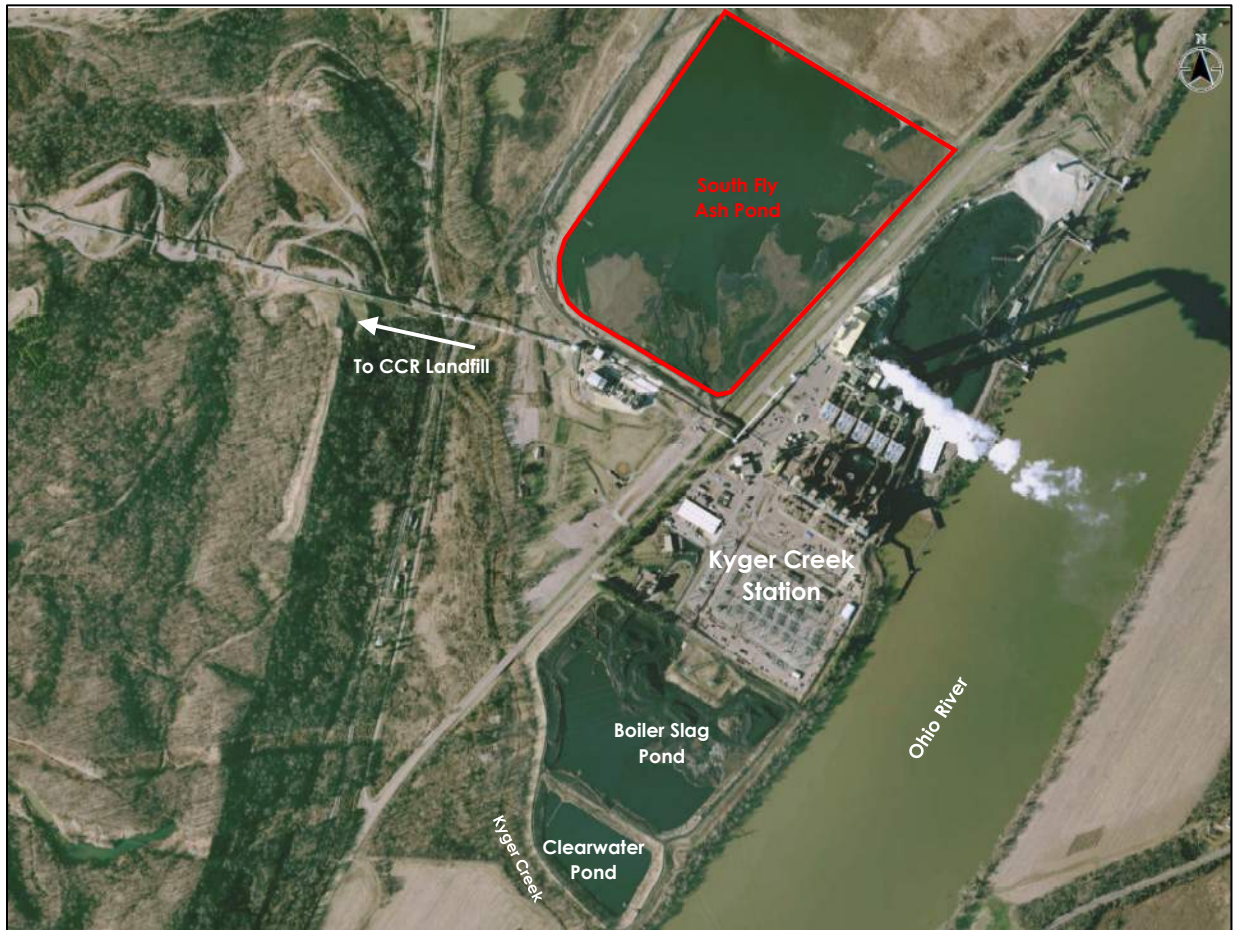
Figure 1 below presents an overview of the Kyger Creek Station and related appurtenances including the main plant and the South Fly Ash Pond.

Figure 1. Aerial View of Kyger Creek Station

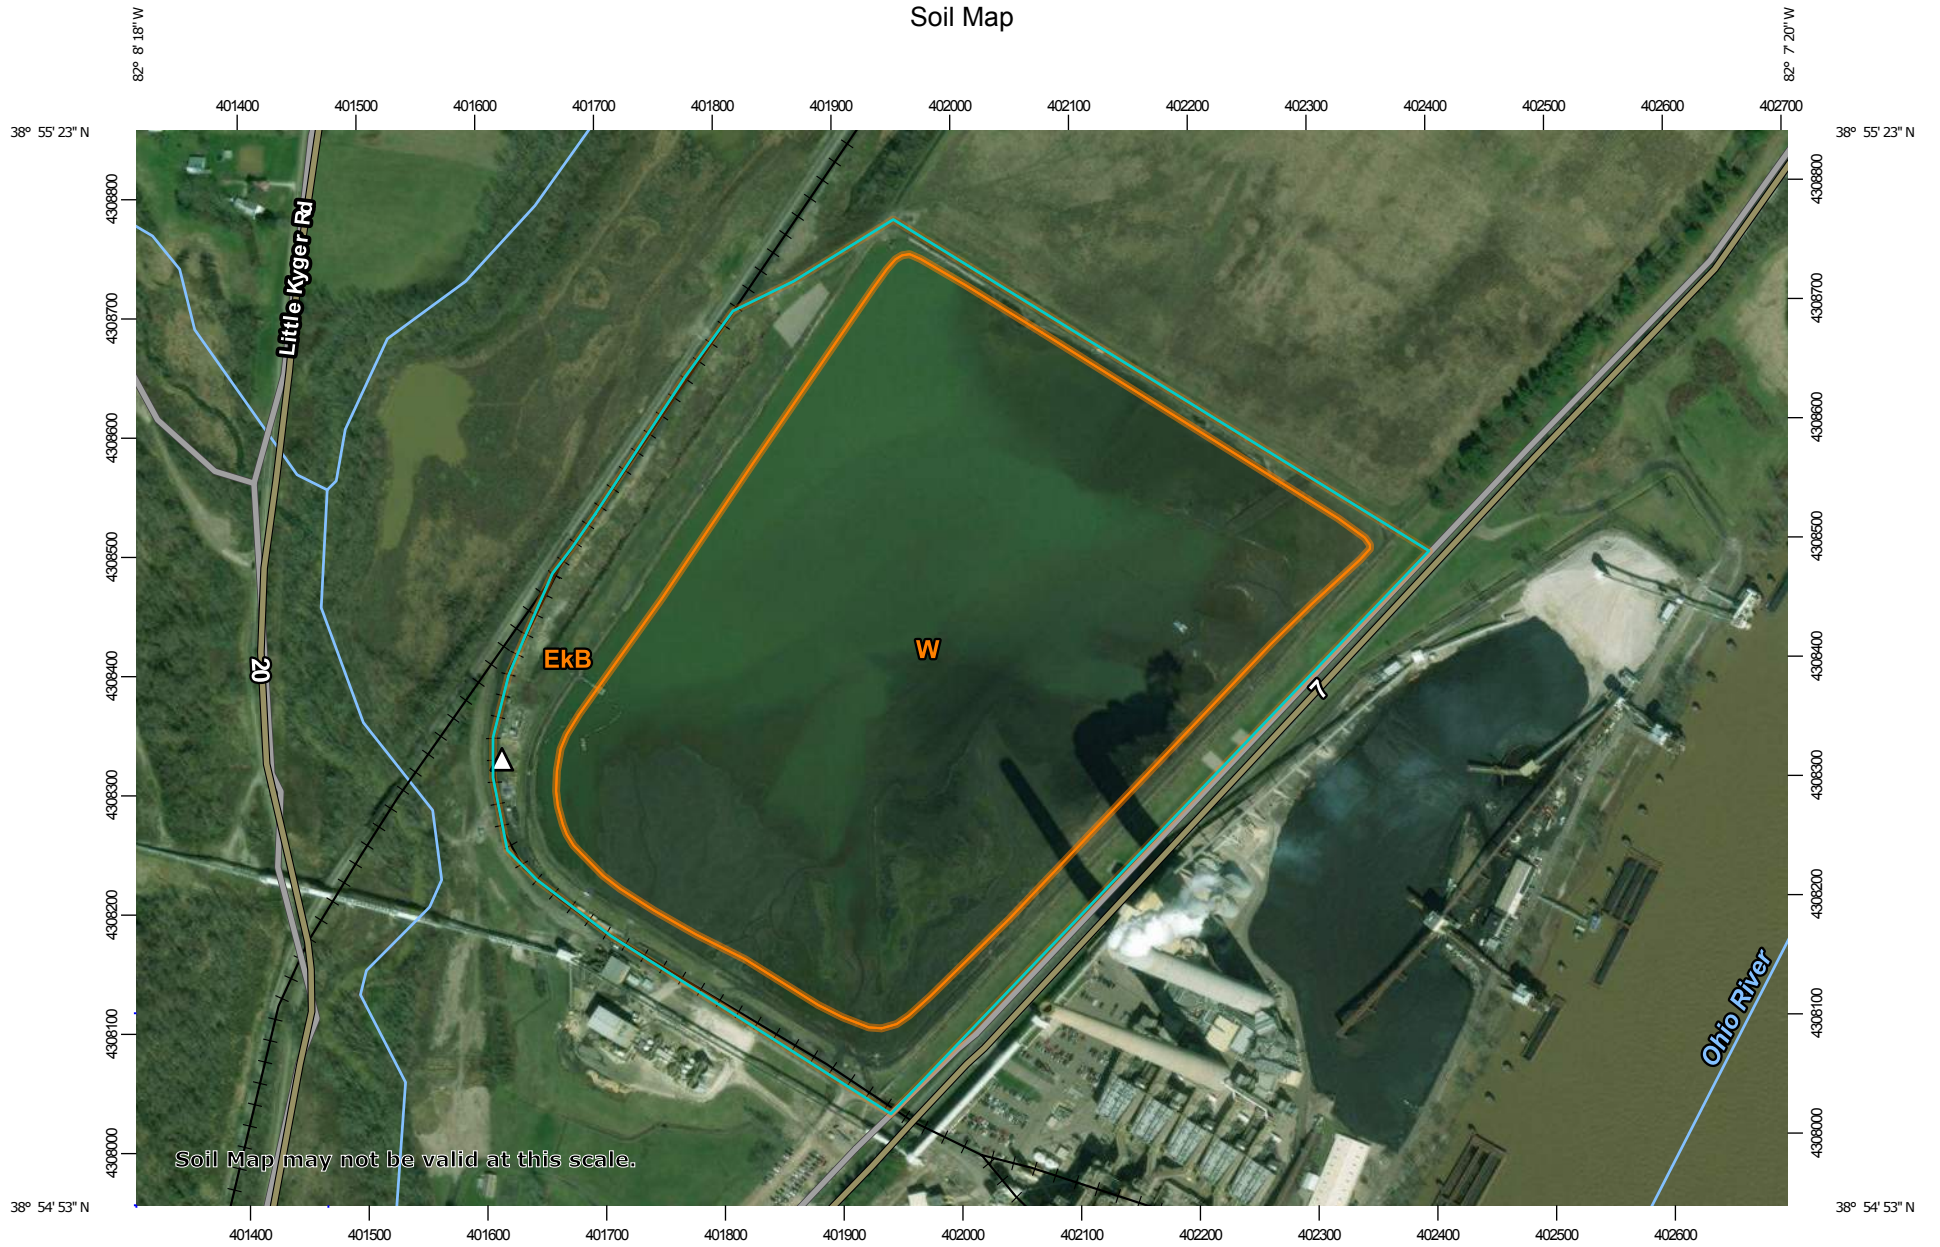
Custom Soil Resource Report Soil Map

The soil map section includes the soil map for the defined area of interest, a list of soil map units on the map and extent of each map unit, and cartographic symbols displayed on the map. Also presented are various metadata about data used to produce the map, and a description of each soil map unit.

Map Scale: 1:6,360 if printed on A landscape (11" x 8.5") sheet.
