Re: Indiana-Kentucky Electric Corporation
Clifty Creek Station's 2018 Annual Landfill Inspection

**Reference: 2018 CCR Rule Inspection
Annual Landfill Inspection
Clifty Creek Generating Station
Madison, Indiana**

**2018 CCR Rule Inspection
Clifty Creek Landfill**

Clifty Creek Generating Station
Madison, Indiana
Jefferson County

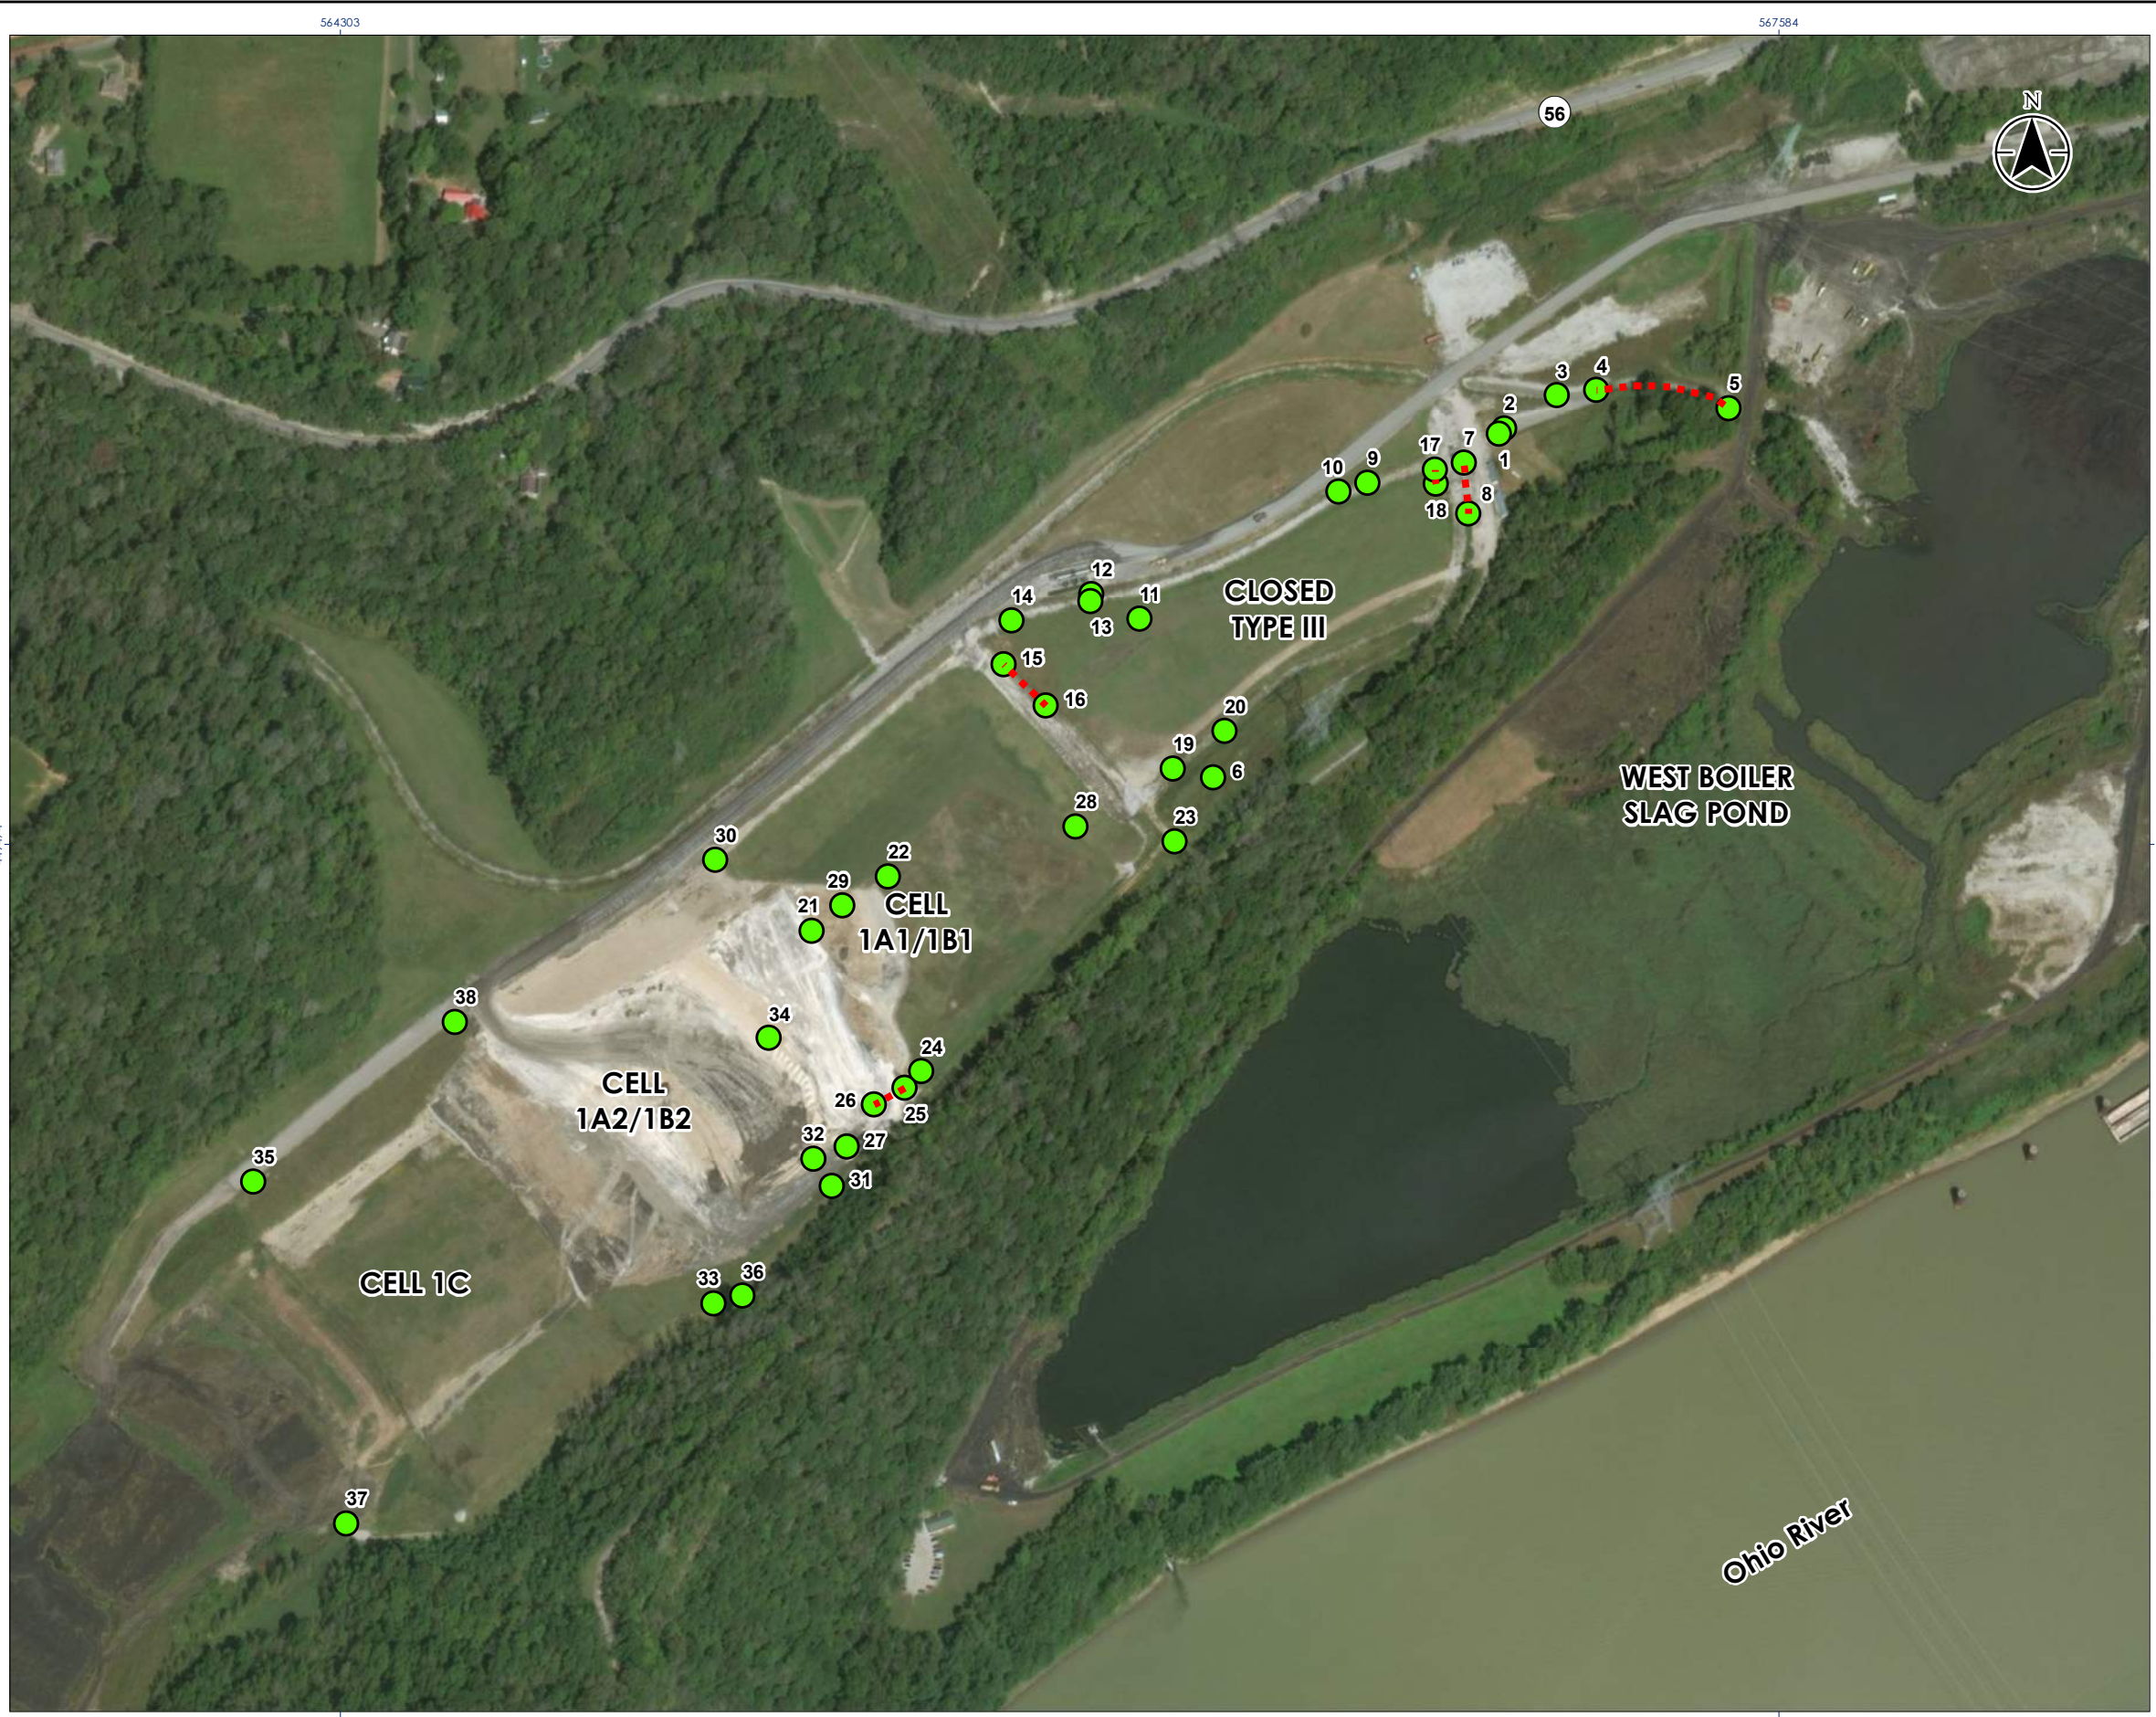
13	Drainage pipe invert from truck wash station. Sediment at outlet.	38.735671	-85.435208
14	Bare area along northern final grade stormwater channel	38.735554	-85.435838
15	Bare area, southwest side of Type III landfill, northern end	38.735275	-85.435904
16	Bare area, southwest side of Type III landfill, southern end	38.735020	-85.435567
17	Potential seep with sheen, approx. 15 feet north of northern leachate outlet	38.736489	-85.432449
18	Sheen on water beside southern leachate pipe headwall	38.736401	-85.432442
19	Sediment in southern final grade surface/storm water channel	38.734622	-85.434549
20	Woody vegetation, 4' tall and 2" diameter	38.734858	-85.434139
21	Taller vegetation, estimated 3'	38.733609	-85.437440
22	Vegetation change, brushy	38.733951	-85.436835
23	Erosion gully, 1' x 1'	38.734163	-85.434536
24	Erosion gully at temporary cover change, 2' wide x 1' deep	38.732728	-85.436568
25	Poor vegetation area, gravelly, rills	38.732626	-85.436701

26	Poor vegetation area, gravelly, rills	38.732522	-85.436951
27	Bare area, 15' x 11'	38.732260	-85.437170
28	Erosion rill zone with bare area (8' diameter), estimated top noted	38.734258	-85.435332
29	Erosion rill, 1' wide x 2' deep, 4 visible, estimated top noted	38.733770	-85.437200
30	Poor vegetation area, gravelly, rills (6" deep, 1' wide, 6 visible)	38.734055	-85.438213
31	End of Subphases 1A2 and 1B2 temporary cover	38.732013	-85.437284
32	Recently vegetated temporary cover	38.732181	-85.437435
33	Estimated edge of liner for Subphase 1C	38.731277	-85.438235
34	Estimated top elevation of active landfill	38.732938	-85.437786
35	Estimated extents of waste	38.732047	-85.441917
36	Estimated stormwater break along southern side of landfill	38.731324	-85.438001
37	Leachate pipe outlet	38.729903	-85.441178
38	Entrance to landfill access road	38.733047	-85.440300

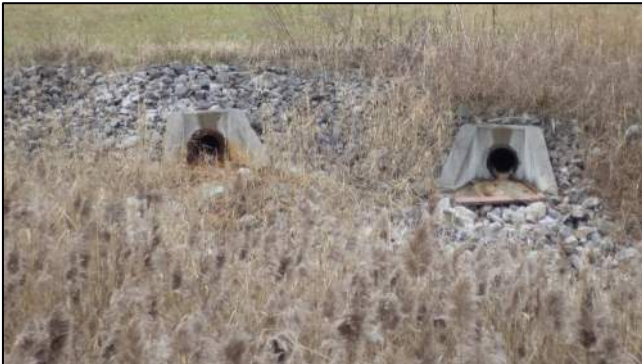
**Photo 17**

- Inspections near the leachate pipe outlet headwalls at the northeast corner of the Type III landfill (Photos 17 through 20, Appendix A; Points 17 and 18, Appendix B) resulted in the following observations:

The two Type I landfill leachate pipe headwalls at the eastern edge of the Type III landfill. Photo looking west.

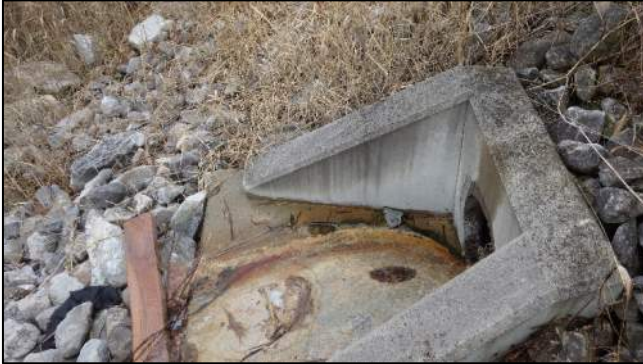
**Photo 18**

- A sheen was seen above and beside the southern leachate pipe headwall (Point 18, Appendix A; Photo 20, Appendix B).
- Sediment was noted in the final grade southern surface/storm water channel (Point 19, Appendix A; Photo 21, Appendix B).

Flow out of the southern leachate pipe. Discoloration around outside circumference of pipe. Standing water and sheen above headwall.

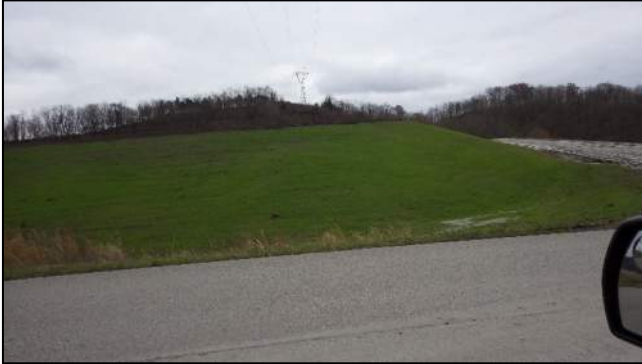
**Photo 28**

- Portions of the landfill near the active cell had recent temporary cover placement and were vegetated at the beginning of this winter season (Point 38, Appendix A; Photo 28, Appendix B).

New temporary cover placed for 2018-2019 winter season near the active cell. See Point 32 in Appendix A. Photo looking south.

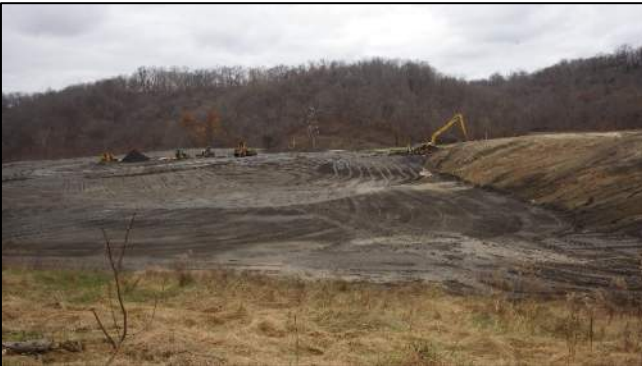
**Photo 29**

- Active waste placement was ongoing in Cells 1C. Piles of bottom ash, used as chimney drains in the landfill, were visible (Photo 29, Appendix B).
- The storm water channel at the toe of the northern slope of the landfill was grassed, and the rock check dams were in place and functioning properly (Photo 30, Appendix B).

The active CCR cell, Subphase 1C. Photo looking north.

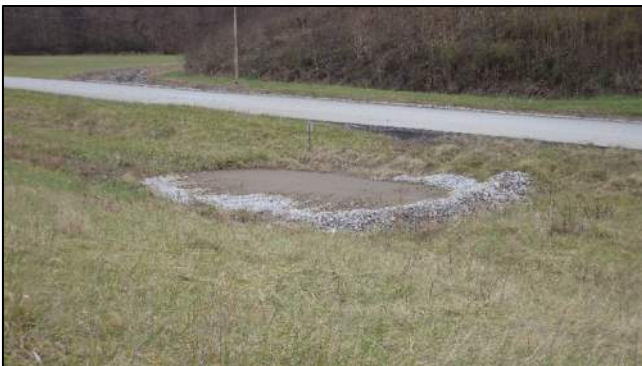
**Photo 30**

Stormwater check dam located in the grassed storm water channel along the northern toe of the landfill. Photo looking northwest.

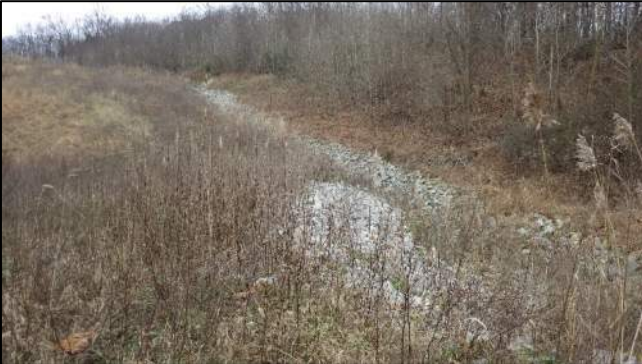
Photo 32

- The temporary storm water channel along the southern edge of the landfill was riprap-lined and maintained (Point 36, Appendix A; Photo 32, Appendix B).

The temporary storm water channel along the southern edge of the landfill. Photo looking southeast. See Point 36 in Appendix A.

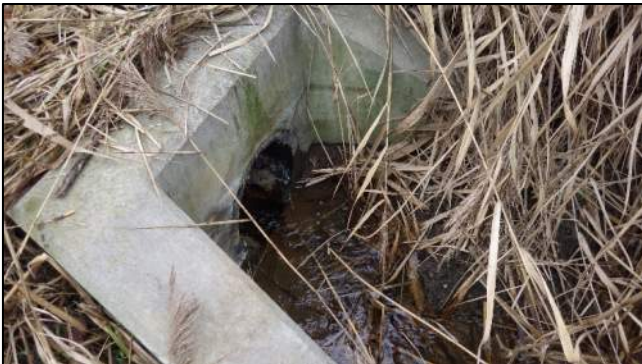
Photo 33

- The leachate pipe appeared unrestricted and actively flowing. Vegetation was maintained around the headwall to allow visual observation (Point 37, Appendix A; Photo 33, Appendix B).

Leachate pipe outlet, west of Subphase 1C. See Point 37 in Appendix A.
