**2024 CCR Rule – Surface Impoundments  
Clifty Creek Dam/Dike Inspections**

Clifty Creek Generating Station  
Madison, Indiana  
Jefferson County

January 19, 2025

Stantec Consulting Services Inc.  
Cincinnati, Ohio

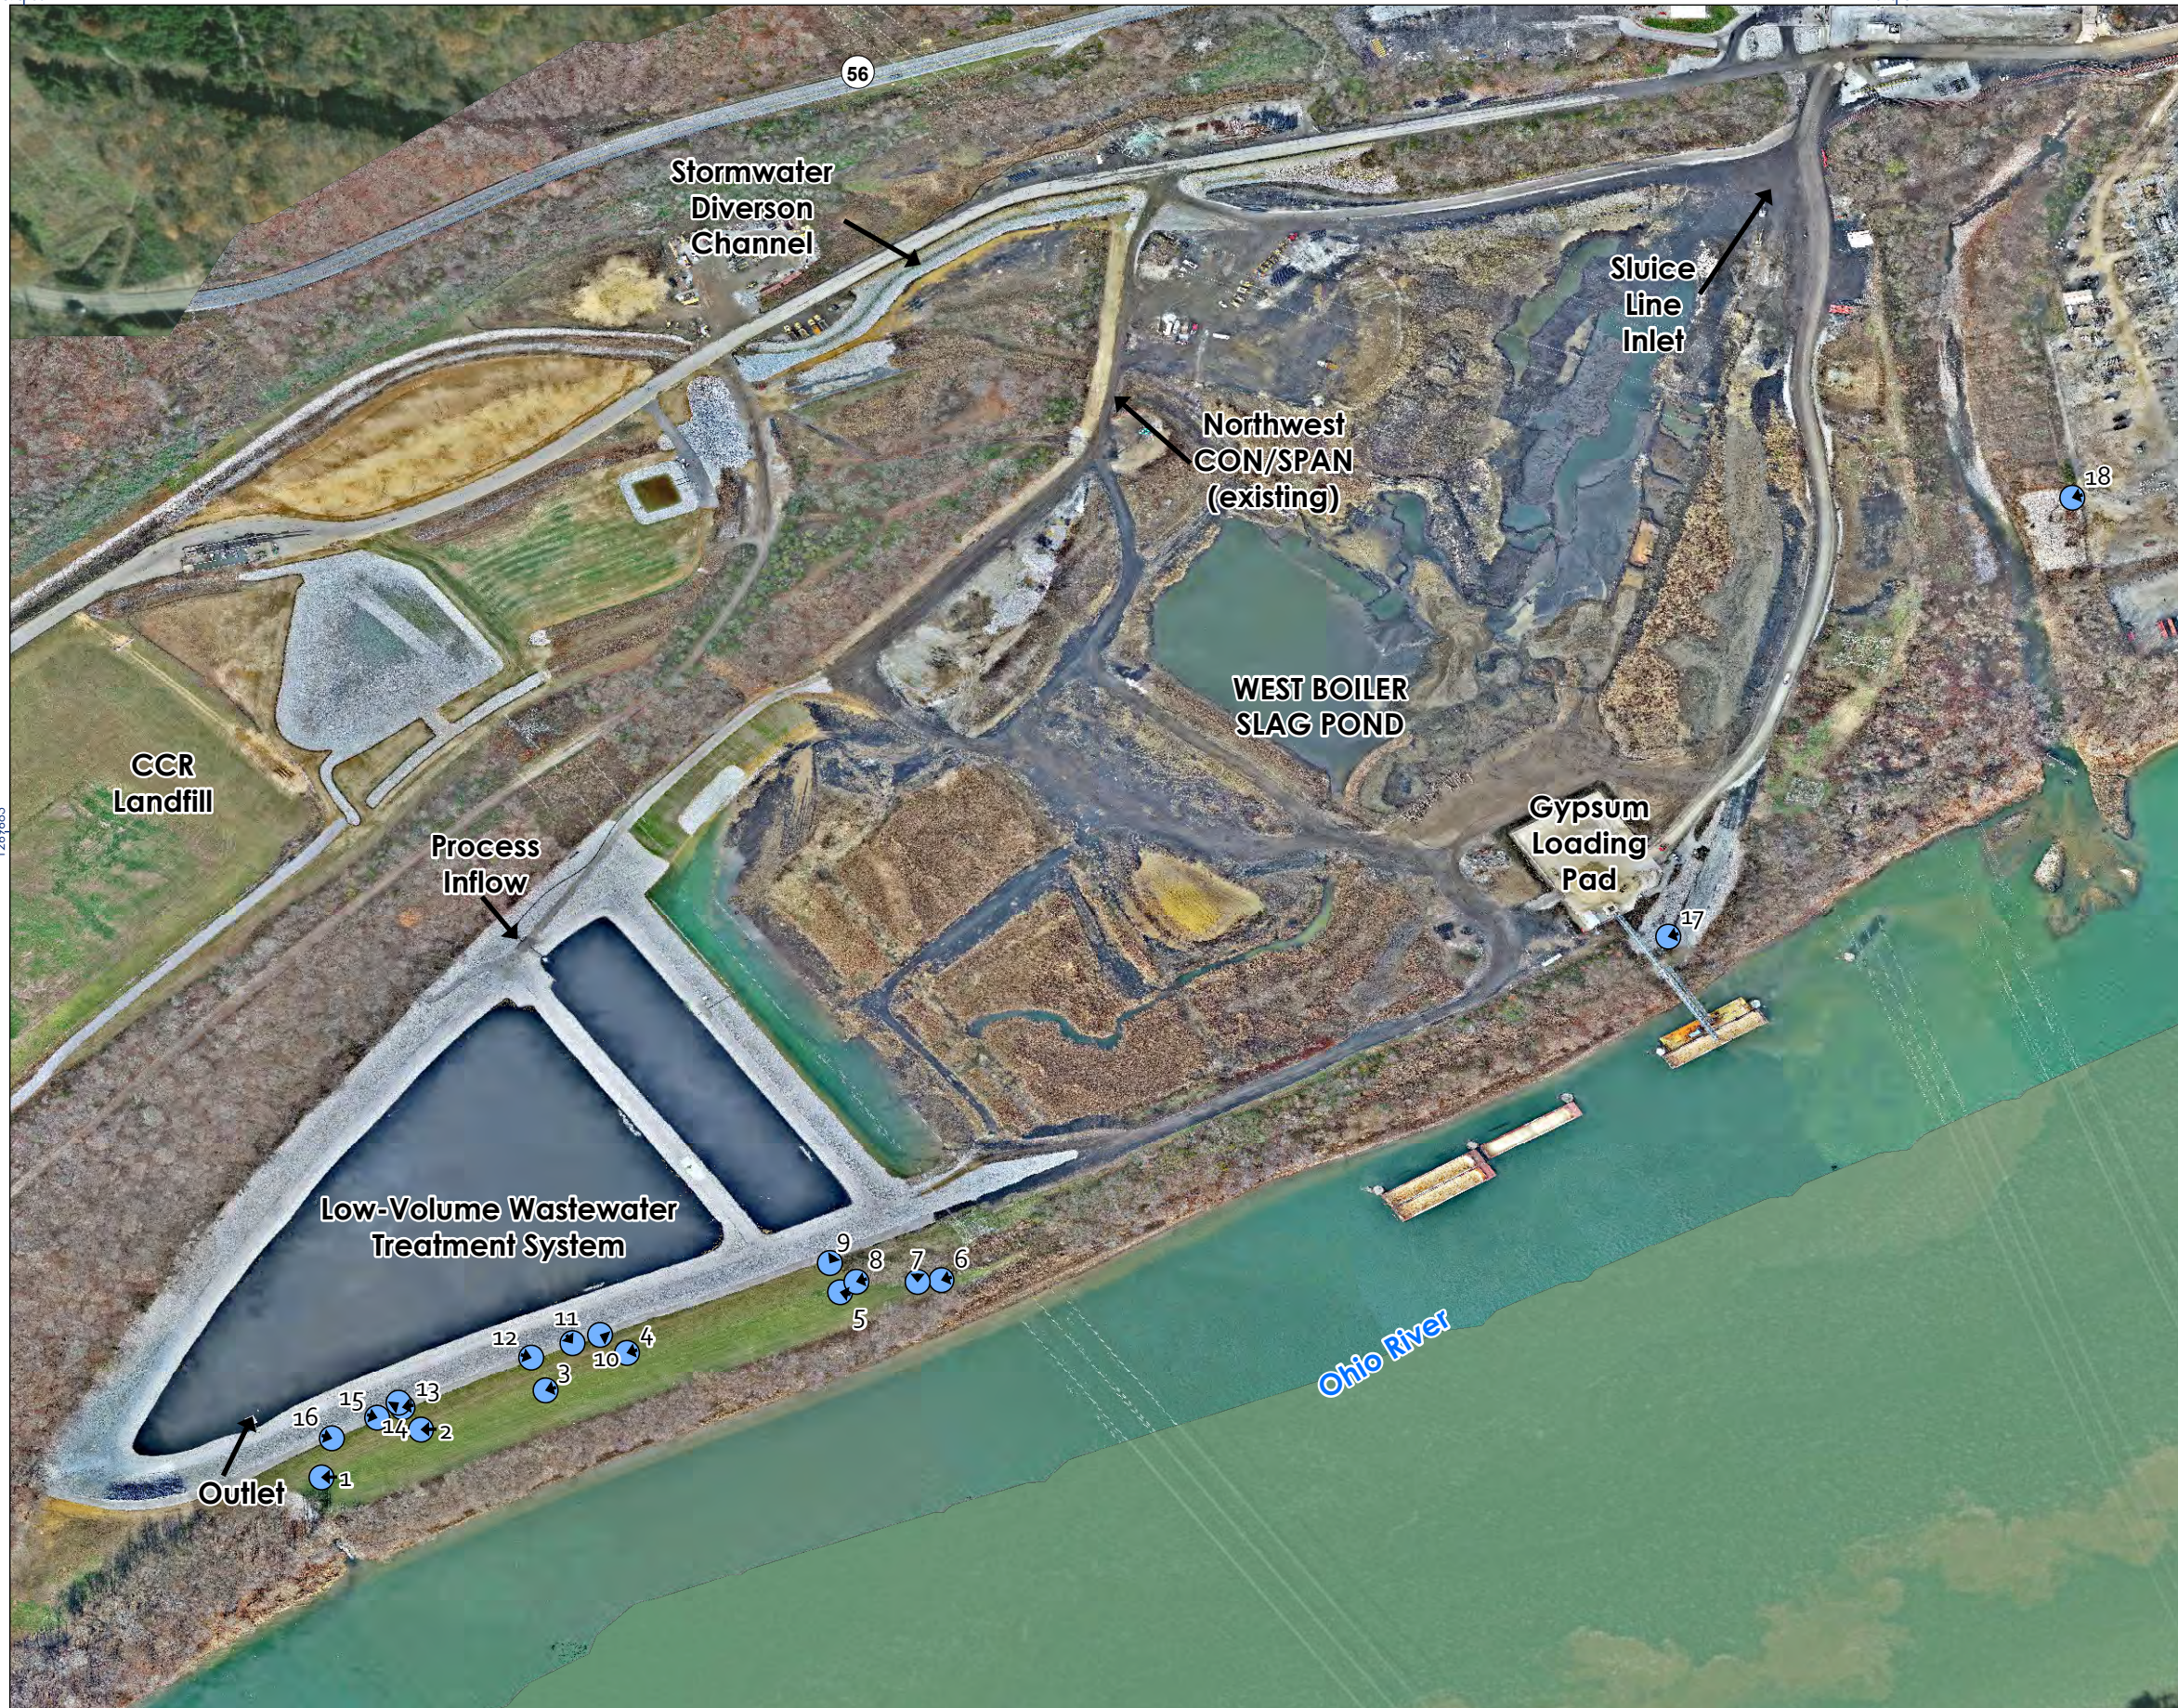
Minor maintenance for the LRCP includes mowing of the dam slopes to observe potential issues or concerns, repairing the erosion rills above the downstream channel, and monitoring the surface-sloughed area beneath the access road to the toe will likely require attention as well (Photographs 1, 2, 3, 6, and 9).

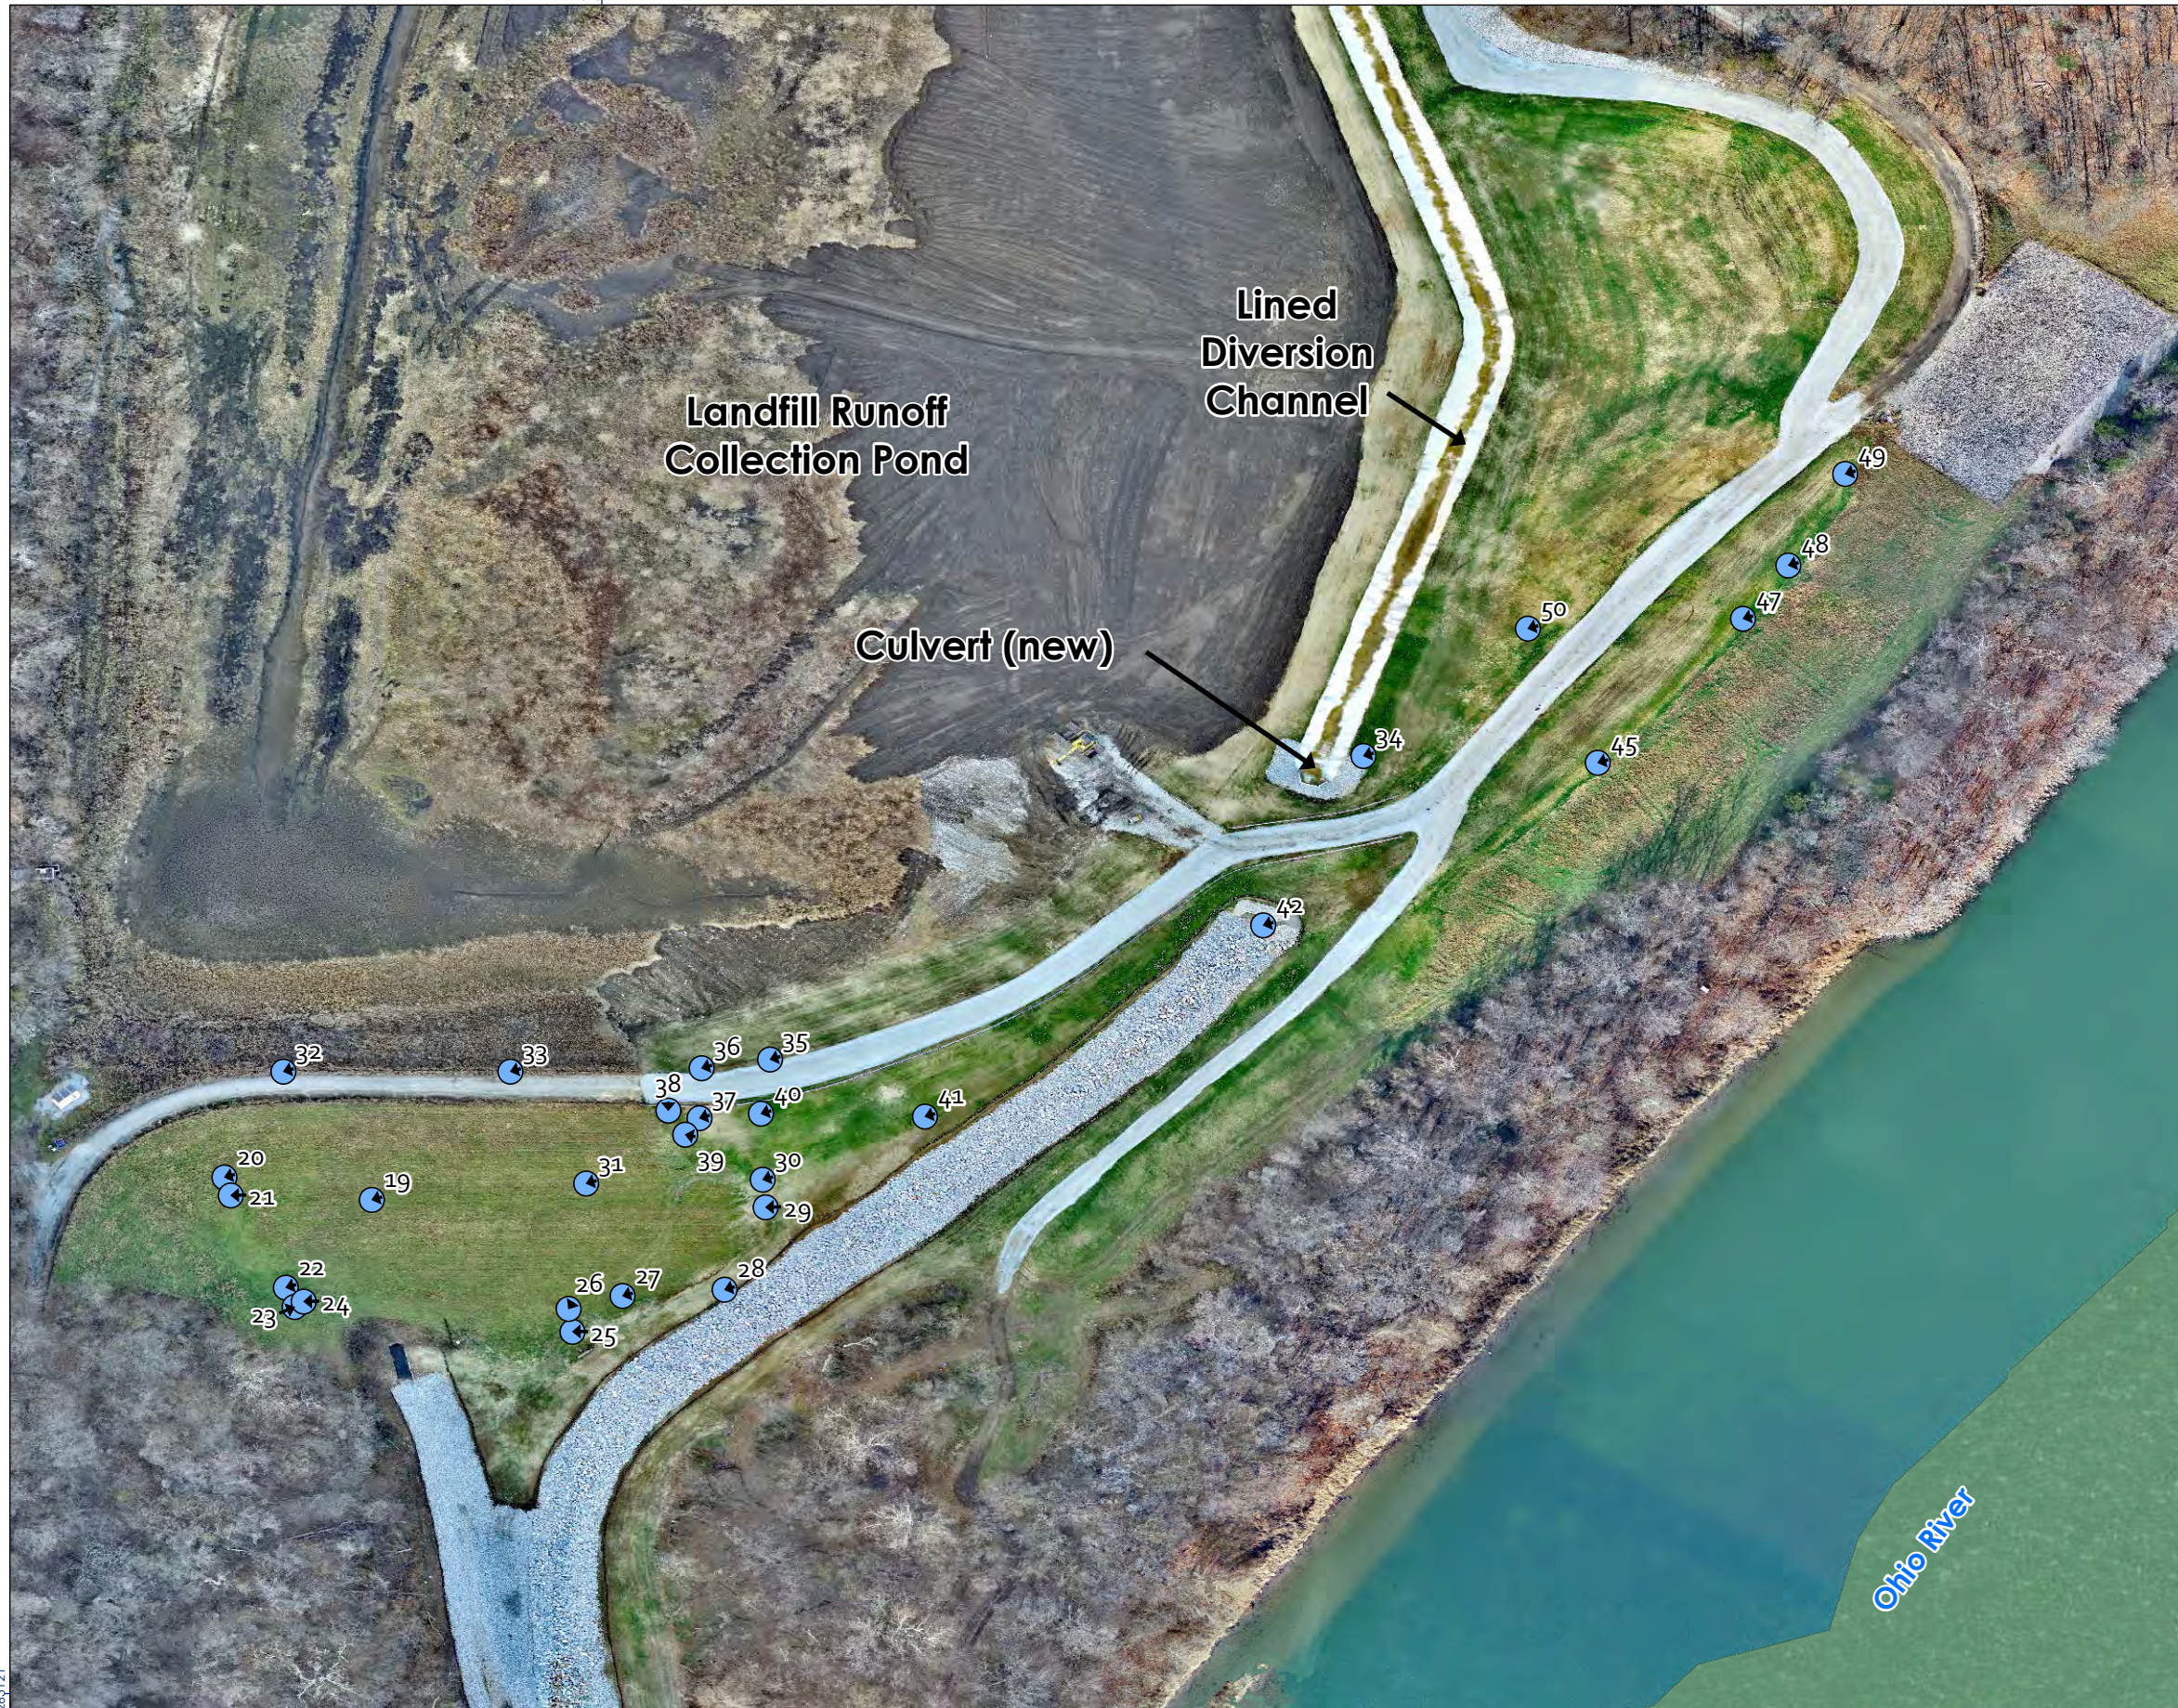
The upstream and downstream dike slopes and crest areas, east of the LVWTS, are overgrown with small to large trees and heavy brush (Photographs 3, 4, and 6 in Appendix D). These conditions make it virtually impossible to inspect the slopes. The trees and larger brush can also provide seepage pathways as the larger foliage dies off. Trees that topple in windstorms can leave large holes exposed in the face of the dam. Stantec recommends that the overgrown crest and downstream side of the dam be stripped of foliage, graded for ease of maintenance, and seeded with grass to protect it from erosion. This will allow for future inspections to be conducted on this portion of the dam.
