**Re: Indiana-Kentucky Electric Corporation
Clifty Creek Station
Notification of CCR Rule Information Posting
Annual Certified CCR Dam and Dike (Surface Impoundment)
Inspection Report Posting**

**2023 CCR Rule – Surface Impoundments
Clifty Creek Dam/Dike Inspections**

Clifty Creek Generating Station
Madison, Indiana
Jefferson County

January 19, 2024

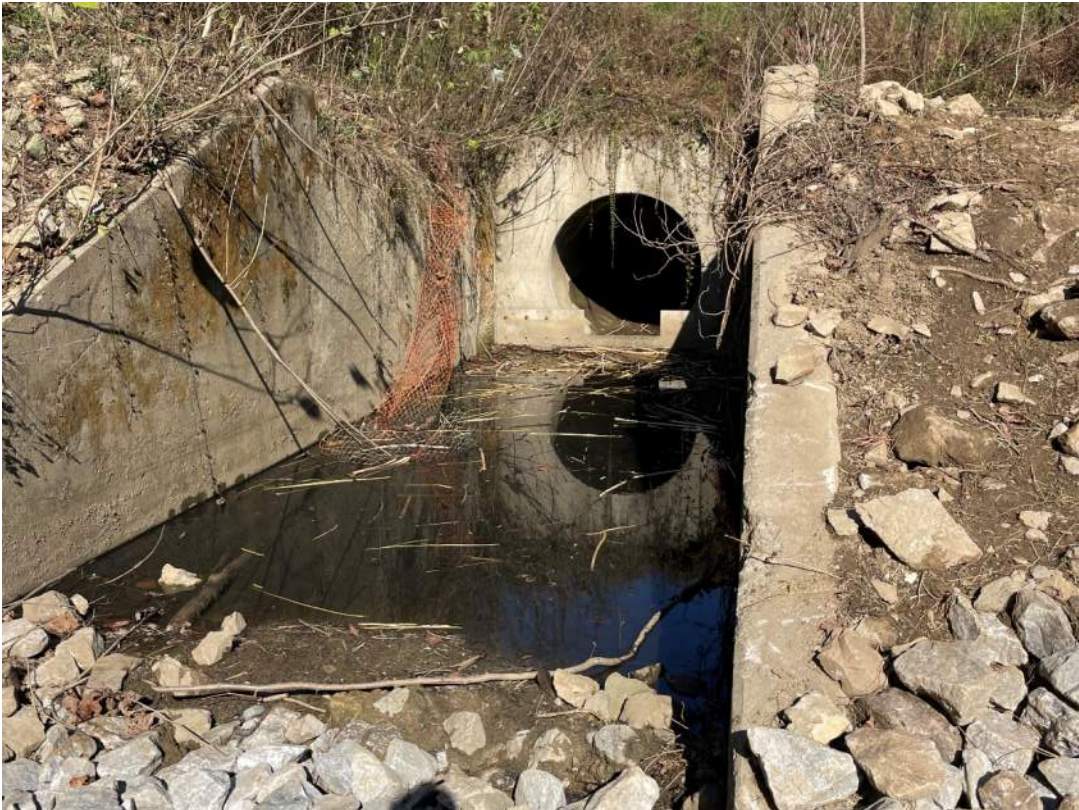
Photograph 5 – Outfall 001 outlet structure at toe of dam.

At the outlet for Outfall 001, we recommend that all brush and tall foliage around the wingwalls be removed to a distance of about 20 feet and replaced with either grass or riprap to aid in observation of the outlet structure. A railing around the top of the head and wing walls could also be considered. Debris left over from previous clearing activities should be removed from inside the culvert outlet box (Photograph 5). Since water will no longer be impounded in the LRCP, we recommend that an area at a distance of 20 feet around the inlet structure be cleared of all tall grasses and brush (Photographs 6 and 7). In addition, railings should be replaced or reinstalled around the inlet structure. A portion of the metal grating that covers one of the old inlets has been cut away leaving an open hole (Photograph 7). The grating should be replaced or the hole covered. Any superfluous materials or fixtures associated with the inlet structure should be removed. It is understood that the inlet elevation will be adjusted as part of the Phase 2 construction (Photograph 8).

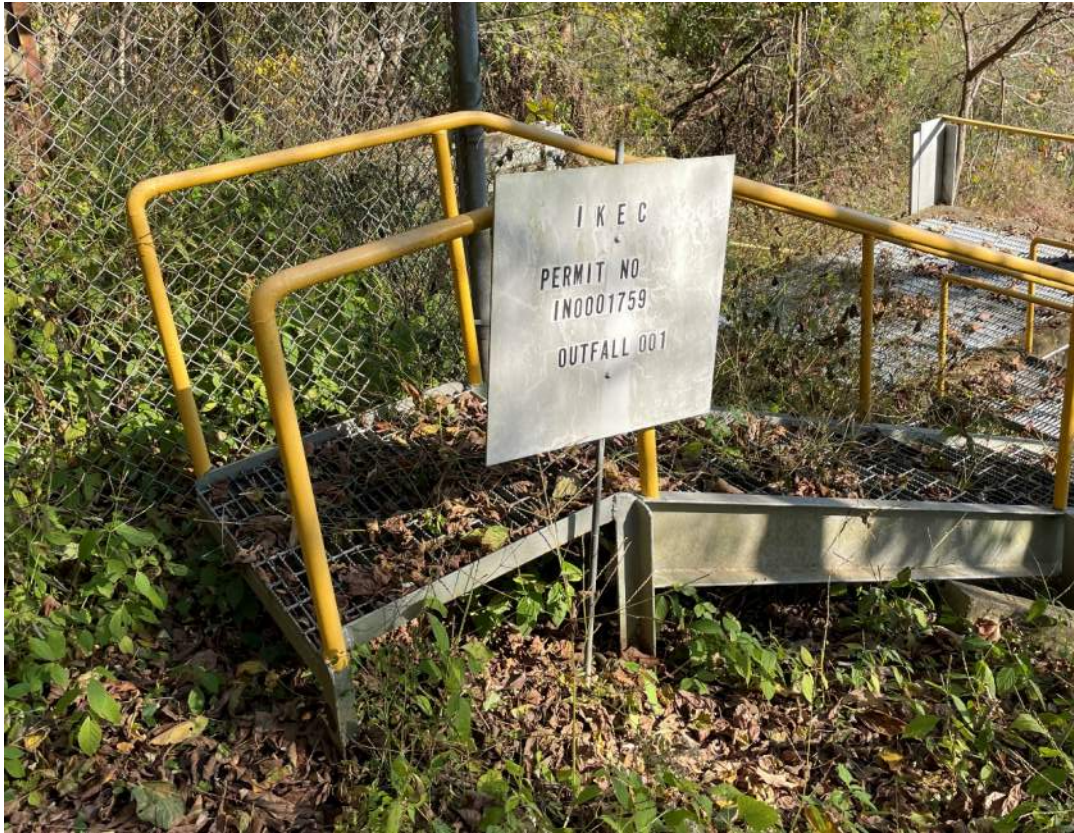
Photograph 6 – Access to inlet of Outfall 001.

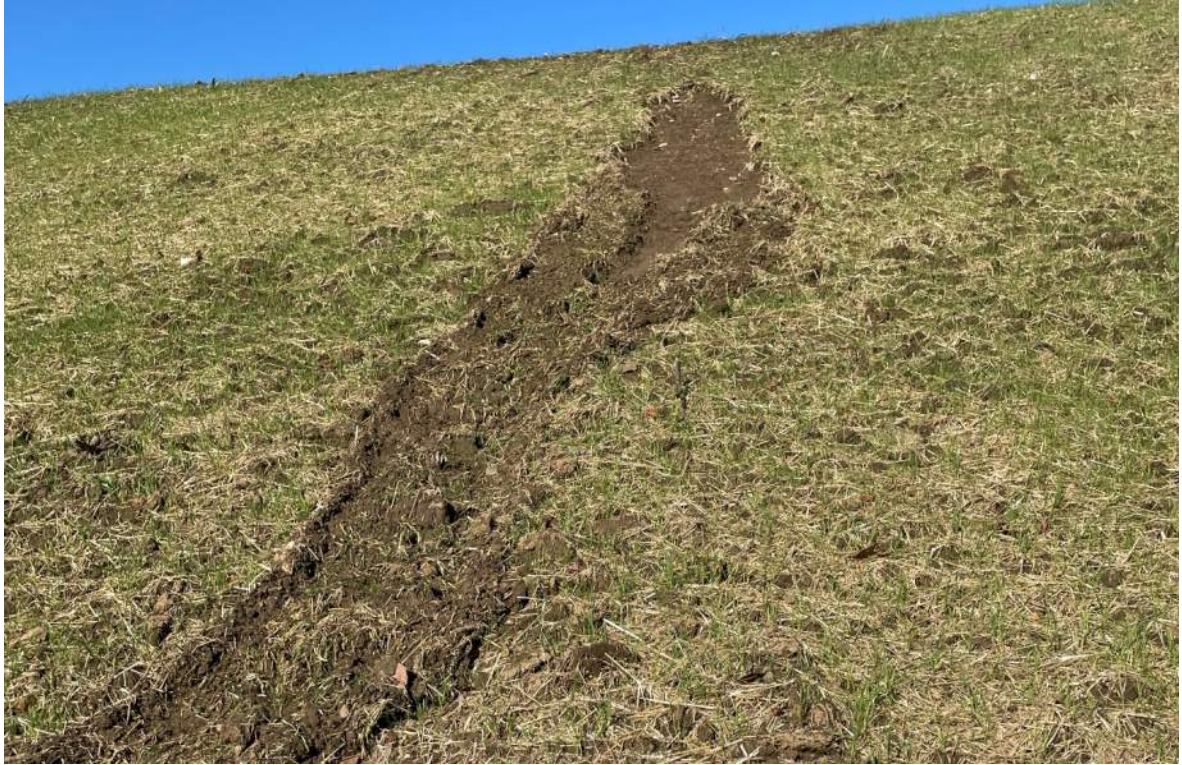
Photograph 12 – Regraded downstream side of dam below access road. Minor surface sloughing.

Minor maintenance for the LRCP includes mowing of the dam slopes to observe potential issues or concerns, repairing the erosion rills above the downstream channel (Photograph 10) and the disturbed areas on the western downstream slope just west of the newly graded slope (Photograph 9). The surface-sloughed area beneath the access road to the toe (Photograph 12) and the thinly vegetated slopes east of the access road (Photograph 13) will likely require attention as well.
