**Re: Ohio Valley Electric Corporation
Kyger Creek Station
Notification of CCR Rule Information Posting
Annual Certified CCR Dam and Dike (Surface Impoundment)
Inspection Report Posting**

**2024 CCR Rule – Surface Impoundments
Kyger Creek Dam/Dike Inspections**

Kyger Creek Generating Station
Cheshire, Ohio
Gallia County

January 19, 2025

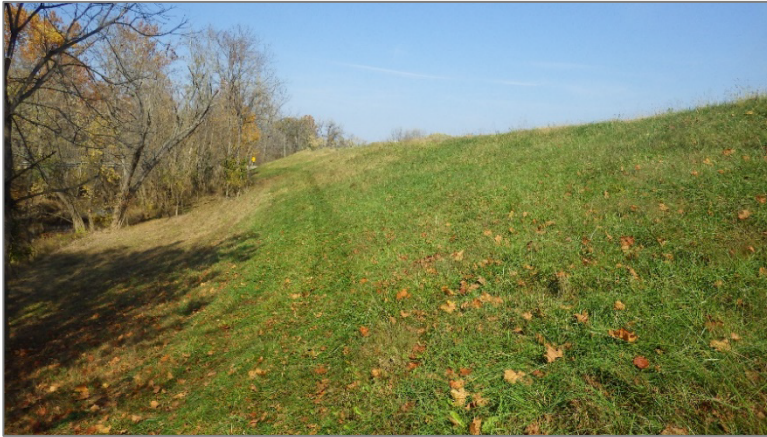
- The exterior slopes are mowed, vegetated, and uniform along the northwest and southwest perimeter of the pond. The southeastern slope was obscured by higher vegetation limiting observations (Photos 1, 15, 19, and 23; Appendix D).
- Surface erosion and erosion rills are noted, particularly as the material changes from the road surfacing to the grassy slopes near the crest along the perimeter embankment (Points 2 through 7 and 15 through 17, Appendix A; Photos 2 through 7 and 15 through 17, Appendix D).
- Surface erosion is noted near the toe of the perimeter embankment on its southeast side (Point 1, Appendix A; Photo 1, Appendix D).

Photo 19, Point 18
LVWTS – West Exterior Slope –
Looking north.

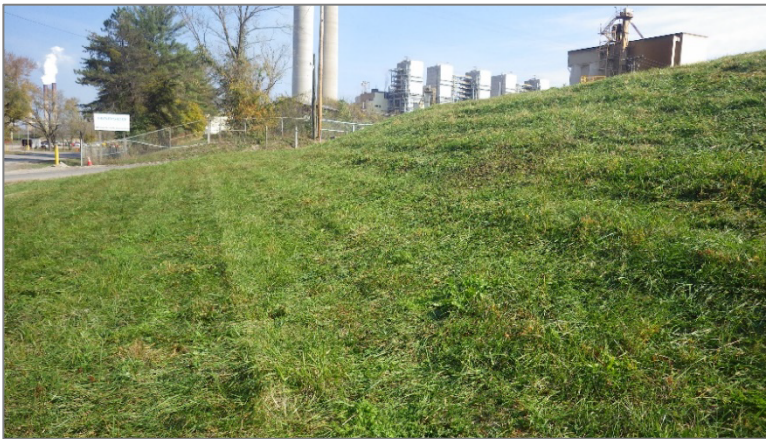
Photo 23, Point 22
LVWTS – West Exterior Slope –
Looking north at Primary Basin.

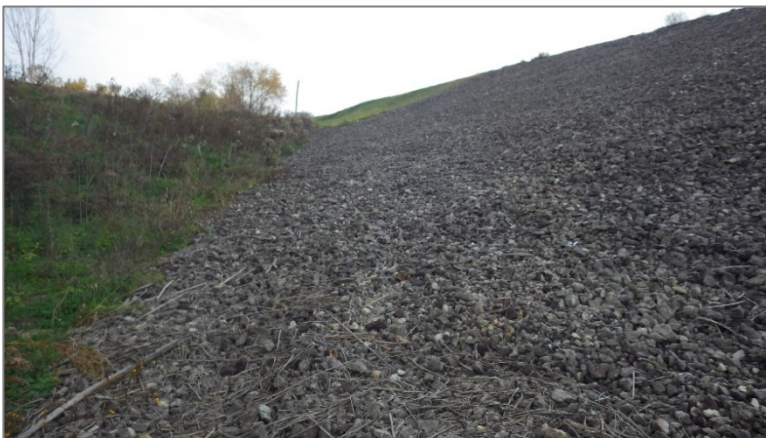
- Historic sluice lines are located along the southern and eastern dikes.
- A uniform depression in the upper one-quarter to one-third of the northwest slope was documented along the length of that slope (Points 27 through 31, Appendix A; Photos 26 through 30, Appendix D).

Photo 27, Point 26
Northwest Exterior Slope – Edge of riprap protection

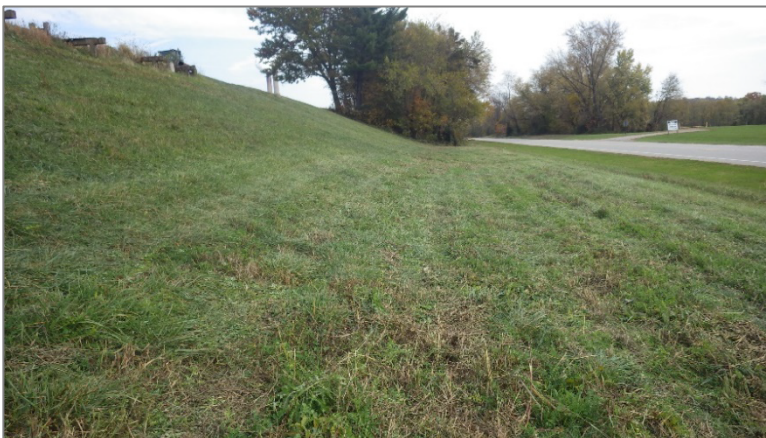
- The tie-in of the piping along the southeast side of the pond into the embankment does not show signs of inconsistency or instability (Points 43 and 44, Appendix A; Photos 42 and 43, Appendix D).
- The Splitter Dike embankment, composed of ash, shows no signs of rutting, erosion or instability (Point 46, Appendix A; Photo 45, Appendix D).
- Sloughing of soil is present near the toe at the west corner of the exterior embankment (Point 47, Appendix A; Photo 46, Appendix D).

Photo 42, Point 41
Southeast Exterior Slope –
Slope tie-in location.

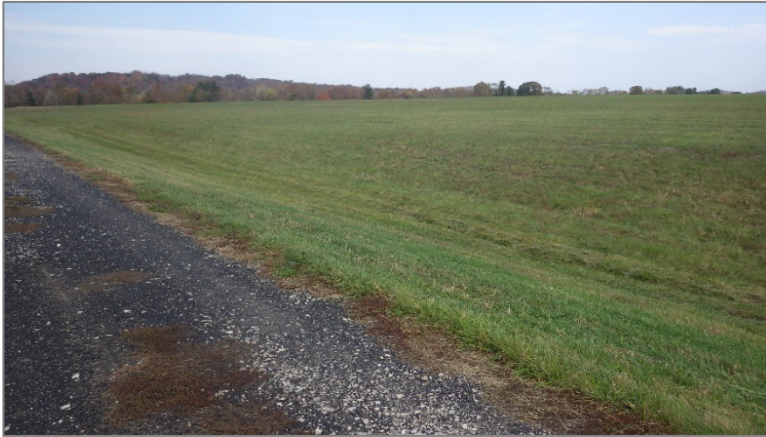
Photo 43, Point 42
Southeast Exterior Slope –
Slope tie-in on northeast side.

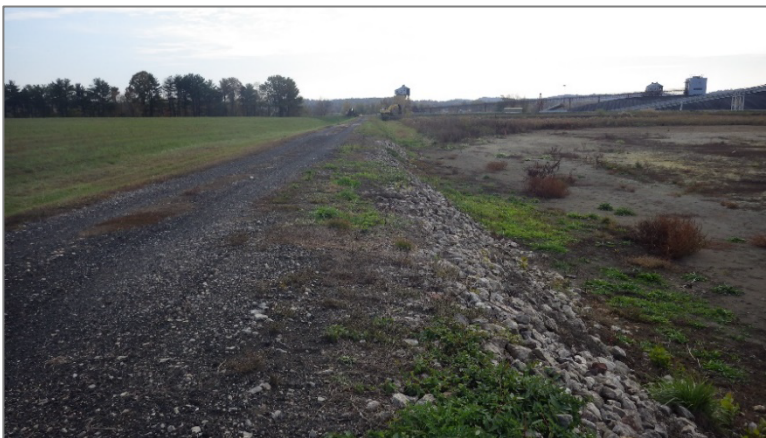
Photo 45, Point 44
Northeast Slope – Divider Dike
cover.
