**Re: Ohio Valley Electric Corporation
Kyger Creek Station's 2020 Annual Landfill Inspection**

**Reference: 2020 CCR Rule Inspection
Annual Landfill Inspection
Kyger Creek Generating Station
Cheshire, Ohio**

**2020 CCR Rule Inspection
Kyger Creek Landfill**

Kyger Creek Generating Station
Cheshire, Ohio
Gallia County

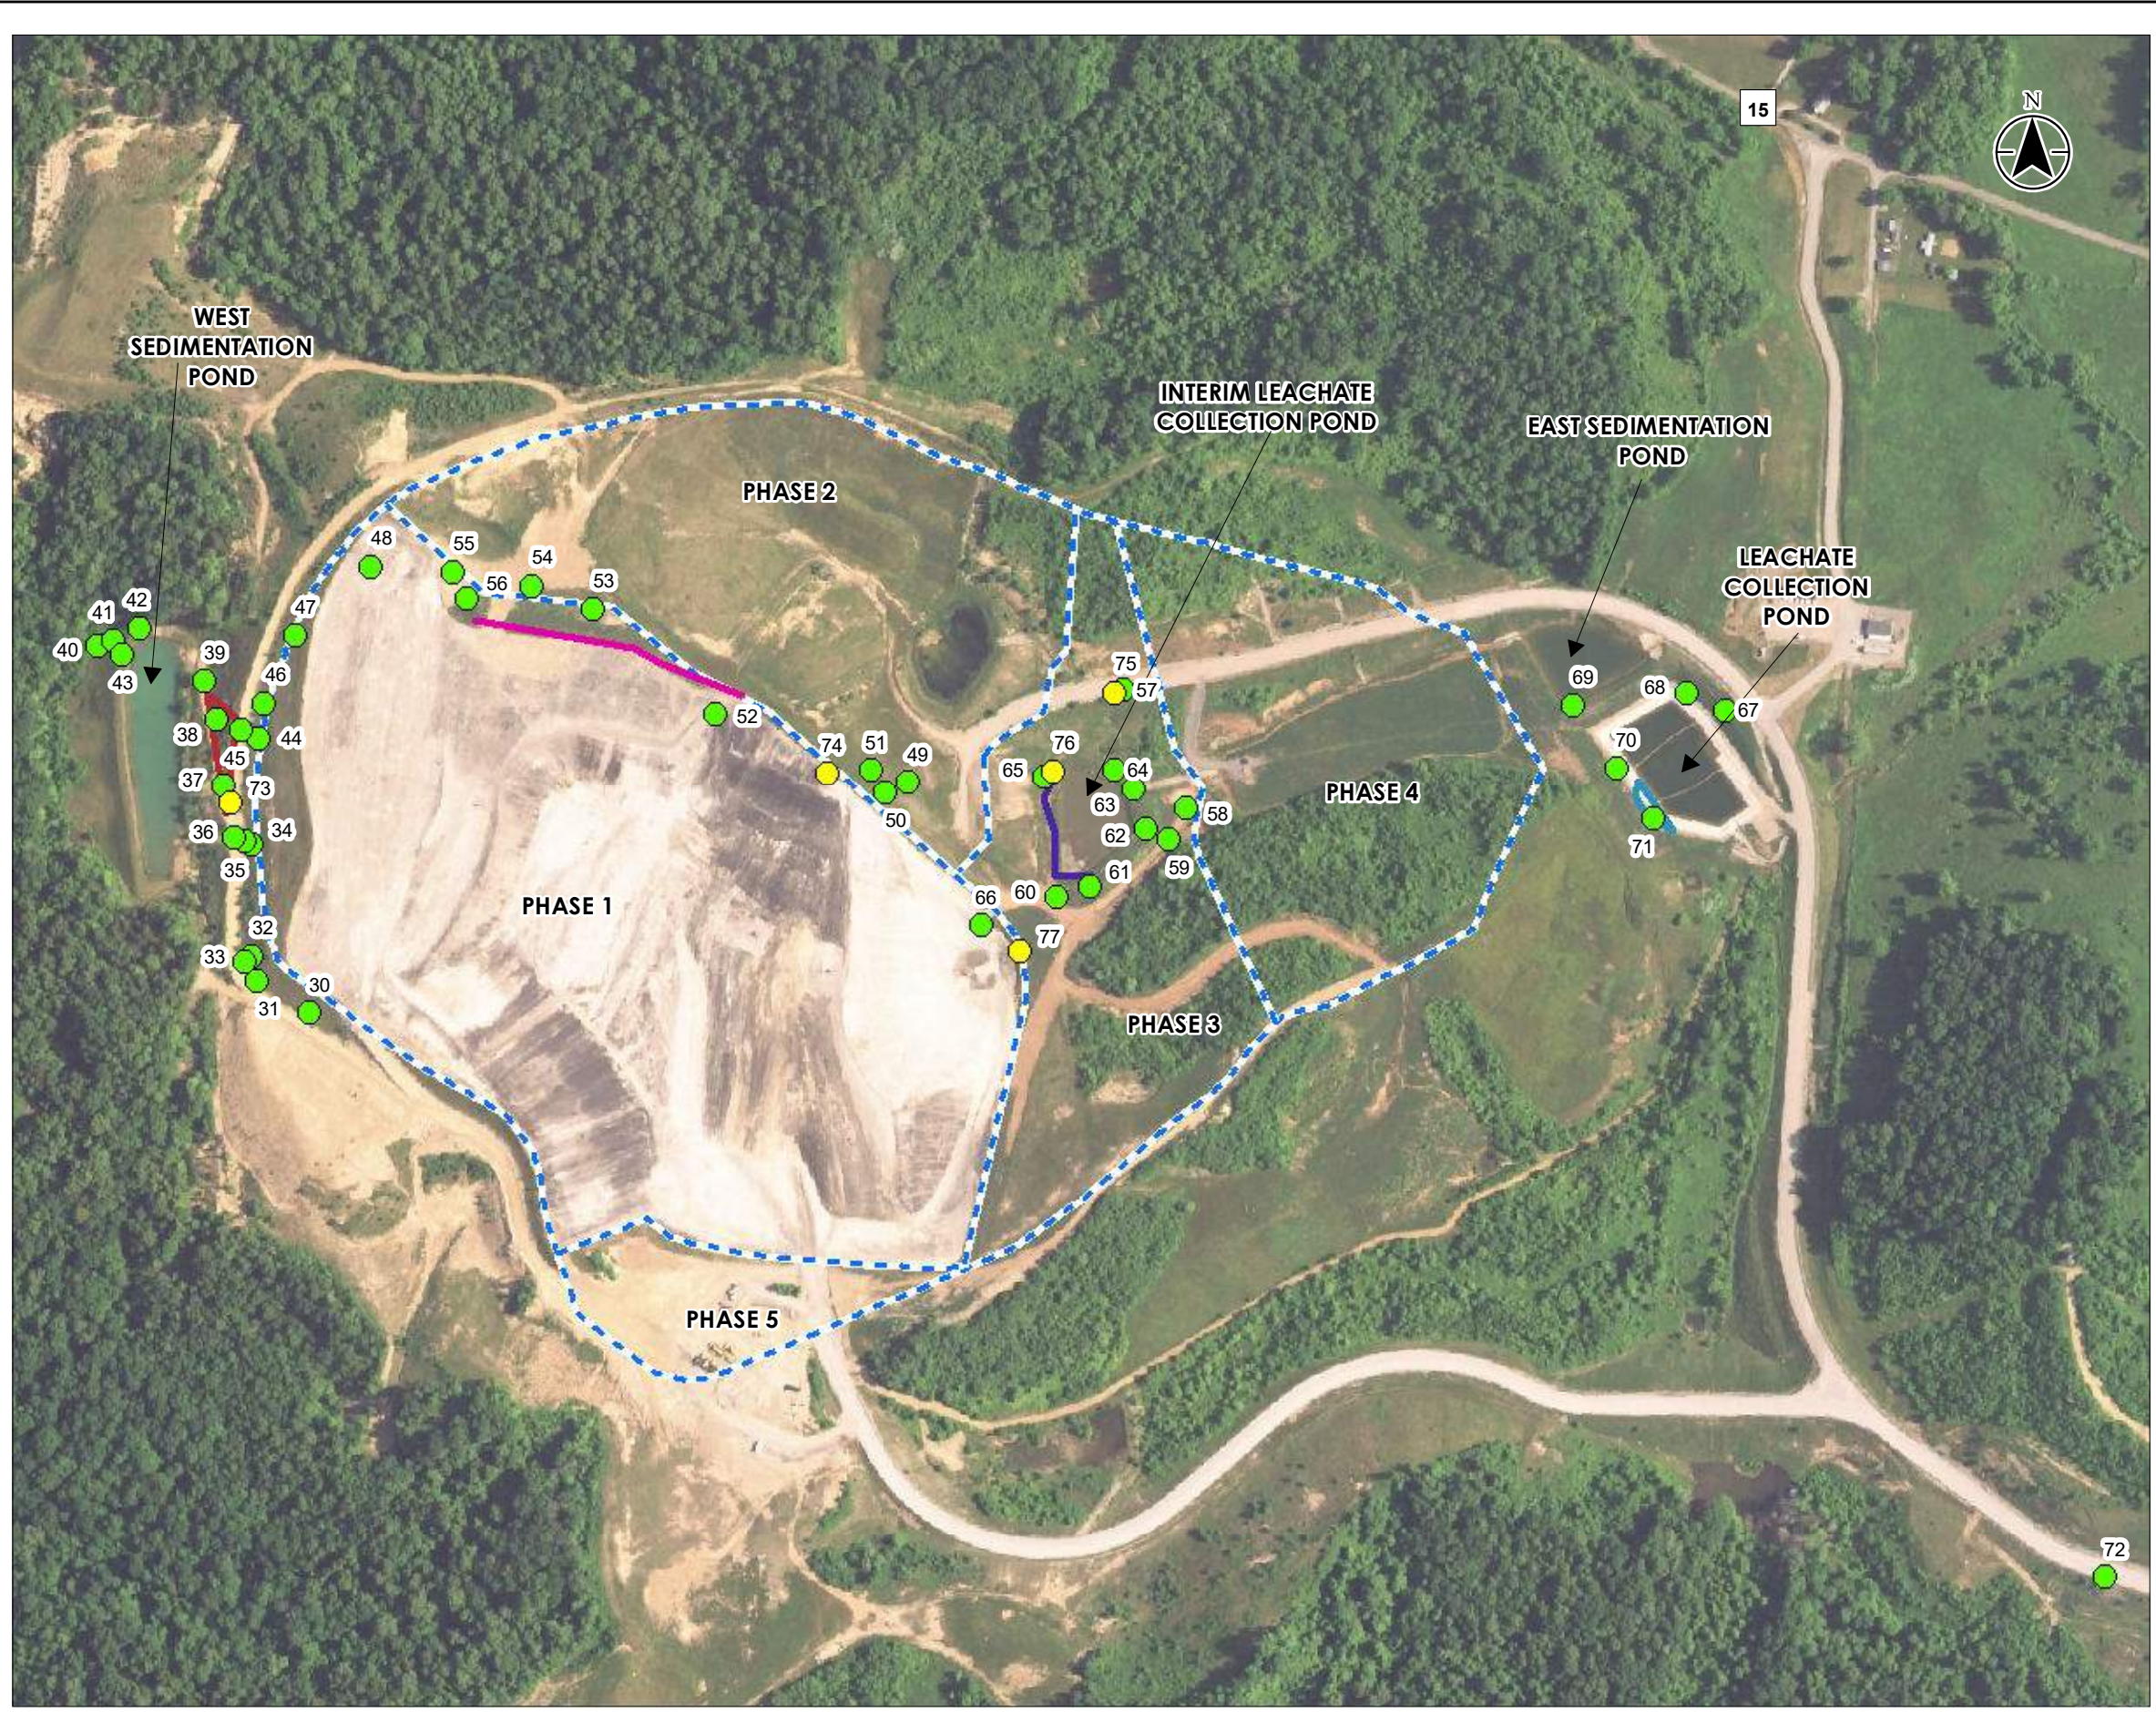
**APPENDIX A – PLAN VIEW AND TABLE OF
INSPECTION LOCATIONS**

The following observations were made while walking around the active Phase 1 landfill footprint. Appendix A includes a plan of the active landfill with GPS-located points. The GPS points of the 2020 inspection (73 to 79) are numbered successively from the 2019 points. The photographic log is provided in Appendix B. Maintenance items noted during the 2019 landfill inspections that remain to be addressed are shown on the figure and log in Appendix A.
