**Re: Ohio Valley Electric Corporation  
Kyger Creek Station's 2022 Annual Landfill Inspection**

**2022 CCR Rule Inspection  
Kyger Creek Landfill**

Kyger Creek Generating Station  
Cheshire, Ohio  
Gallia County

Stantec Consulting Services Inc.  
Cincinnati, Ohio

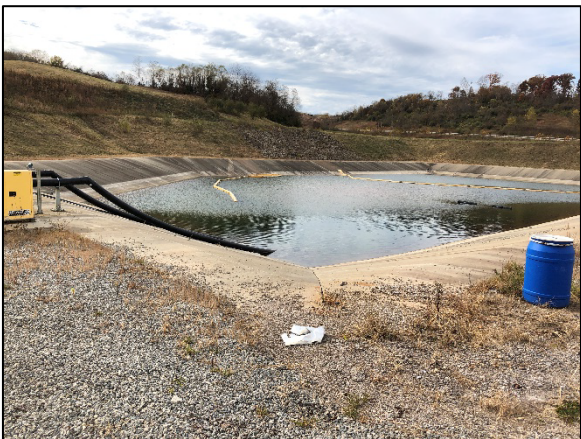
**Photo 20**

- Berm between East Sedimentation Pond and Leachate Collection Pond is well-vegetated and appears stable.
- Bank erosion was noted at Point 30 on the interior southeaster slope shared with the Leachate Collection Pond. (Appendix A; Photo 20, Appendix B)
- The Interim Leachate Collection Pond is located east of Phase 1. The crest was mowed, but the slopes are heavily vegetated. Cracks and small burrows were noted in the embankment. (Point 28, Appendix A; Photo 26, Appendix B)
- The access road and stormwater channel east of Phase 1 and south of the Interim Leachate Collection Pond is heavily vegetated. Erosion gullies were visible in this area. (Points 31-32, Appendix A; Photos 27-28, Appendix B)

Bank erosion on interior southeastern slope of East Sedimentation Pond. (Point 30, Appendix A)

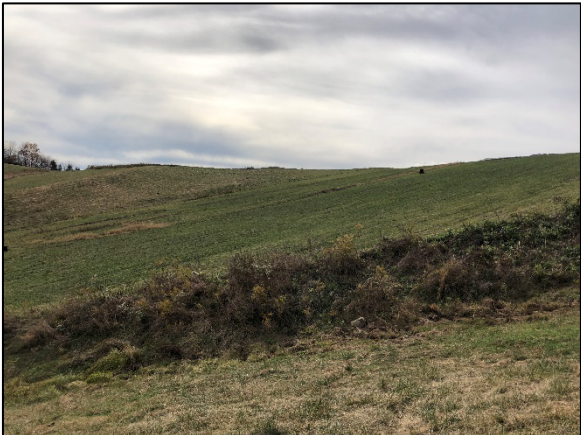
**Photo 22**

- The earthen slopes above the concrete slopes appear well vegetated and uniform on all sides of the interior of the embankment at the Leachate Collection Pond.
- Stationary pumps are present at the south end and pump through the eastern culvert.
- Seepage was not noted around the southwestern riprap zone during this site visit.
- A small slough was noted in the north corner. (Point 29, Appendix A; Photo 22, Appendix B)

Small slough in north corner of the Leachate Collection Pond. (Point 29, Appendix A)

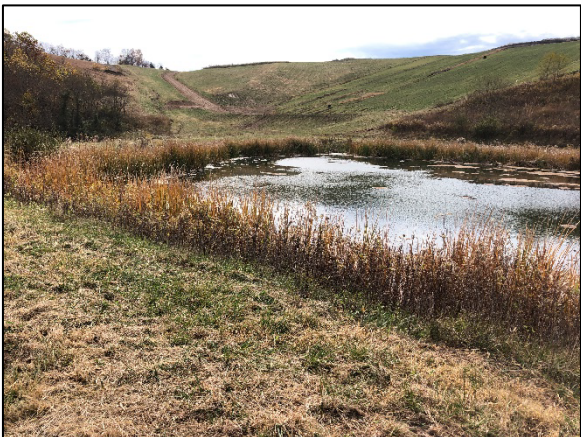
**Photo 25**

- Five plastic culverts connect the stormwater channel of the Phase 1 exterior temporary slope to the West Sedimentation Pond. Heavy woody vegetation at the upstream end inhibits inspection. Soil and debris limit the culvert capacity. Erosion gullies are present at the pipe outlets on the western side of the road. (Points 18-19, Appendix A; Photos 13-15, Appendix B)
- The eastern temporary slope of Phase 1 is mowed, uniform, and vegetated with a temporary silt trap at toe of slope. (Photo 23, Appendix B)
- A temporary silt trap is located at the toe of the eastern slope of Phase 1. (Photo 24, Appendix B)
- Erosion rills are noted above the temporary silt trap at the eastern Phase 1 slope toe. (Point 27, Appendix A; Photo 25, Appendix B)

Erosion rills above temporary silt trap at toe of eastern Phase 1 slope. (Point 27, Appendix A)

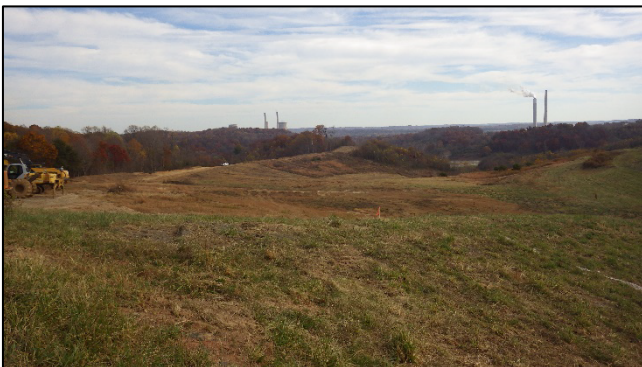
**Photo 28**

Access road and stormwater erosion east of the Phase 1 landfill, looking west. Interim Leachate Collection Pond on the right. (Points 31-32, Appendix A)
