**2024 CCR Rule - Landfill
Kyger Creek Landfill Inspection**

Kyger Creek Generating Station
Cheshire, Ohio
Gallia County

January 19, 2025

Stantec Consulting Services Inc.
Cincinnati, Ohio

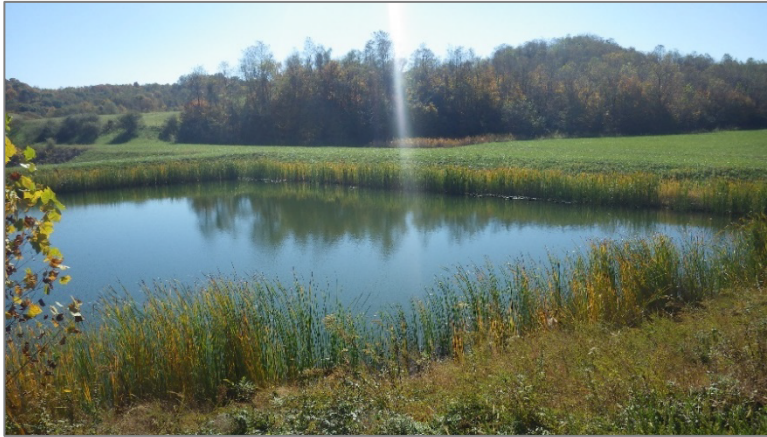
The East Sedimentation Pond (Photo 25, Appendix B) was constructed as part of the initial Phase 1 site activities. It manages stormwater from the eastern paved haul road and the closed Sediment Pond #1. See Appendices A and C for a plan view. The following observations were made at the East Sedimentation Pond:

Photo 25
East Sedimentation Pond –
looking east to west.

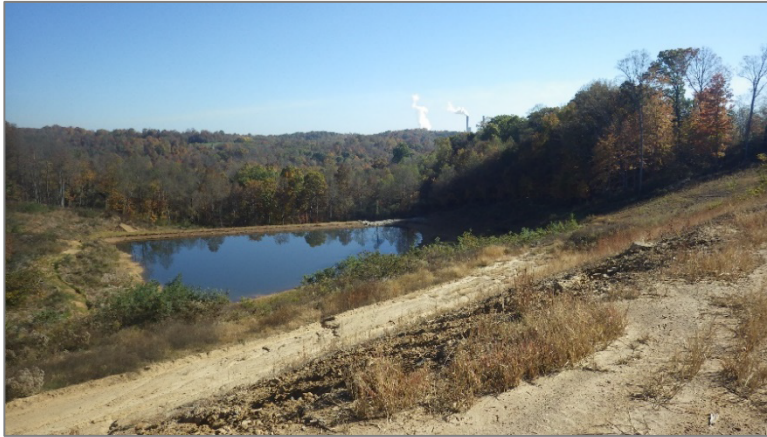
The North Sedimentation Pond lies north of the planned Phase 2 landfill (Photo 28, Appendix B). It manages the stormwater from the area north of Phase 1 where the planned Phase 2 landfill will be constructed. Observations made at the North Sedimentation Pond include:

Photo 28
North Sedimentation Pond –
looking south to north.

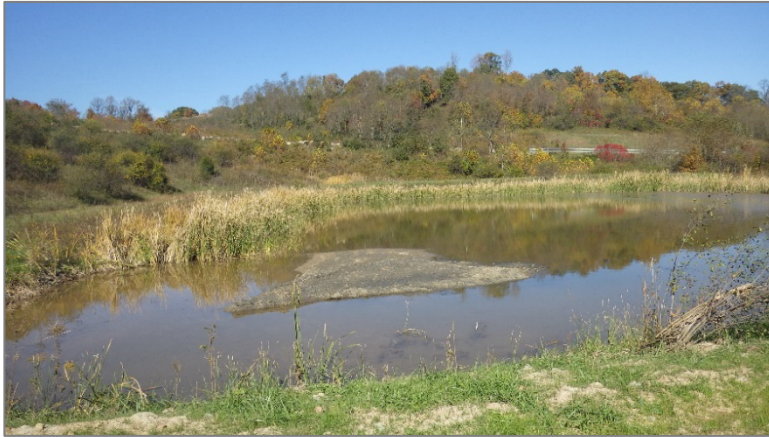
The Interim Leachate Collection Pond is part of Phase 1 construction activities (Photo 34, Appendix B). It manages leachate from the active CCR landfill. Observations made at the Interim Leachate Collection Pond include:

Photo 34
Interim Leachate Collection
Pond – south looking north.

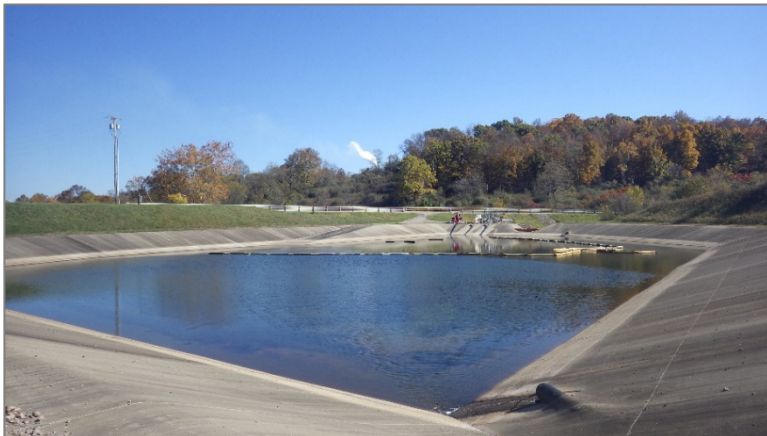
The Leachate Collection Pond (Photo 42, Appendix B) is concrete lined and was constructed as part of the initial Phase 1 site activities. It manages leachate from the active CCR landfill. Inflows are piped from the Interim Leachate Collection Pond. See Appendix A for a plan view of the pond. The following observations were made during the site visit.

Photo 42
Leachate Collection Pond –
Northwest looking southeast.
