# **2020 Annual Dam and Dike Inspection Report**

**Bottom Ash Pond Complex  
South Fly Ash Pond**

**Kyger Creek Plant  
Ohio Valley Electric Corporation (OVEC)  
Gallia County, Ohio**

**October 2020**

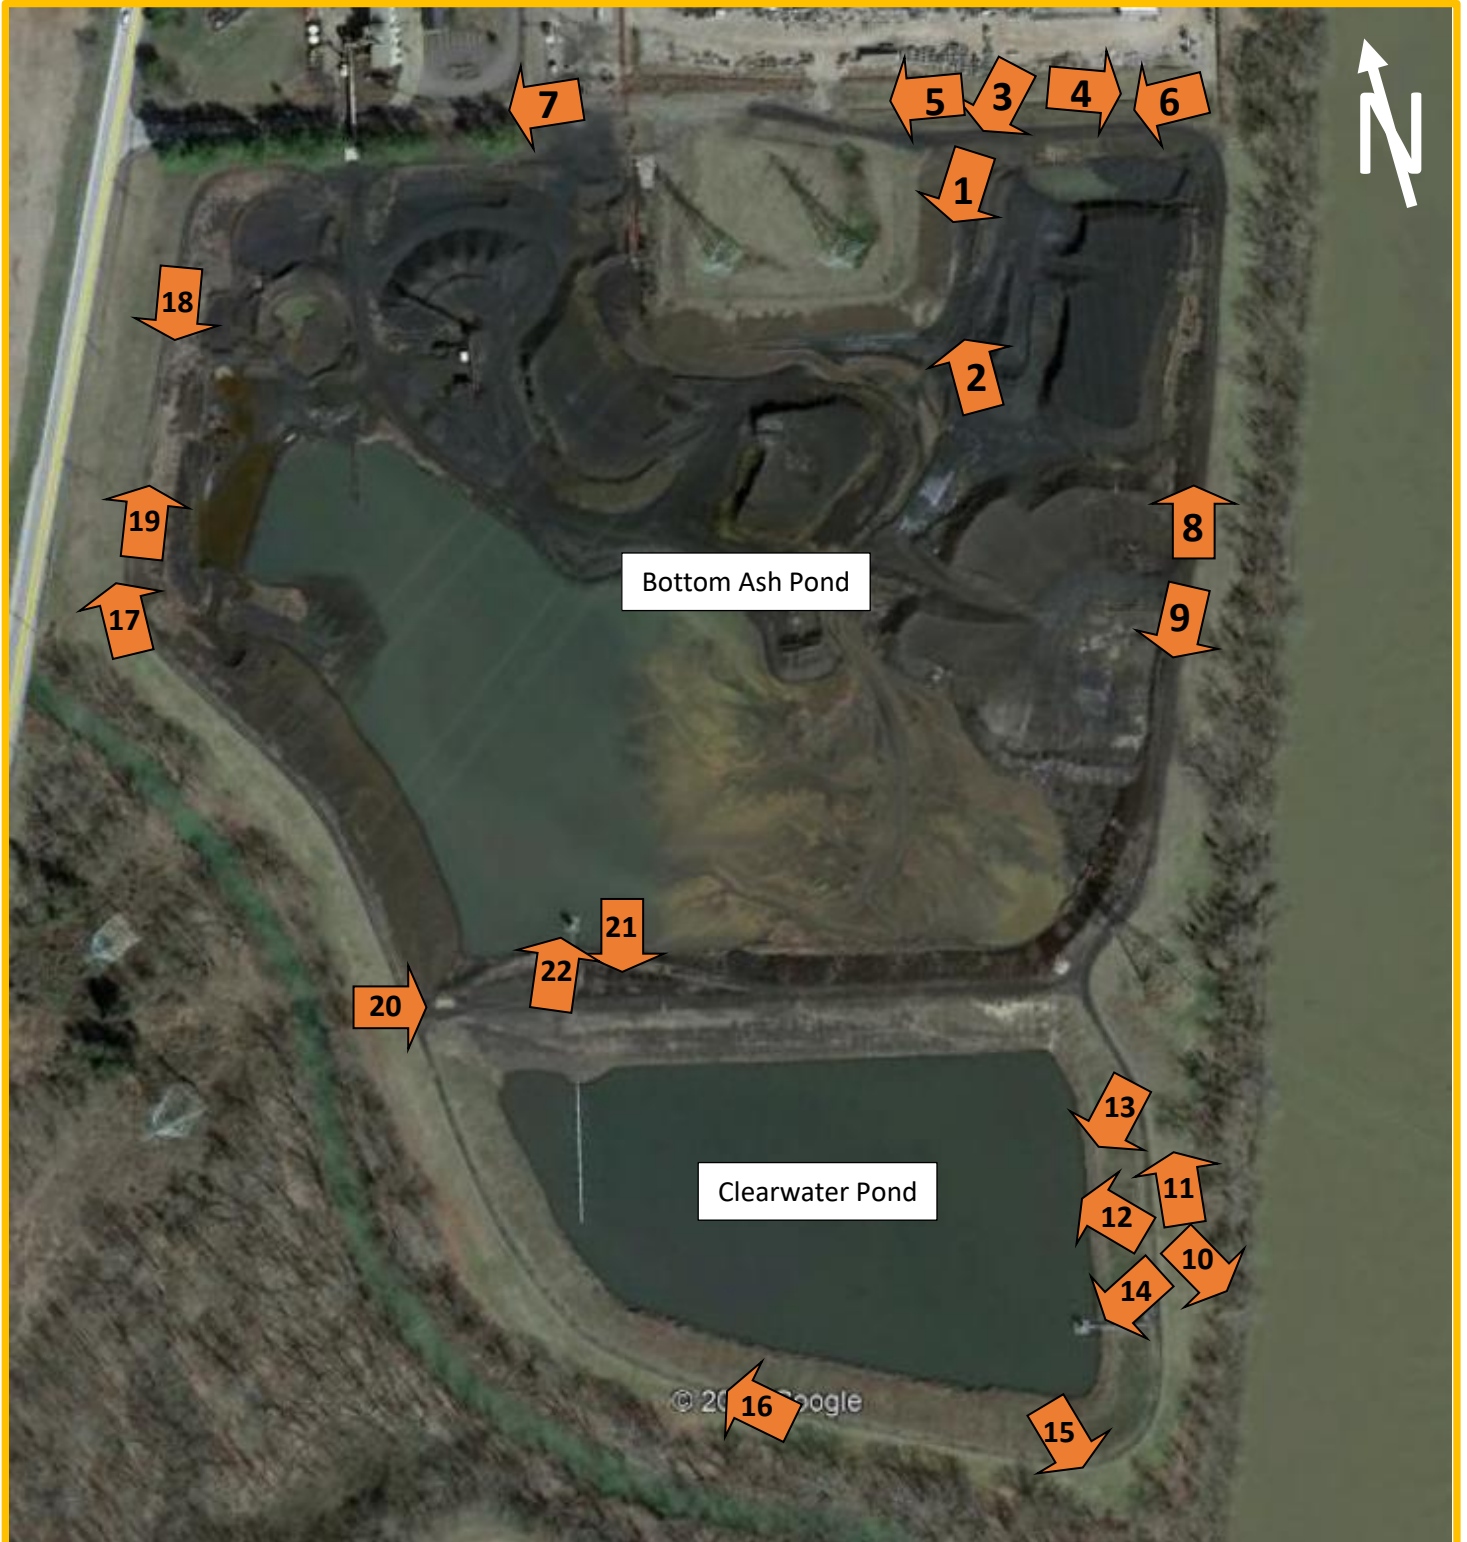
**Figure 3 – Inspection Photograph Map**  
**Bottom Ash Pond Complex**  
**Kyger Creek Plant, Cheshire, OH**

Overall the facility is in good condition and is being well maintained. The impoundment is functioning as intended with no signs of potential structural weakness or conditions which are disrupting to the safe operation of the impoundment. Inspection photograph locations are shown on Figure 3. Inspection photos are included in Attachment A. Additional pictures taken during the inspection can be made available upon request.

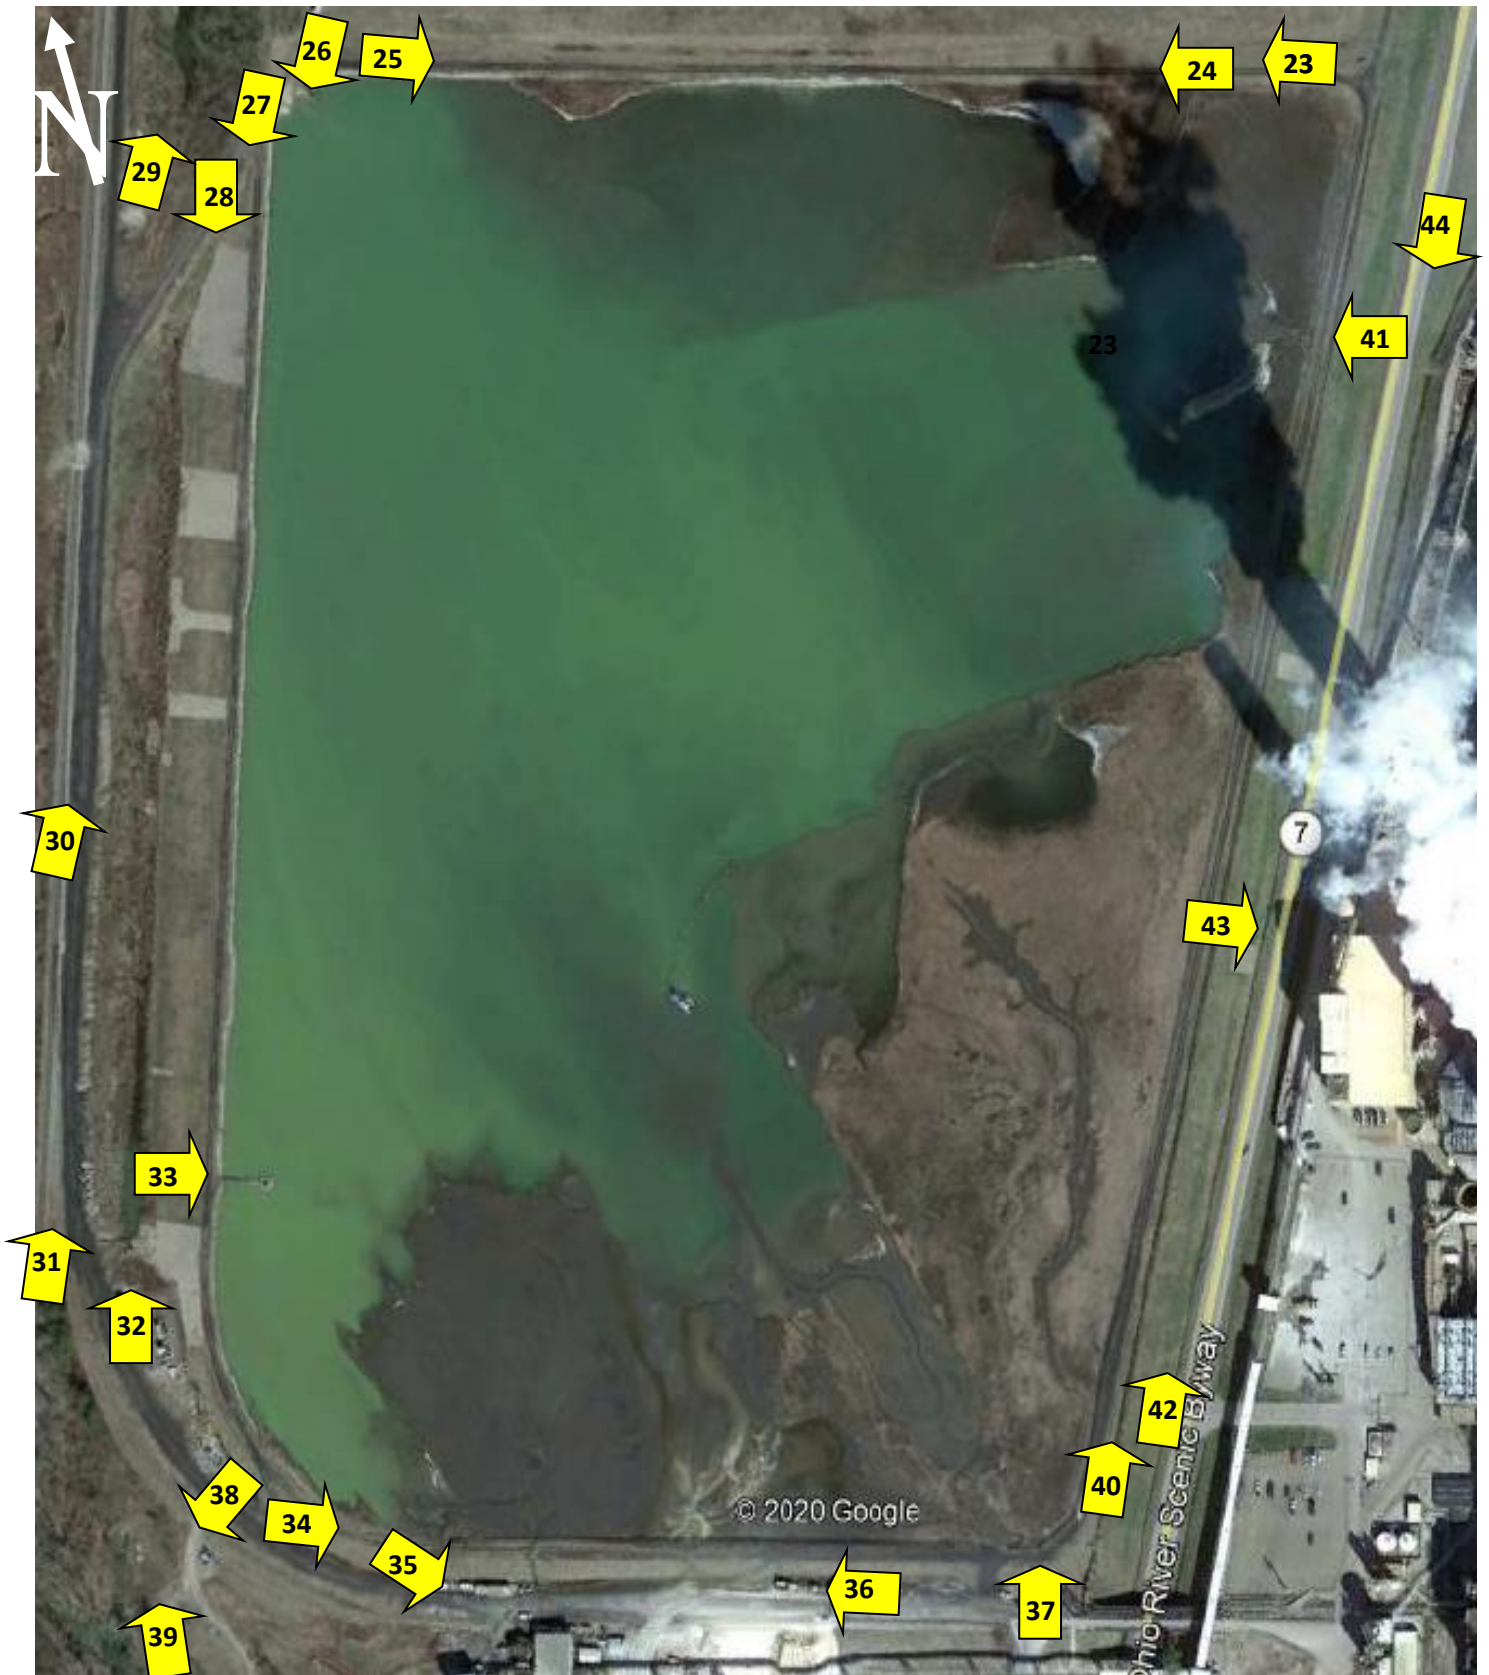
# Figure 6 – Inspection Photograph Map

Overall, the facility is in good condition. The impoundment is functioning as intended with no signs of potential structural weakness or conditions which are disrupting to the safe operation of the impoundment. Inspection photograph locations are shown on Figure 6. Inspection photos are included in Attachment B. Additional pictures taken during the inspection can be made available upon request.

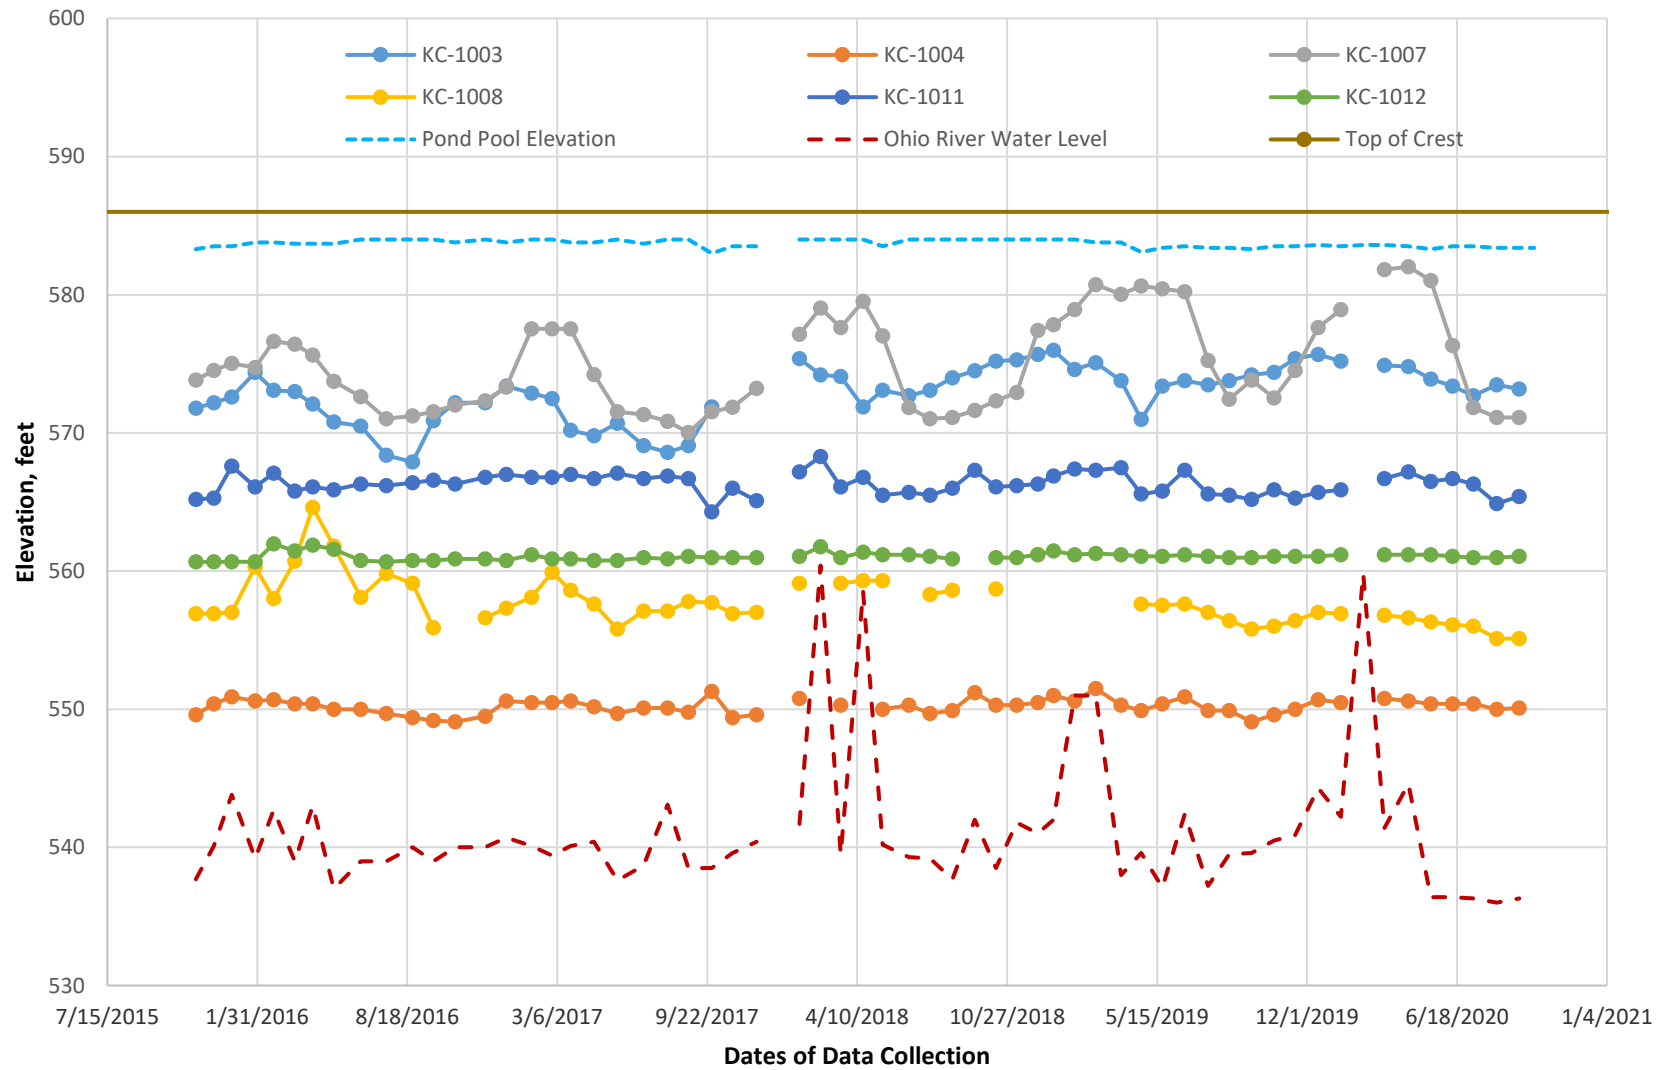
**Figure 7 - South Flyash Pond Piezometer Data.**

The pond stages have remained fairly constant since the last annual inspection. A review of the piezometer hydrographs for each piezometer indicates that no adverse trends are present (Figure 7).

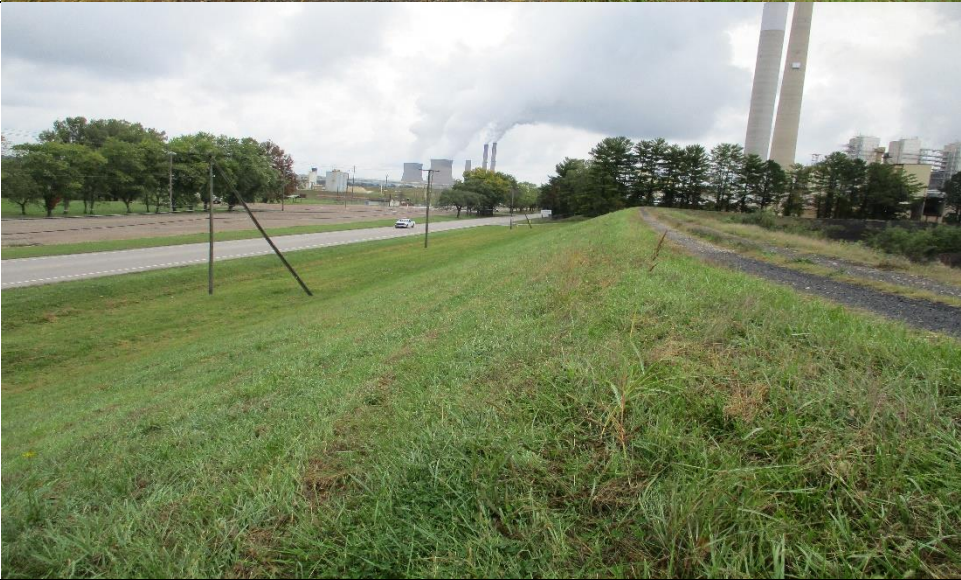
A photograph showing a grassy dike crest and upstream slope. The dike is covered in green grass with some gravel patches. In the background, there are trees, utility poles, and a body of water under a cloudy sky.
<p><u>Photograph No. 17</u></p> <p>This photograph illustrates downstream slope parallel to State Route 7 (looking north). The slope appeared stable and generally in good condition.</p>

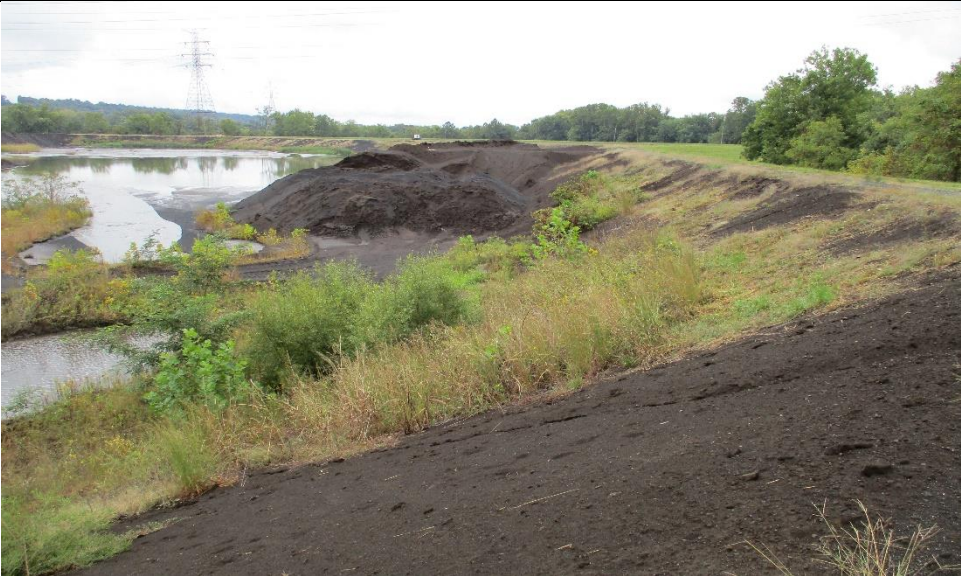
A photograph showing a grassy downstream slope of a dike. The slope is covered in green grass. In the background, there is a road (State Route 7), trees, and industrial buildings with smokestacks under a cloudy sky.
<p><u>Photograph No. 18</u></p> <p>This photograph illustrates bottom ash built-up in the southwest area at the upstream of the west dike.</p>

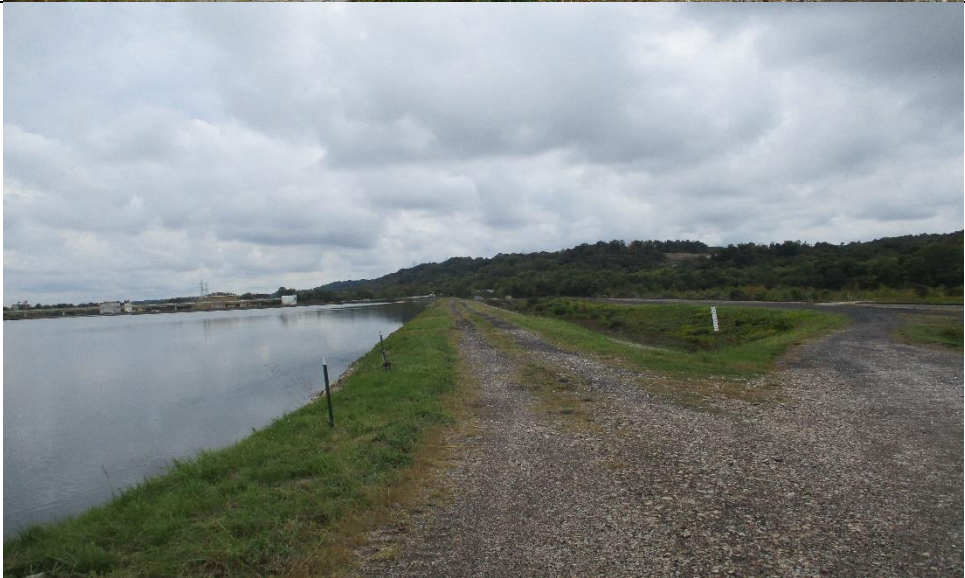
- (ii) The upstream slope of the west dike is illustrated in Photograph No. 26. The slope with riprap protection appeared in good condition with controlled vegetation in the upper section. The crest (Photograph No. 27) had no signs of distress and the access ramp (Photograph No. 28) to the perimeter road appeared good.

A wide-angle photograph showing the upstream slope of a dike. The dike is covered in a layer of grey riprap. To the left is a large body of water, and to the right is a gravelly area with some sparse vegetation. The sky is overcast with grey clouds.
<p><u>Photograph No. 27</u></p> <p>This photograph illustrate the crest of the west dike and access ramp to the perimeter road.</p>

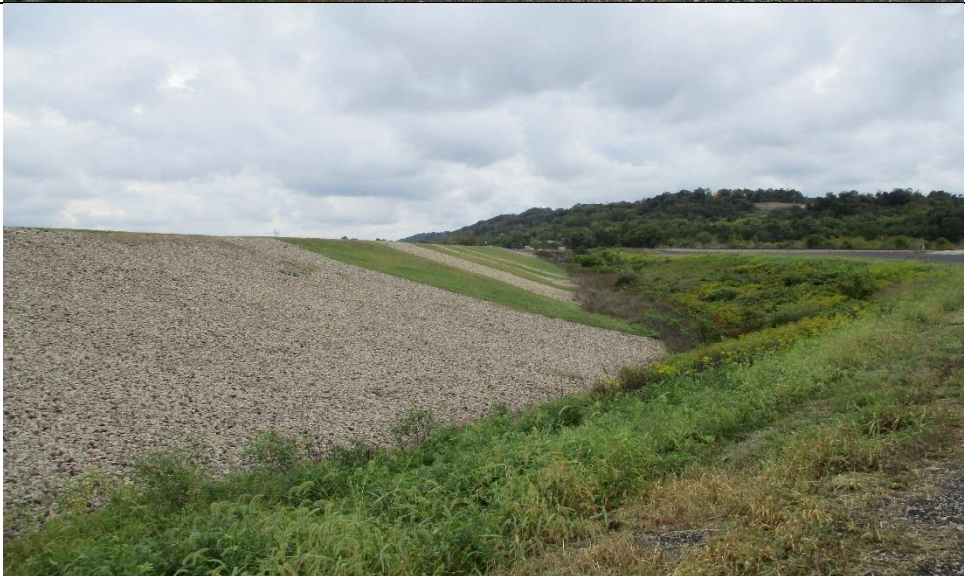
- (iii) The overall condition of the west dike downstream slope consists of several sections with riprap protection along the slope. The slope appeared in good and stable condition (Photograph No. 28). The drainage channel located at the toe of the slope indicated positive drainage but consists of thick brush and vegetation growth (Photographs No. 29

A photograph showing the crest of the dike, which is a gravelly path. To the left is the water, and to the right is a gravelly area that appears to be an access ramp or road. The background shows a line of trees and a cloudy sky.
<p><u>Photograph No. 28</u></p> <p>This photograph illustrate the downstream slope and the discharge drainage ditch of the west dike.</p>
