**Re: Indiana-Kentucky Electric Corporation
Clifty Creek Station
Notification of CCR Rule Information Posting
Annual Certified CCR Dam and Dike (Surface Impoundment)
Inspection Report Posting**

**2023 CCR Rule – Surface Impoundments
Clifty Creek Dam/Dike Inspections**

Clifty Creek Generating Station
Madison, Indiana
Jefferson County

January 19, 2024

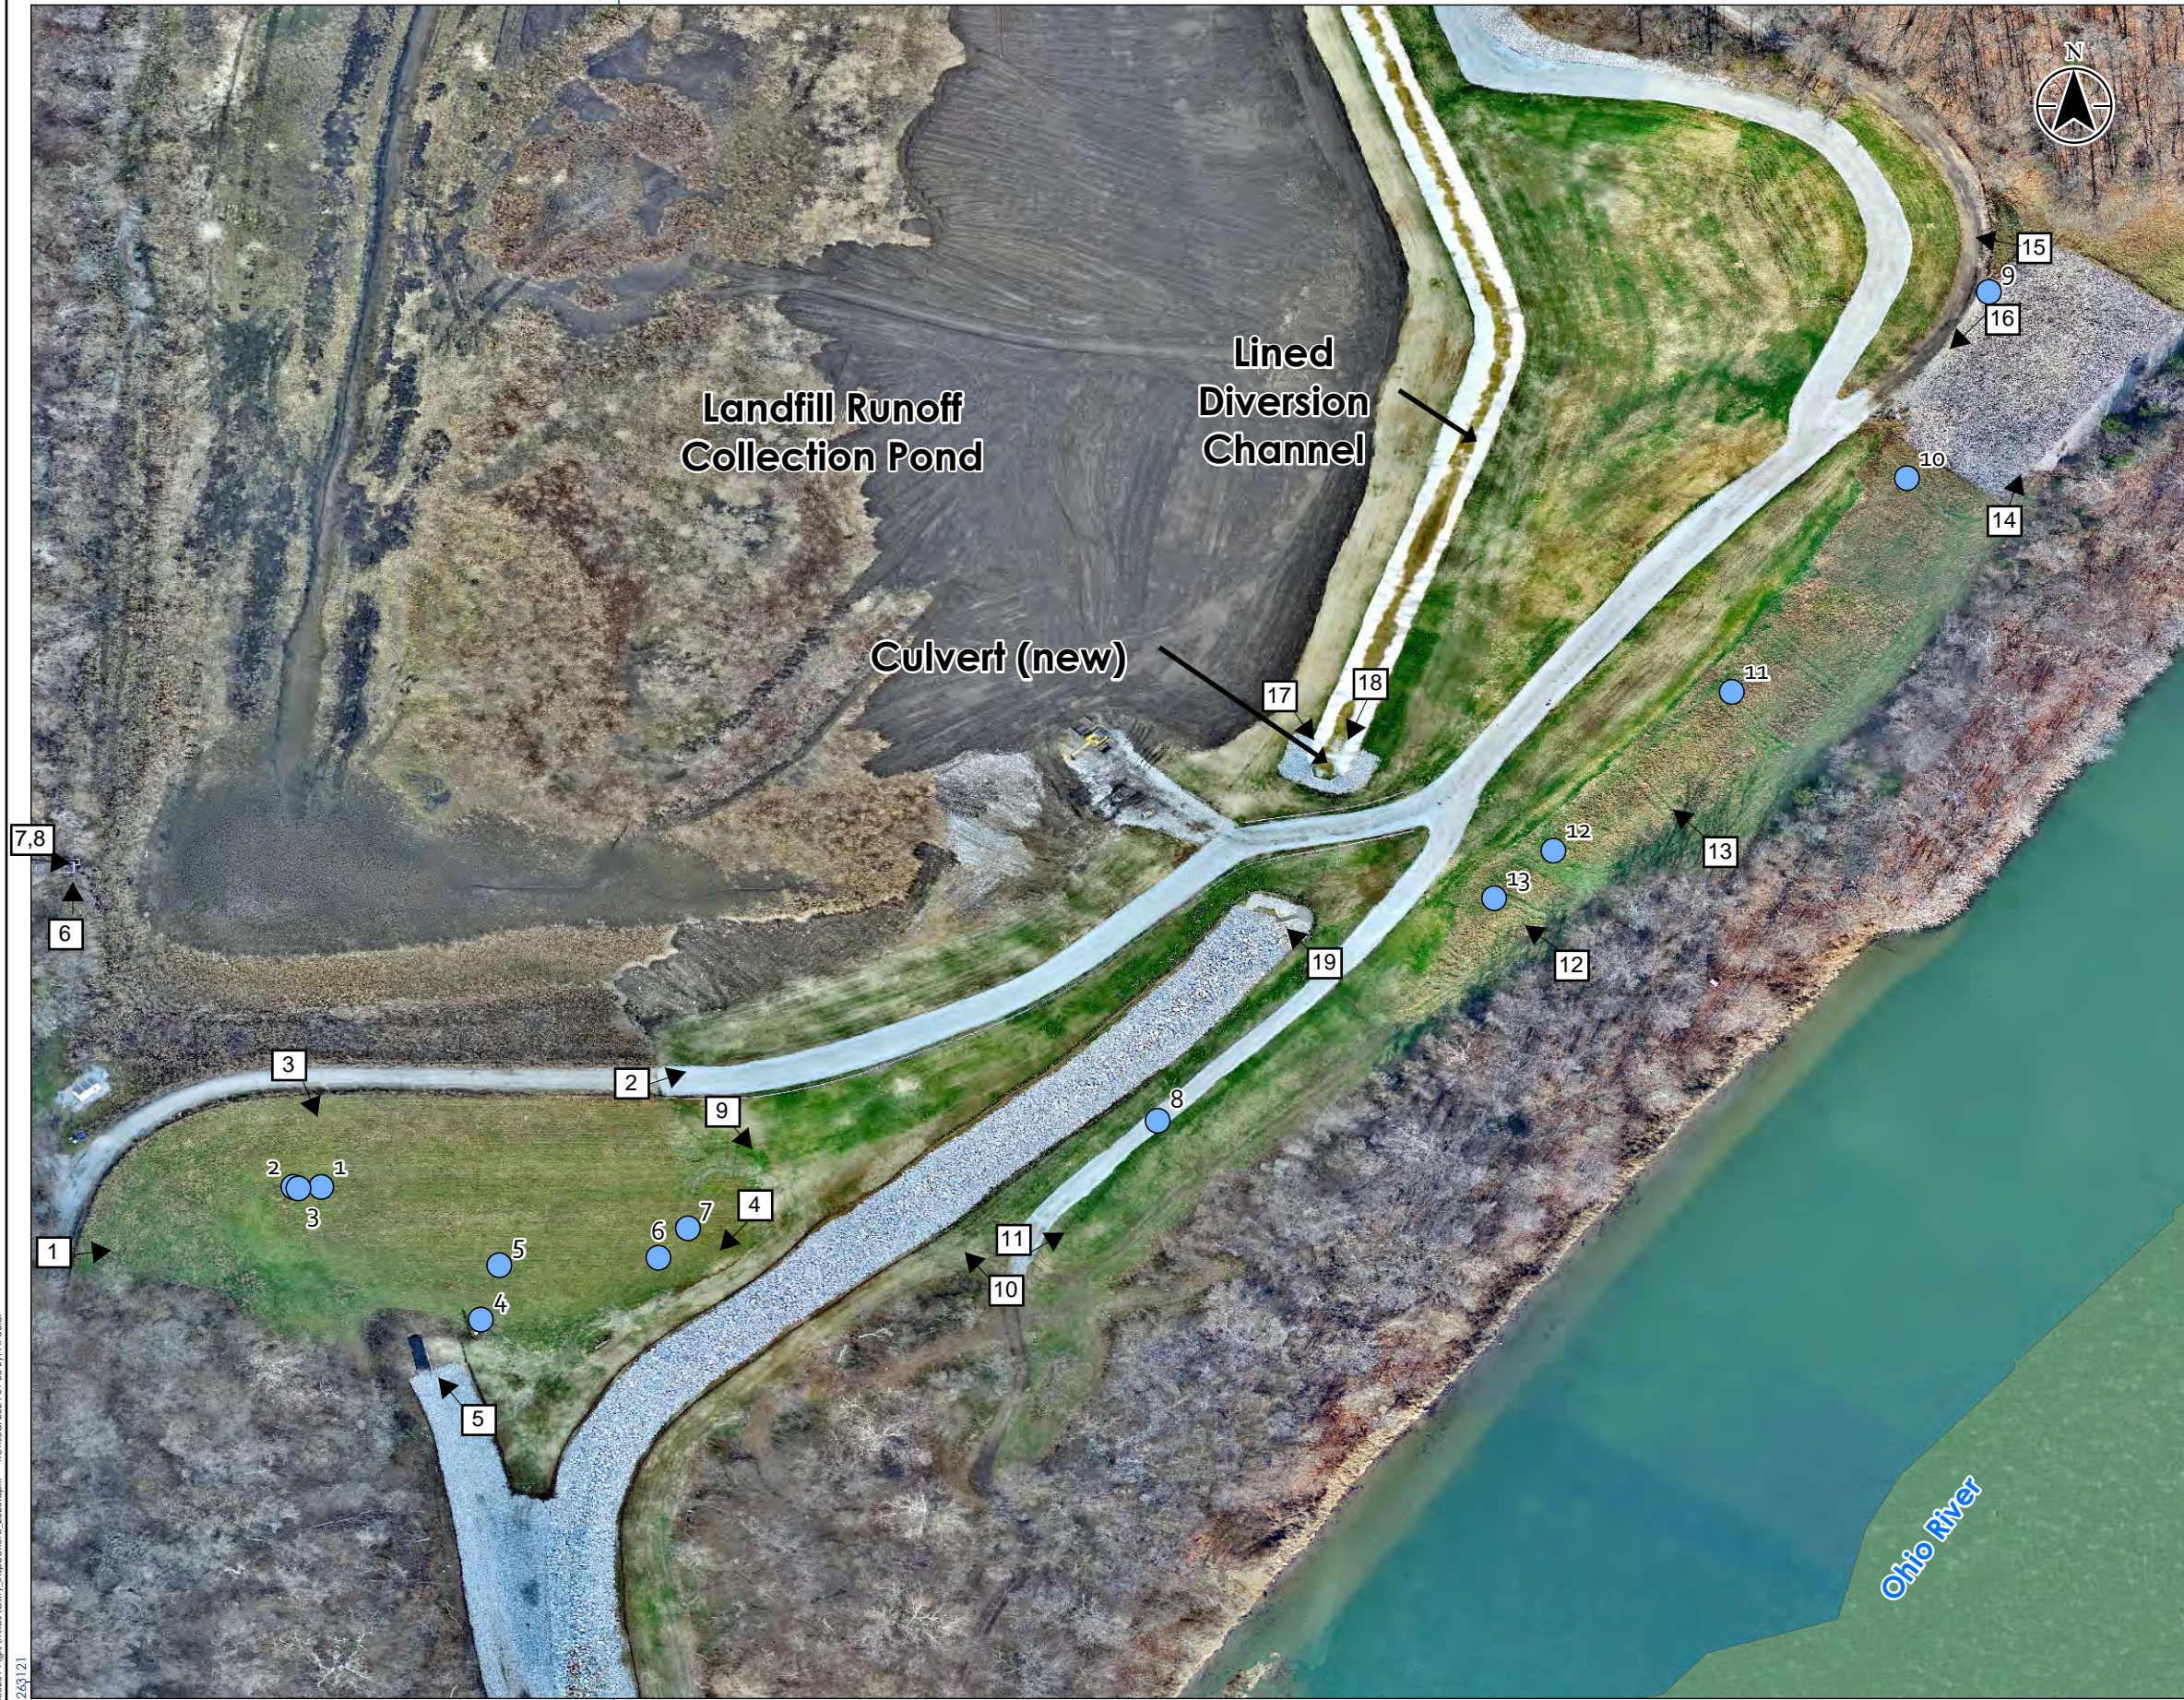
Client/Project: Indiana - Kentucky Electric Corporation
 Landfill Runoff Collection Pond

along the north edge of the new channel where erosion rills had started to form and one location below the access road to the toe where the seeded surface had sloughed off the slope. On the downstream slope between the access road to the toe and the riprap-covered slope are several areas where minor grading occurred. In these areas the bulldozer trampled the grass and may require reseeding to prevent erosion. Overall, the dam and associated structures appear to be in satisfactory condition.

Appendix A includes a plan view and table with inspection points identified in the field. Appendix D includes a photographic log of the conditions.

Dam degradation and the addition of the 12-foot by 4-foot box culvert to allow routing of run-on stormwater around the LRCP have potential for affecting the stability of the dam. Placement of a structure in or below an earthen dam provides the potential for seepage around the structure. Stantec provided a professional engineer to provide quality assurance during construction activities on the LRCP dam. Based on review of the construction observation reports, clay fill was adequately placed and compacted around the outside of the culvert structure. Shortly after completion of construction, the culvert appeared to adequately convey water from the upstream side to the downstream channel. Grass should help protect the slopes from erosion once the newly seeded slopes have matured.

Minor maintenance for the LRCP includes mowing of the dam slopes to observe potential issues or concerns, repairing the erosion rills above the downstream channel (Photograph 10) and the disturbed areas on the western downstream slope just west of the newly graded slope (Photograph 9). The surface-sloughed area beneath the access road to the toe (Photograph 12) and the thinly vegetated slopes east of the access road (Photograph 13) will likely require attention as well.
