# **2021 Annual Dam and Dike Inspection Report**

**Bottom Ash Pond Complex  
South Fly Ash Pond**

**Kyger Creek Plant  
Ohio Valley Electric Corporation (OVEC)  
Gallia County, Ohio**

Document Number: GERS-21-074

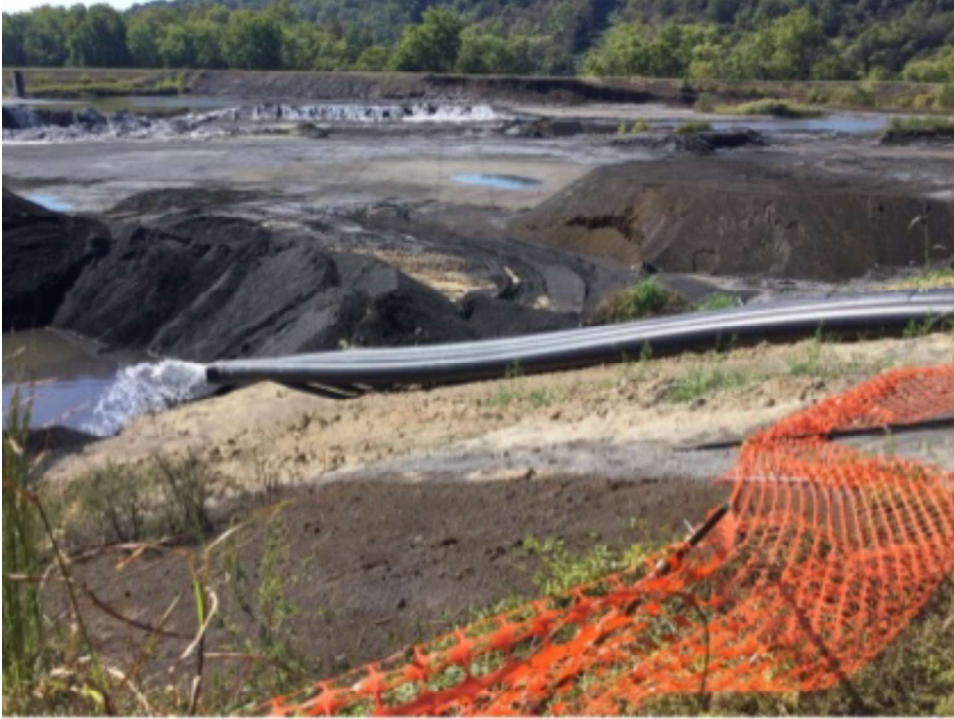
Photo #: 83

Notes: West discharge pipes on along north dike interior slope
